# Bloomfield Municipal Airport

## Pavement Management Report

**AUGUST 2025**

# BLOOMFIELD MUNICIPAL AIRPORT PAVEMENT MANAGEMENT REPORT

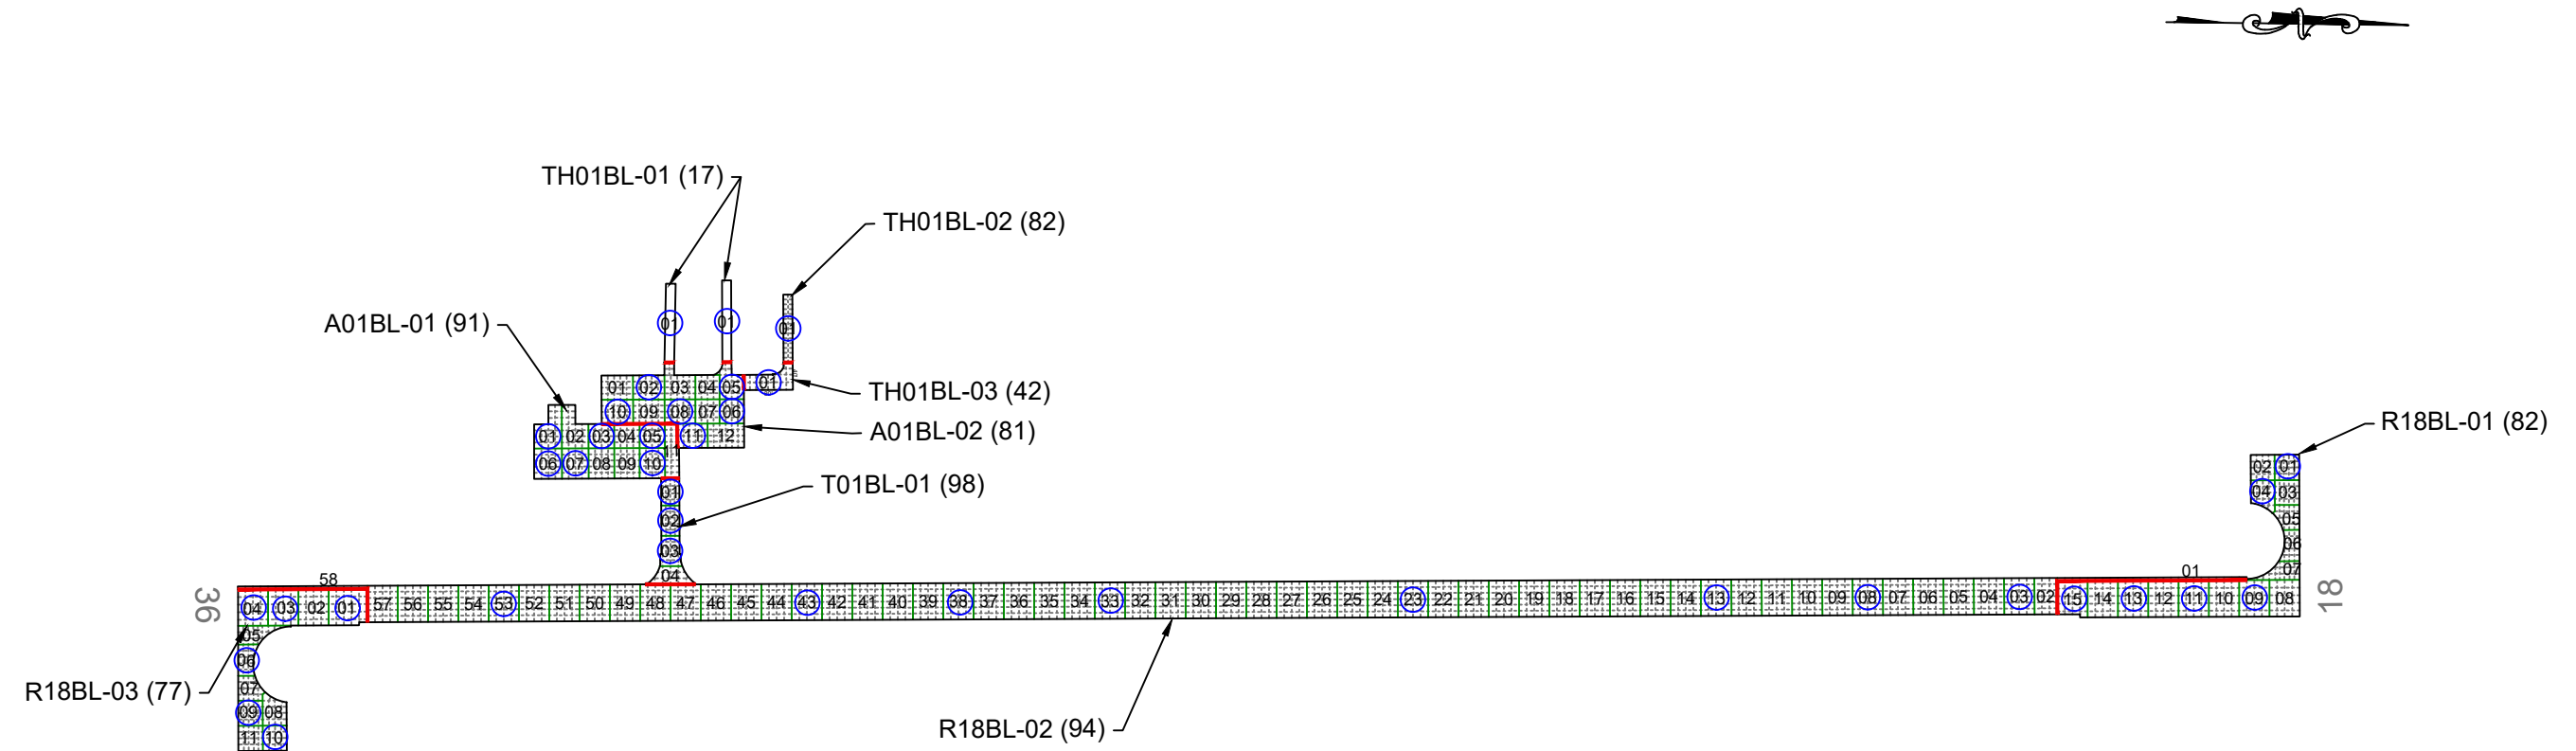
FIGURE 3. NETWORK DEFINITION MAP.

Approximately 290,100 square feet of pavement were evaluated at Bloomfield Municipal Airport, as illustrated in Figure 2. This figure also shows the area-weighted age in years of the pavements at the time of the inspection. Figure 3 provides a map that details how the pavement network was divided into management units and identifies the sample units that were evaluated during the pavement inspection at Bloomfield Municipal Airport.

The network definition map provided in Figure 3 of this report shows the location of all runways, taxiways, aprons, and T-hangars at Bloomfield Municipal Airport. If any new pavements are constructed or any pavement areas are permanently closed, this map must be updated. Project plans should be submitted to the Iowa DOT after project completion.

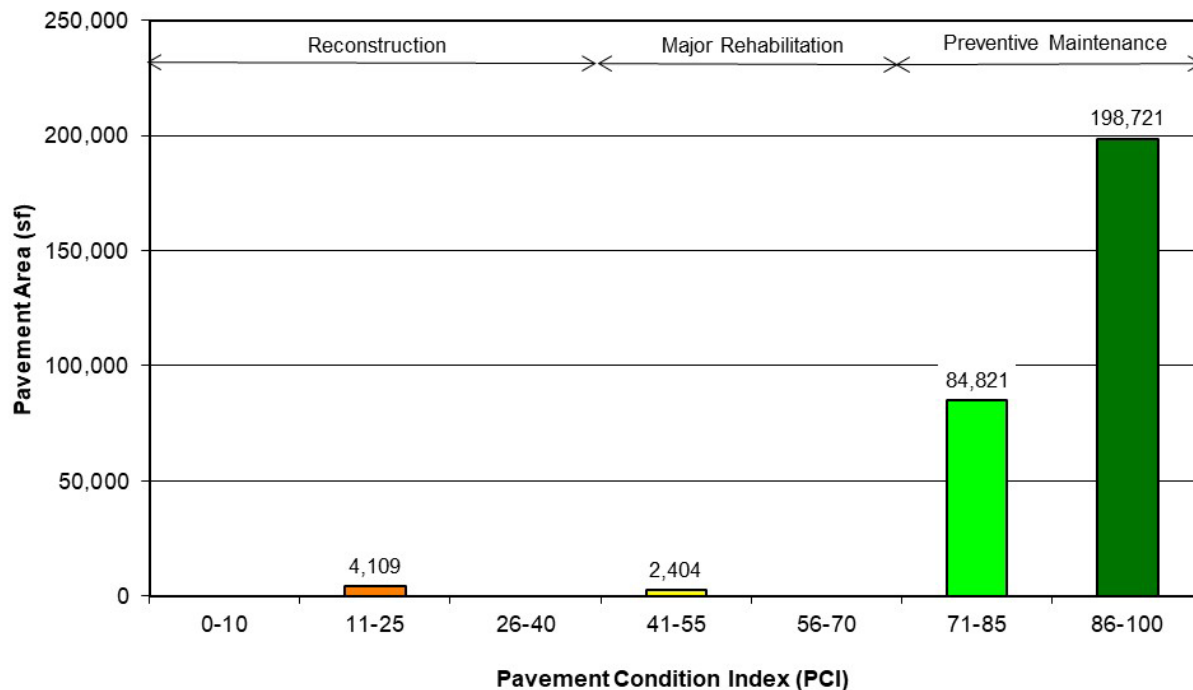
Figure 6. Pavement area by PCI range at Bloomfield Municipal Airport.

Figure 6 summarizes the overall condition of the pavements at Bloomfield Municipal Airport, and Figure 7 presents area-weighted condition (average PCI adjusted to account for the relative size of the pavement sections) by branch use. Figure 8 is a map that displays the condition of the evaluated pavements. Table 1 summarizes the results of the pavement evaluation. Appendix B presents photographs taken during the PCI inspection, and Appendix C contains detailed information on the distress types observed during the visual survey. Appendix D includes detailed work history information that was collected during the record review process.
