Centerville Municipal Airport

Pavement Management Report

JULY 2024

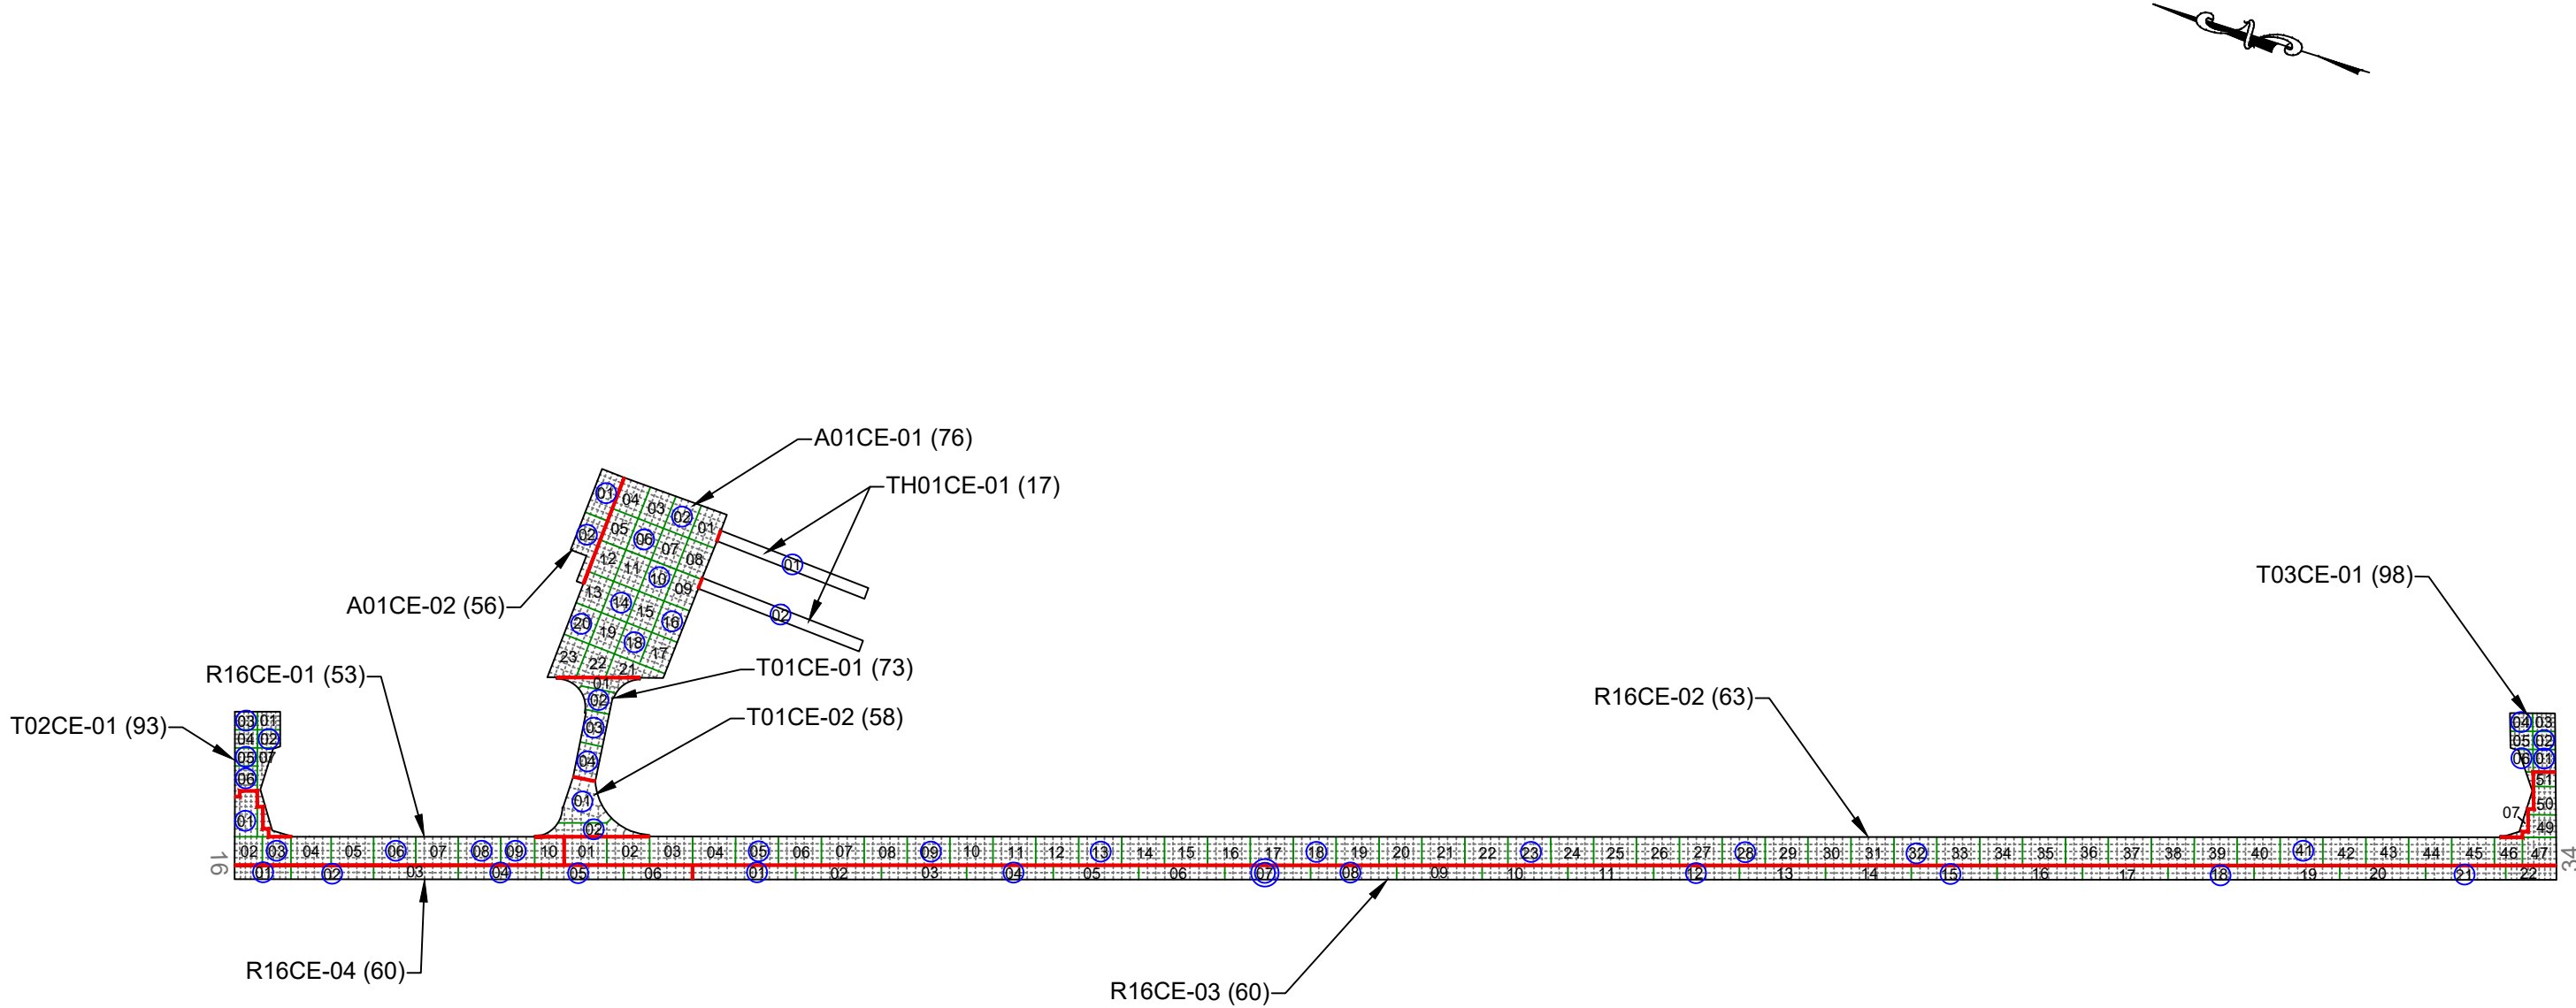
FIGURE 3. NETWORK DEFINITION MAP.

Approximately 439,400 square feet of pavement were evaluated at Centerville Municipal Airport, as illustrated in Figure 2. This figure also shows the area-weighted age in years of the pavements at the time of the inspection. Figure 3 provides a map that details how the pavement network was divided into management units and identifies the sample units that were evaluated during the pavement inspection at Centerville Municipal Airport.

The network definition map provided in Figure 3 of this report shows the location of all runways, taxiways, aprons, and T-hangars at Centerville Municipal Airport. If any new pavements are constructed or any pavement areas are permanently closed, this map must be updated. Project plans should be submitted to the Iowa DOT after project completion.

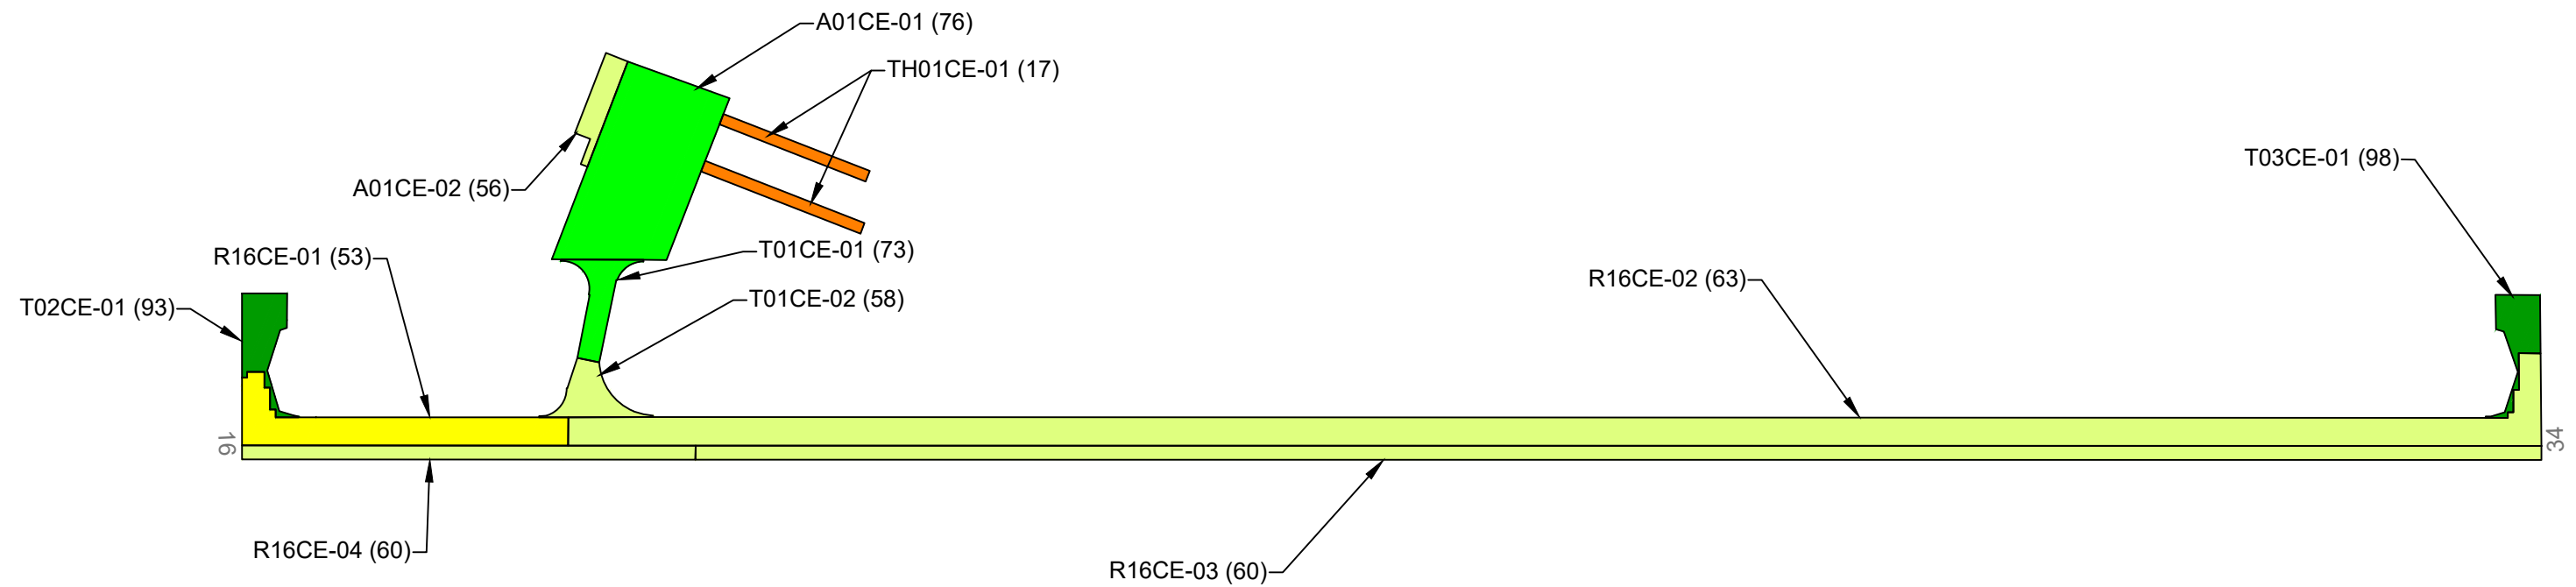
FIGURE 8. PCI MAP.

The pavements at Centerville Municipal Airport were inspected in November 2023. The 2023 area-weighted condition of Centerville Municipal Airport is 64, with conditions ranging from 17 to 98 (on a scale of 0 [failed] to 100 [excellent]). During the previous pavement inspection in 2020, the area-weighted PCI of the airport was 68.

Figure 6 summarizes the overall condition of the pavements at Centerville Municipal Airport, and Figure 7 presents area-weighted condition (average PCI adjusted to account for the relative size of the pavement sections) by branch use. Figure 8 is a map that displays the condition of the evaluated pavements. Table 1 summarizes the results of the pavement evaluation. Appendix B presents photographs taken during the PCI inspection, and Appendix C contains detailed information on the distress types observed during the visual survey. Appendix D includes detailed work history information that was collected during the record review process.
