# Chariton Municipal Airport

## PAVEMENT MANAGEMENT REPORT

**JULY 2022**

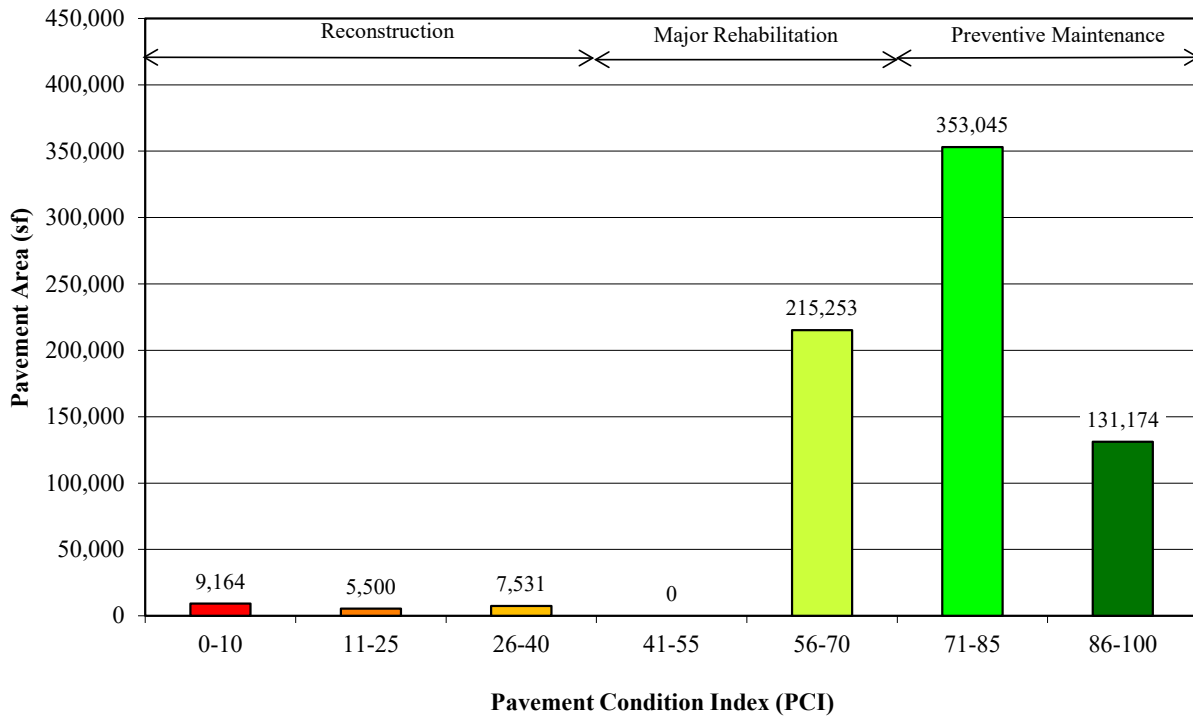
Figure 6. Pavement area by PCI range at Chariton Municipal Airport.

The pavements at Chariton Municipal Airport were inspected in November 2021. The 2021 area-weighted condition of Chariton Municipal Airport is 76, with conditions ranging from 2 to 97 (on a scale of 0 [failed] to 100 [excellent]). During the previous pavement inspection in 2018, the area-weighted PCI of the airport was 80.

Figure 6 summarizes the overall condition of the pavements at Chariton Municipal Airport, and Figure 7 presents area-weighted condition (average PCI adjusted to account for the relative size of the pavement sections) by branch use. Figure 8 is a map that displays the condition of the evaluated pavements. Table 1 summarizes the results of the pavement evaluation. Appendix B presents photographs taken during the PCI inspection, and Appendix C contains detailed information on the distress types observed during the visual survey. Appendix D includes detailed work history information that was collected during the record review process.
