Chariton Municipal Airport

Pavement Management Report

AUGUST 2025

CHARITON MUNICIPAL AIRPORT PAVEMENT MANAGEMENT REPORT

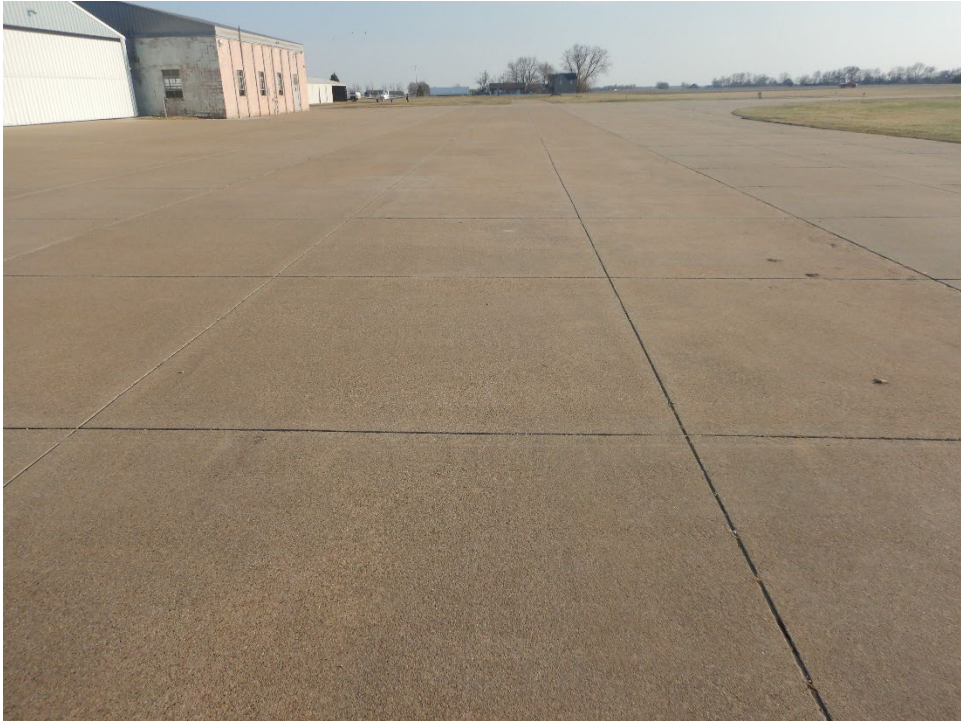
A01CH-01. Overview.

Branch	Section	Surface Type	Section Area (sf)	LCD	2025 PCI	% Distress Due to Load	% Distress Due to Climate/Durability	% Distress Due to Other	Type of Distress
A01CH	01	PCC	30,018	5/1/2000	88	41	41	18	ASR, Corner Break, Corner Spalling, Joint Spalling, Joint Seal Damage, Large Patch, LTD Cracking, Shattered Slab
A02CH	01	PCC	30,600	6/1/1996	75	0	20	80	ASR, Corner Spalling, Faulting, Joint Spalling, Joint Seal Damage, Small Patch
A02CH	02	PCC	7,583	6/3/2024	98	0	0	100	Faulting
R10CH	01	PCC	302,631	6/1/1996	79	15	23	62	ASR, Corner Break, Corner Spalling, Joint Seal Damage, Large Patch, LTD Cracking, Small Patch
R10CH	02	PCC	5,963	7/1/2018	98	0	100	0	Joint Seal Damage
R17CH	01	PCC	215,253	6/2/1997	62	46	14	40	ASR, Corner Break, Corner Spalling, Faulting, Joint Spalling, Joint Seal Damage, Large Patch, LTD Cracking, Shattered Slab, Small Patch
T01CH	01	PCC	8,180	5/1/2000	88	43	42	15	Joint Spalling, Joint Seal Damage, Large Patch, LTD Cracking, Shrinkage Cracking

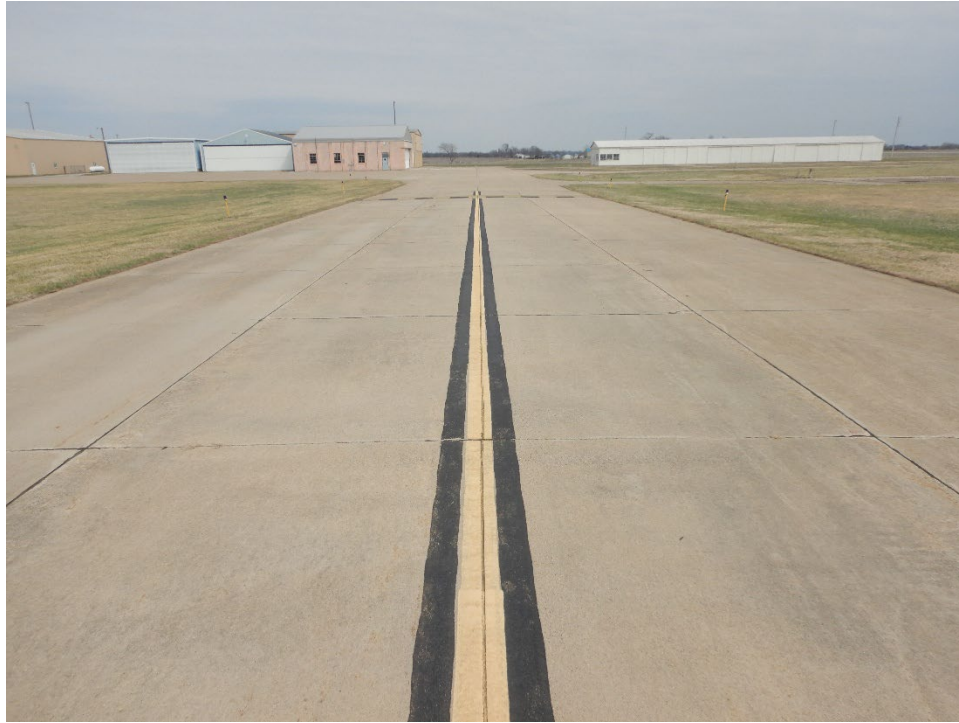
T01CH-02. Overview.

T01CH	02	PCC	8,728	6/1/1997	75	15	22	63	ASR, Corner Break, Faulting, Joint Spalling, Joint Seal Damage, LTD Cracking, Scaling, Shrinkage Cracking
T02CH	01	PCC	11,431	6/1/1996	71	21	15	64	ASR, Corner Break, Corner Spalling, Faulting, Joint Spalling, Joint Seal Damage, Large Patch, LTD Cracking, Shrinkage Cracking
T03CH	01	PCC	42,207	6/1/1996	88	0	45	55	ASR, Faulting, Joint Spalling, Joint Seal Damage, Scaling
T04CH	01	PCC	49,043	1/1/2017	95	0	74	26	Corner Spalling, Faulting, Joint Seal Damage

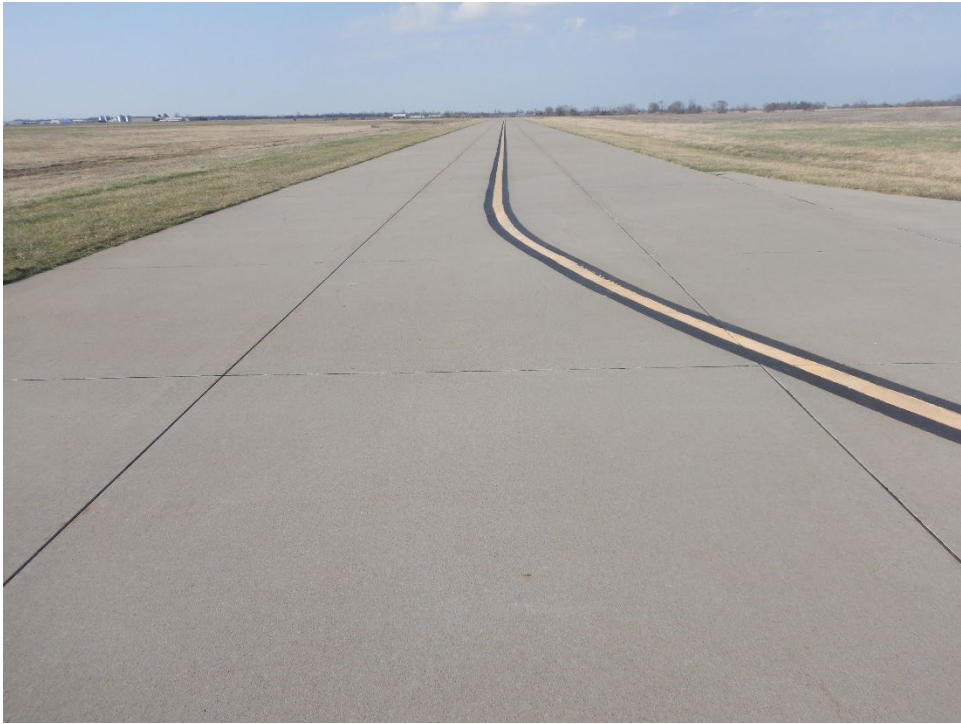
T04CH-01. Overview.

Taxiway 04 consisted of one section with low-severity corner spalling, low-severity faulting, and low- and medium-severity joint seal damage.

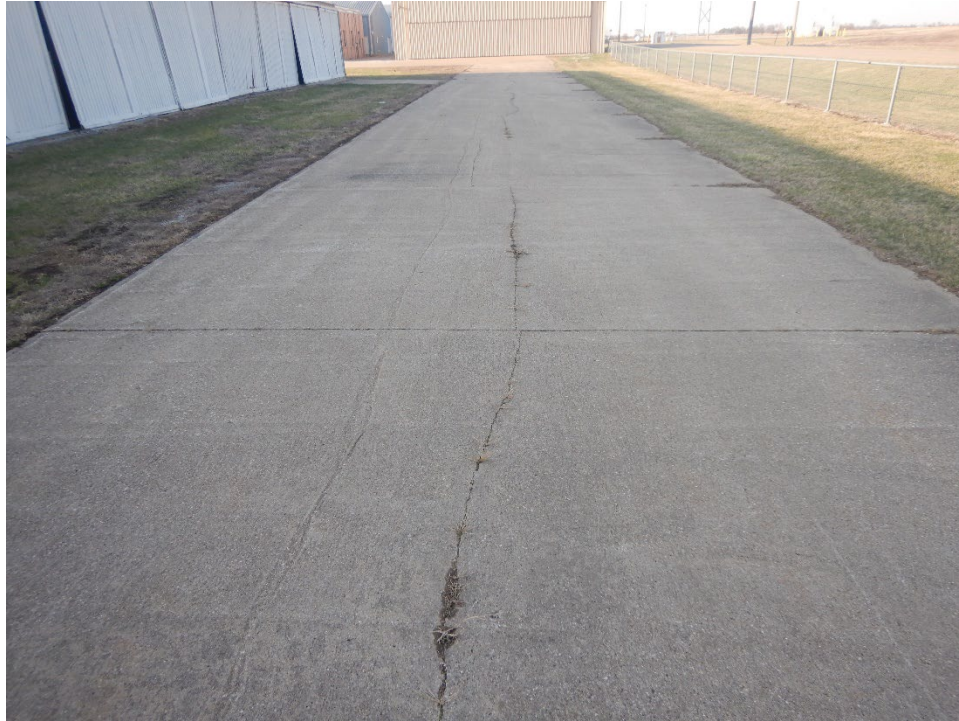
TH01CH-01. Overview.

Branch	Section	Surface Type	Section Area (sf)	LCD	2025 PCI	% Distress Due to Load	% Distress Due to Climate/Durability	% Distress Due to Other	Type of Distress
TH01CH	01	PCC	7,531	1/1/1977	29	52	11	37	ASR, Corner Spalling, Faulting, Joint Seal Damage, LTD Cracking, Shrinkage Cracking
TH01CH	02	PCC	9,164	1/1/1977	1	35	32	33	ASR, Blowup, Corner Break, Corner Spalling, Joint Spalling, Joint Seal Damage, LTD Cracking, Scaling, Shattered Slab
TH01CH	03	PCC	5,500	1/1/1977	25	73	11	16	ASR, Joint Seal Damage, LTD Cracking, Shattered Slab
