# Cherokee County Regional Airport

## Pavement Management Report

**AUGUST 2026**

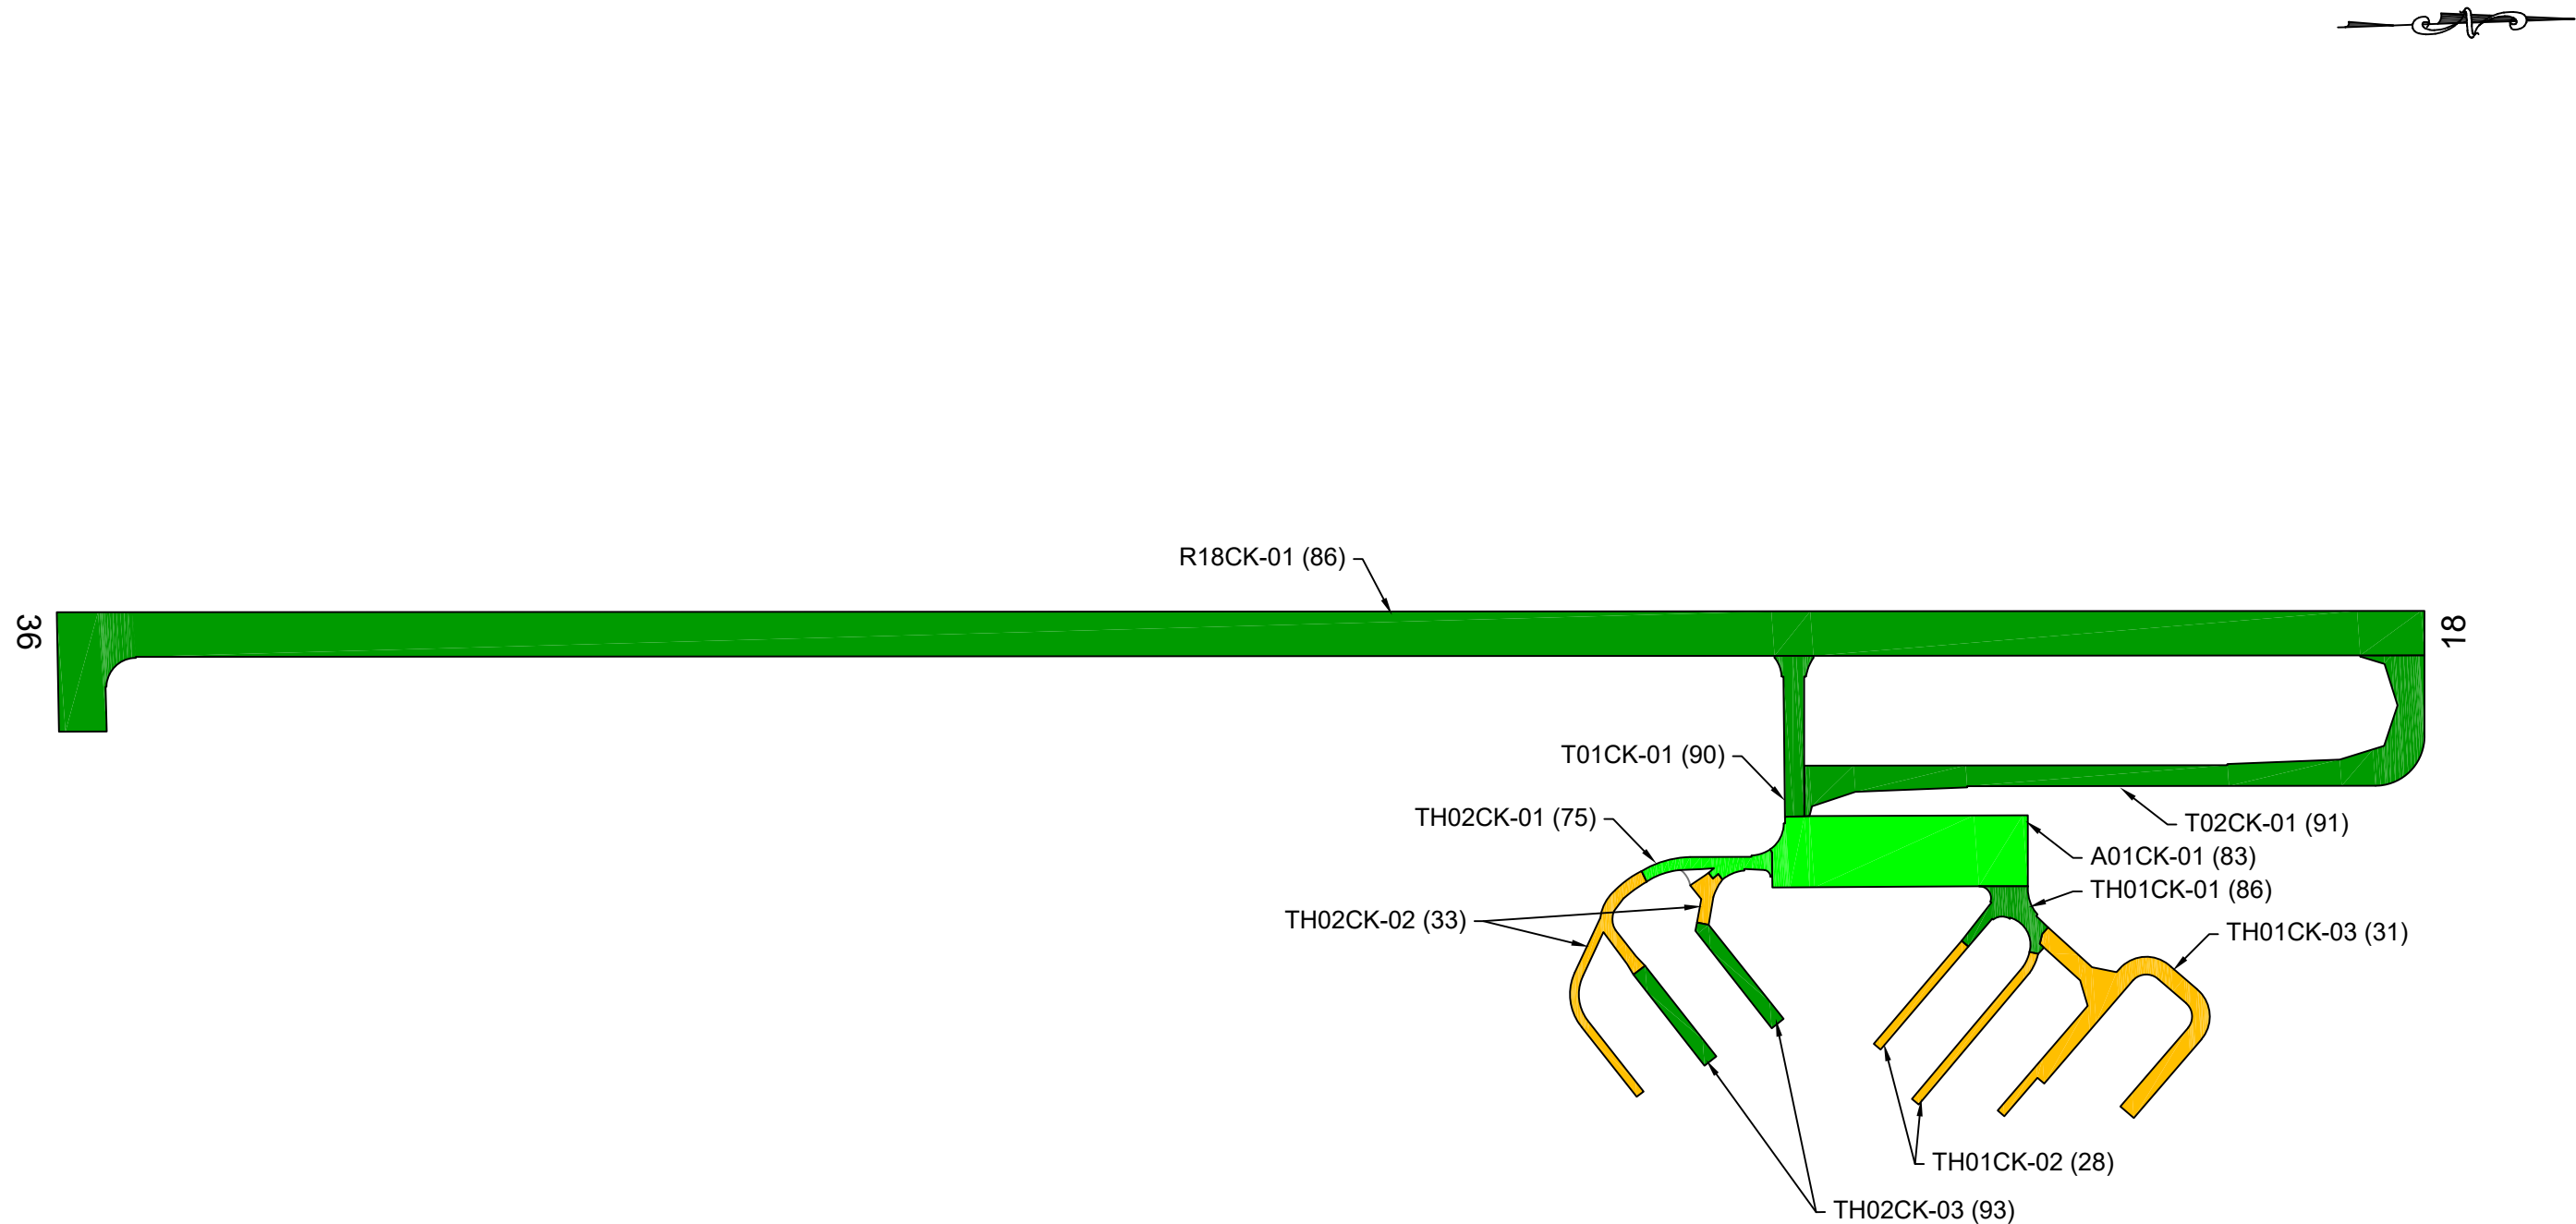
FIGURE 8. PCI MAP.

The pavements at Cherokee County Regional Airport were inspected in March 2026. The 2026 area-weighted condition of Cherokee County Regional Airport is 81, with conditions ranging from 28 to 93 (on a scale of 0 [*Failed*] to 100 [*Excellent*]). During the previous pavement inspection in 2022, the area-weighted PCI of the airport was 83.

Figure 6 summarizes the overall condition of the pavements at Cherokee County Regional Airport, and Figure 7 presents area-weighted condition (average PCI adjusted to account for the relative size of the pavement sections) by branch use. Figure 8 is a map that displays the condition of the evaluated pavements. Table 1 summarizes the results of the pavement evaluation. Appendix B presents photographs taken during the PCI inspection, and Appendix C contains detailed information on the distress types observed during the visual survey. Appendix
