# Clarinda-Schenck Field Airport

## Pavement Management Report

**AUGUST 2025**

# CLARINDA-SCHENCK FIELD AIRPORT PAVEMENT MANAGEMENT REPORT

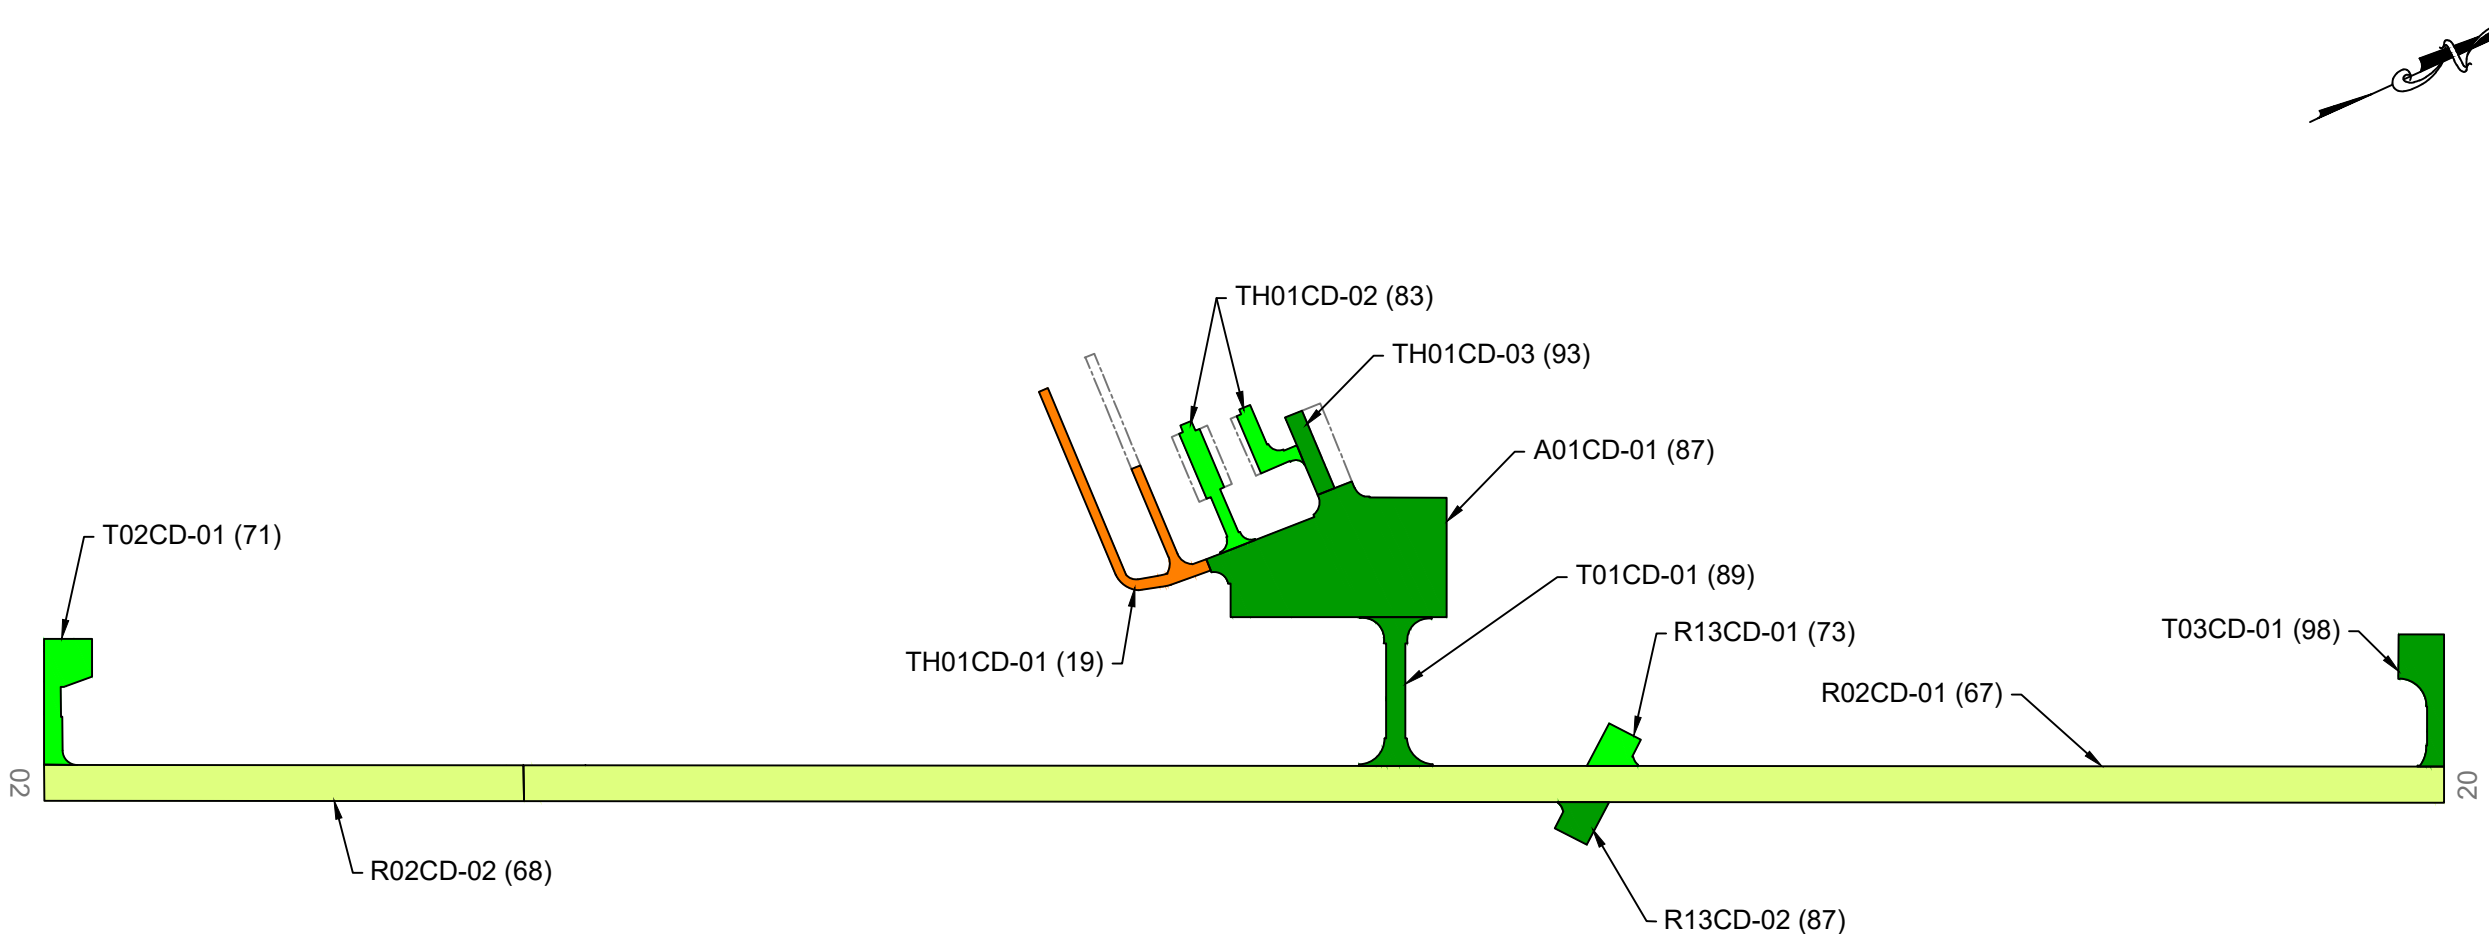
FIGURE 8. PCI MAP.

Figure 6 summarizes the overall condition of the pavements at Clarinda-Schenck Field Airport, and Figure 7 presents area-weighted condition (average PCI adjusted to account for the relative size of the pavement sections) by branch use. Figure 8 is a map that displays the condition of the evaluated pavements. Table 1 summarizes the results of the pavement evaluation.
