# Clinton Municipal Airport

## Pavement Management Report

**AUGUST 2025**

# CLINTON MUNICIPAL AIRPORT PAVEMENT MANAGEMENT REPORT

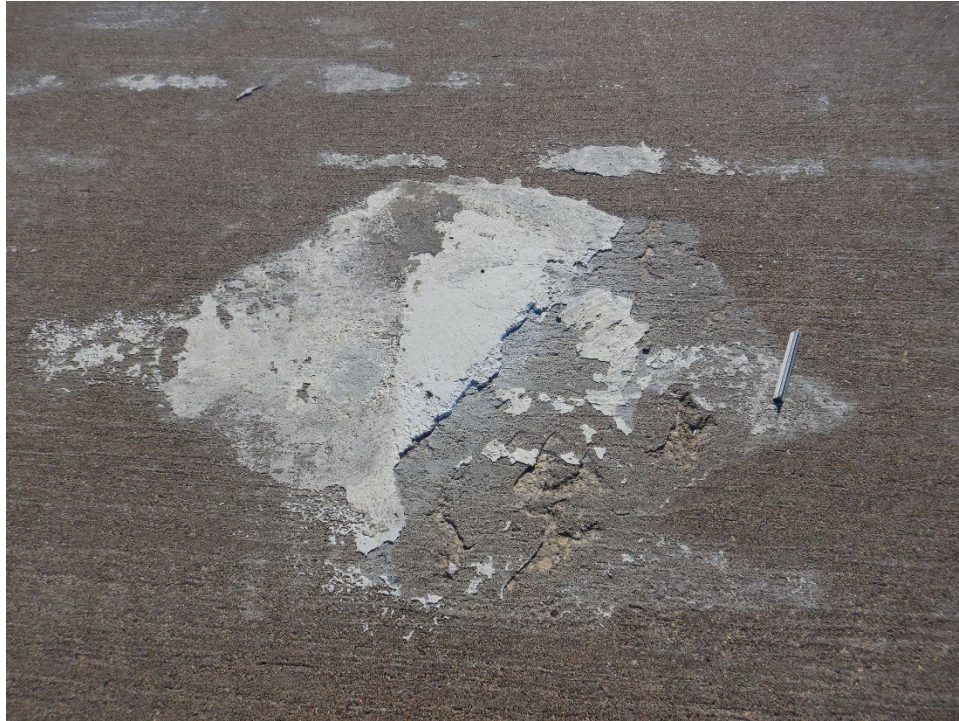
R03CN-01. Scaling (Additional Sample Unit No. 110).

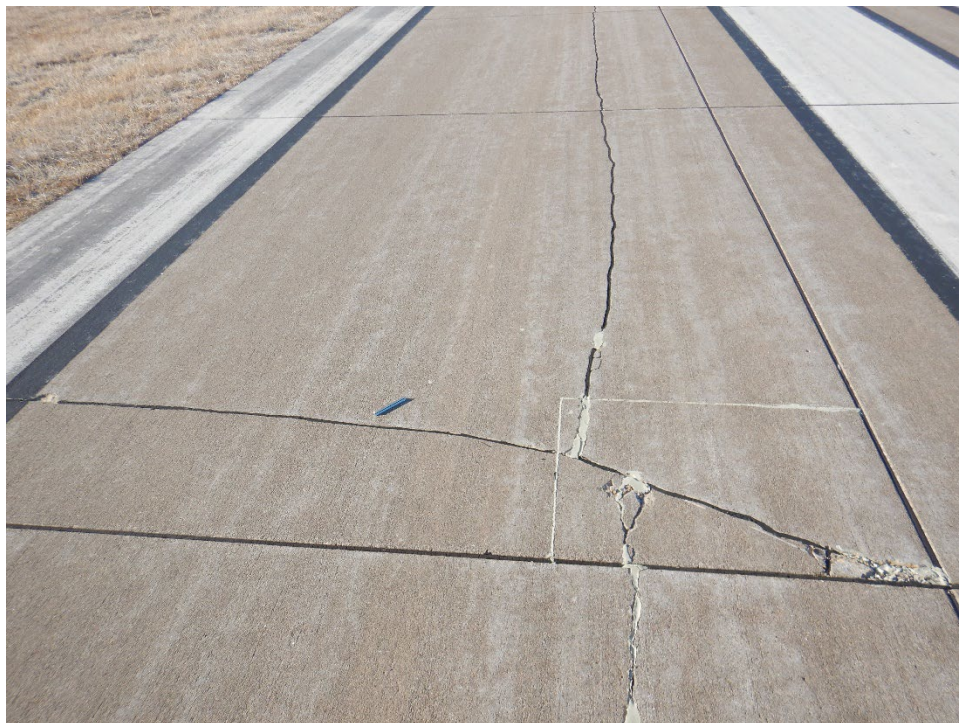
R03CN-01. Shattered Slab (Sample Unit No. 44).

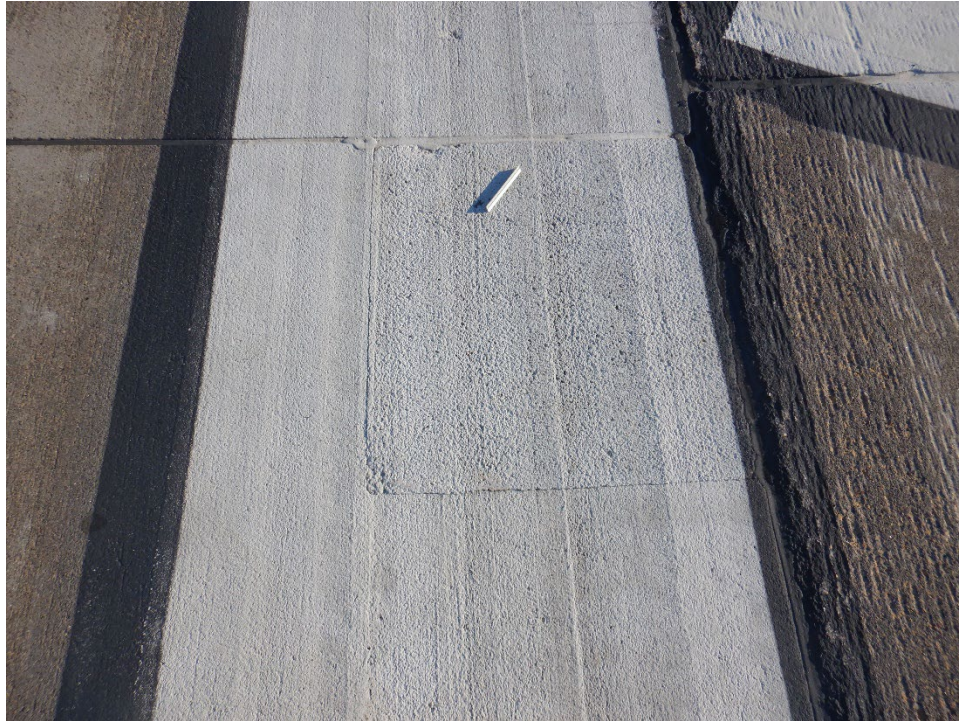
R03CN-02. Small Patching (Sample Unit No. 04).

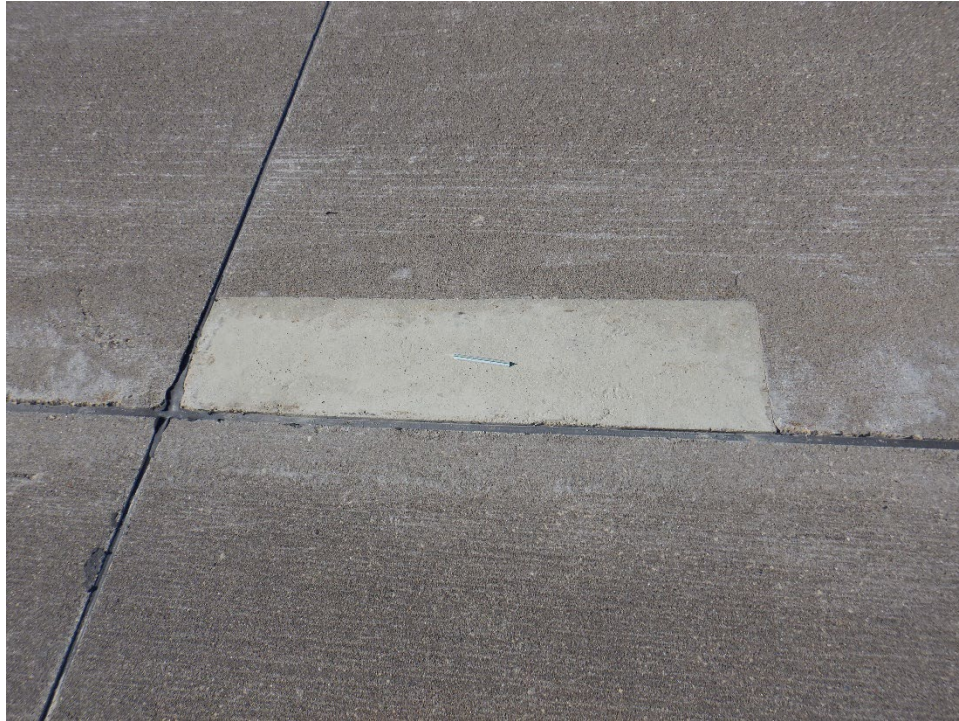
R14CN-01. Large Patching (Sample Unit No. 53).

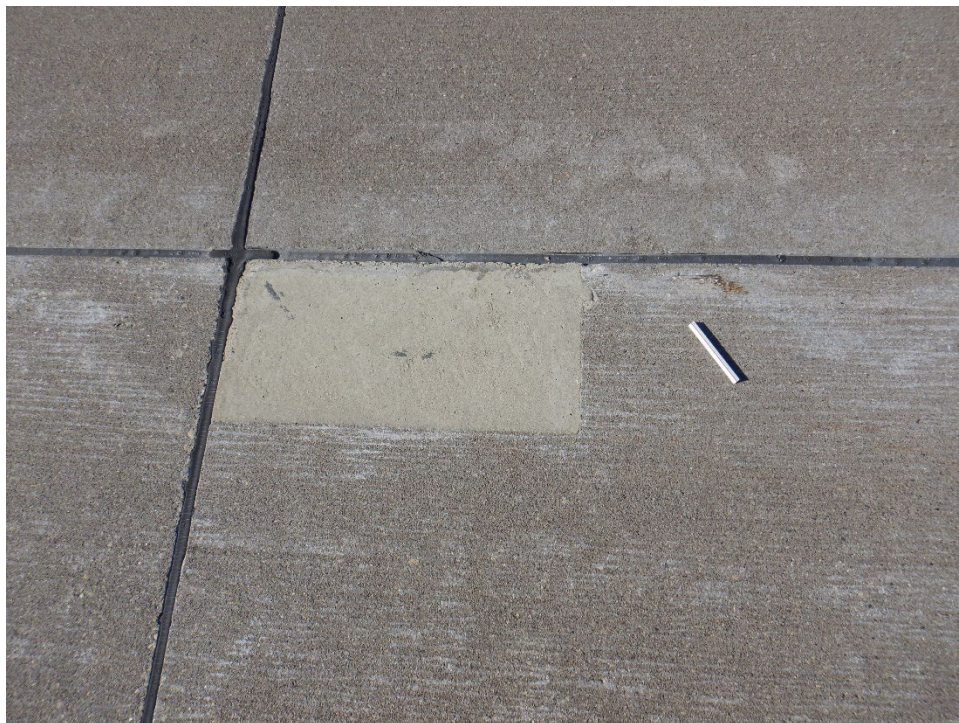
R14CN-01. Small Patching (Sample Unit No. 06).

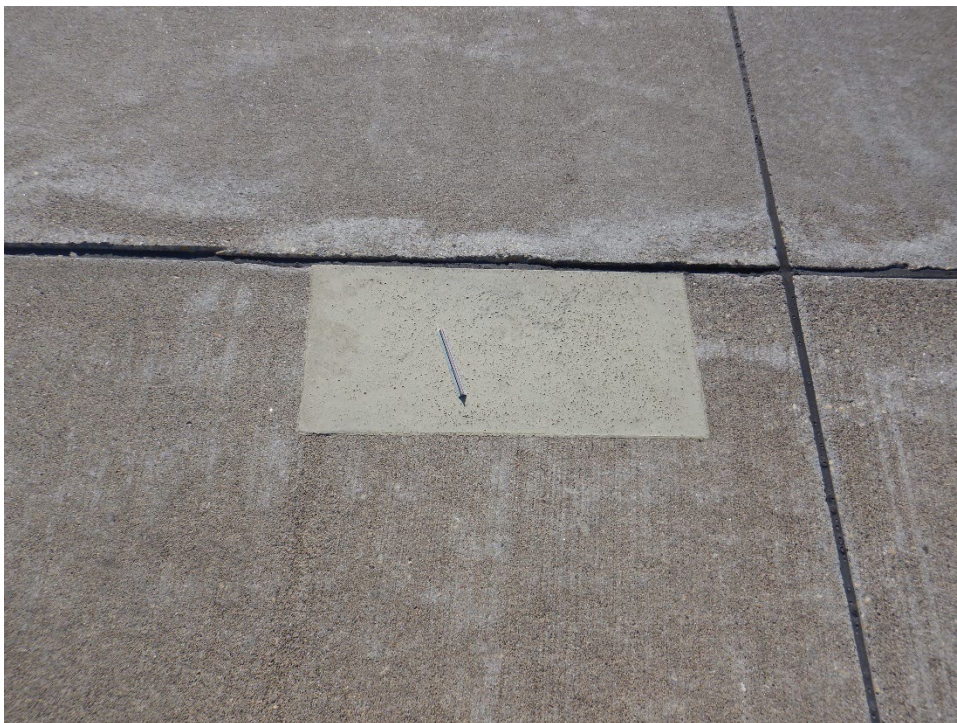
T02CN-01. Small Patching (Sample Unit No. 07).

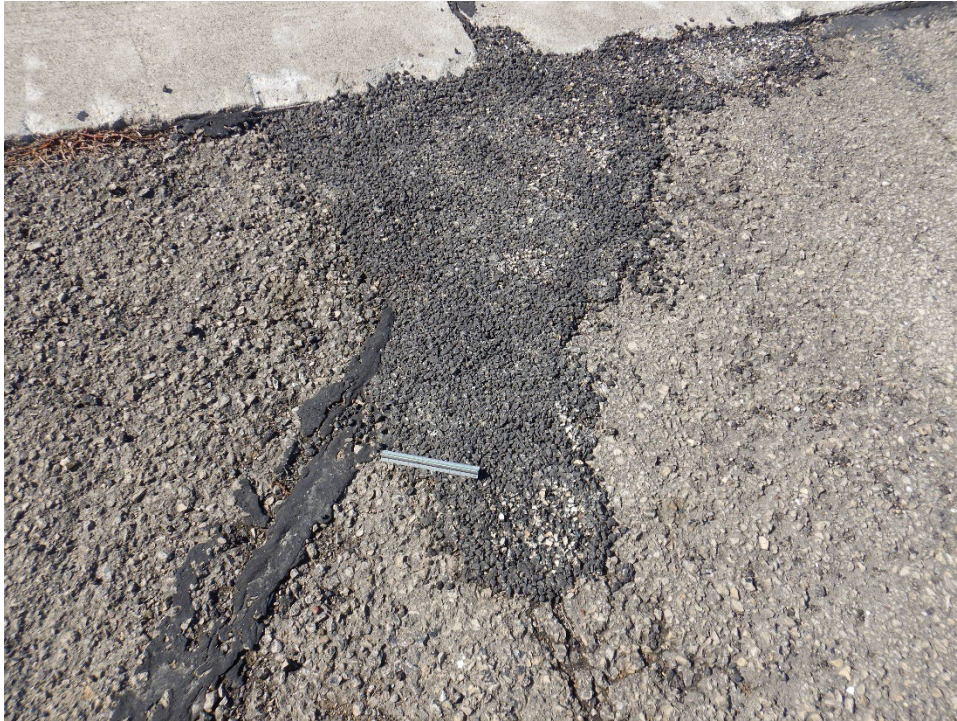
T04CN-01. Patching (Sample Unit No. 01).

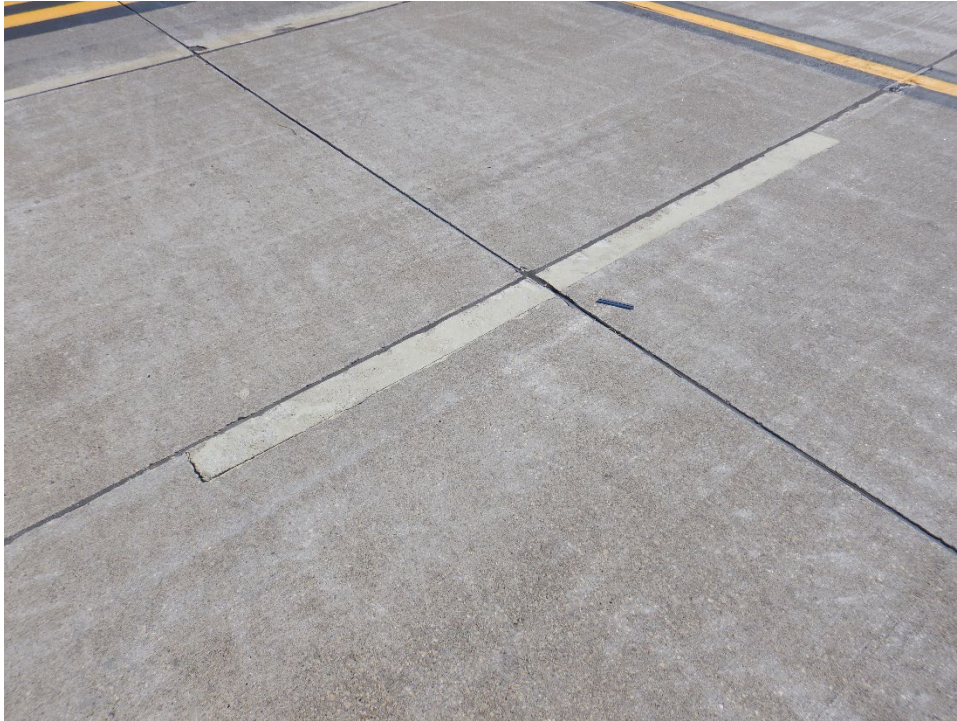
T07CN-01. Small Patching (Sample Unit No. 04).

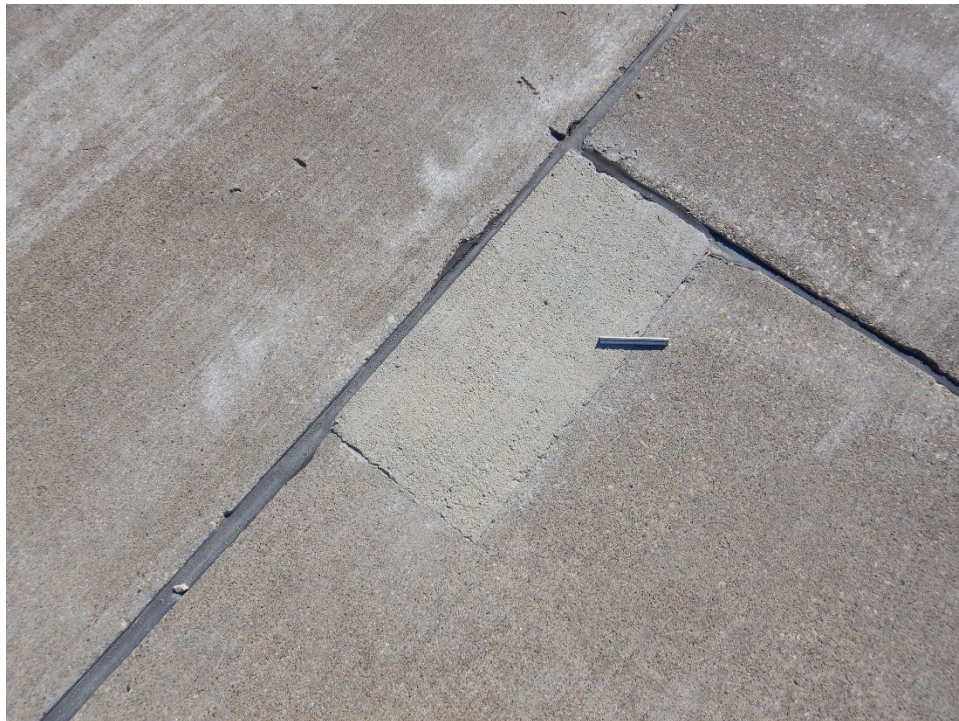
TCCN-02. Small Patching (Sample Unit No. 01).
