# Corning Municipal Airport

## Pavement Management Report

**AUGUST 2025**

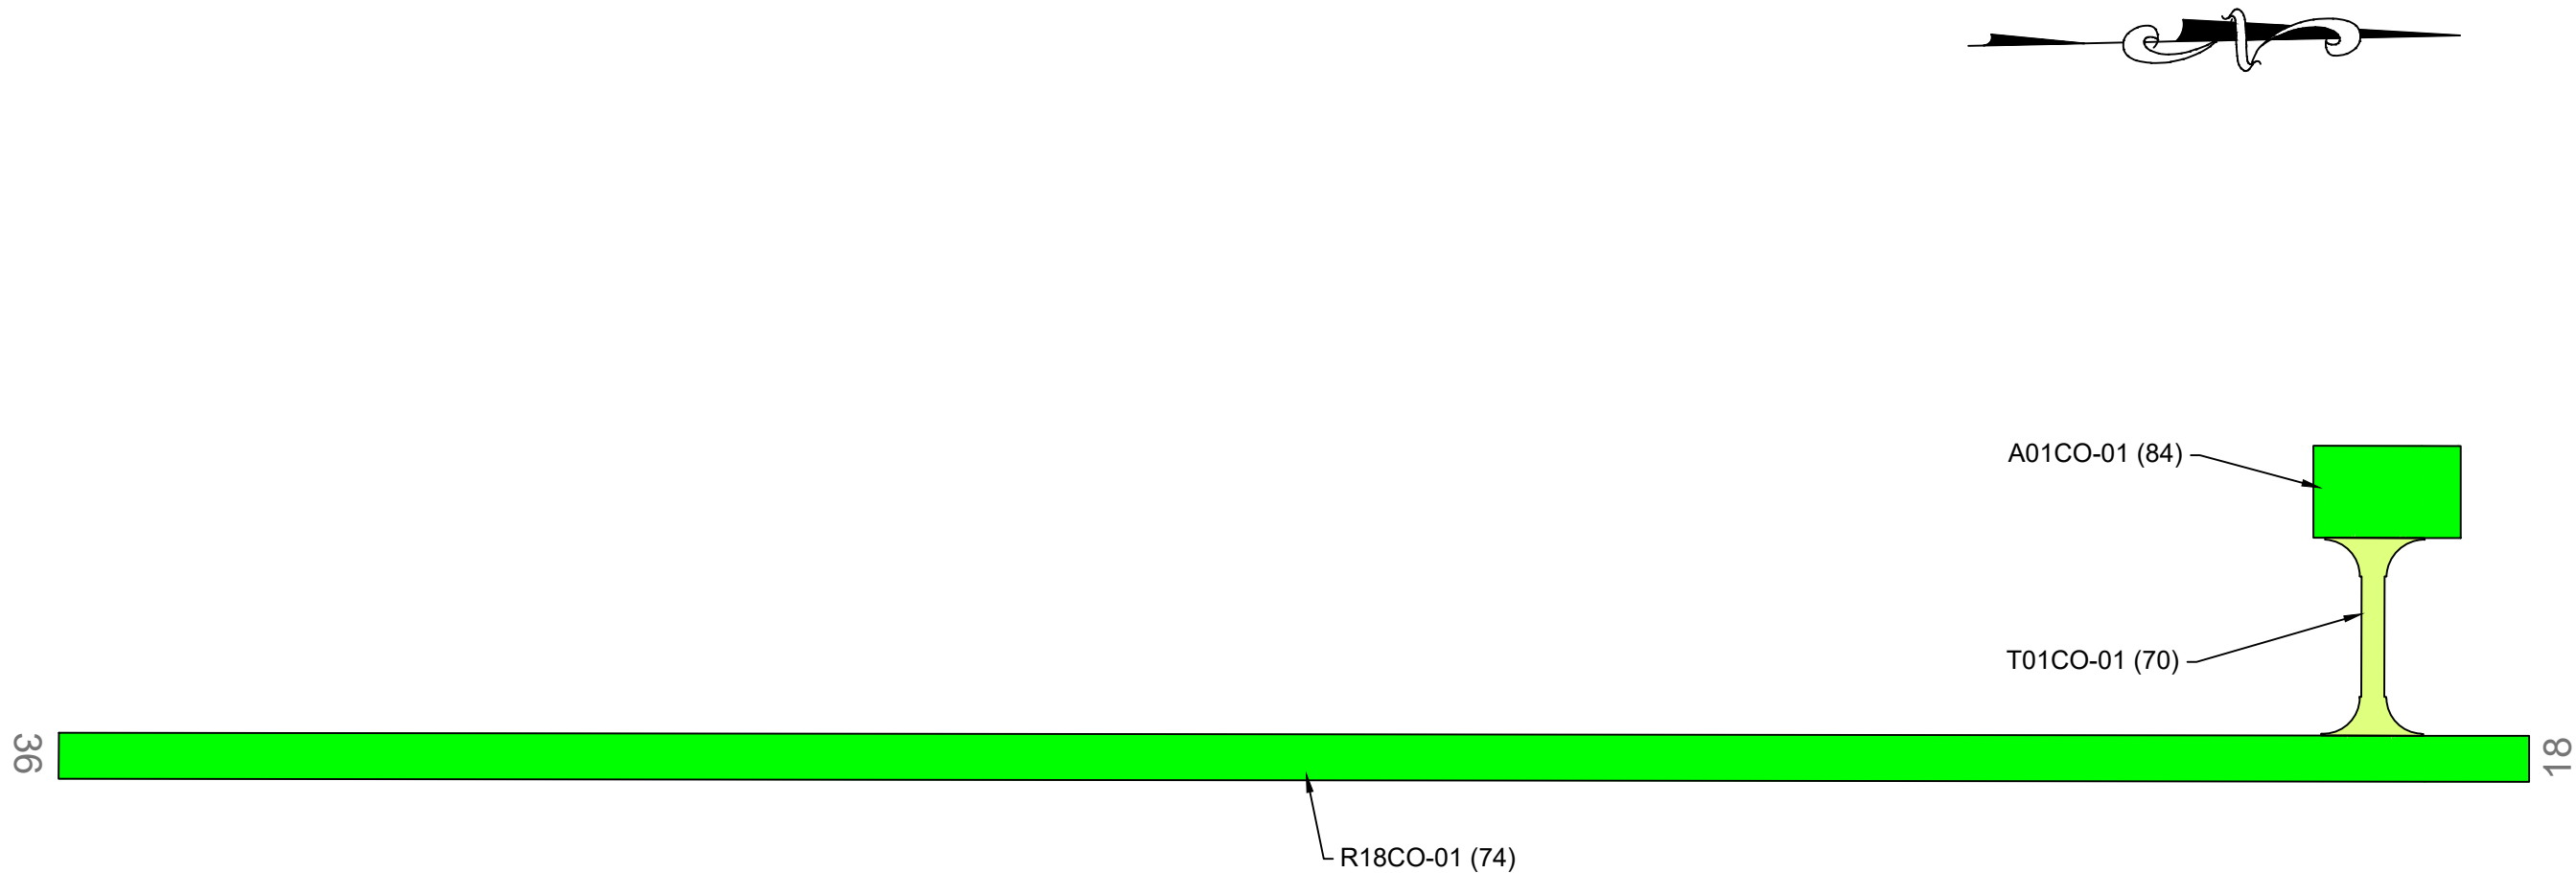
FIGURE 8. PCI MAP.

The pavements at Corning Municipal Airport were inspected in March 2025. The 2025 area-weighted condition of Corning Municipal Airport is 75, with conditions ranging from 70 to 84 (on a scale of 0 [failed] to 100 [excellent]). During the previous pavement inspection in 2018, the area-weighted PCI of the airport was 76.

Figure 6 summarizes the overall condition of the pavements at Corning Municipal Airport, and Figure 7 presents area-weighted condition (average PCI adjusted to account for the relative size of the pavement sections) by branch use. Figure 8 is a map that displays the condition of the evaluated pavements. Table 1 summarizes the results of the pavement evaluation. Appendix B presents photographs taken during the PCI inspection, and Appendix C contains detailed information on the distress types observed during the visual survey. Appendix D includes detailed work history information that was collected during the record review process.
