# Cresco-Allen Church Field Airport

## Pavement Management Report

**AUGUST 2025**

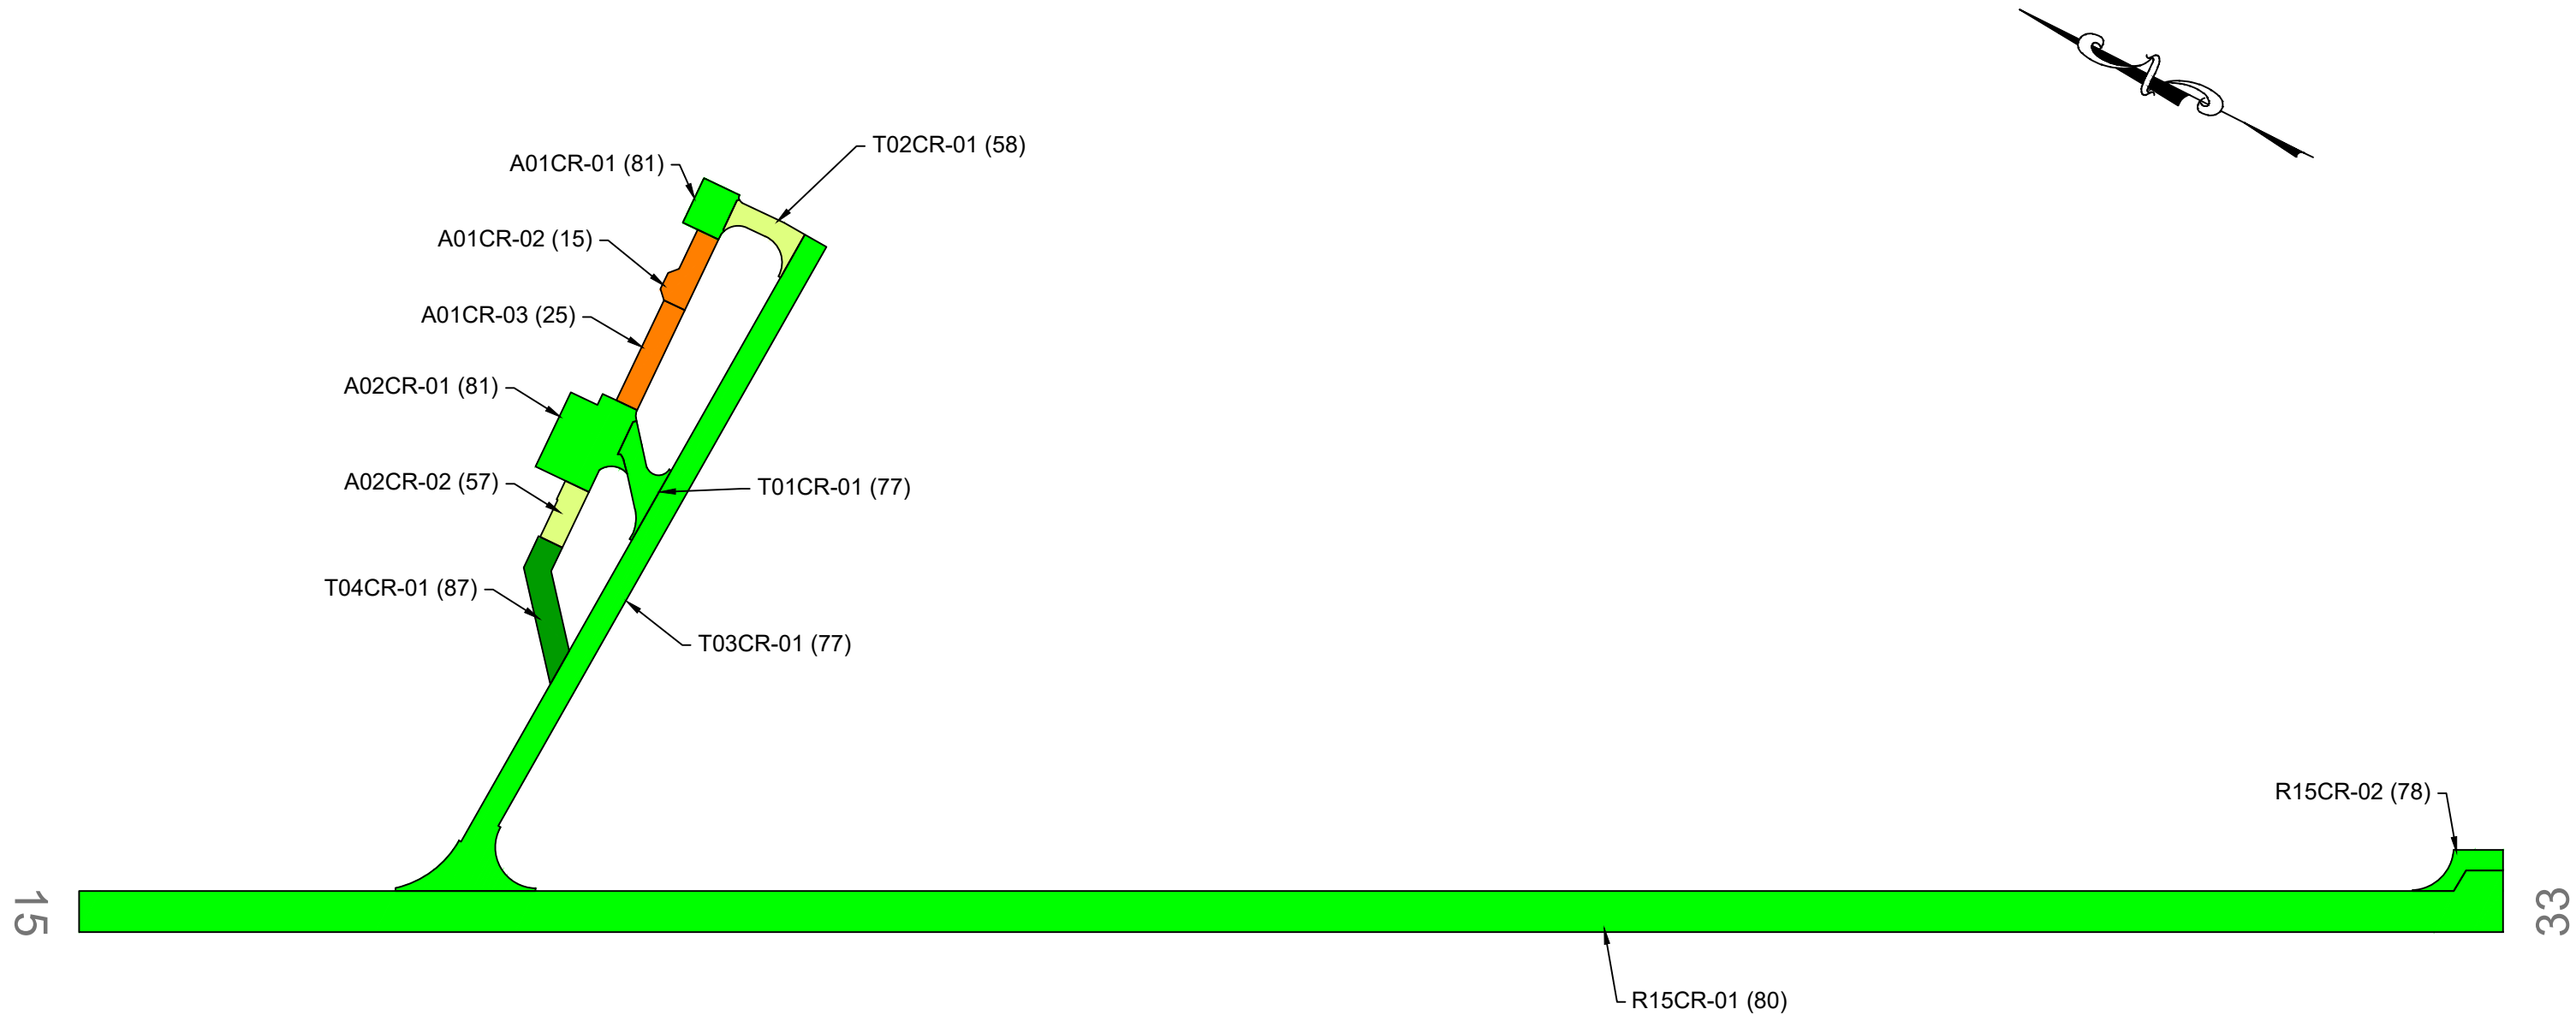
FIGURE 8. PCI MAP.

The pavements at Cresco-Ellen Church Field Airport were inspected in March 2025. The 2025 area-weighted condition of Cresco-Ellen Church Field Airport is 77, with conditions ranging from 15 to 87 (on a scale of 0 [failed] to 100 [excellent]). During the previous pavement inspection in 2018, the area-weighted PCI of the airport was 55.

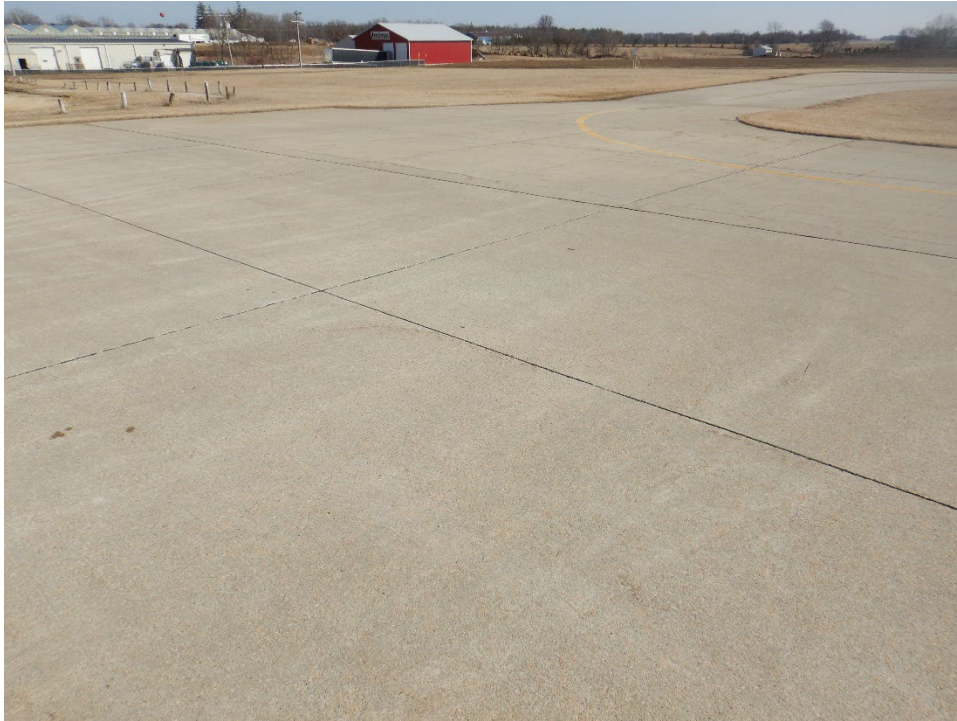
A01CR-01. Overview.

| Branch | Section | Surface Type | Section Area (sf) | LCD | 2025 PCI | % Distress Due to Load | % Distress Due to Climate/Durability | % Distress Due to Other | Type of Distress |
|---|---|---|---|---|---|---|---|---|---|
| A01CR | 01 | PCC | 2,910 | 6/2/2008 | 81 | 0 | 57 | 43 | Joint Spalling, Joint Seal Damage |

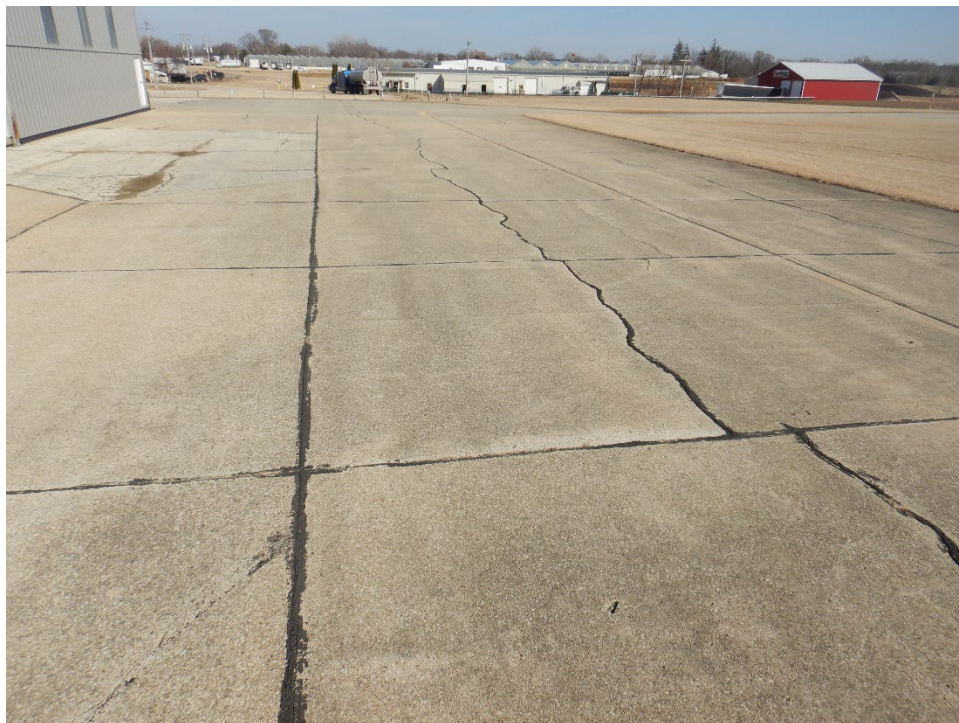
A01CR-02. Overview.

| Branch | Section | Surface Type | Section Area (sf) | LCD | 2025 PCI | % Distress Due to Load | % Distress Due to Climate/Durability | % Distress Due to Other | Type of Distress |
|---|---|---|---|---|---|---|---|---|---|
| A01CR | 02 | PCC | 2,979 | 6/1/1985 | 15 | 87 | 9 | 4 | Corner Break, Corner Spalling, Joint Seal Damage, LTD Cracking, Shattered Slab |

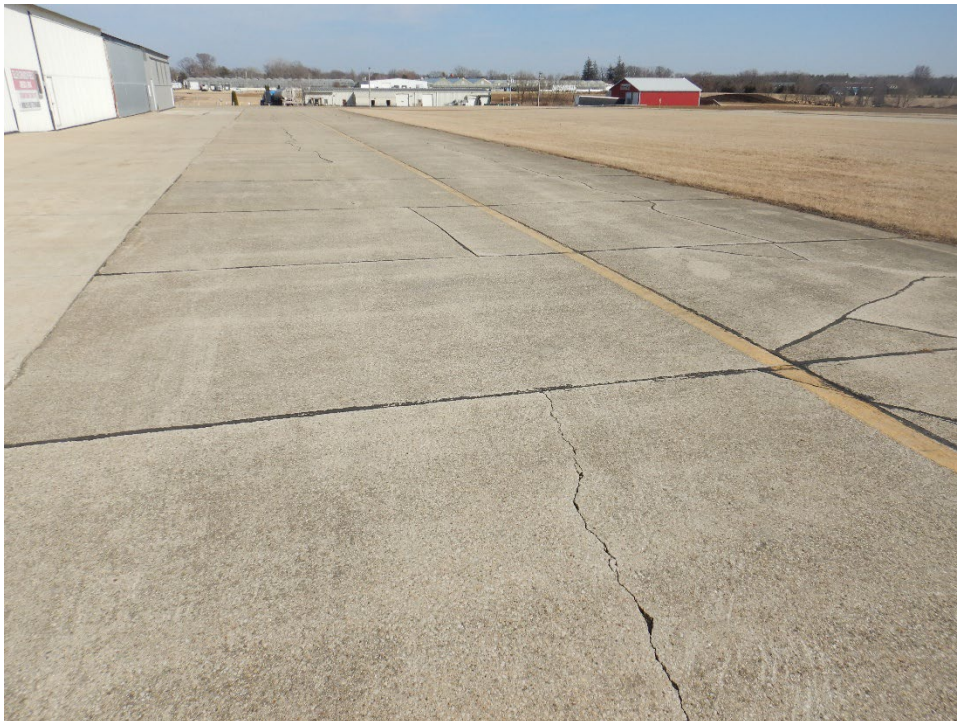
A01CR-03. Overview.

| Branch | Section | Surface Type | Section Area (sf) | LCD | 2025 PCI | % Distress Due to Load | % Distress Due to Climate/Durability | % Distress Due to Other | Type of Distress |
|---|---|---|---|---|---|---|---|---|---|
| A01CR | 03 | PCC | 3,780 | 6/1/1984 | 25 | 86 | 10 | 4 | Corner Break, Corner Spalling, Joint Seal Damage, LTD Cracking, Shattered Slab |

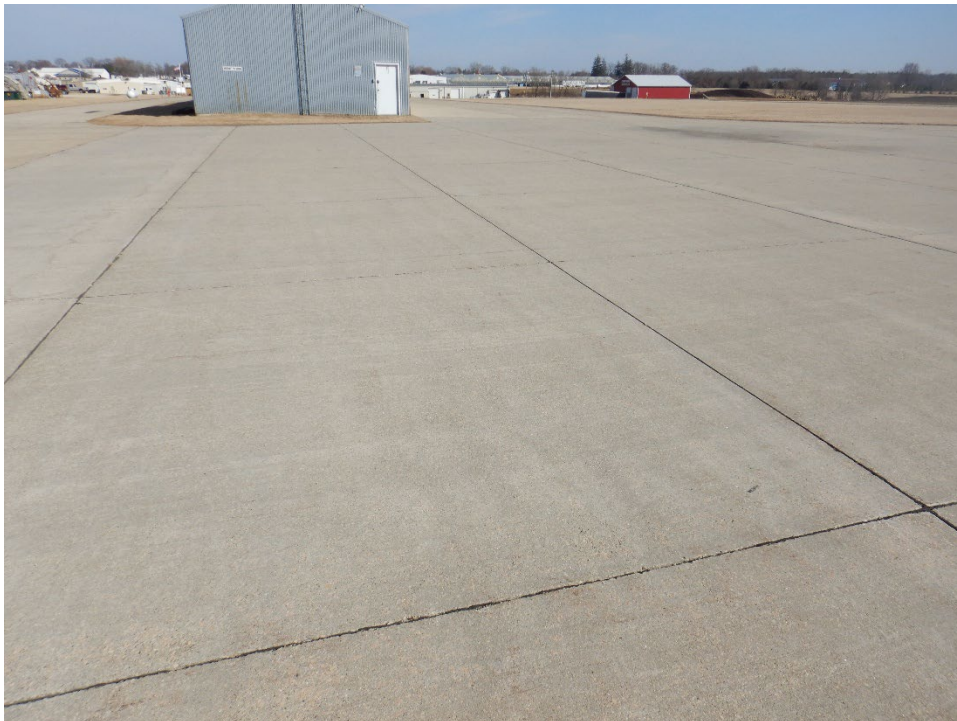
A02CR-01. Overview.

| Branch | Section | Surface Type | Section Area (sf) | LCD | 2025 PCI | % Distress Due to Load | % Distress Due to Climate/Durability | % Distress Due to Other | Type of Distress |
|---|---|---|---|---|---|---|---|---|---|
| A02CR | 01 | PCC | 8,900 | 6/2/2008 | 81 | 27 | 56 | 17 | Corner Spalling, Joint Spalling, Joint Seal Damage, Large Patch, LTD Cracking, Small Patch |

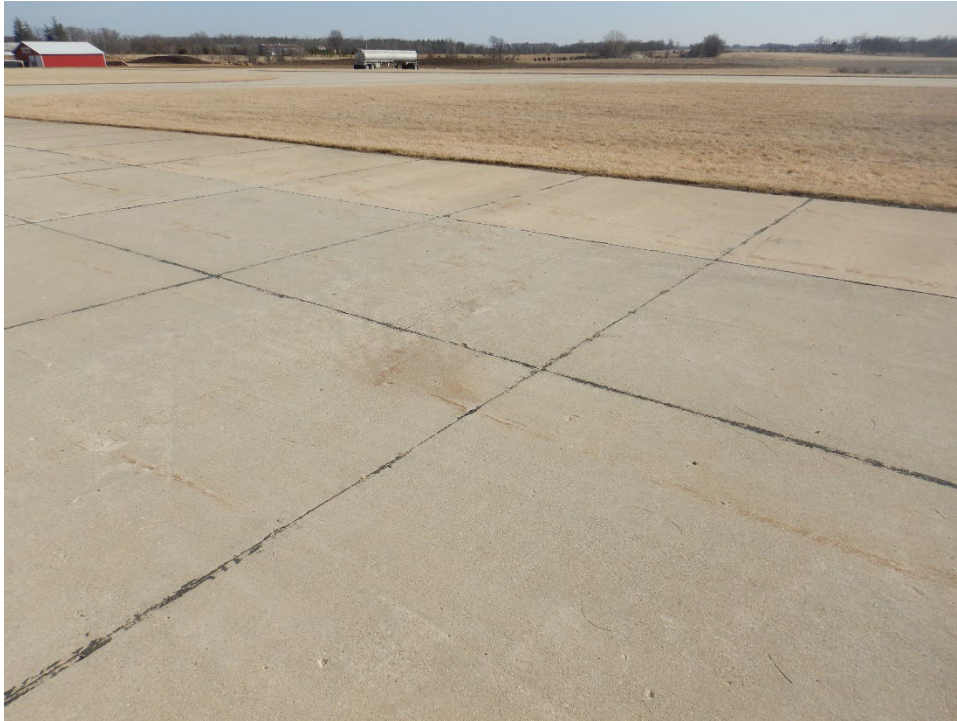
A02CR-02. Overview.

| Branch | Section | Surface Type | Section Area (sf) | LCD | 2025 PCI | % Distress Due to Load | % Distress Due to Climate/Durability | % Distress Due to Other | Type of Distress |
|---|---|---|---|---|---|---|---|---|---|
| A02CR | 02 | PCC | 2,287 | 6/1/1999 | 57 | 33 | 0 | 67 | ASR, Corner Break, Corner Spalling, Faulting, Joint Spalling, LTD Cracking |

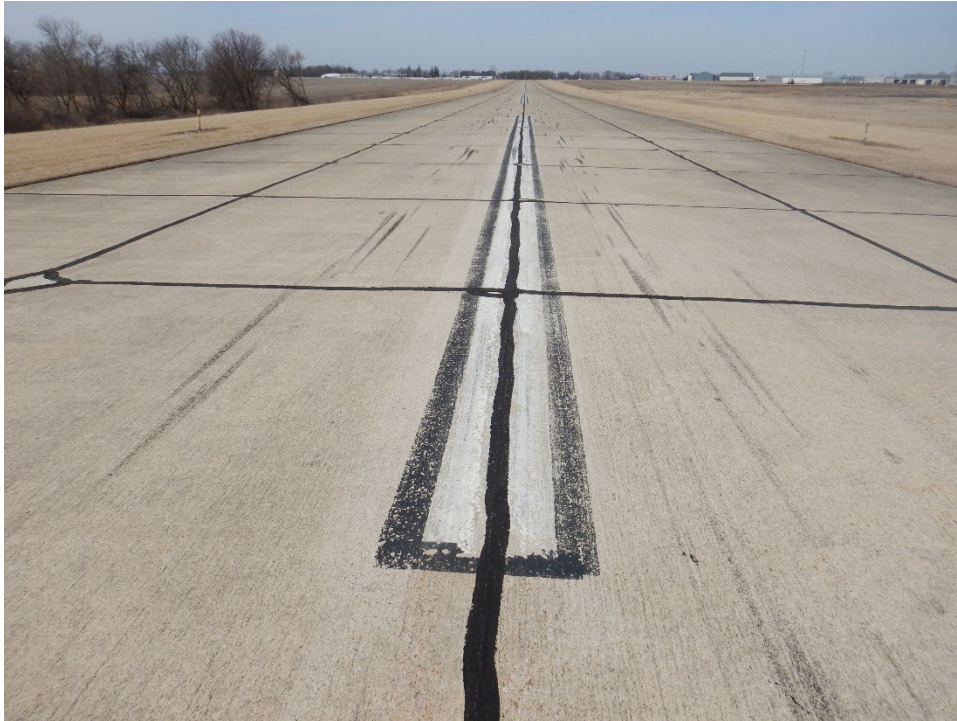
R15CR-01. Overview.

| Branch | Section | Surface Type | Section Area (sf) | LCD | 2025 PCI | % Distress Due to Load | % Distress Due to Climate/Durability | % Distress Due to Other | Type of Distress |
|---|---|---|---|---|---|---|---|---|---|
| R15CR | 01 | PCC | 148,209 | 6/1/1973 | 80 | 33 | 0 | 67 | ASR, Corner Break, Faulting, Joint Spalling, Large Patch, LTD Cracking, Small Patch |

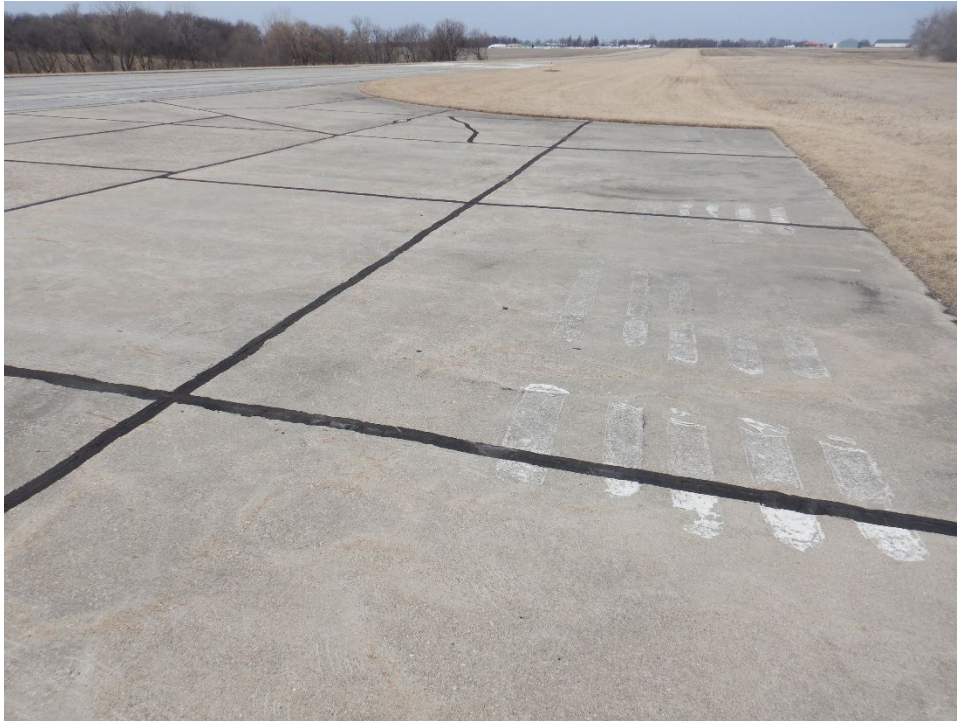
R15CR-02. Overview.

| Branch | Section | Surface Type | Section Area (sf) | LCD | 2025 PCI | % Distress Due to Load | % Distress Due to Climate/Durability | % Distress Due to Other | Type of Distress |
|---|---|---|---|---|---|---|---|---|---|
| R15CR | 02 | PCC | 2,329 | 6/1/1981 | 78 | 26 | 0 | 74 | ASR, Joint Spalling, LTD Cracking, Small Patch |

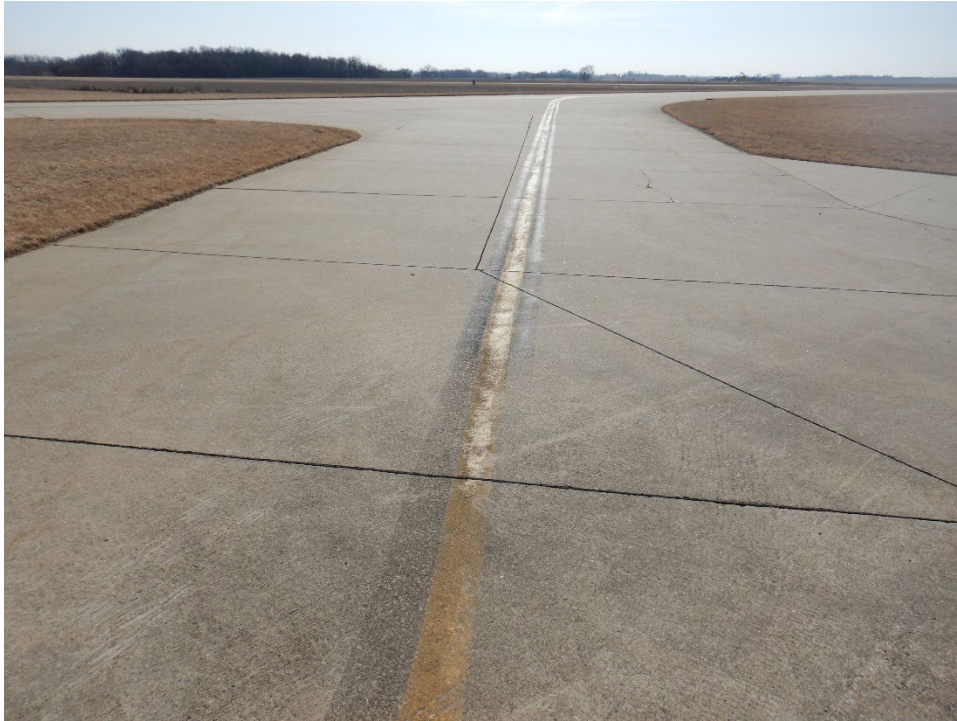
T01CR-01. Overview.

| Branch | Section | Surface Type | Section Area (sf) | LCD | 2025 PCI | % Distress Due to Load | % Distress Due to Climate/Durability | % Distress Due to Other | Type of Distress |
|---|---|---|---|---|---|---|---|---|---|
| T01CR | 01 | PCC | 3,140 | 6/2/2008 | 77 | 57 | 43 | 0 | Joint Seal Damage, LTD Cracking |

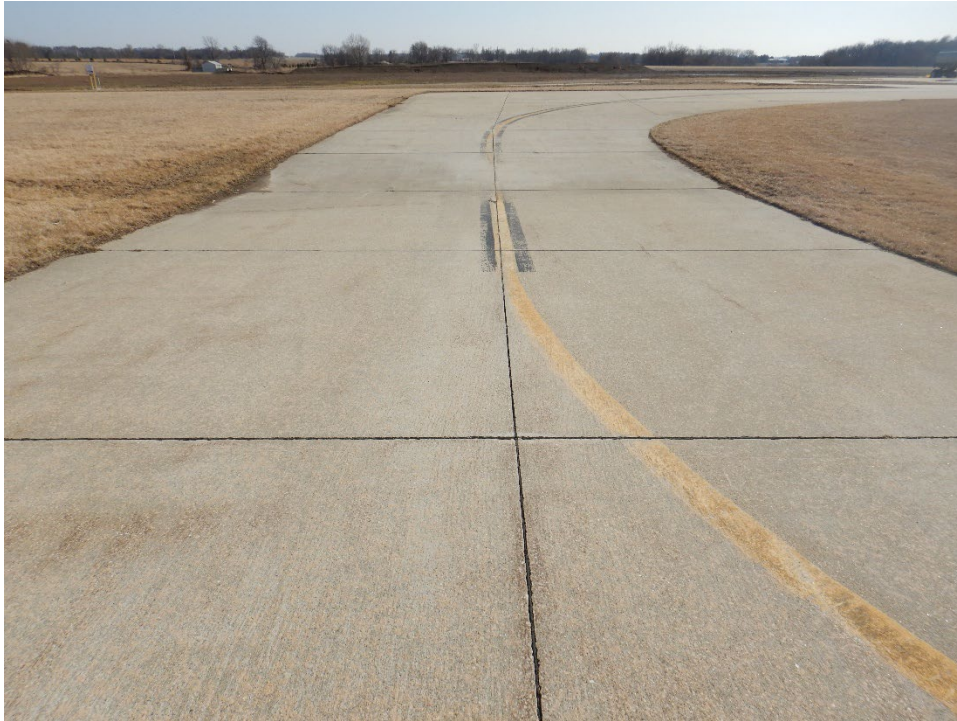
T02CR-01. Overview.

| Branch | Section | Surface Type | Section Area (sf) | LCD | 2025 PCI | % Distress Due to Load | % Distress Due to Climate/Durability | % Distress Due to Other | Type of Distress |
|---|---|---|---|---|---|---|---|---|---|
| T02CR | 01 | PCC | 2,815 | 6/2/2008 | 58 | 0 | 23 | 77 | ASR, Joint Spalling, Joint Seal Damage |

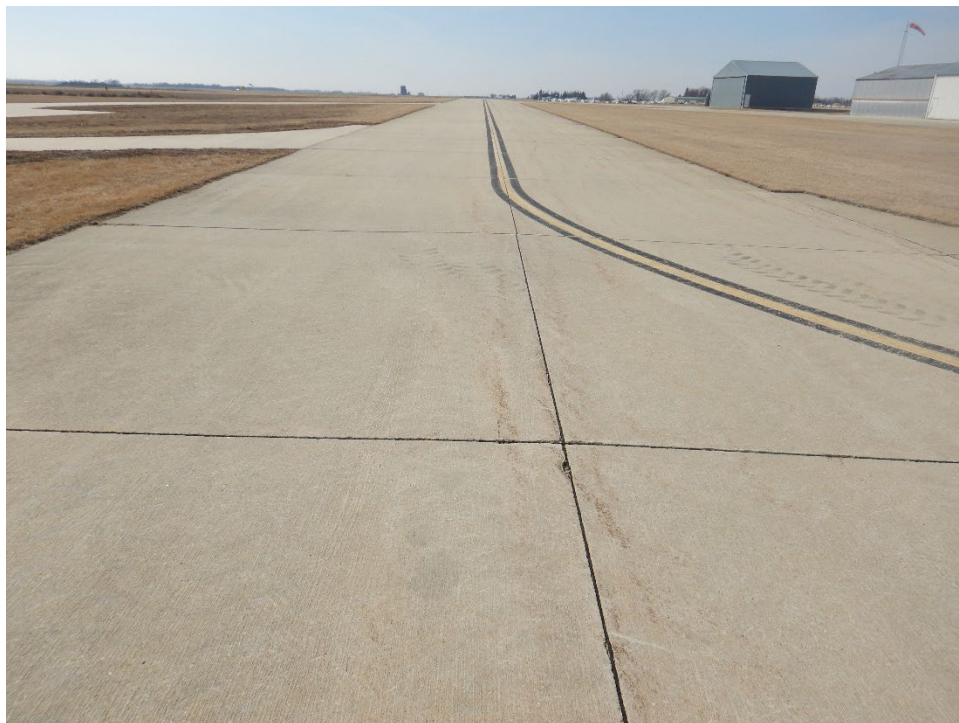
T03CR-01. Overview.

| Branch | Section | Surface Type | Section Area (sf) | LCD | 2025 PCI | % Distress Due to Load | % Distress Due to Climate/Durability | % Distress Due to Other | Type of Distress |
|---|---|---|---|---|---|---|---|---|---|
| T03CR | 01 | PCC | 30,406 | 6/2/2008 | 77 | 48 | 38 | 14 | Faulting, Joint Seal Damage, LTD Cracking |

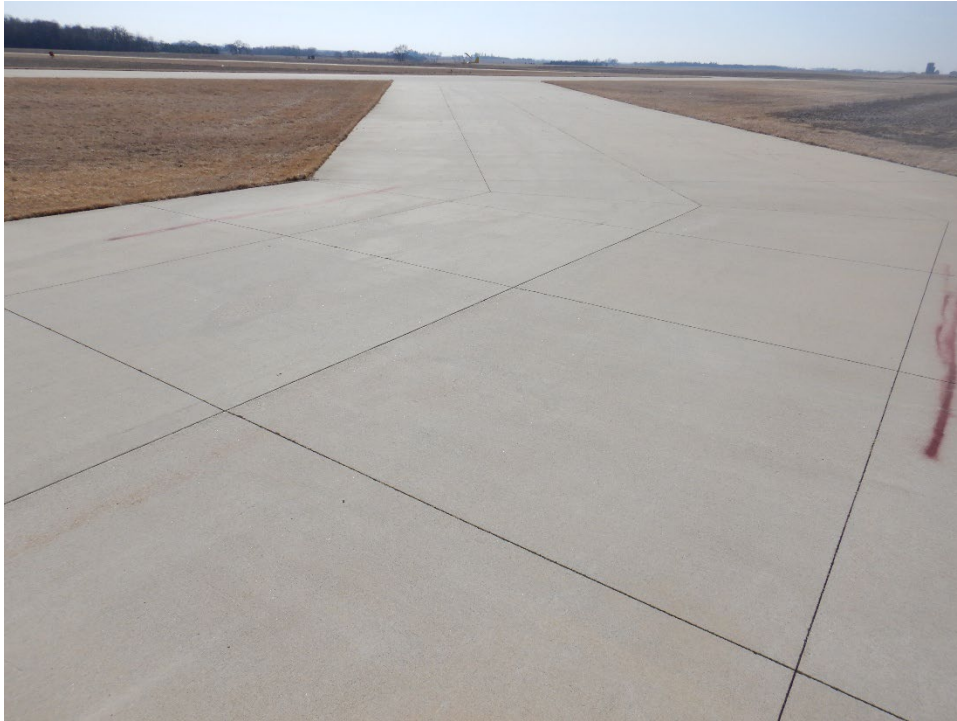
T04CR-01. Overview.

| Branch | Section | Surface Type | Section Area (sf) | LCD | 2025 PCI | % Distress Due to Load | % Distress Due to Climate/Durability | % Distress Due to Other | Type of Distress |
|---|---|---|---|---|---|---|---|---|---|
| T04CR | 01 | PCC | 5,053 | 6/1/2018 | 87 | 0 | 95 | 5 | Corner Spalling, Joint Seal Damage |
