# Creston Municipal Airport

## Pavement Management Report

**AUGUST 2025**

# CRESTON MUNICIPAL AIRPORT PAVEMENT MANAGEMENT REPORT

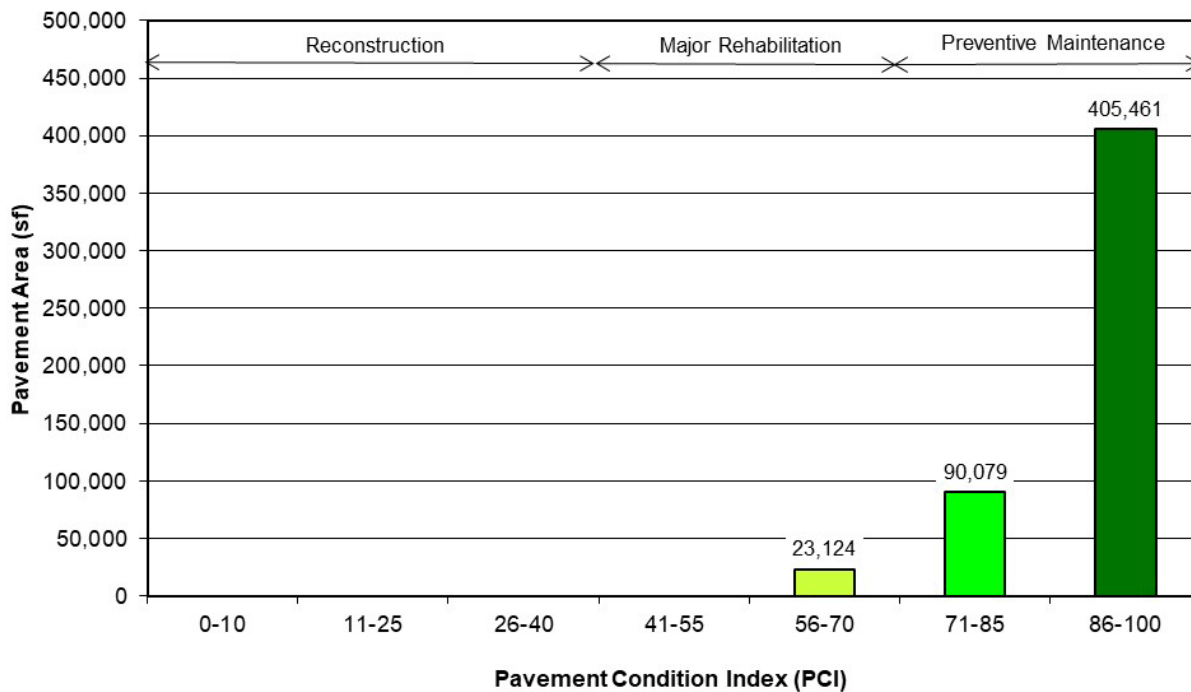
Figure 6. Pavement area by PCI range at Creston Municipal Airport.

The pavements at Creston Municipal Airport were inspected in March 2025. The 2025 area-weighted condition of Creston Municipal Airport is 94, with conditions ranging from 58 to 99 (on a scale of 0 [failed] to 100 [excellent]). During the previous pavement inspection in 2021, the area-weighted PCI of the airport was 43.

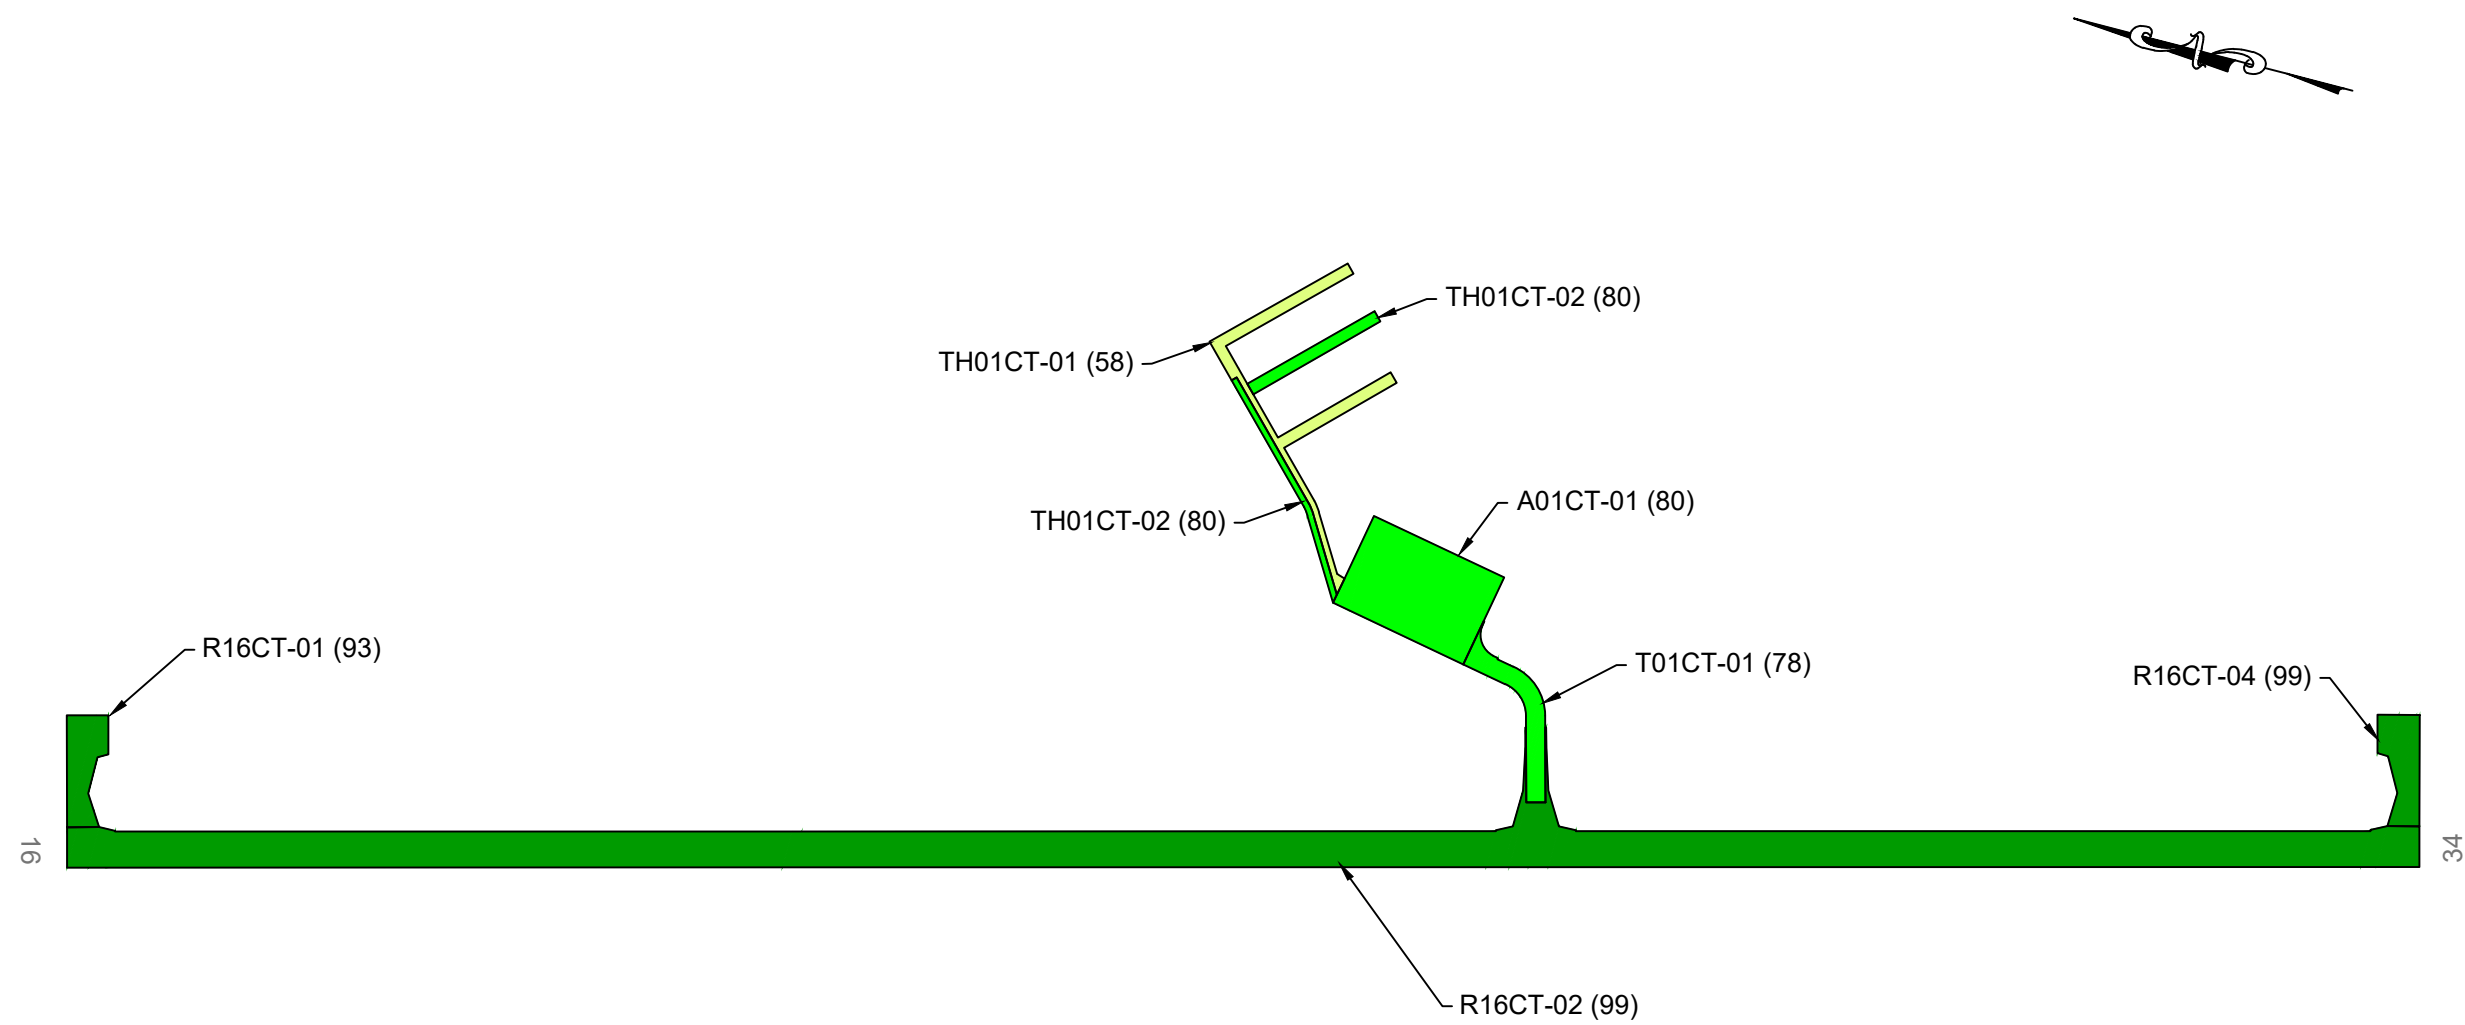
FIGURE 8. PCI MAP.

Figure 6 summarizes the overall condition of the pavements at Creston Municipal Airport, and Figure 7 presents area-weighted condition (average PCI adjusted to account for the relative size of the pavement sections) by branch use. Figure 8 is a map that displays the condition of the evaluated pavements. Table 1 summarizes the results of the pavement evaluation. Appendix B presents photographs taken during the PCI inspection, and Appendix C contains detailed information on the distress types observed during the visual survey. Appendix D includes detailed work history information that was collected during the record review process.
