# Davenport Municipal Airport

## Pavement Management Report

**AUGUST 2026**

# DAVENPORT MUNICIPAL AIRPORT PAVEMENT MANAGEMENT REPORT

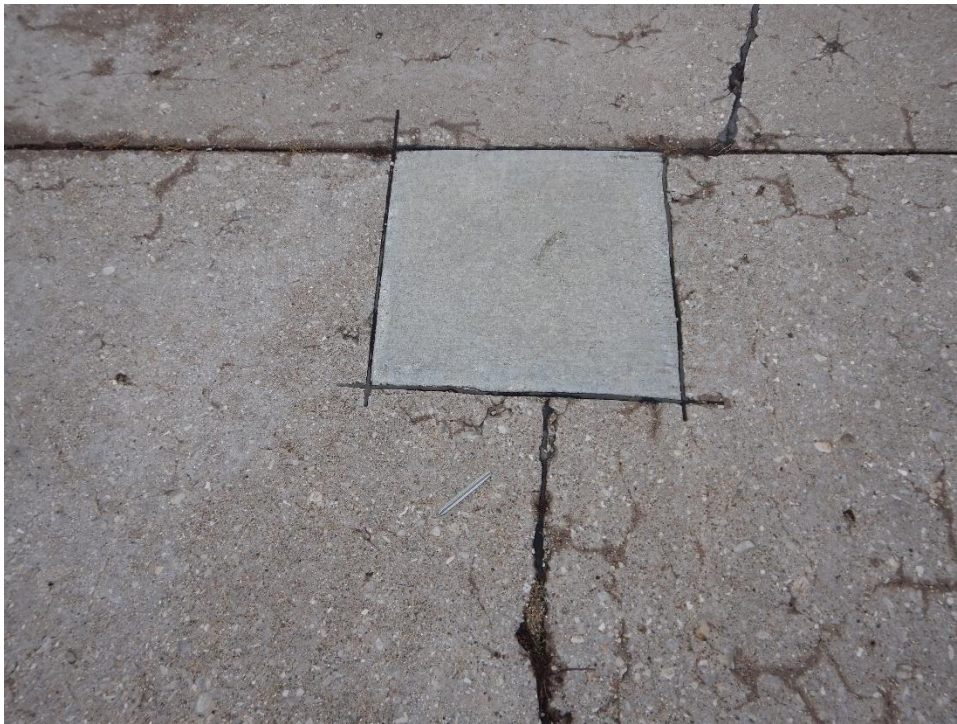
A01DA-01. Small Patching (Sample Unit No. 07).

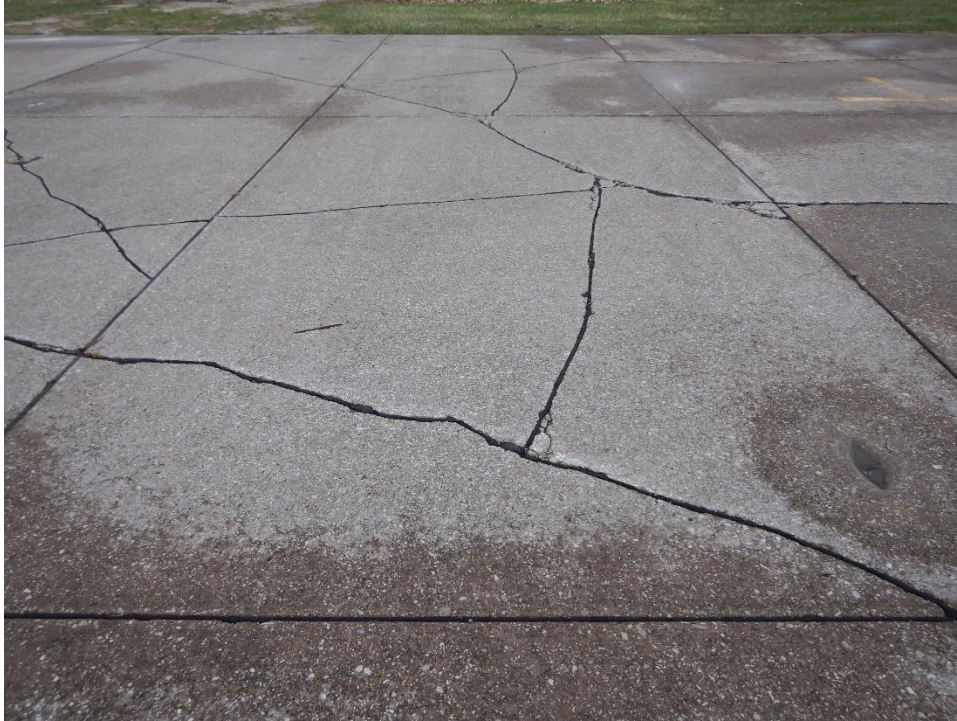
A02DA-01. Shattered Slab (Sample Unit No. 07).

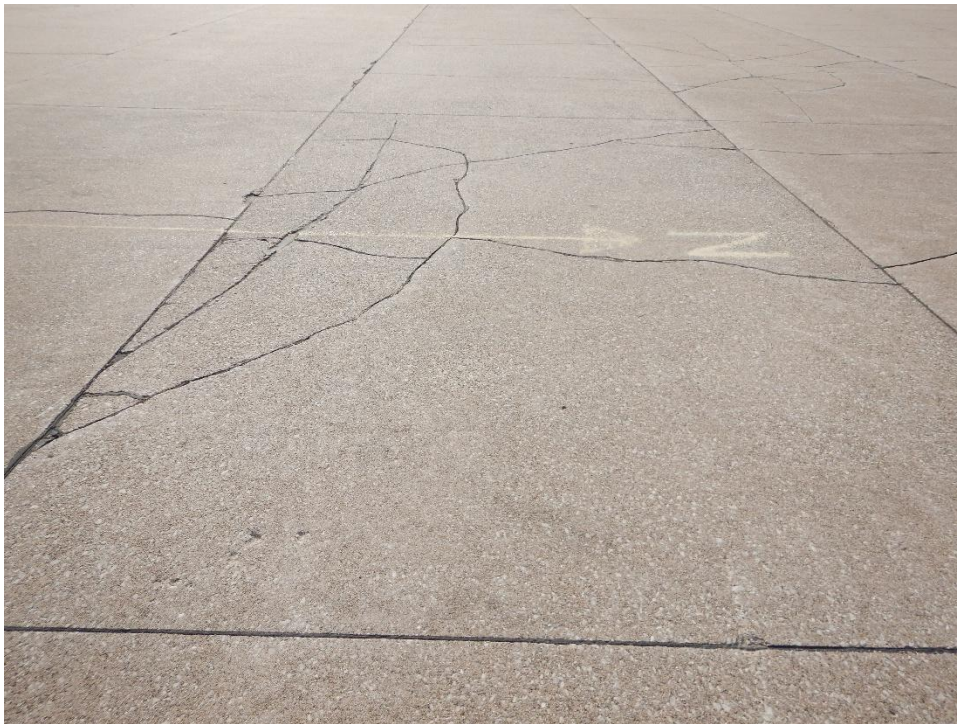
A03DA-01. Shattered Slab (Sample Unit No. 03).

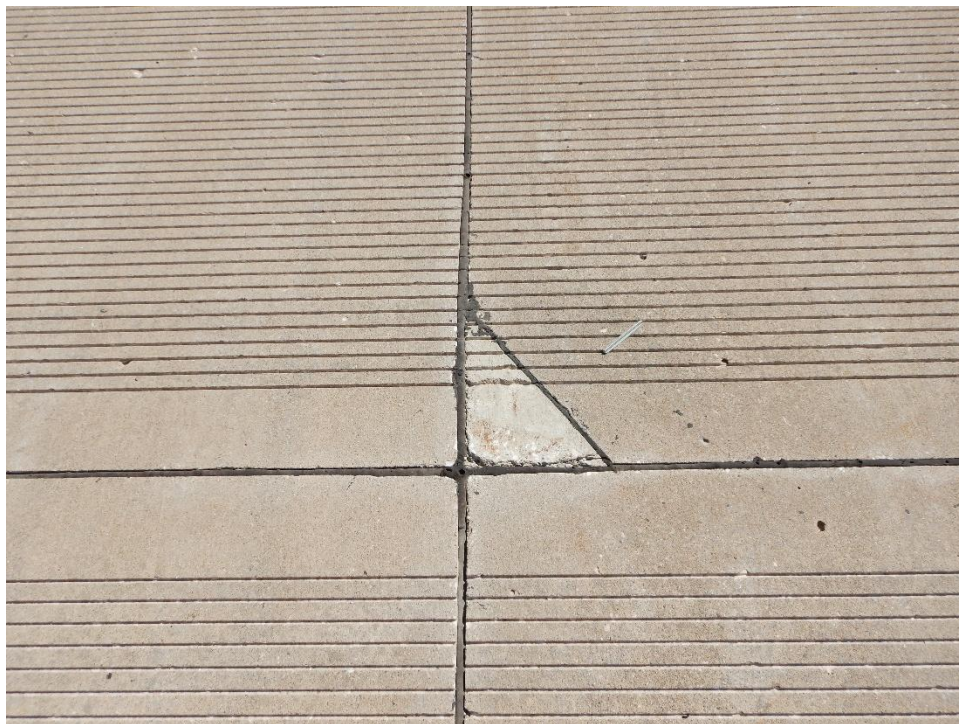
R15DA-02. Small Patching (Sample Unit No. 24).

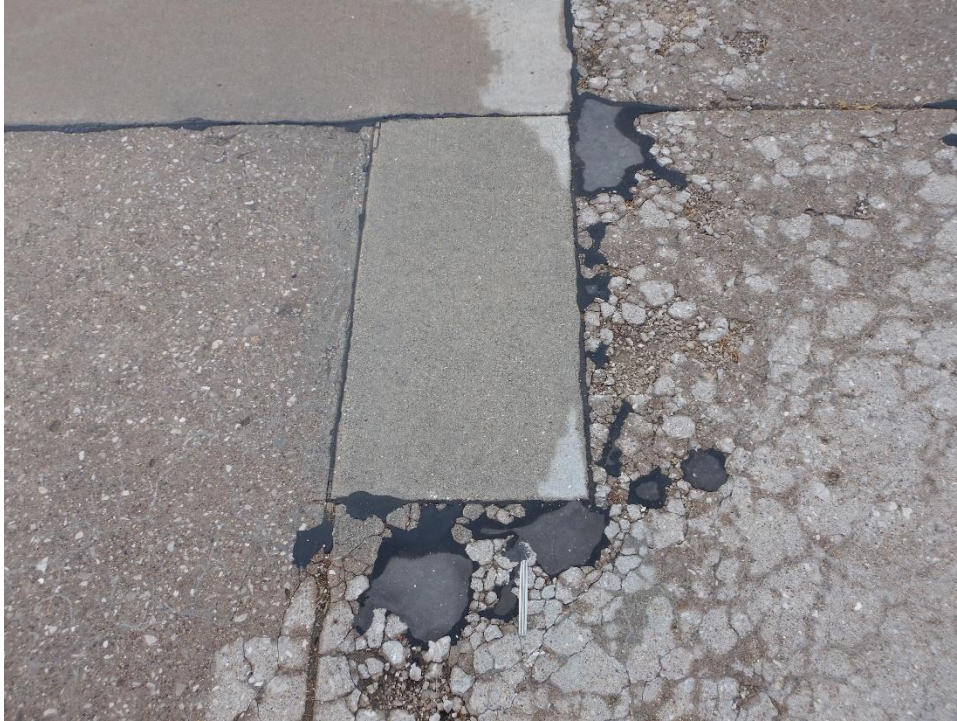
T04DA-01. Small Patching (Sample Unit No. 02).

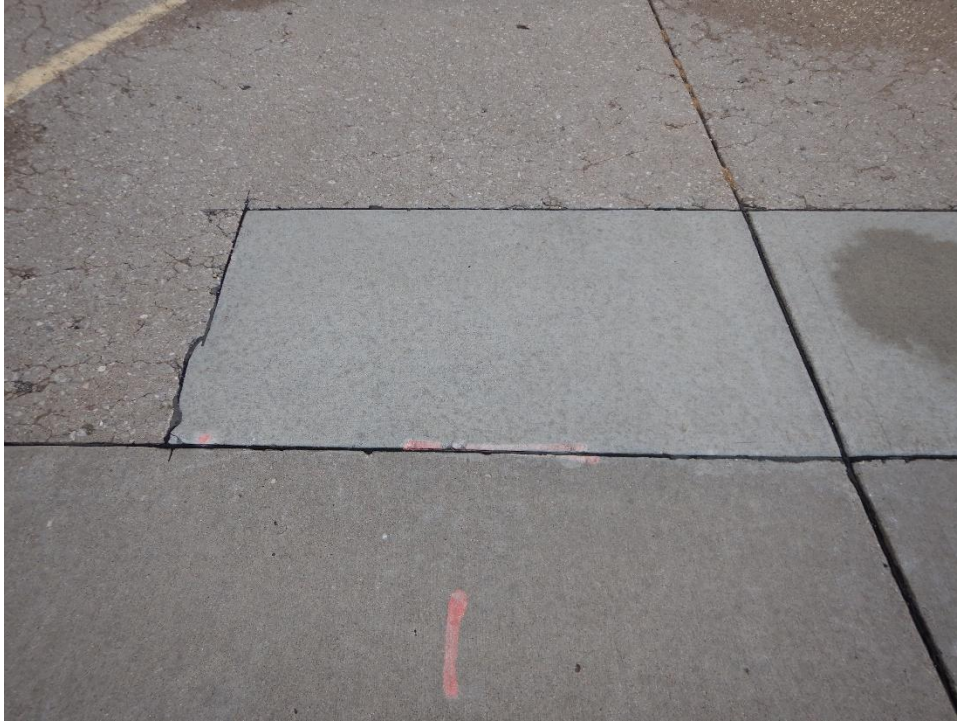
T05DA-01. Large Patching (Sample Unit No. 01).

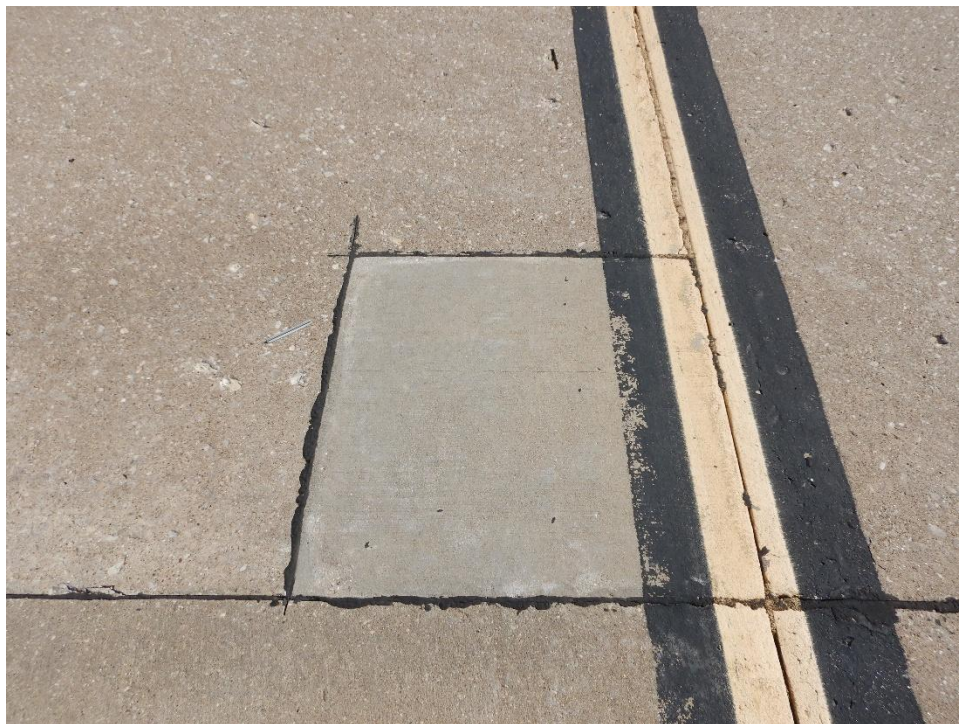
TADA-02. Large Patching (Sample Unit No. 02).

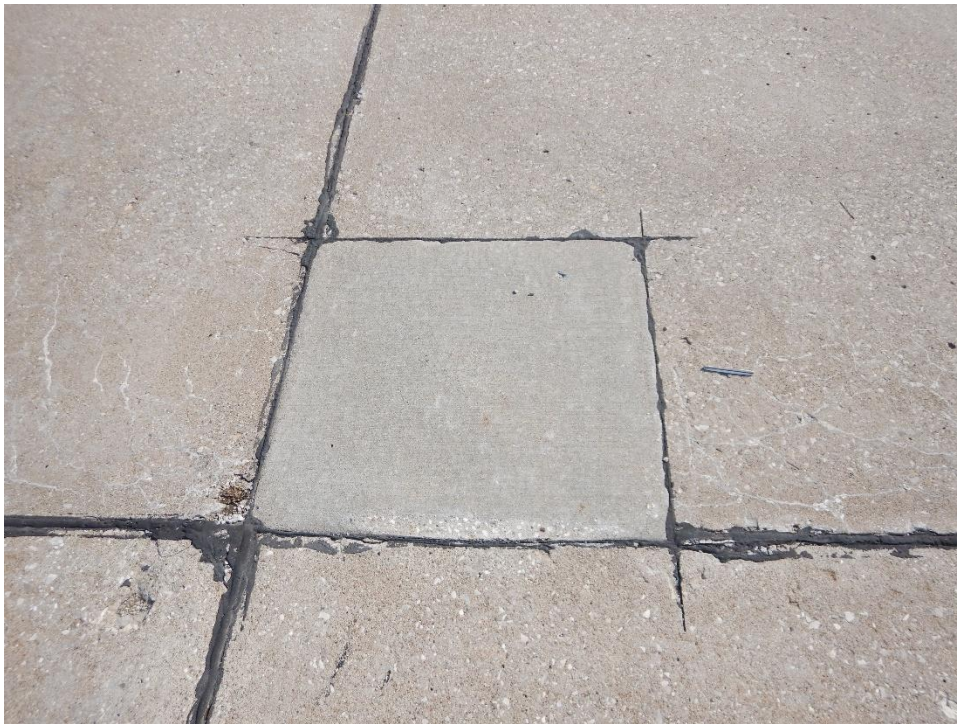
TADA-03. Large Patching (Sample Unit No. 01).

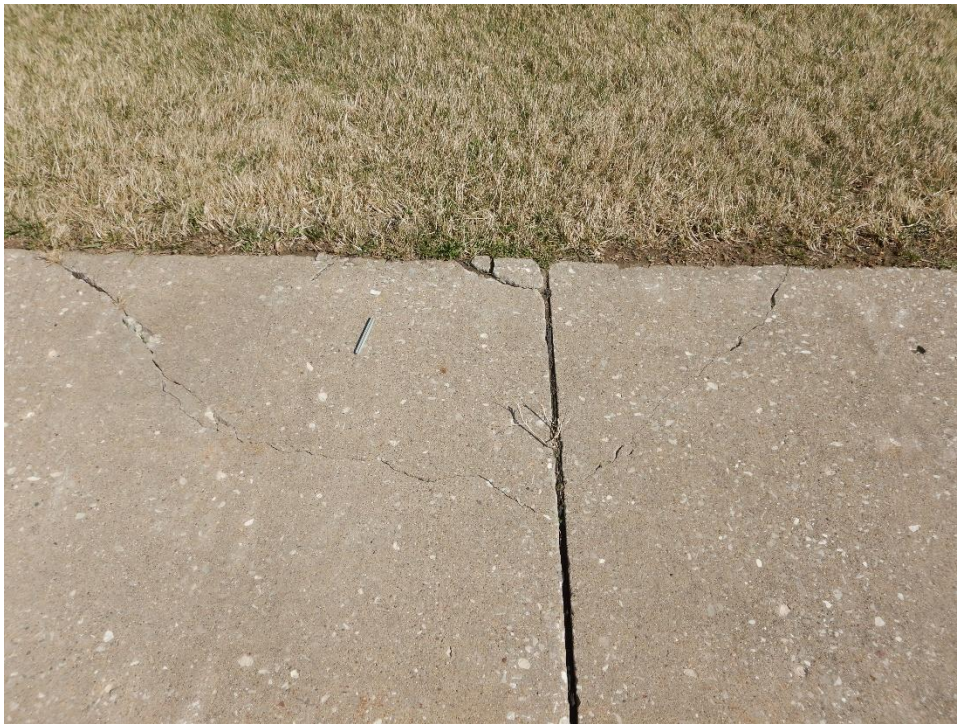
TB1DA-01. Corner Break (Sample Unit No. 01).

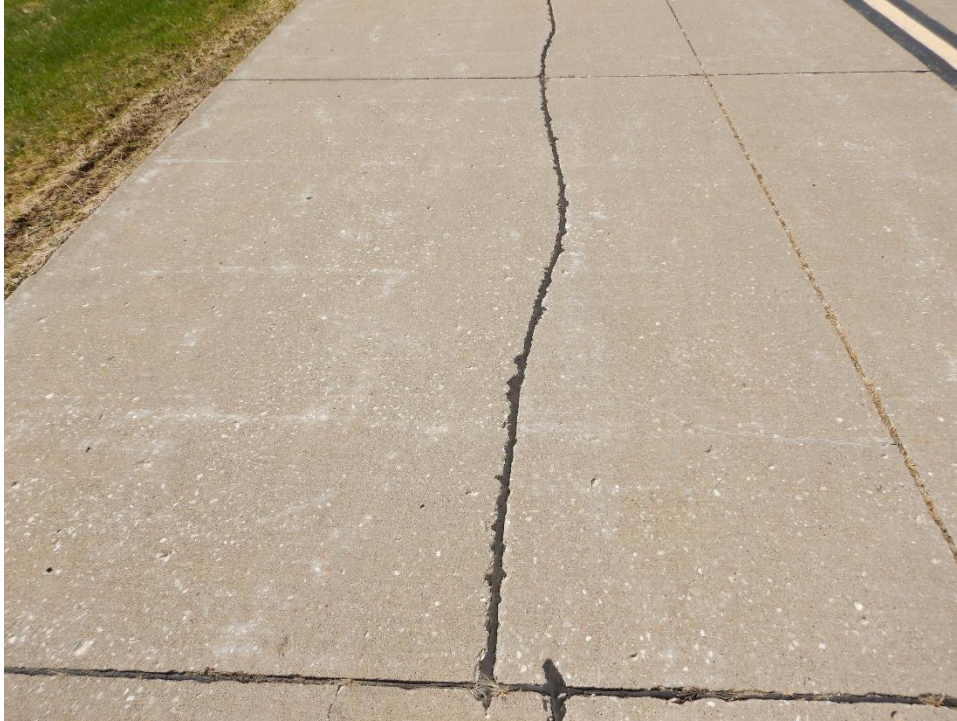
TBDA-01. LTD Cracking (Sample Unit No. 02) (1).

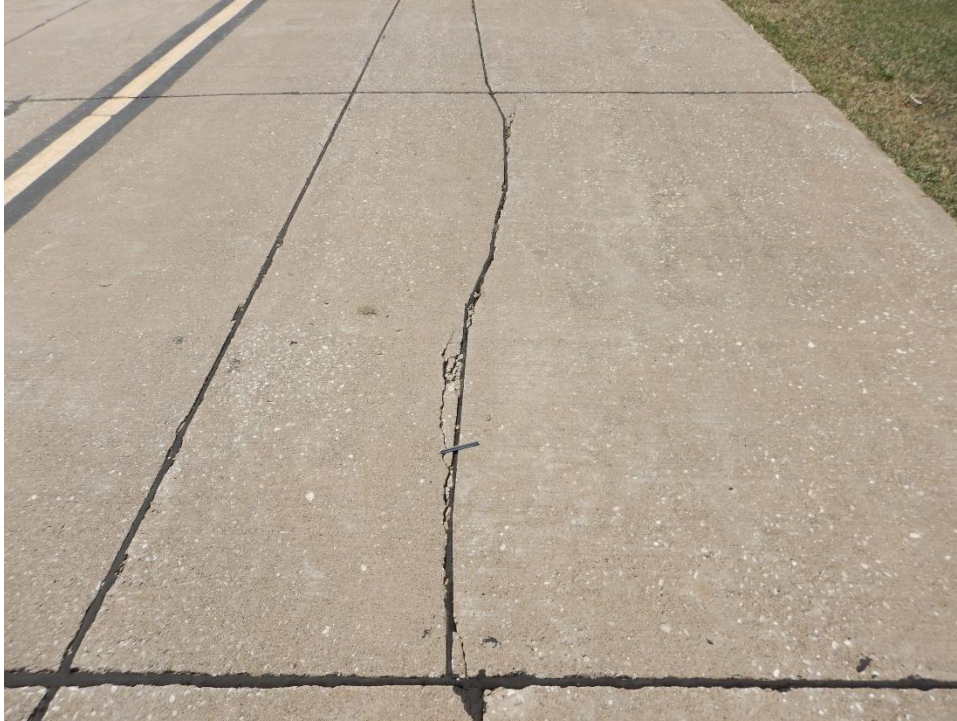
TBDA-01. LTD Cracking (Sample Unit No. 17).

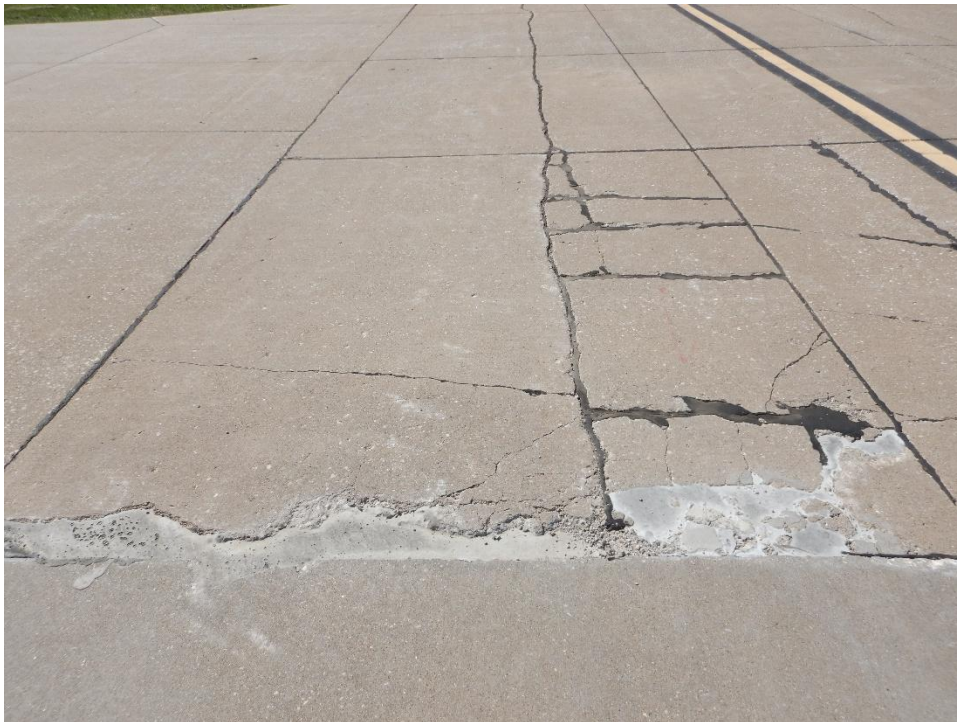
TBDA-01. Shattered Slab (Sample Unit No. 17).

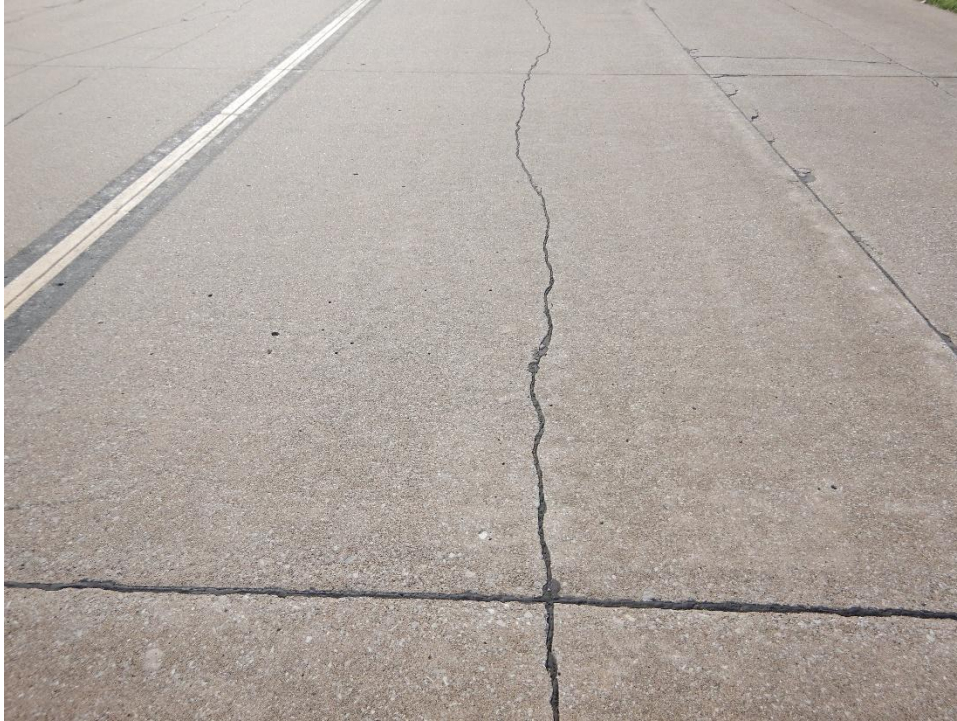
TCDA-01. LTD Cracking (Sample Unit No. 10).

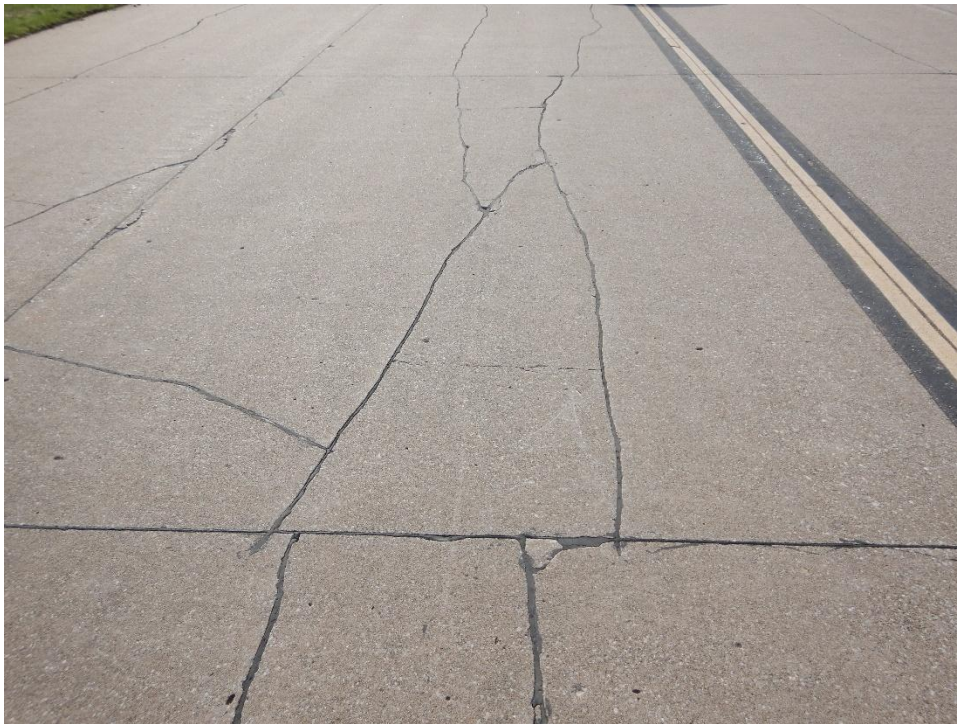
TCDA-02. Overview.

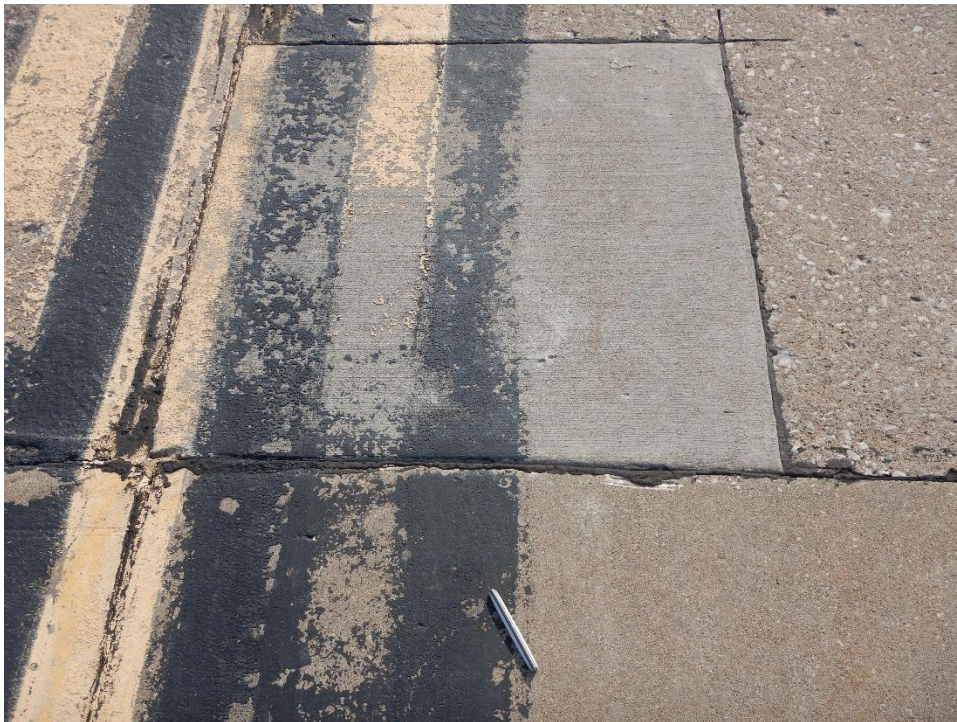
TCDA-03. Overview.

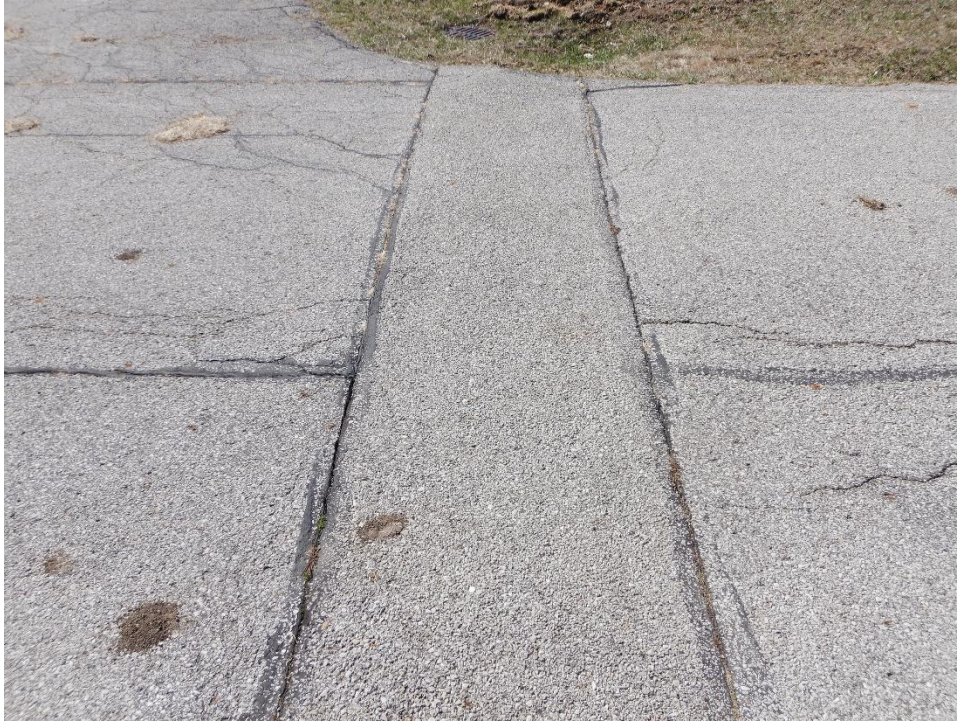
TH01DA-02. Weathering (Sample Unit No. 05).

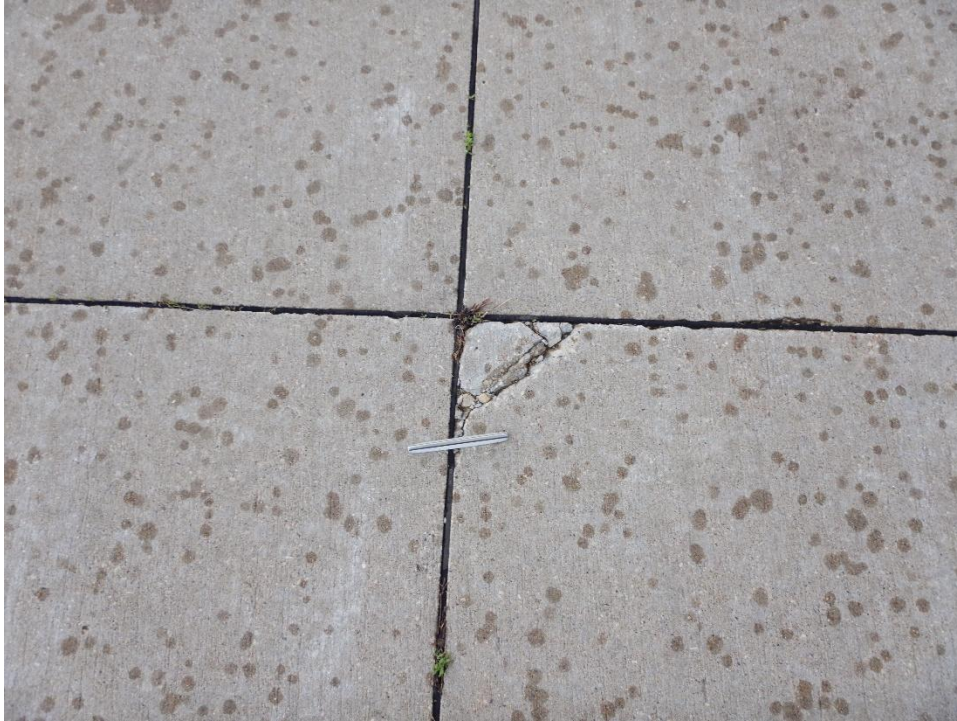
TH01DA-04. Joint Seal Damage (Sample Unit No. 05).
