# Eagle Grove Municipal Airport

## Pavement Management Report

**AUGUST 2025**

# EAGLE GROVE MUNICIPAL AIRPORT PAVEMENT MANAGEMENT REPORT

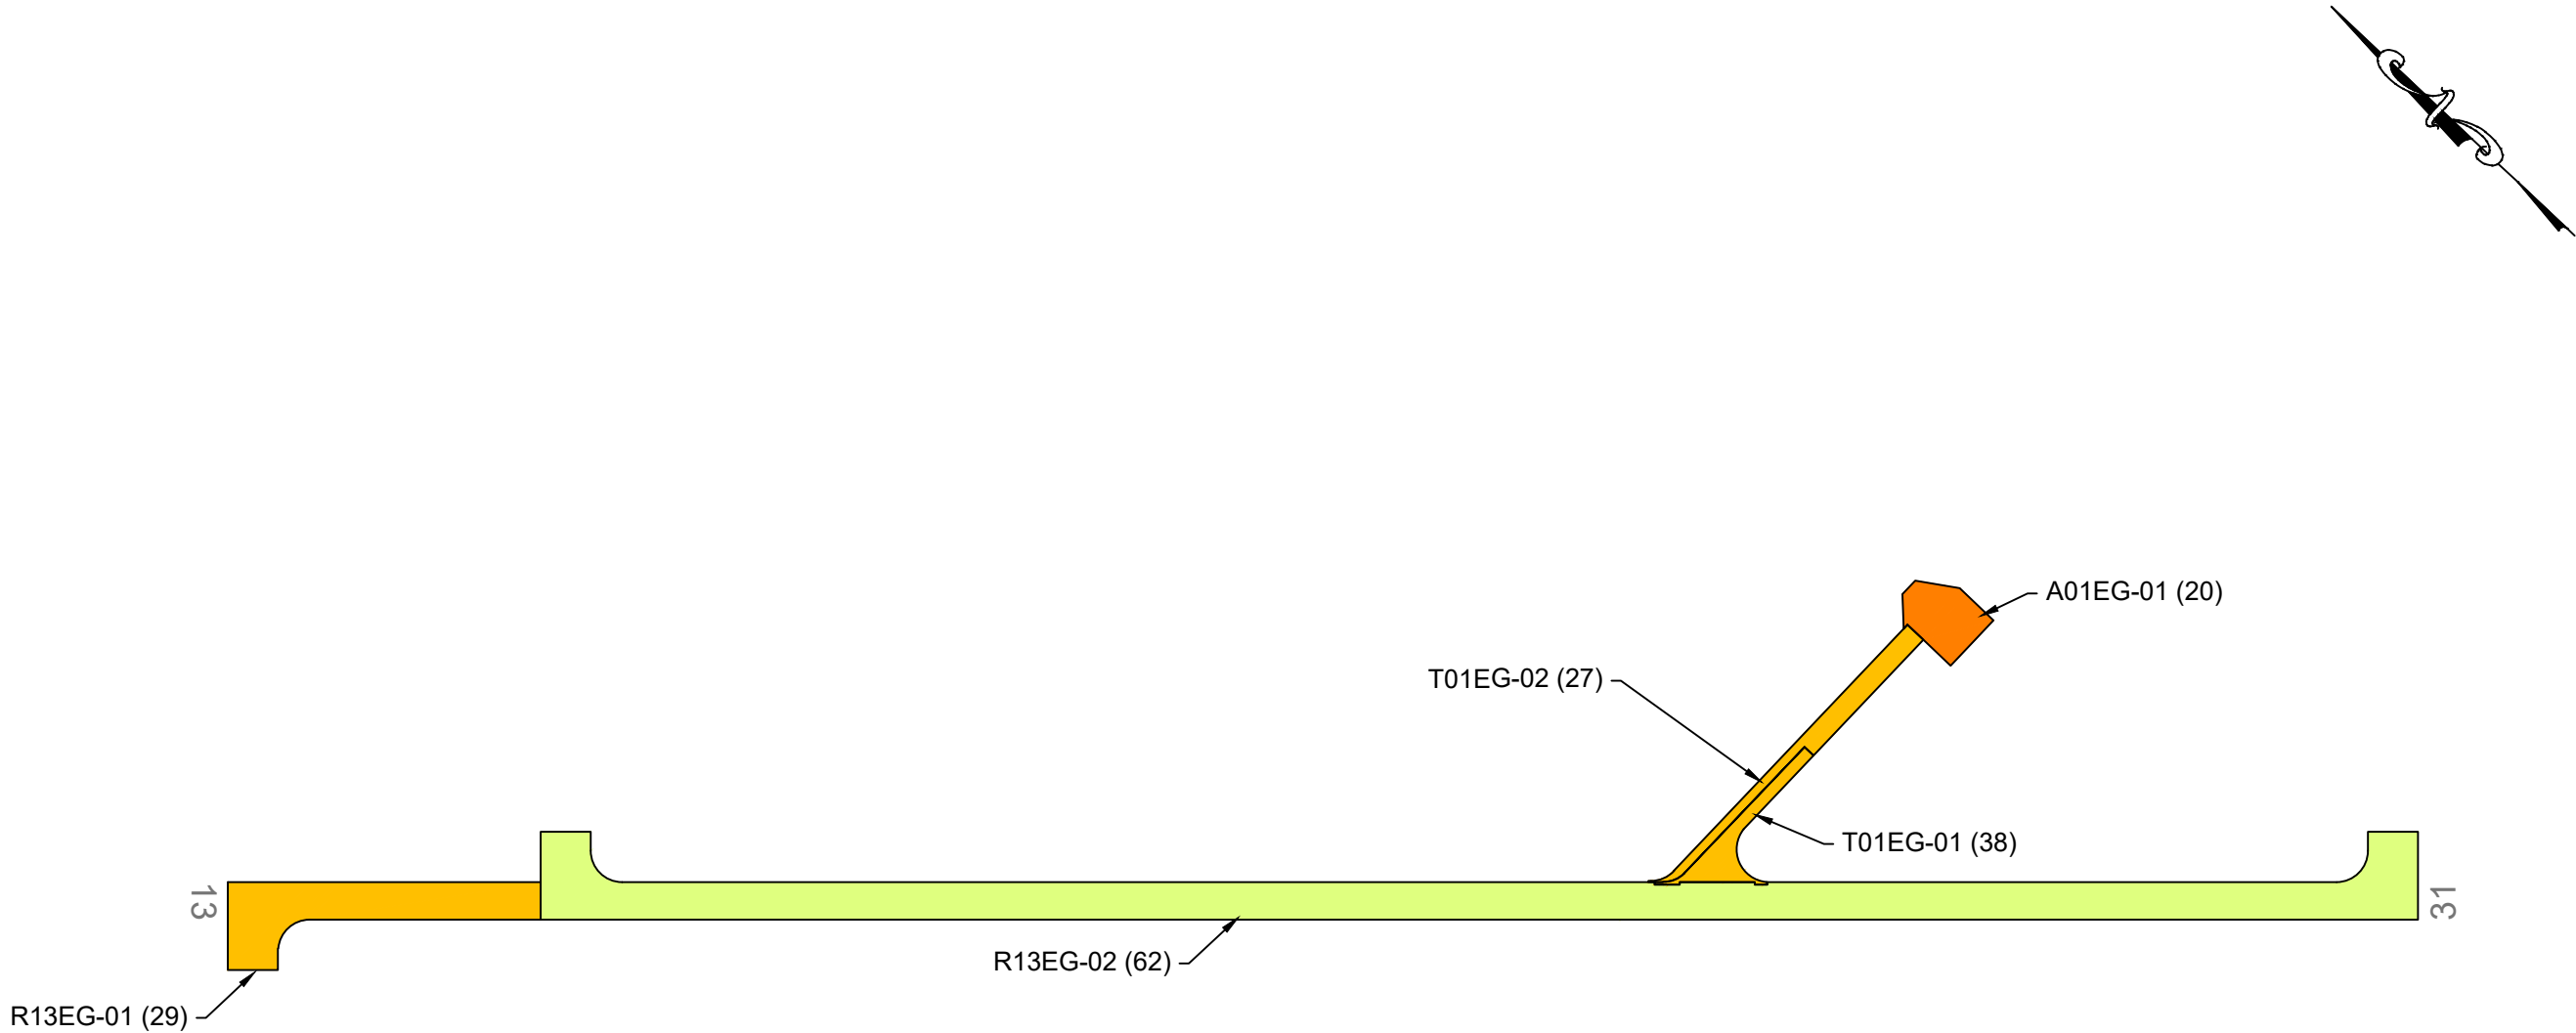
FIGURE 8. PCI MAP.

The pavements at Eagle Grove Municipal Airport were inspected in March 2025. The 2025 area-weighted condition of Eagle Grove Municipal Airport is 53, with conditions ranging from 20 to 62 (on a scale of 0 [failed] to 100 [excellent]). During the previous pavement inspection in 2018, the area-weighted PCI of the airport was 61.
