# Emmetsburg Municipal Airport

## Pavement Management Report

**AUGUST 2026**

# EMMETSBURG MUNICIPAL AIRPORT PAVEMENT MANAGEMENT REPORT

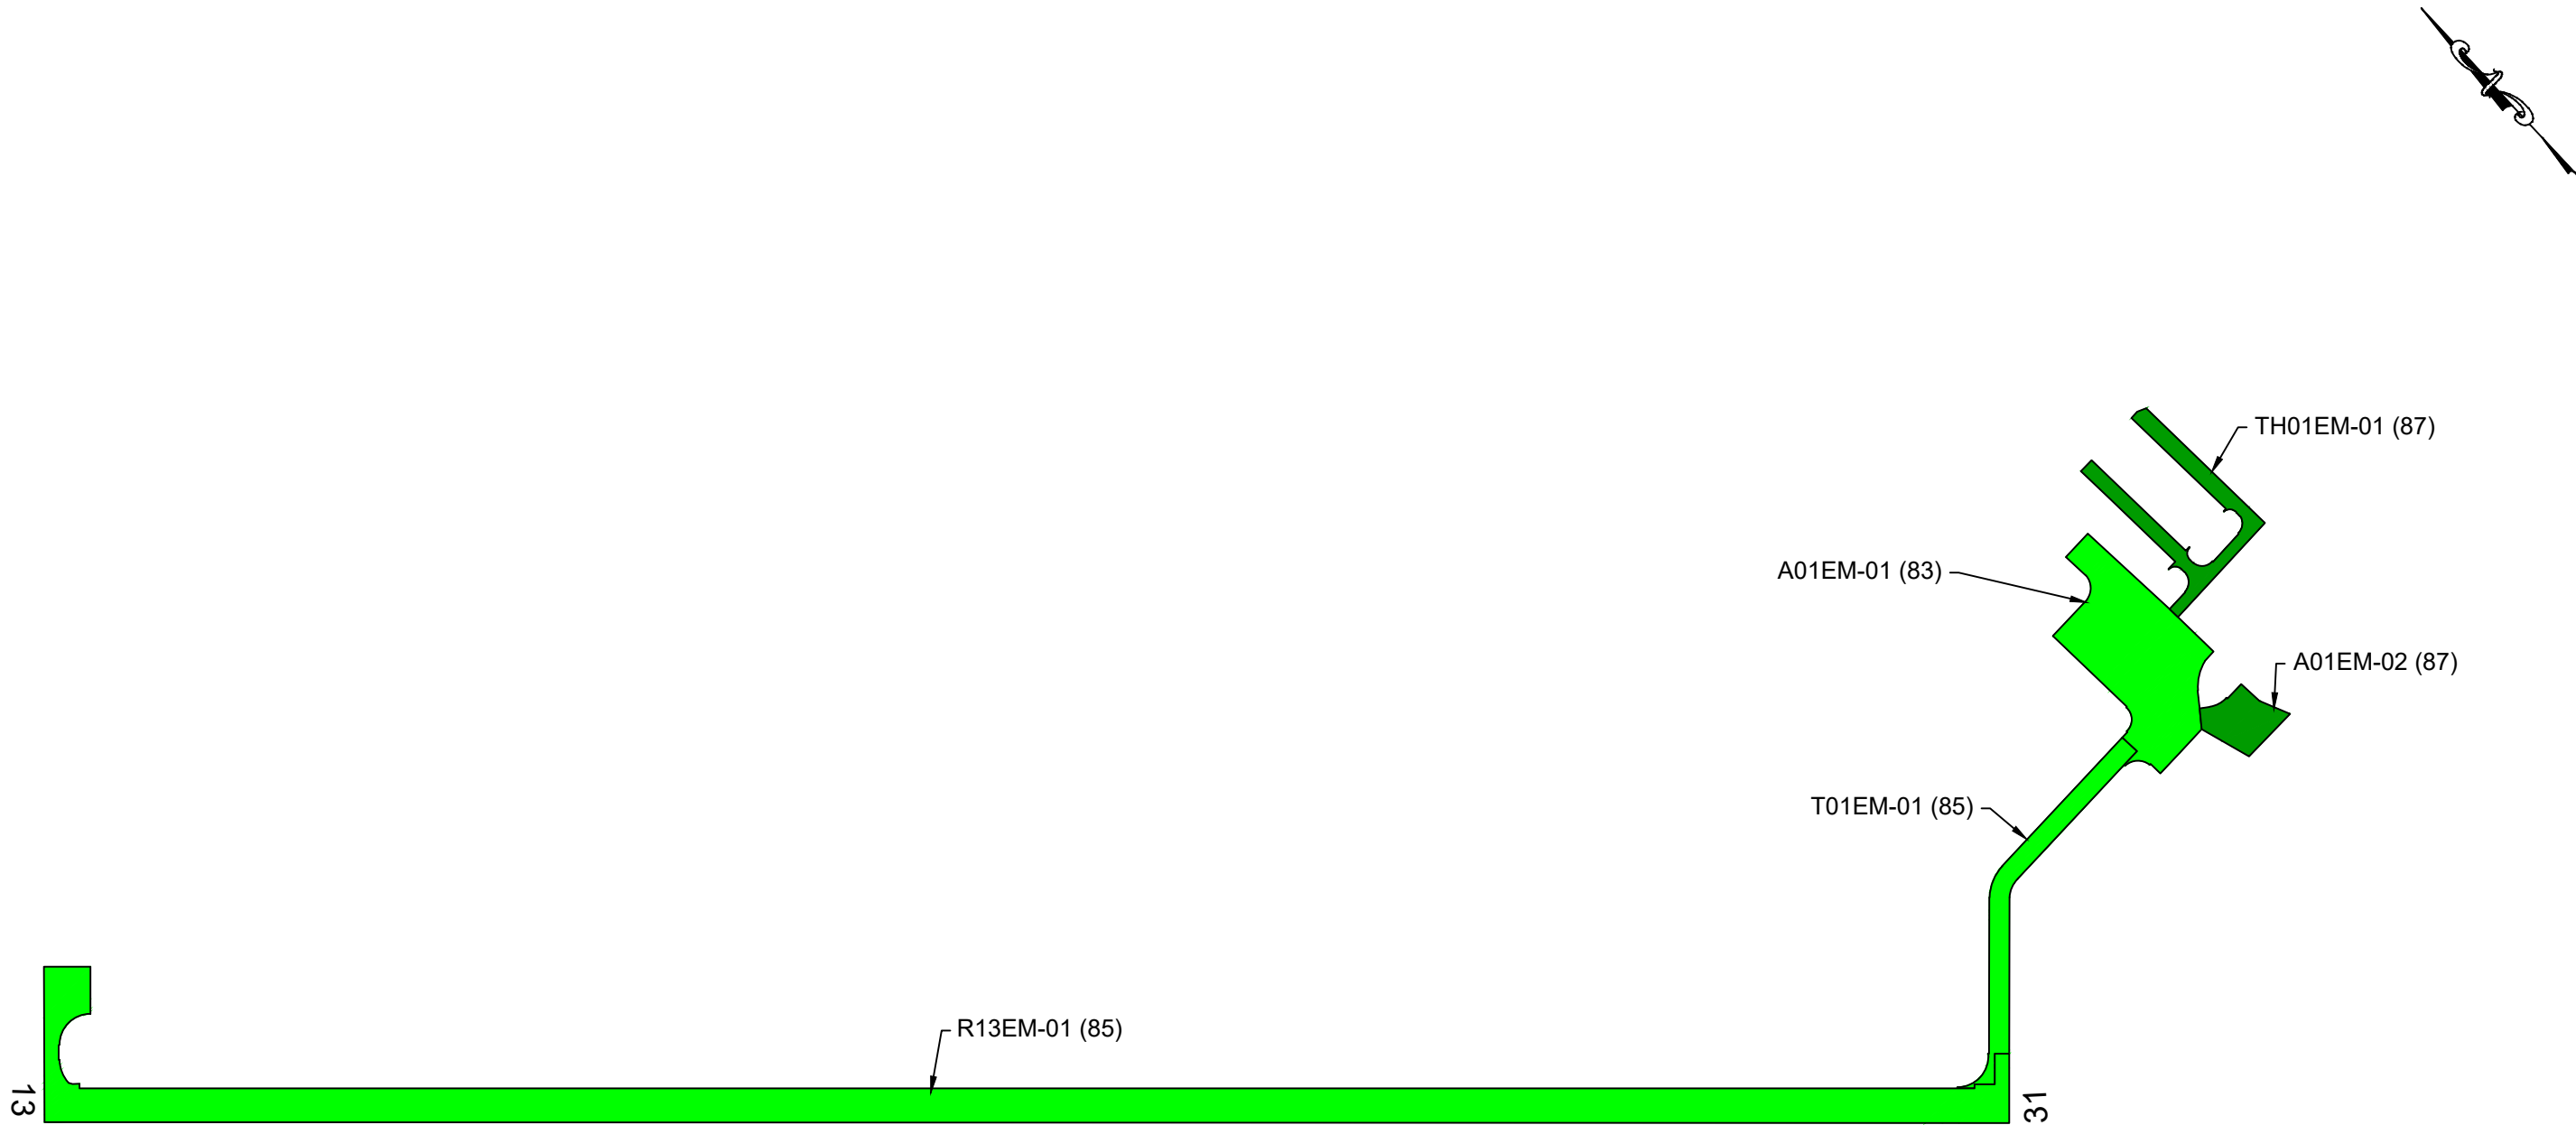
FIGURE 8. PCI MAP.

The pavements at Emmetsburg Municipal Airport were inspected in February 2026. The 2026 area-weighted condition of Emmetsburg Municipal Airport is 85, with conditions ranging from 83 to 87 (on a scale of 0 [*Failed*] to 100 [*Excellent*]). During the previous pavement inspection in 2022, the area-weighted PCI of the airport was 85.

Runway 13/31 consisted of one section with low- and high-severity corner spalling, high-severity joint seal damage, and medium-severity joint spalling and longitudinal, transverse, and diagonal (LTD) cracking.

The taxiway was defined by one section that contained areas of high-severity joint seal damage and low-severity faulting and LTD cracking.

The apron area contained two sections. Section 01 had low-severity corner break, faulting, and LTD cracking; high-severity corner spalling and joint seal damage; and medium-severity joint spalling identified during the inspection. Low-severity corner spalling and high-severity joint seal damage were observed in Section 02.

The T-hangar area consisted of one section. Medium-severity corner spalling, faulting, joint seal damage, and joint spalling were recorded in Section 01.
