# Estherville Municipal Airport

## Pavement Management Report

**AUGUST 2026**

# ESTHERVILLE MUNICIPAL AIRPORT PAVEMENT MANAGEMENT REPORT

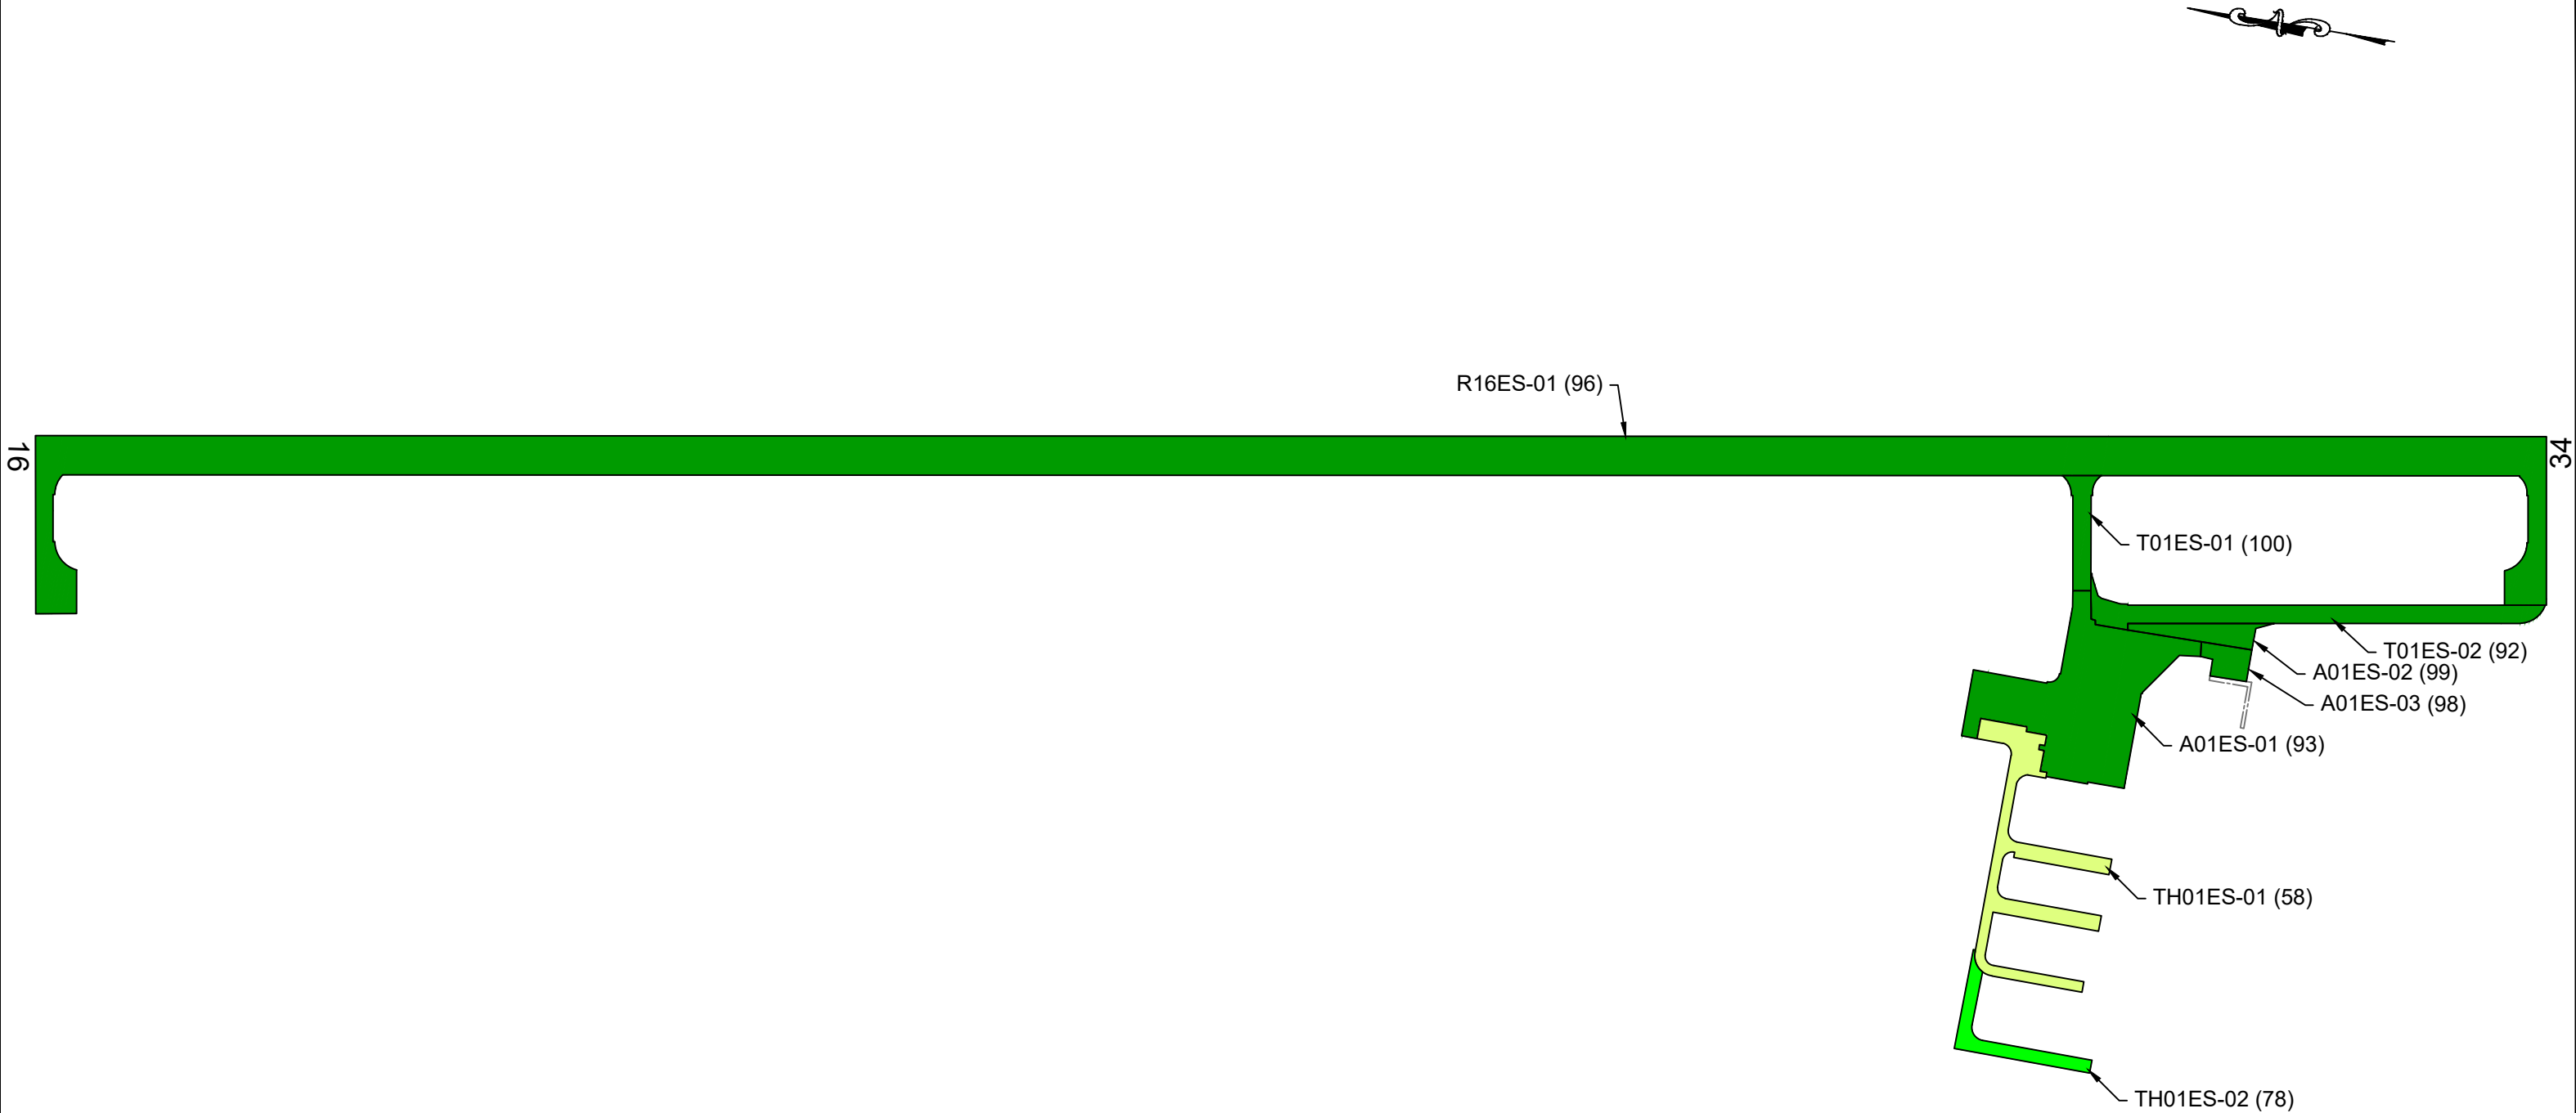
FIGURE 8. PCI MAP.

The pavements at Estherville Municipal Airport were inspected in February 2026. The 2026 area-weighted condition of Estherville Municipal Airport is 93, with conditions ranging from 58 to 100 (on a scale of 0 [*Failed*] to 100 [*Excellent*]). During the previous pavement inspection in 2022, the area-weighted PCI of the airport was 83.

Figure 6 summarizes the overall condition of the pavements at Estherville Municipal Airport, and Figure 7 presents area-weighted condition (average PCI adjusted to account for the relative size of the pavement sections) by branch use. Figure 8 is a map that displays the condition of the evaluated pavements. Table 1 summarizes the results of the pavement evaluation. Appendix B presents photographs taken during the PCI inspection, and Appendix C contains detailed information on the distress types observed during the visual survey. Appendix D includes detailed work history information that was collected during the record review process.
