# Forest City Municipal Airport/Trimble Field

## Pavement Management Report

**AUGUST 2026**

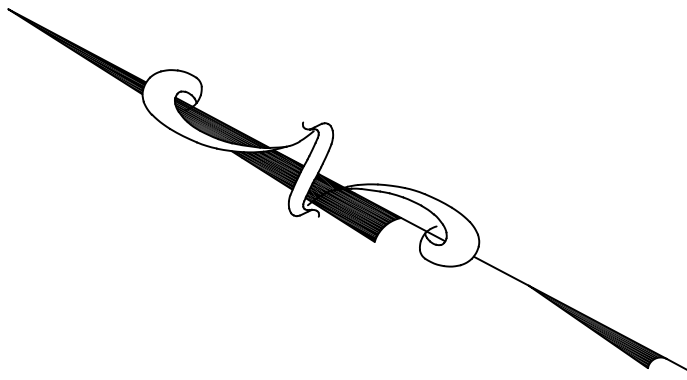
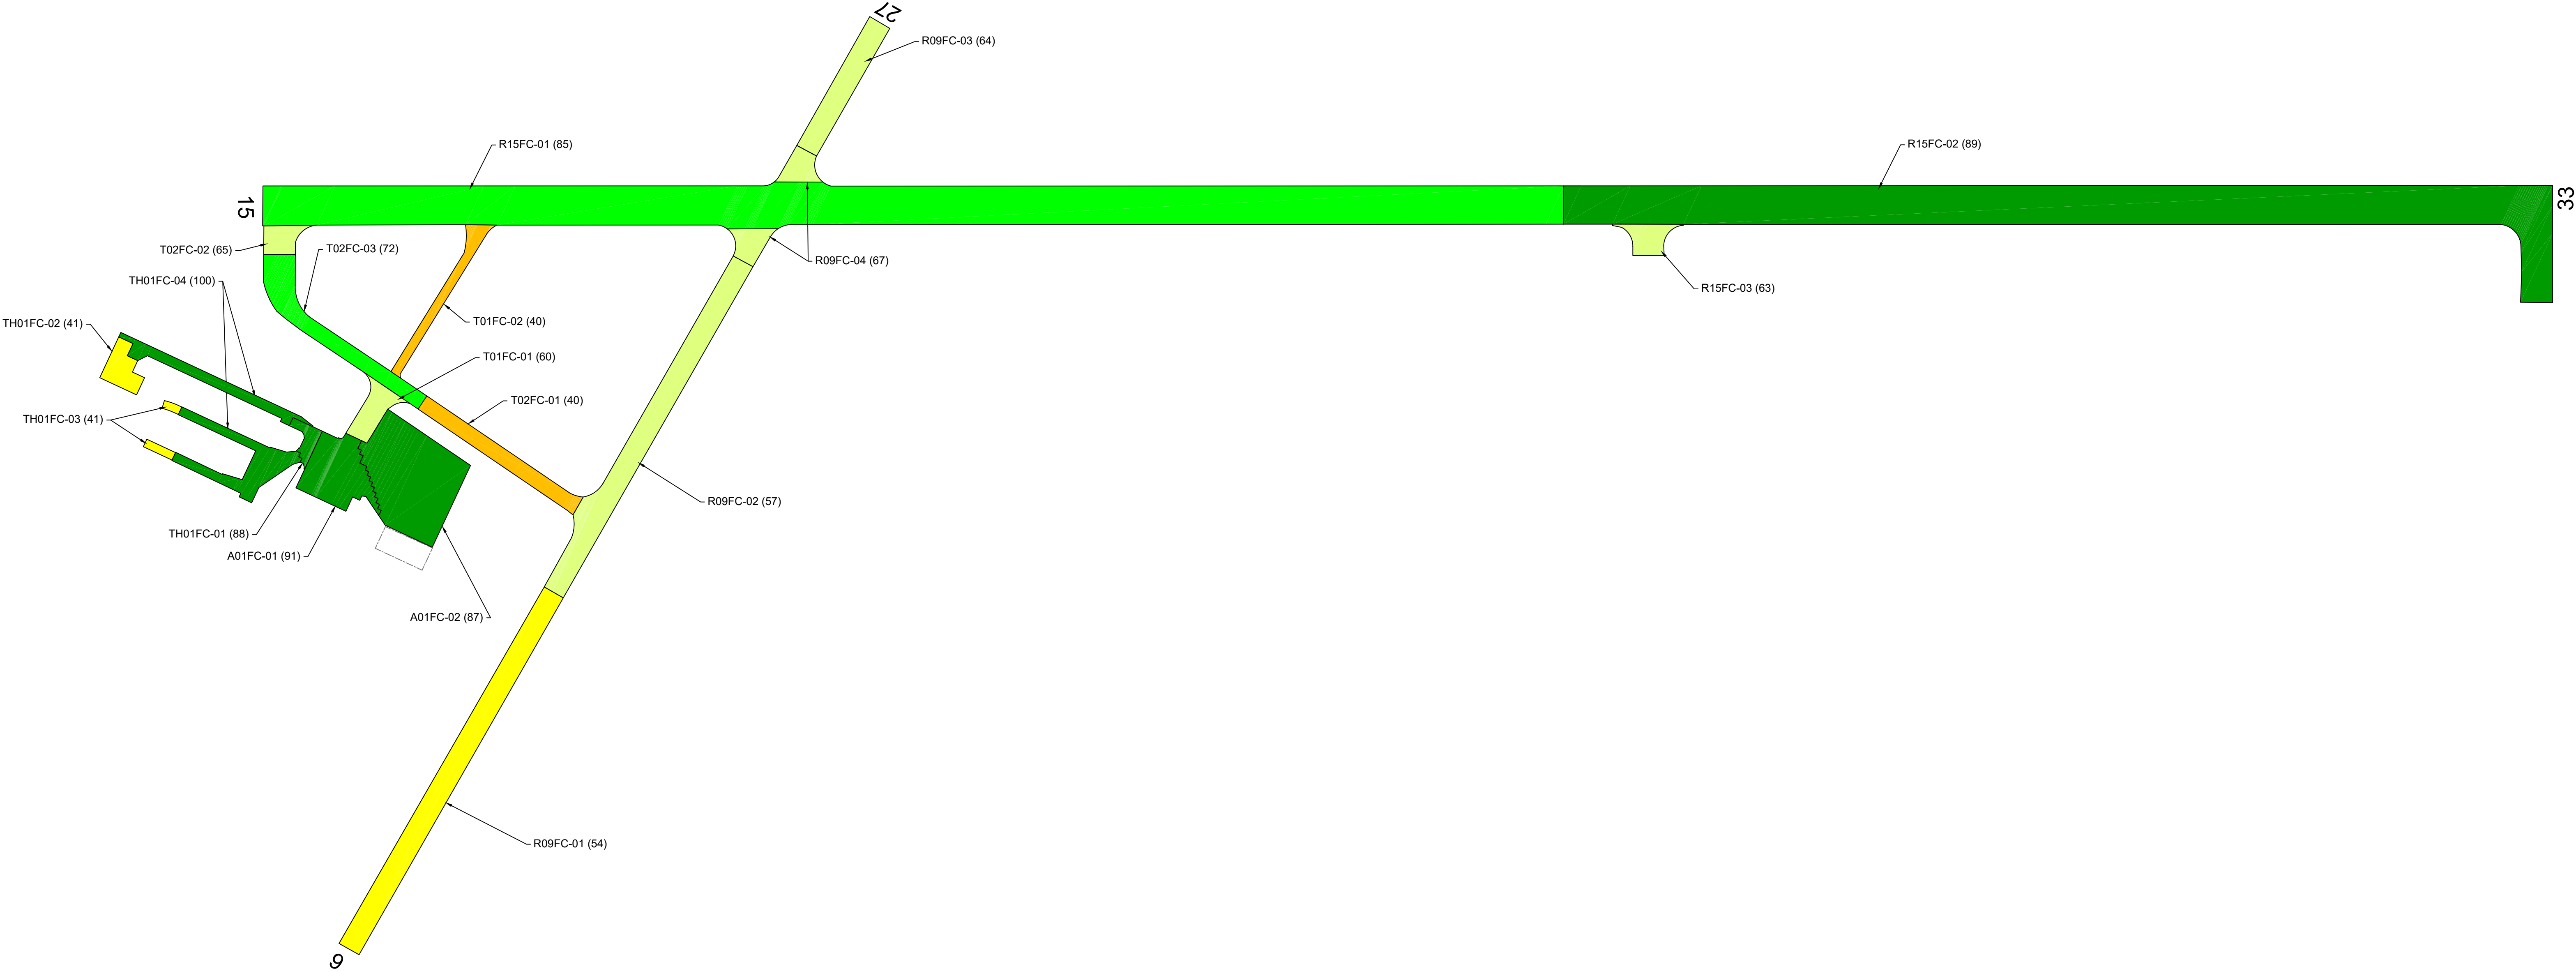
FIGURE 8. PCI MAP.

The pavements at Forest City Municipal Airport/Trimble Field were inspected in February 2026. The 2026 area-weighted condition of Forest City Municipal Airport/Trimble Field is 80, with conditions ranging from 40 to 100 (on a scale of 0 [*Failed*] to 100 [*Excellent*]). During the previous pavement inspection in 2022, the area-weighted PCI of the airport was 56.

Figure 6 summarizes the overall condition of the pavements at Forest City Municipal Airport/Trimble Field, and Figure 7 presents area-weighted condition (average PCI adjusted to account for the relative size of the pavement sections) by branch use. Figure 8 is a map that displays the condition of the evaluated pavements. Table 1 summarizes the results of the pavement evaluation. Appendix B presents photographs taken during the PCI inspection, and Appendix C contains detailed information on the distress types observed during the visual

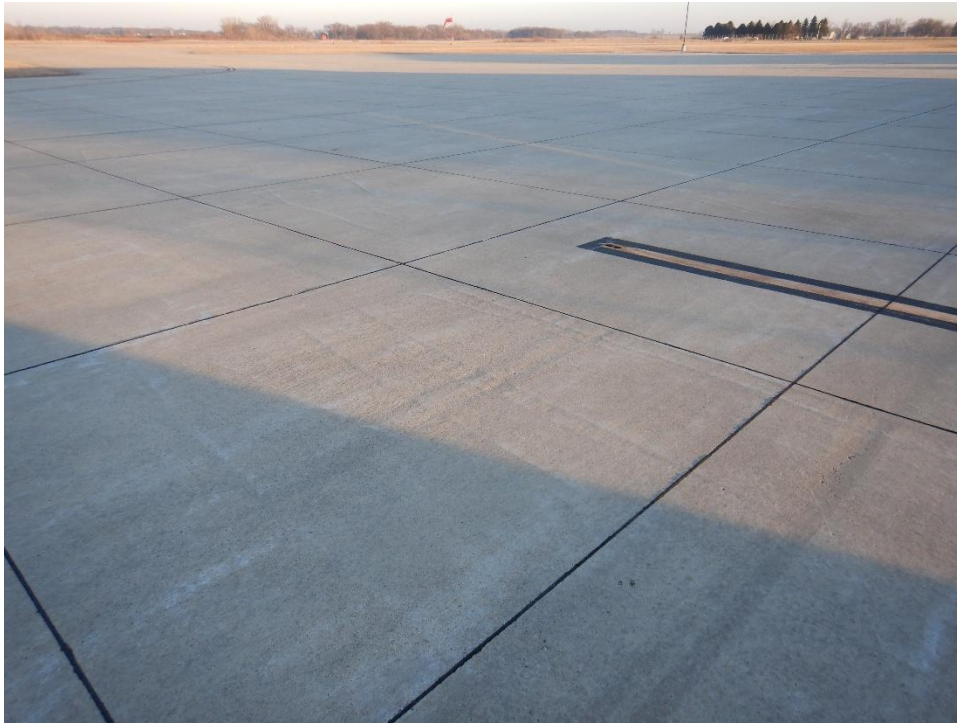
A01FC-01. Overview.

| Branch | Section | Surface Type | Section Area (sf) | LCD | 2026 PCI | % Distress Due to Load | % Distress Due to Climate/Durability | % Distress Due to Other | Type of Distress |
|---|---|---|---|---|---|---|---|---|---|
| A01FC | 01 | PCC | 25,521 | 6/1/2007 | 91 | 23 | 65 | 12 | Corner Spalling, Joint Spalling, Joint Seal Damage, LTD Cracking |

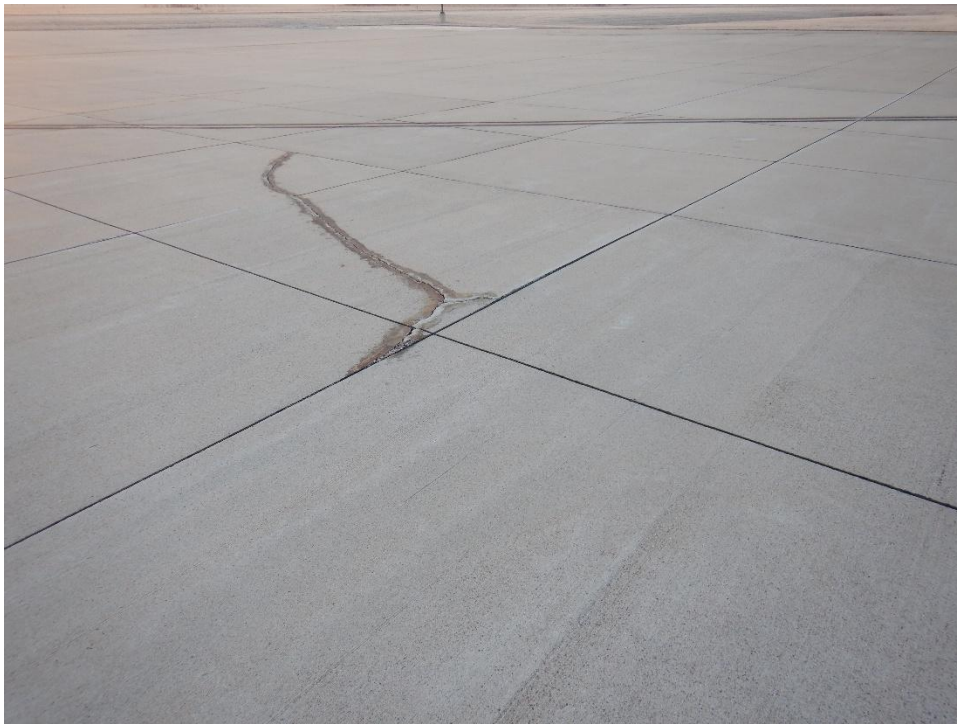
A01FC-02. Overview.

| Branch | Section | Surface Type | Section Area (sf) | LCD | 2026 PCI | % Distress Due to Load | % Distress Due to Climate/Durability | % Distress Due to Other | Type of Distress |
|---|---|---|---|---|---|---|---|---|---|
| A01FC | 02 | PCC | 56,548 | 6/3/2014 | 87 | 38 | 39 | 23 | Corner Break, Faulting, Joint Spalling, Joint Seal Damage, LTD Cracking |

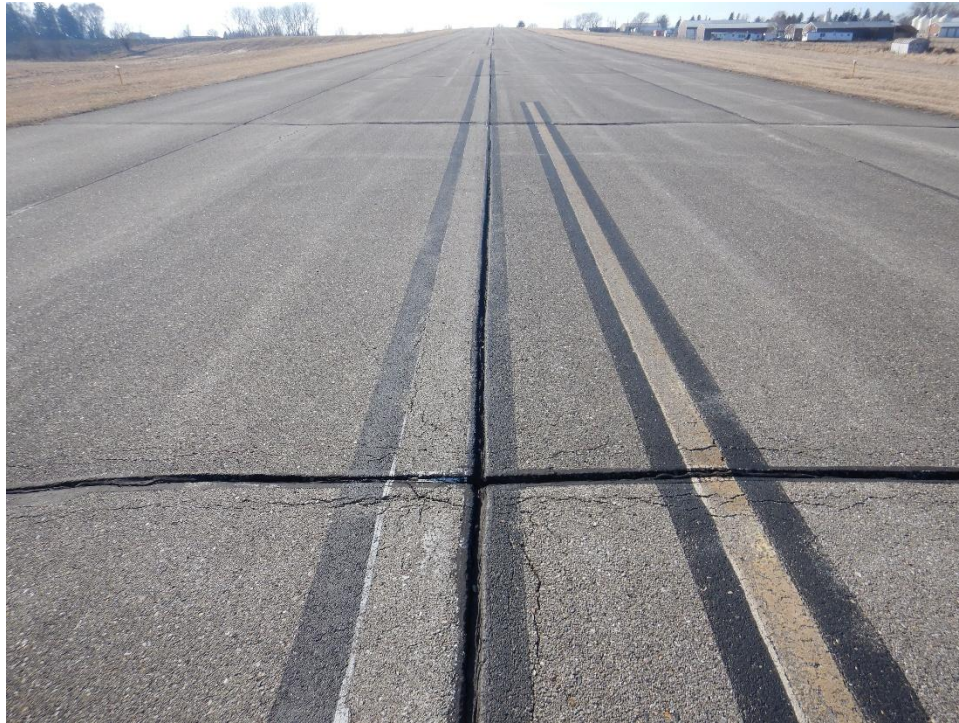
R09FC-01. Overview.

| Branch | Section | Surface Type | Section Area (sf) | LCD | 2026 PCI | % Distress Due to Load | % Distress Due to Climate/Durability | % Distress Due to Other | Type of Distress |
|---|---|---|---|---|---|---|---|---|---|
| R09FC | 01 | AAC | 59,477 | 6/1/2004 | 54 | 0 | 100 | 0 | L&T Cracking, Raveling, Weathering |

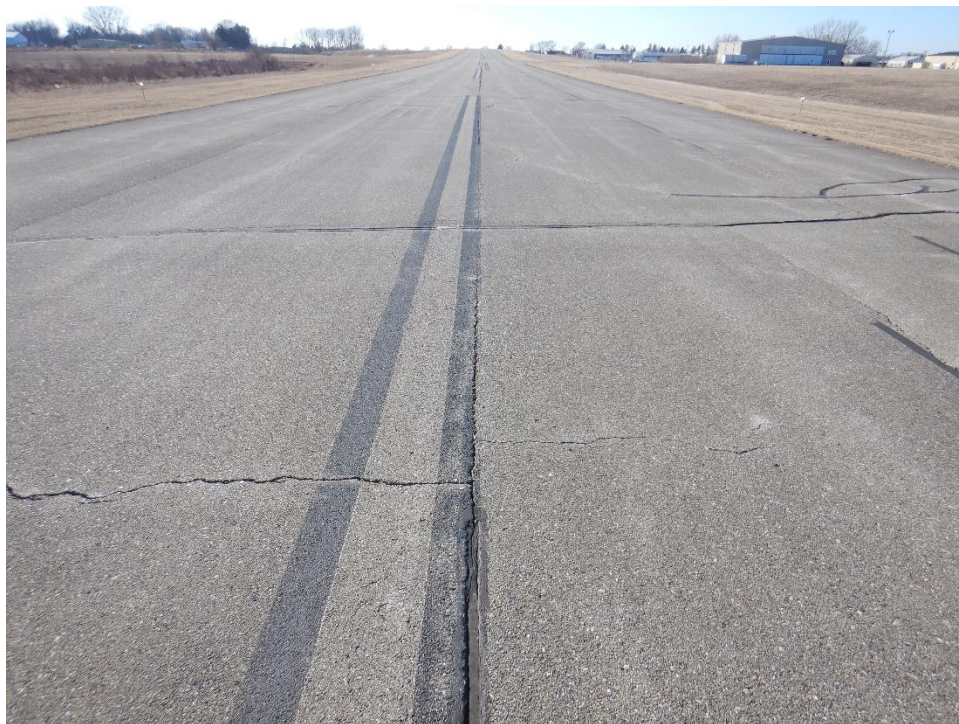
R09FC-02. Overview.

| Branch | Section | Surface Type | Section Area (sf) | LCD | 2026 PCI | % Distress Due to Load | % Distress Due to Climate/Durability | % Distress Due to Other | Type of Distress |
|---|---|---|---|---|---|---|---|---|---|
| R09FC | 02 | AAC | 57,466 | 6/1/2004 | 57 | 0 | 100 | 0 | L&T Cracking, Weathering |

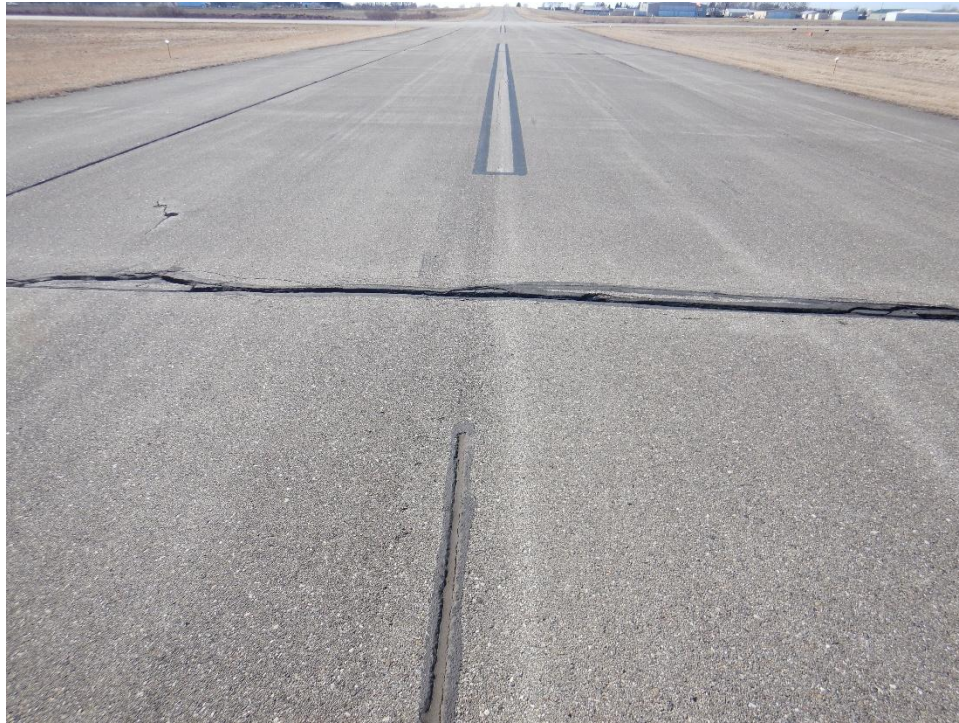
R09FC-03. Overview.

| Branch | Section | Surface Type | Section Area (sf) | LCD | 2026 PCI | % Distress Due to Load | % Distress Due to Climate/Durability | % Distress Due to Other | Type of Distress |
|---|---|---|---|---|---|---|---|---|---|
| R09FC | 03 | AAC | 21,667 | 6/1/2004 | 64 | 17 | 83 | 0 | Alligator Cracking, L&T Cracking, Weathering |

Medium-severity alligator cracking and weathering and low- and medium-severity L&T cracking were recorded in Section 03. Section 04 was in *Excellent* condition with no distress noted at the time of inspection.

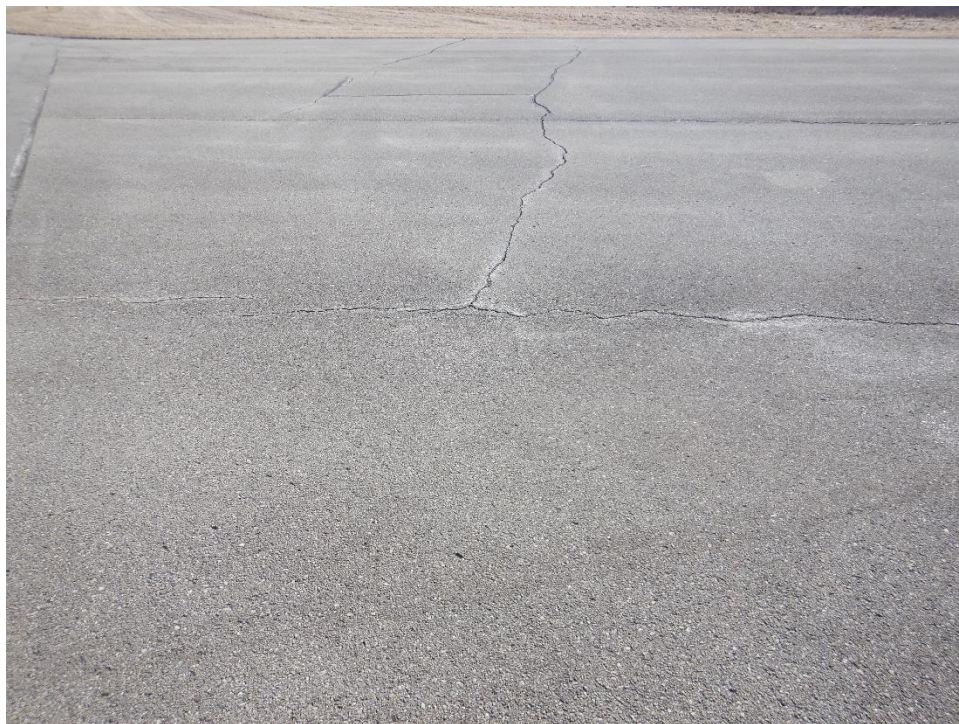
R09FC-04. Overview.

| Branch | Section | Surface Type | Section Area (sf) | LCD | 2026 PCI | % Distress Due to Load | % Distress Due to Climate/Durability | % Distress Due to Other | Type of Distress |
|---|---|---|---|---|---|---|---|---|---|
| R09FC | 04 | AAC | 13,202 | 6/1/2007 | 67 | 0 | 100 | 0 | L&T Cracking, Raveling, Weathering |

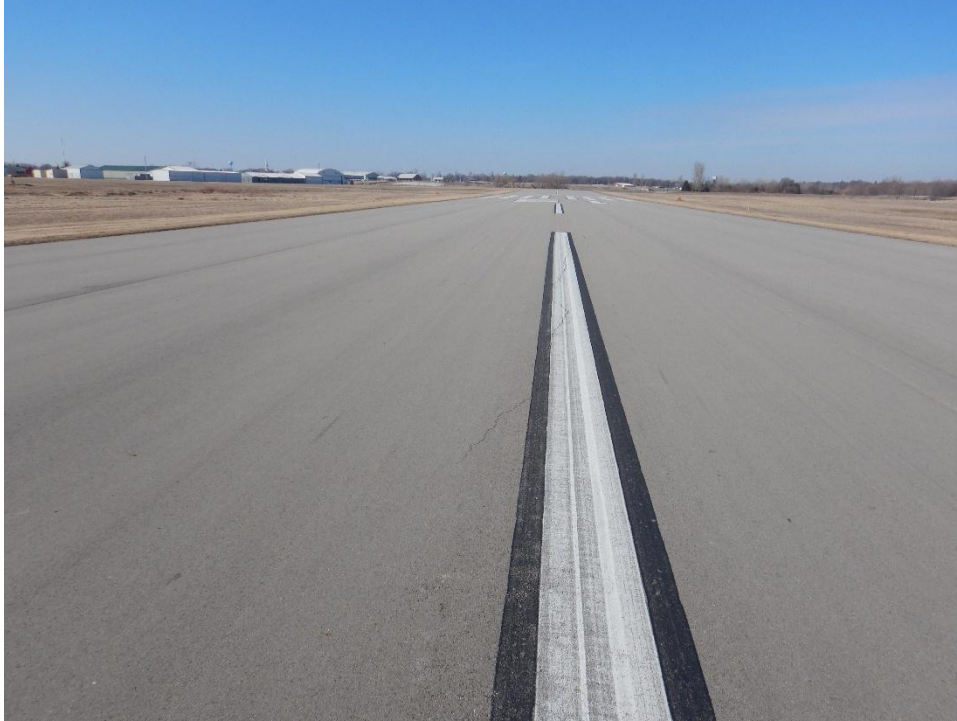
R15FC-01. Overview.

| Branch | Section | Surface Type | Section Area (sf) | LCD | 2026 PCI | % Distress Due to Load | % Distress Due to Climate/Durability | % Distress Due to Other | Type of Distress |
|---|---|---|---|---|---|---|---|---|---|
| R15FC | 01 | AAC | 327,248 | 10/2/2024 | 85 | 0 | 100 | 0 | L&T Cracking |

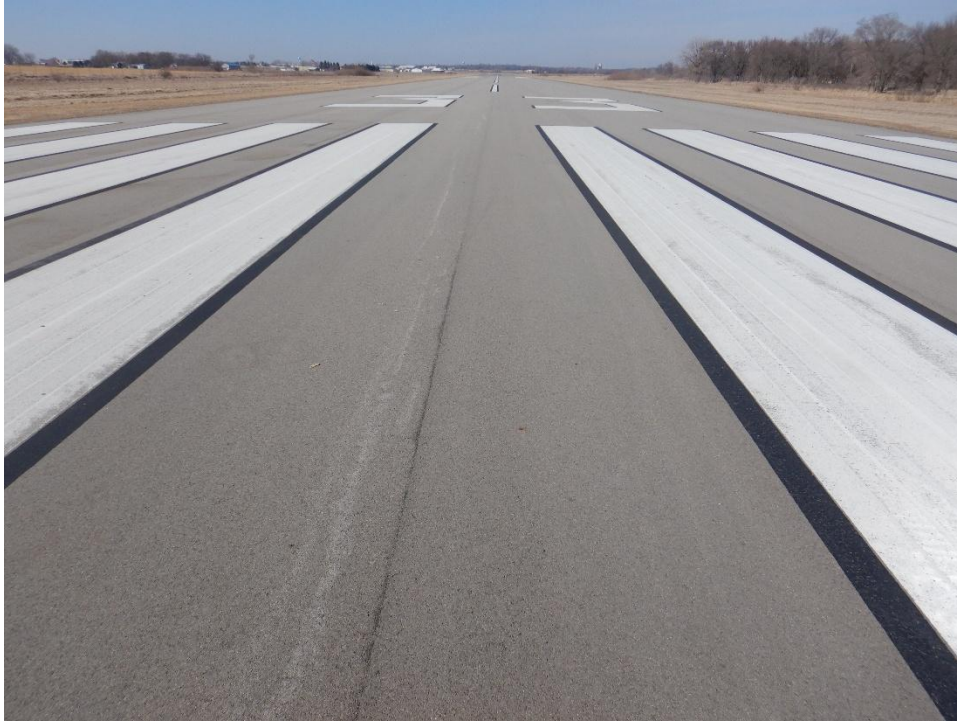
R15FC-02. Overview.

| Branch | Section | Surface Type | Section Area (sf) | LCD | 2026 PCI | % Distress Due to Load | % Distress Due to Climate/Durability | % Distress Due to Other | Type of Distress |
|---|---|---|---|---|---|---|---|---|---|
| R15FC | 02 | AAC | 262,494 | 10/2/2024 | 89 | 0 | 100 | 0 | L&T Cracking |

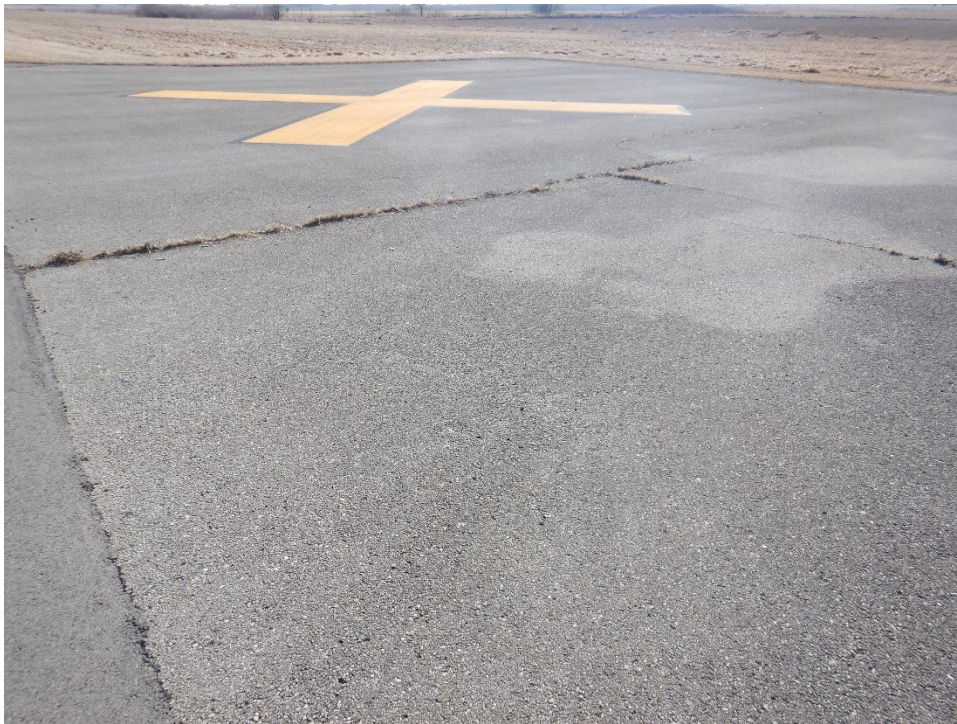
R15FC-03. Overview.

| Branch | Section | Surface Type | Section Area (sf) | LCD | 2026 PCI | % Distress Due to Load | % Distress Due to Climate/Durability | % Distress Due to Other | Type of Distress |
|---|---|---|---|---|---|---|---|---|---|
| R15FC | 03 | AAC | 7,689 | 8/1/2007 | 63 | 0 | 100 | 0 | L&T Cracking, Raveling, Weathering |

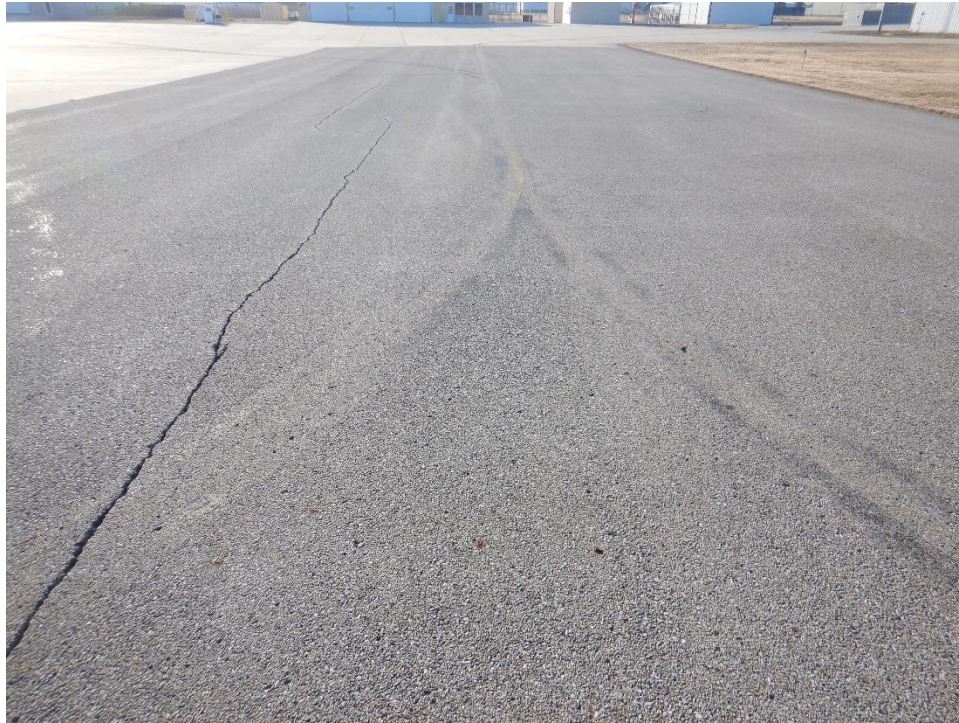
T01FC-01. Overview.

| Branch | Section | Surface Type | Section Area (sf) | LCD | 2026 PCI | % Distress Due to Load | % Distress Due to Climate/Durability | % Distress Due to Other | Type of Distress |
|---|---|---|---|---|---|---|---|---|---|
| T01FC | 01 | AAC | 9,807 | 6/1/2012 | 60 | 0 | 100 | 0 | L&T Cracking, Raveling, Weathering |

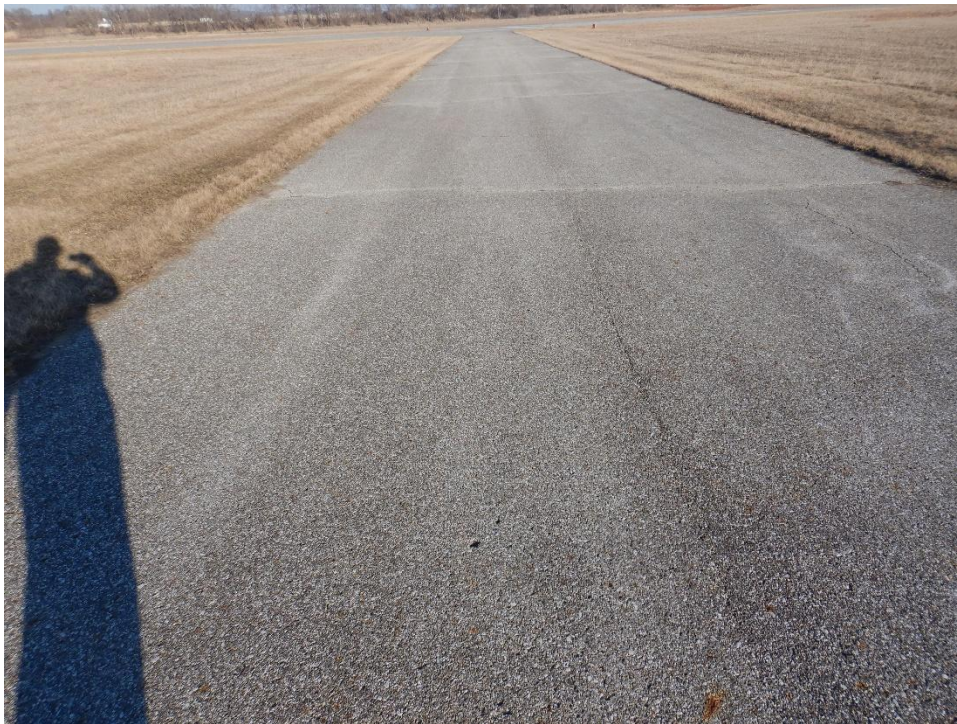
T01FC-02. Overview.

| Branch | Section | Surface Type | Section Area (sf) | LCD | 2026 PCI | % Distress Due to Load | % Distress Due to Climate/Durability | % Distress Due to Other | Type of Distress |
|---|---|---|---|---|---|---|---|---|---|
| T01FC | 02 | AC | 11,766 | 11/1/2004 | 40 | 20 | 76 | 4 | Alligator Cracking, Depression, L&T Cracking, Patching, Raveling, Weathering |

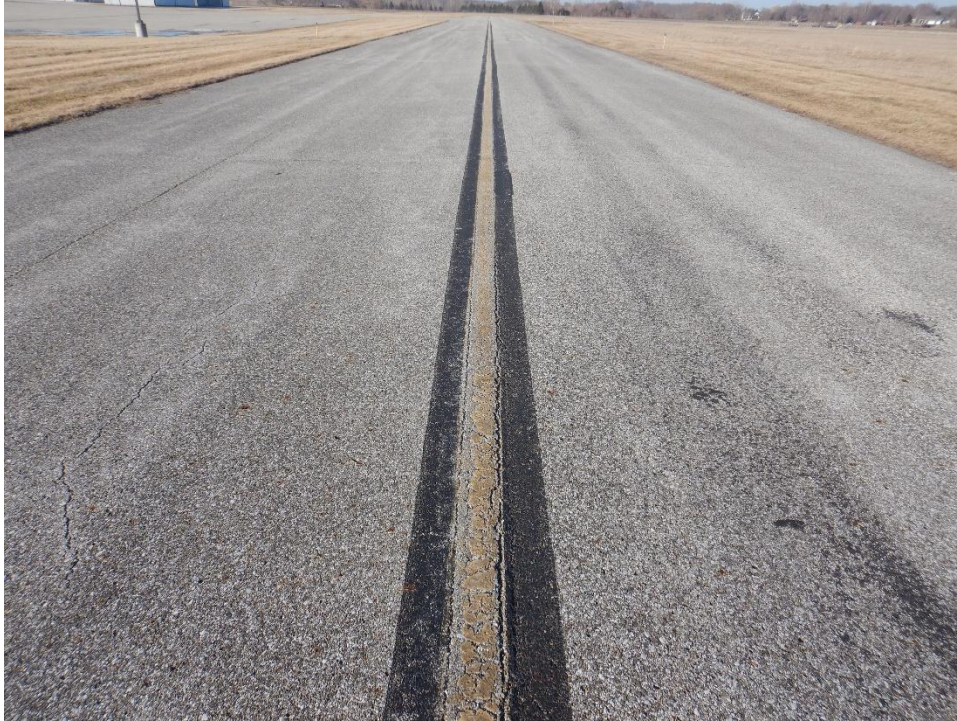
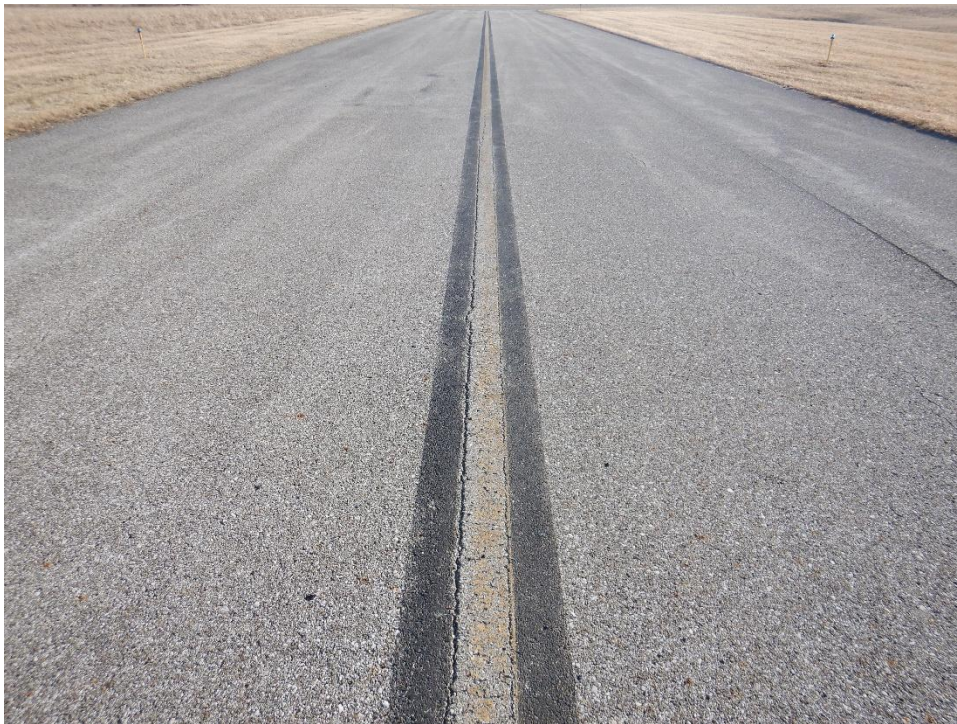
| Branch | Section | Surface Type | Section Area (sf) | LCD | 2026 PCI | % Distress Due to Load | % Distress Due to Climate/Durability | % Distress Due to Other | Type of Distress |
|---|---|---|---|---|---|---|---|---|---|
| T02FC | 01 | AC | 19,122 | 7/1/1985 | 40 | 8 | 61 | 31 | Alligator Cracking, Bleeding, L&T Cracking, Patching, Raveling, Weathering |

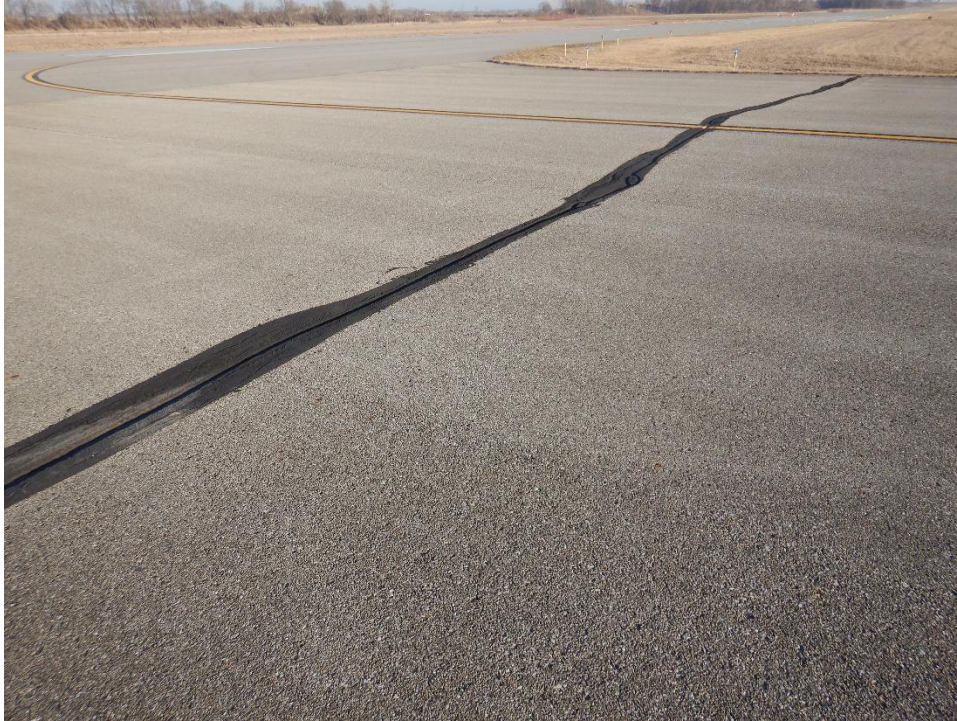
T02FC-02. Overview.

| Branch | Section | Surface Type | Section Area (sf) | LCD | 2026 PCI | % Distress Due to Load | % Distress Due to Climate/Durability | % Distress Due to Other | Type of Distress |
|---|---|---|---|---|---|---|---|---|---|
| T02FC | 02 | AAC | 6,532 | 6/1/2012 | 65 | 0 | 100 | 0 | L&T Cracking, Raveling, Weathering |

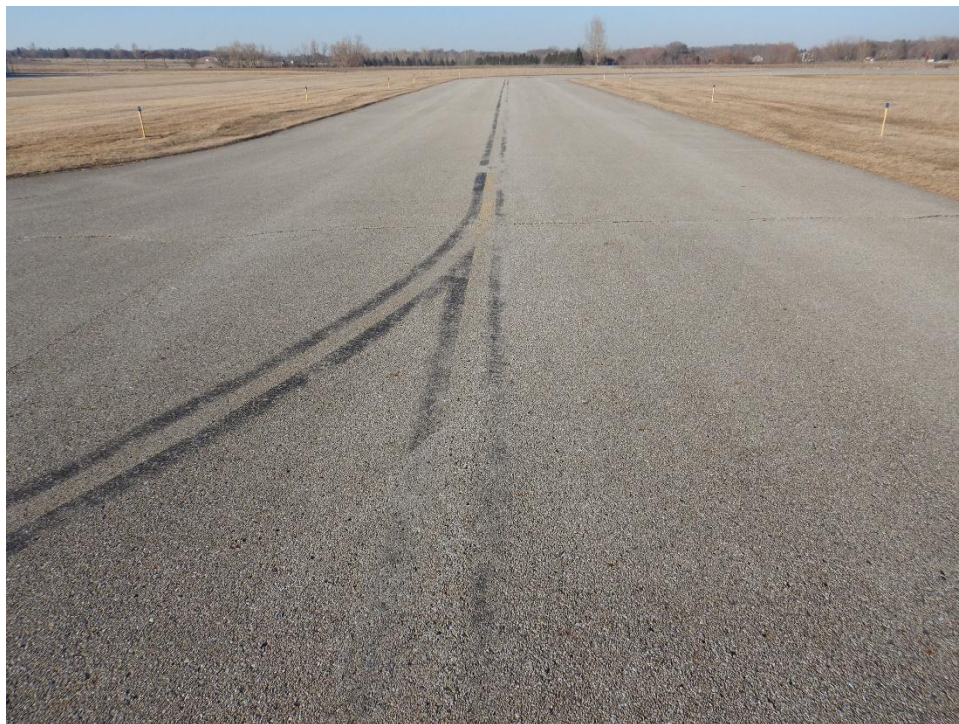
T02FC-03. Overview.

| Branch | Section | Surface Type | Section Area (sf) | LCD | 2026 PCI | % Distress Due to Load | % Distress Due to Climate/Durability | % Distress Due to Other | Type of Distress |
|---|---|---|---|---|---|---|---|---|---|
| T02FC | 03 | AAC | 27,616 | 6/1/2012 | 72 | 0 | 100 | 0 | L&T Cracking, Raveling, Weathering |

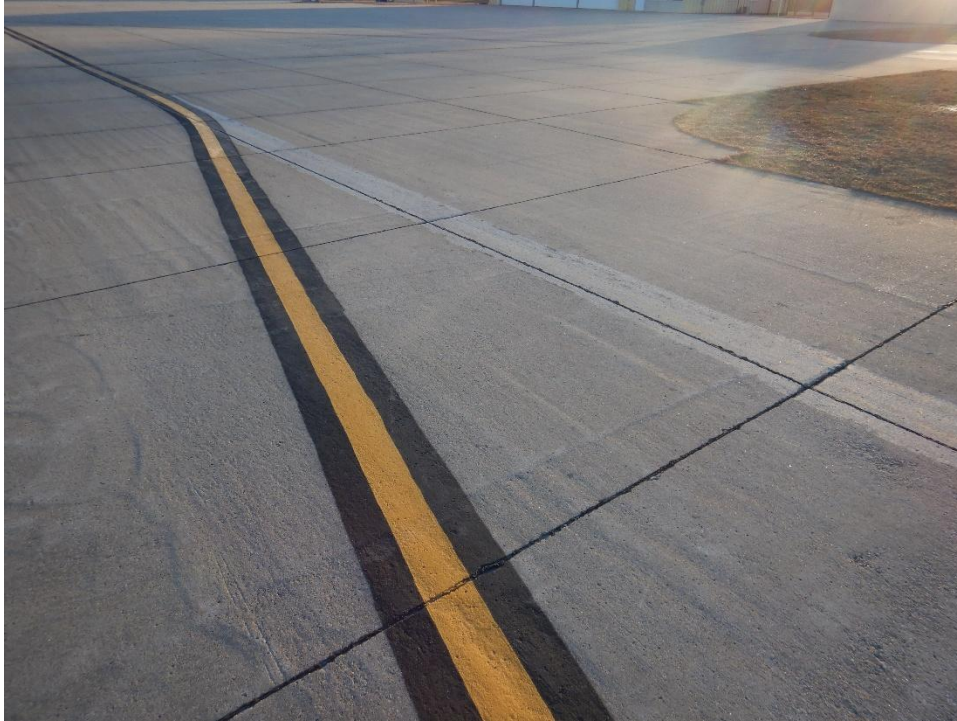
TH01FC-01. Overview.

| Branch | Section | Surface Type | Section Area (sf) | LCD | 2026 PCI | % Distress Due to Load | % Distress Due to Climate/Durability | % Distress Due to Other | Type of Distress |
|---|---|---|---|---|---|---|---|---|---|
| TH01FC | 01 | PCC | 4,229 | 6/1/2006 | 88 | 0 | 100 | 0 | Joint Seal Damage |

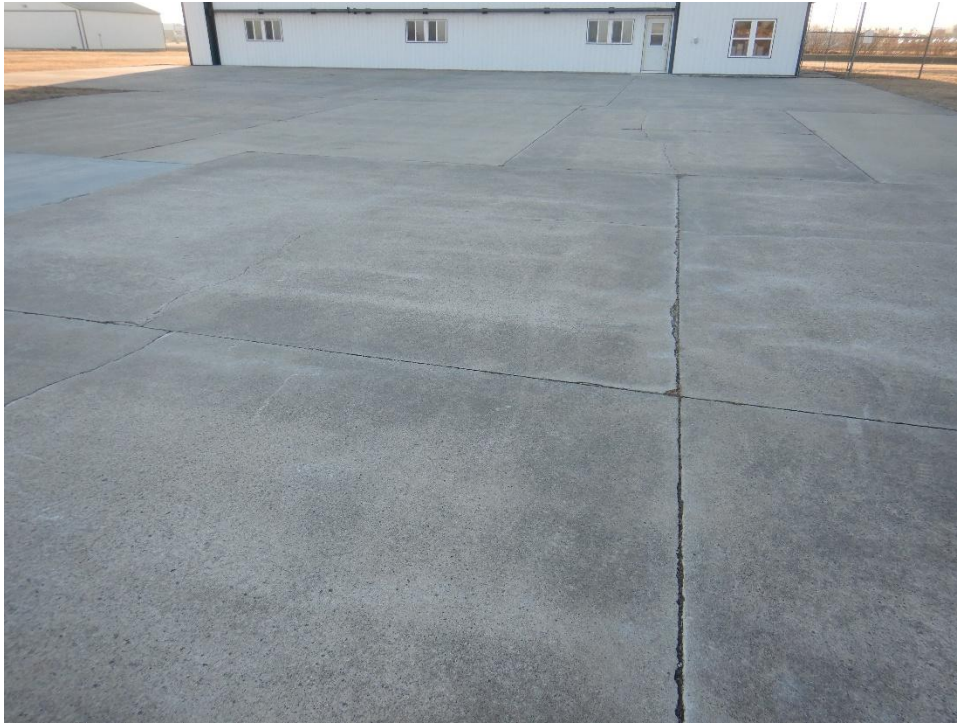
TH01FC-02. Overview.

| Branch | Section | Surface Type | Section Area (sf) | LCD | 2026 PCI | % Distress Due to Load | % Distress Due to Climate/Durability | % Distress Due to Other | Type of Distress |
|---|---|---|---|---|---|---|---|---|---|
| TH01FC | 02 | PCC | 8,516 | 1/1/1991 | 41 | 83 | 12 | 5 | Joint Spalling, Joint Seal Damage, LTD Cracking, Shattered Slab, Shrinkage Cracking |

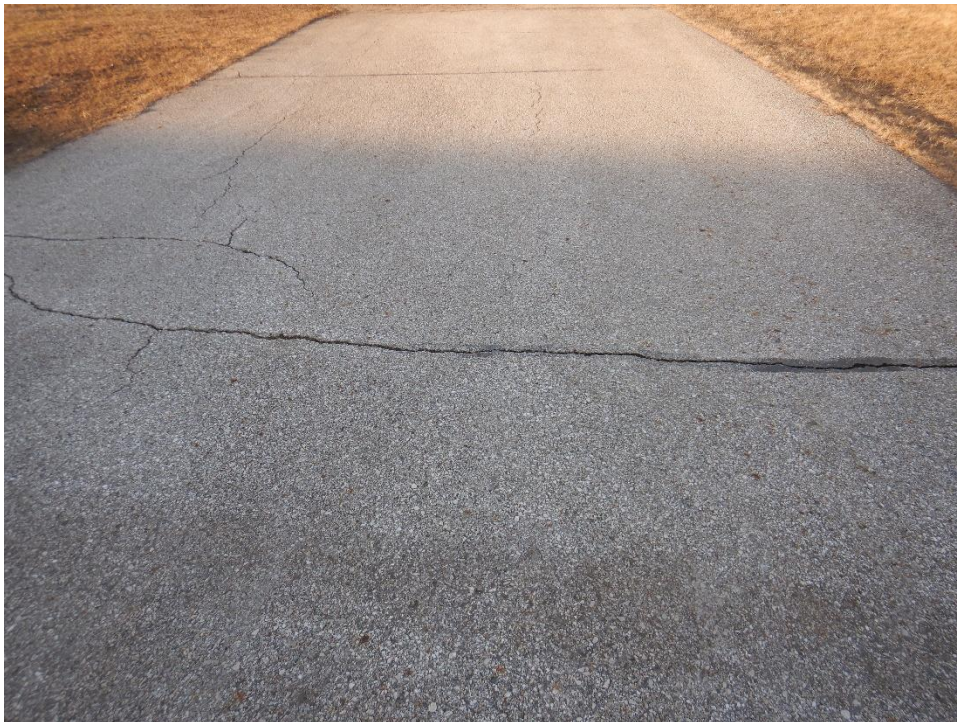
TH01FC-03. Overview.

| Branch | Section | Surface Type | Section Area (sf) | LCD | 2026 PCI | % Distress Due to Load | % Distress Due to Climate/Durability | % Distress Due to Other | Type of Distress |
|---|---|---|---|---|---|---|---|---|---|
| TH01FC | 03 | AC | 2,646 | 1/1/1994 | 41 | 44 | 56 | 0 | Alligator Cracking, L&T Cracking, Weathering |
