# Greenfield Municipal Airport

## PAVEMENT MANAGEMENT REPORT

**JULY 2022**

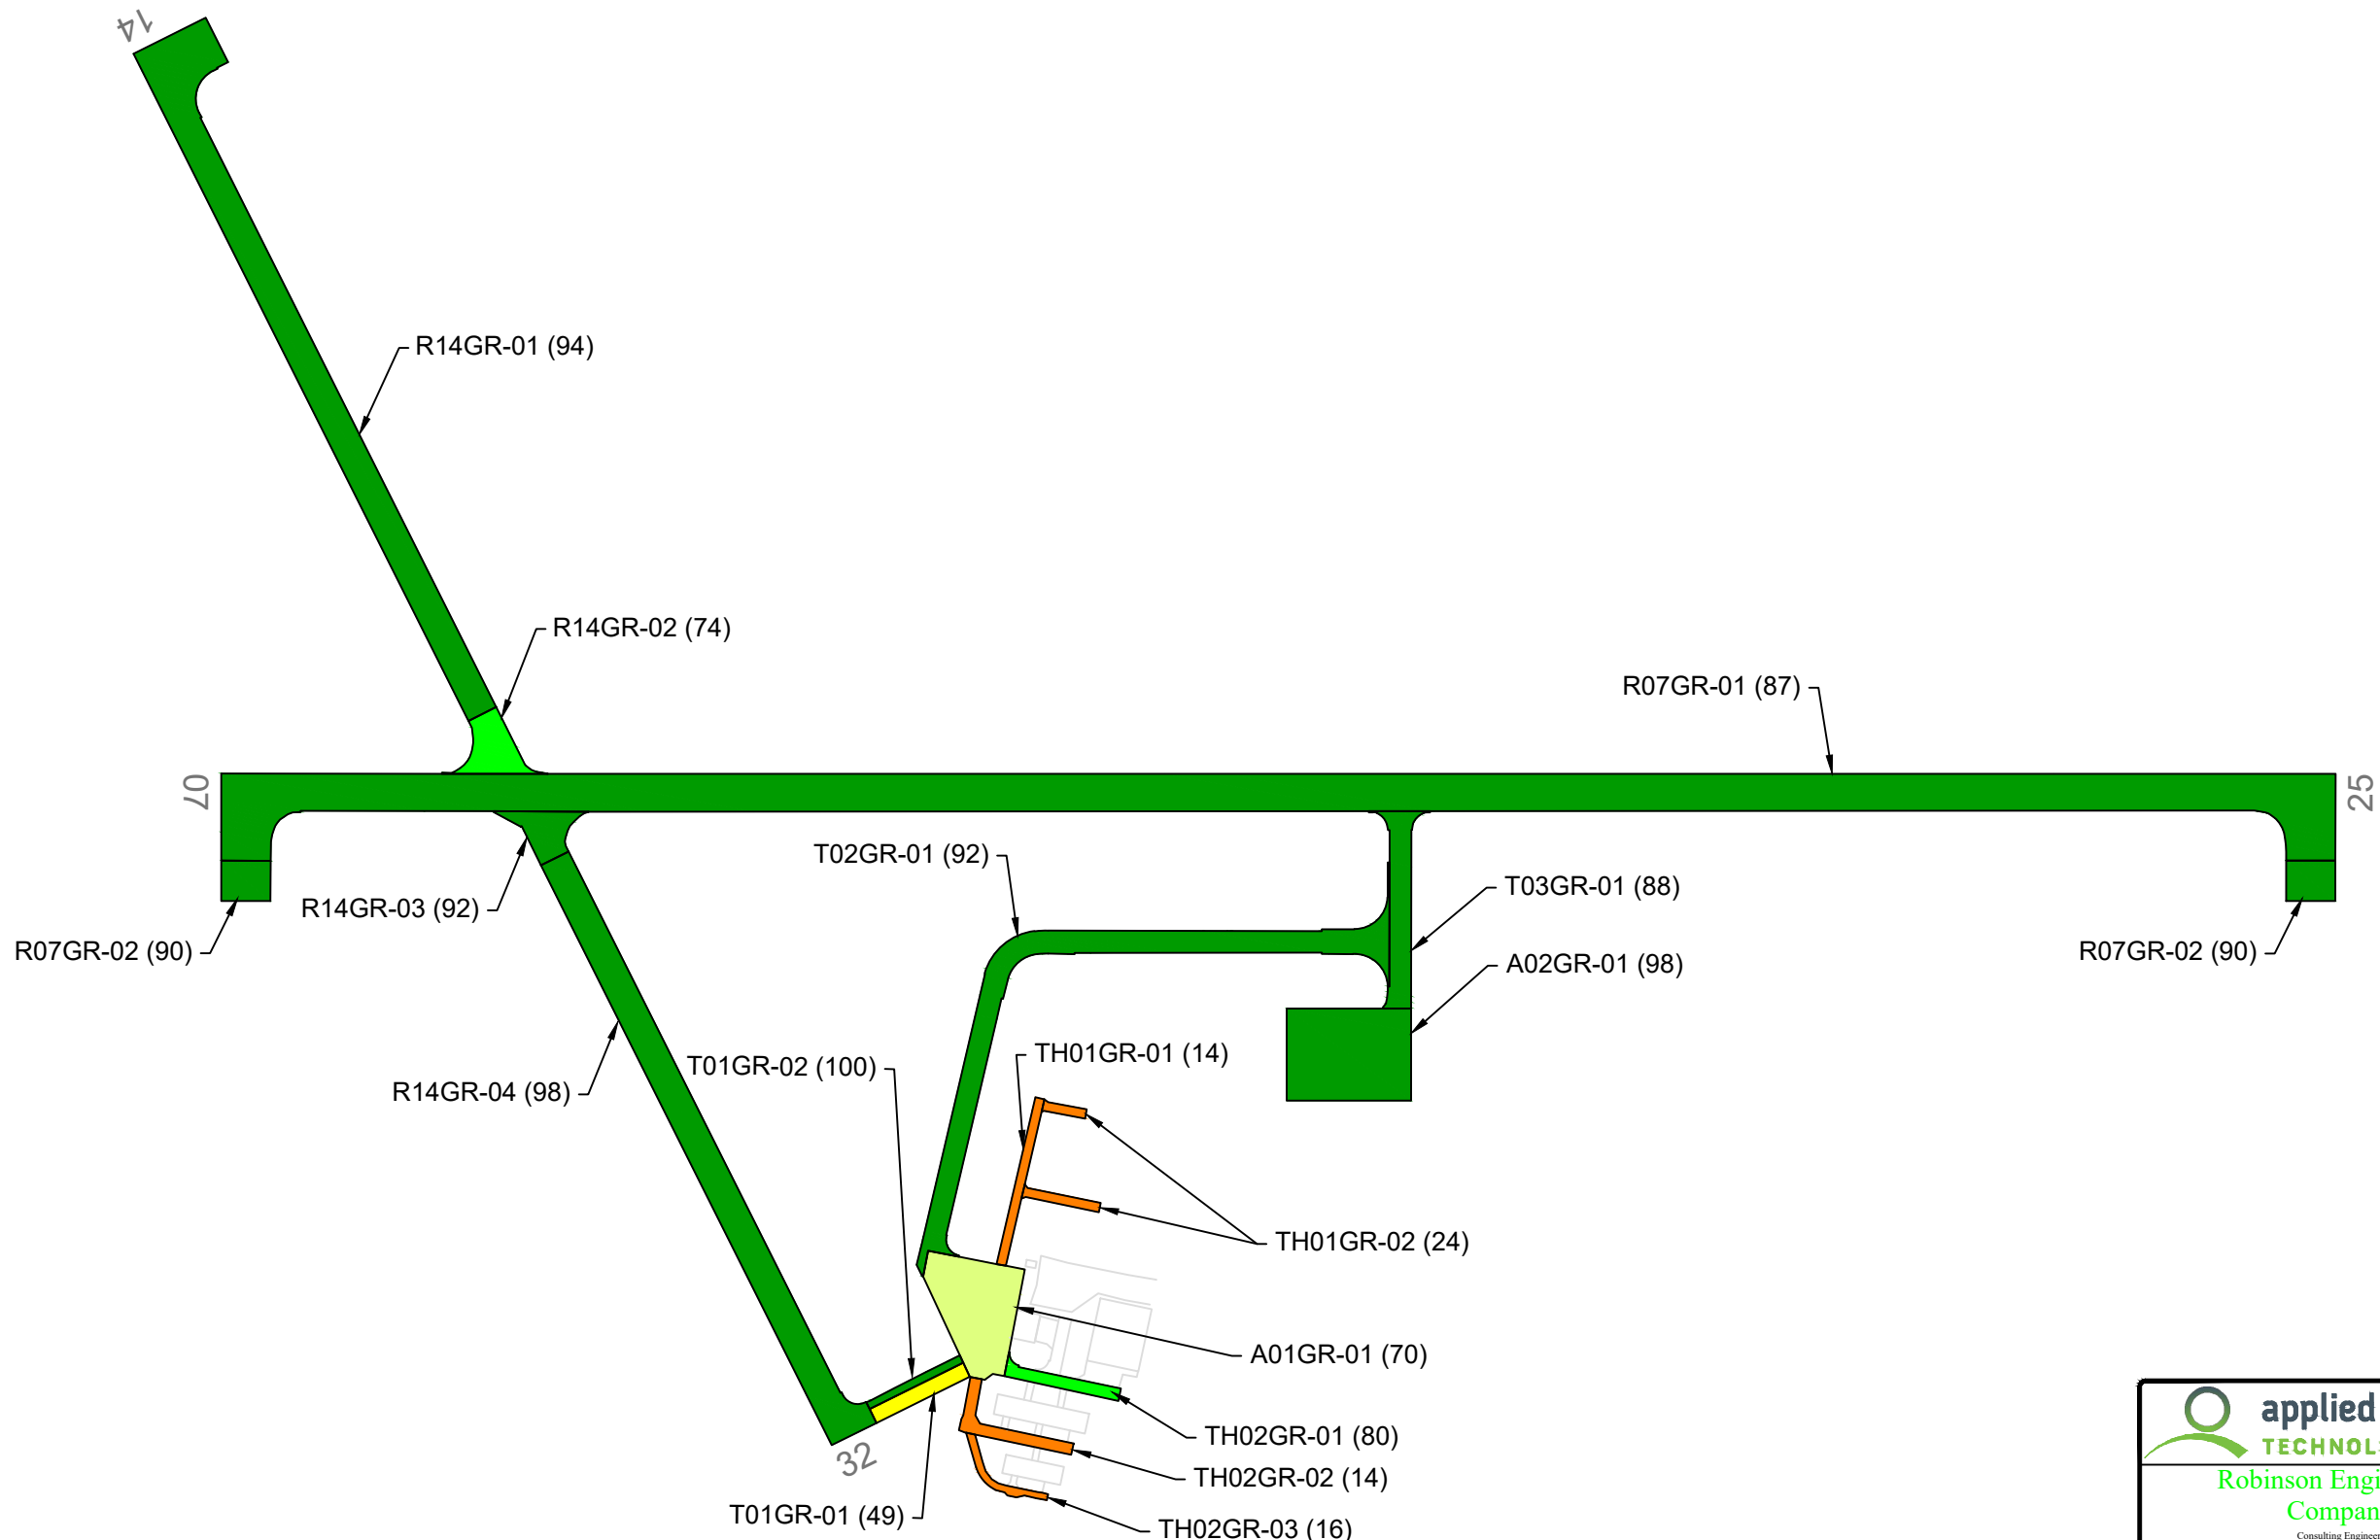
FIGURE 8. PCI MAP.

The pavements at Greenfield Municipal Airport were inspected in November 2021. The 2021 area-weighted condition of Greenfield Municipal Airport is 87, with conditions ranging from 14 to 100 (on a scale of 0 [failed] to 100 [excellent]). During the previous pavement inspection in 2018, the area-weighted PCI of the airport was 85.

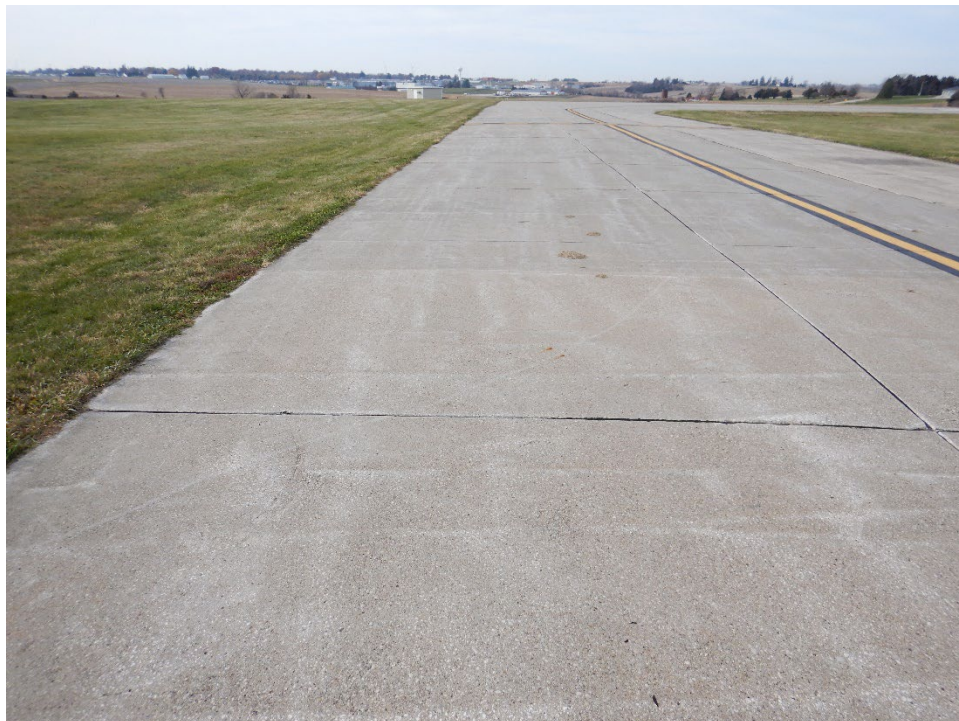
T01GR-01. Overview.

Taxiway 01 connected Runway 14/32 to the Apron 01 area and contained two sections. Section 01 contained low-severity corner break, medium-severity faulting, and low- and medium-severity joint spalling and LTD cracking. Section 02 was in excellent condition with no distress recorded at the time of inspection.
