# Greenfield Municipal Airport

## Pavement Management Report

**AUGUST 2025**

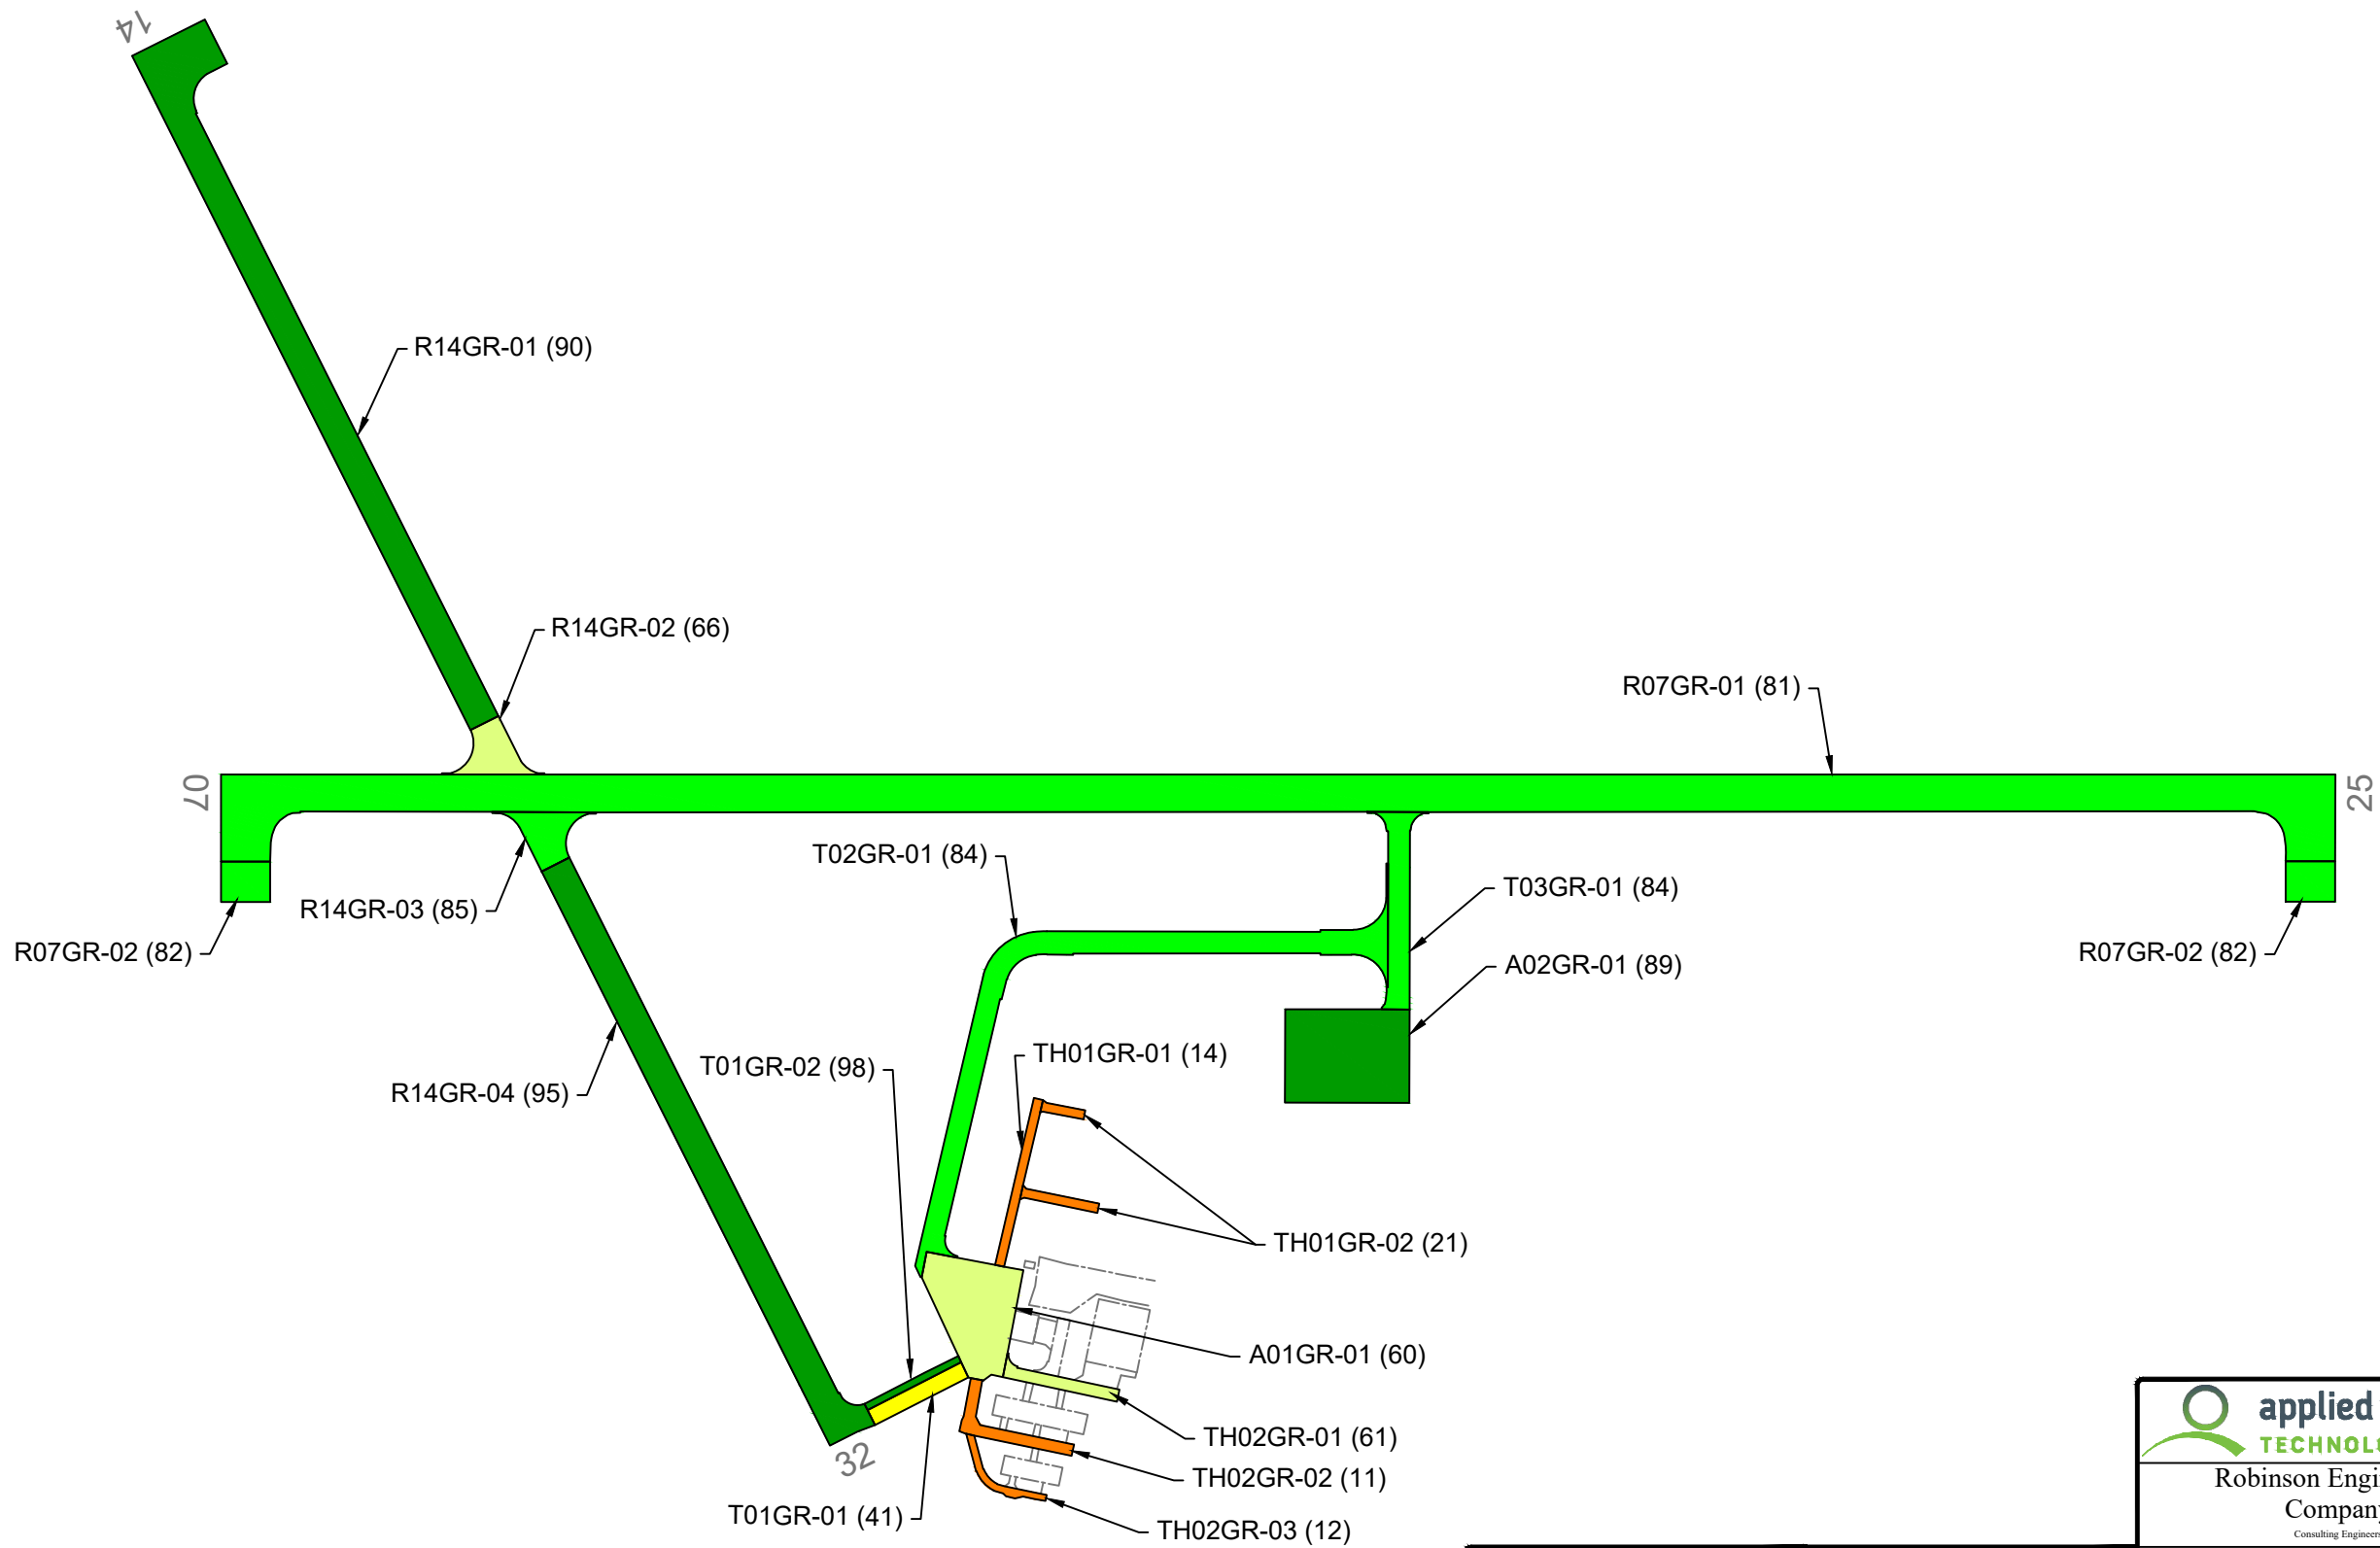
FIGURE 8. PCI MAP.

The pavements at Greenfield Municipal Airport were inspected in March 2025. The 2025 area-weighted condition of Greenfield Municipal Airport is 81, with conditions ranging from 11 to 98 (on a scale of 0 [failed] to 100 [excellent]). During the previous pavement inspection in 2021, the area-weighted PCI of the airport was 87.

Figure 6 summarizes the overall condition of the pavements at Greenfield Municipal Airport, and Figure 7 presents area-weighted condition (average PCI adjusted to account for the relative size of the pavement sections) by branch use. Figure 8 is a map that displays the condition of the evaluated pavements. Table 1 summarizes the results of the pavement evaluation. Appendix B presents photographs taken during the PCI inspection, and Appendix C contains detailed information on the distress types observed during the visual survey. Appendix D includes detailed work history information that was collected during the record review process.

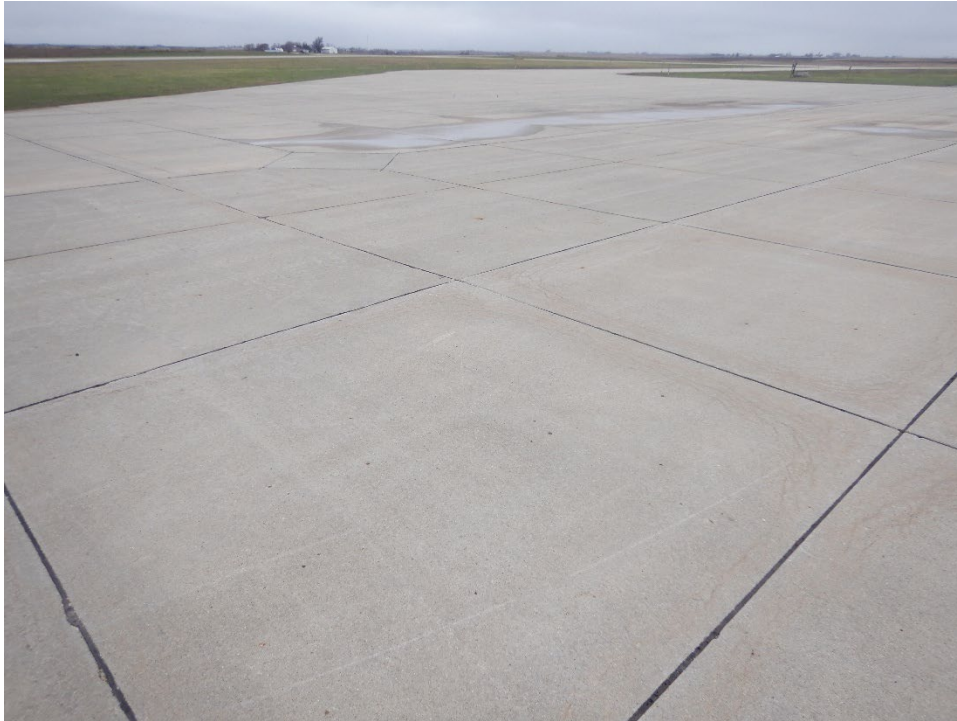
A01GR-01. Overview.

| Branch | Section | Surface Type | Section Area (sf) | LCD | 2025 PCI | % Distress Due to Load | % Distress Due to Climate/Durability | % Distress Due to Other | Type of Distress |
|---|---|---|---|---|---|---|---|---|---|
| A01GR | 01 | PCC | 21,725 | 6/2/2003 | 60 | 6 | 29 | 65 | ASR, Corner Spalling, Joint Seal Damage, Large Patch, LTD Cracking |

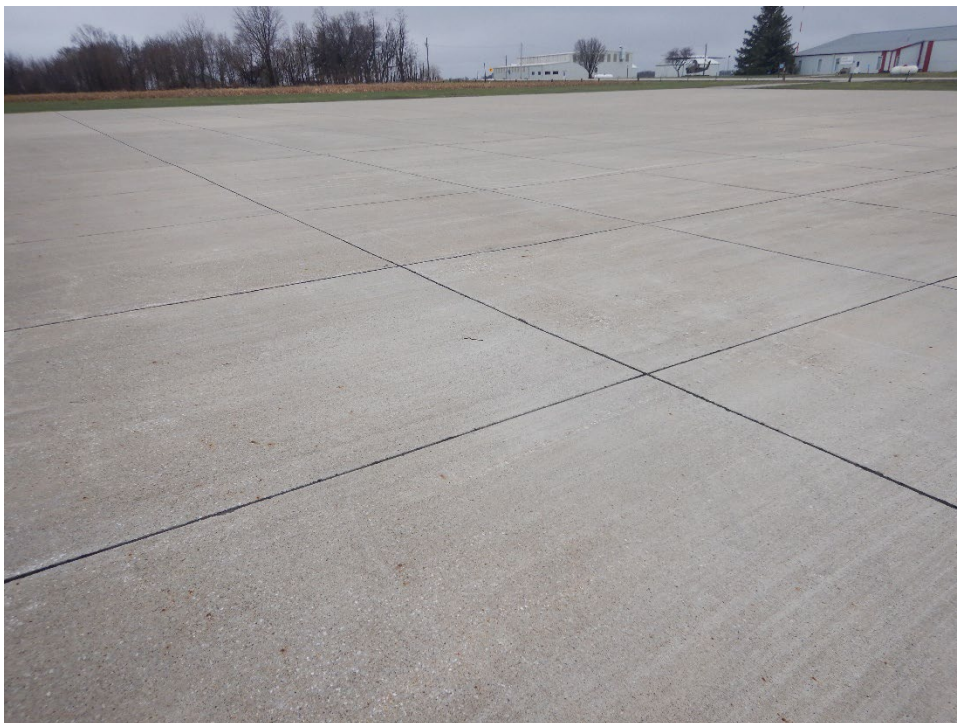
A02GR-01. Overview.

| Branch | Section | Surface Type | Section Area (sf) | LCD | 2025 PCI | % Distress Due to Load | % Distress Due to Climate/Durability | % Distress Due to Other | Type of Distress |
|---|---|---|---|---|---|---|---|---|---|
| A02GR | 01 | PCC | 30,000 | 6/2/2006 | 89 | 11 | 83 | 6 | Corner Break, Corner Spalling, Joint Spalling, Joint Seal Damage, LTD Cracking, Shrinkage Cracking |

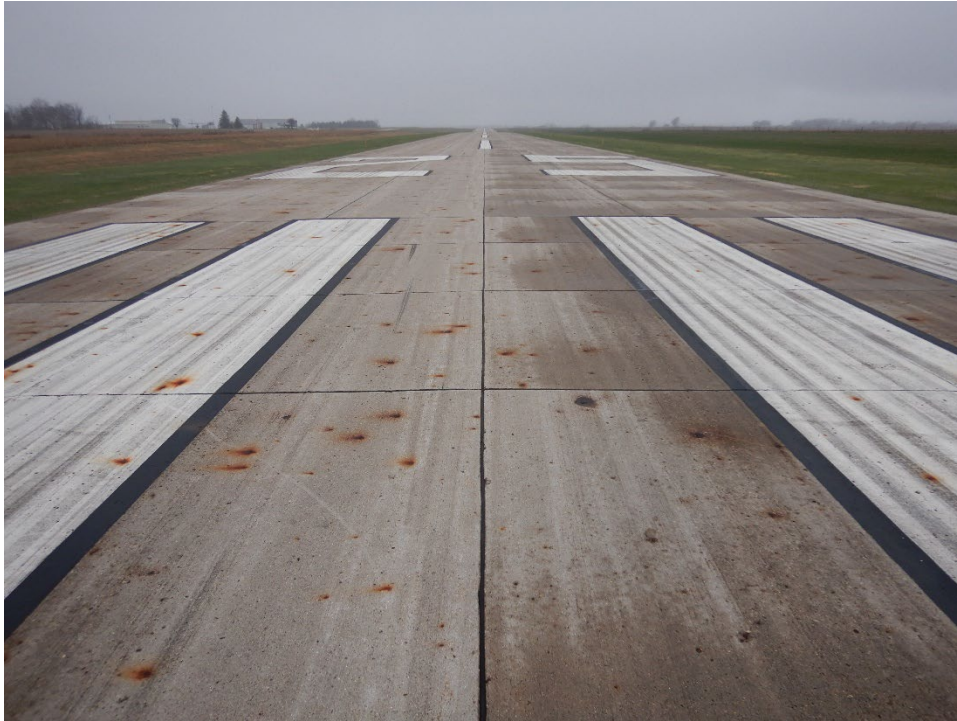
R07GR-01. Overview.

| Branch | Section | Surface Type | Section Area (sf) | LCD | 2025 PCI | % Distress Due to Load | % Distress Due to Climate/Durability | % Distress Due to Other | Type of Distress |
|---|---|---|---|---|---|---|---|---|---|
| R07GR | 01 | PCC | 218,192 | 6/1/1994 | 81 | 6 | 28 | 66 | ASR, Corner Break, Corner Spalling, Faulting, Joint Spalling, Joint Seal Damage, LTD Cracking, Shrinkage Cracking, Small Patch |

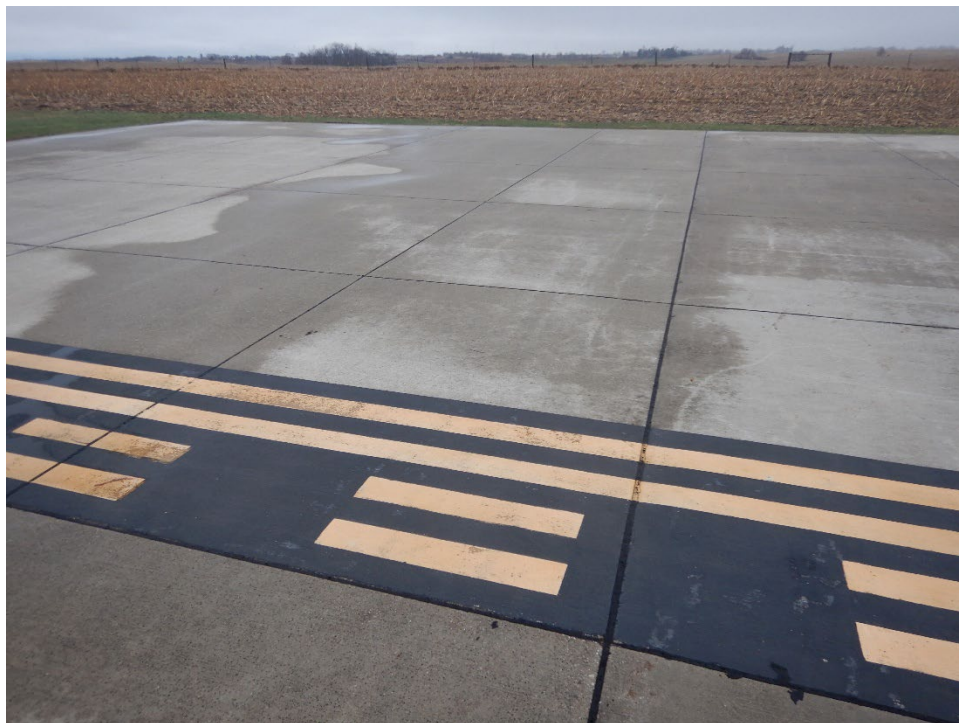
R07GR-02. Overview.

| Branch | Section | Surface Type | Section Area (sf) | LCD | 2025 PCI | % Distress Due to Load | % Distress Due to Climate/Durability | % Distress Due to Other | Type of Distress |
|---|---|---|---|---|---|---|---|---|---|
| R07GR | 02 | PCC | 10,294 | 6/3/2013 | 82 | 69 | 31 | 0 | Joint Seal Damage, LTD Cracking |

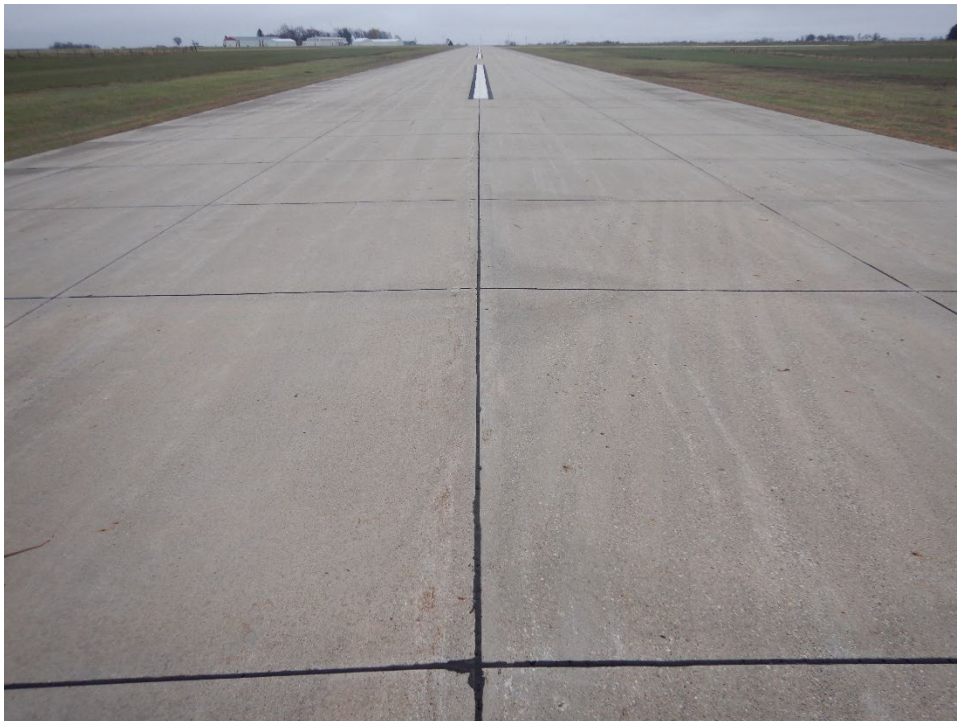
R14GR-01. Overview.

| Branch | Section | Surface Type | Section Area (sf) | LCD | 2025 PCI | % Distress Due to Load | % Distress Due to Climate/Durability | % Distress Due to Other | Type of Distress |
|---|---|---|---|---|---|---|---|---|---|
| R14GR | 01 | PCC | 67,174 | 9/1/2001 | 90 | 29 | 12 | 59 | ASR, Corner Break, Corner Spalling, Joint Spalling, Joint Seal Damage, LTD Cracking |

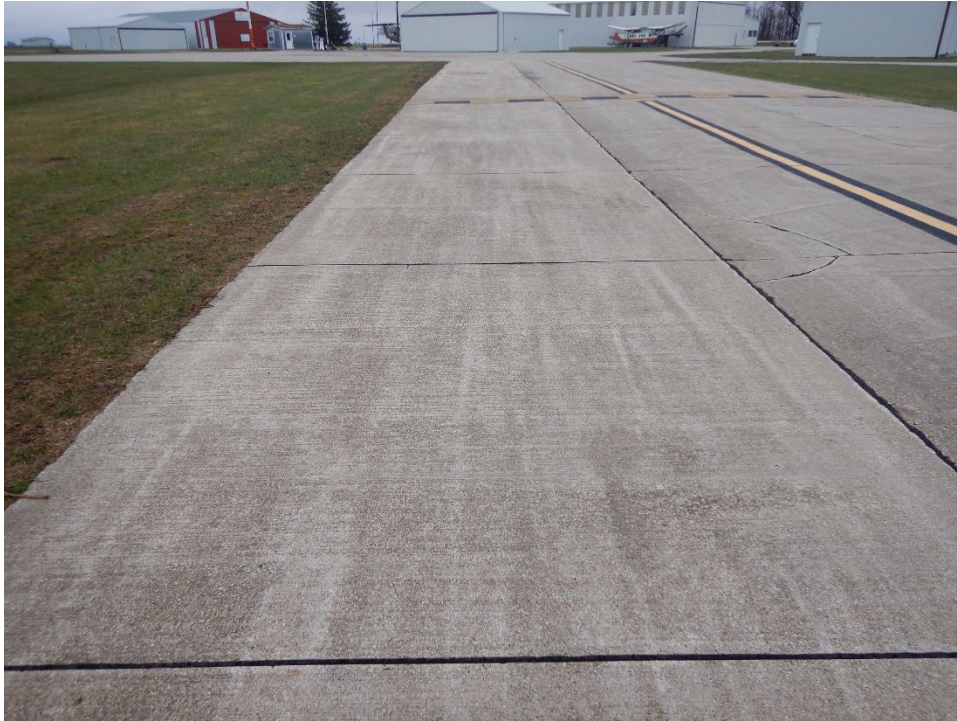
T01GR-02. Overview.

| Branch | Section | Surface Type | Section Area (sf) | LCD | 2025 PCI | % Distress Due to Load | % Distress Due to Climate/Durability | % Distress Due to Other | Type of Distress |
|---|---|---|---|---|---|---|---|---|---|
| T01GR | 02 | PCC | 1,916 | 9/5/1998 | 98 | 0 | 100 | 0 | Joint Seal Damage |
