# Harlan Municipal Airport

## Pavement Management Report

**AUGUST 2025**

# HARLAN MUNICIPAL AIRPORT PAVEMENT MANAGEMENT REPORT

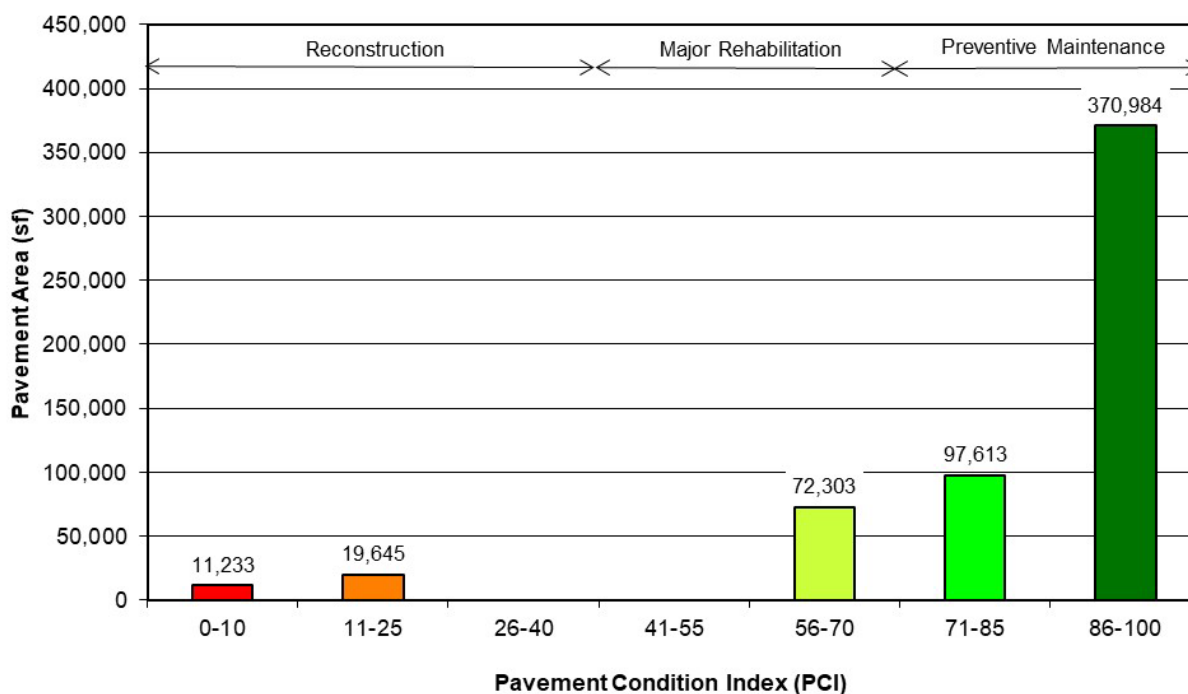
Figure 6. Pavement area by PCI range at Harlan Municipal Airport.

The pavements at Harlan Municipal Airport were inspected in March 2025. The 2025 area-weighted condition of Harlan Municipal Airport is 81, with conditions ranging from 10 to 98 (on a scale of 0 [failed] to 100 [excellent]). During the previous pavement inspection in 2021, the area-weighted PCI of the airport was 80.

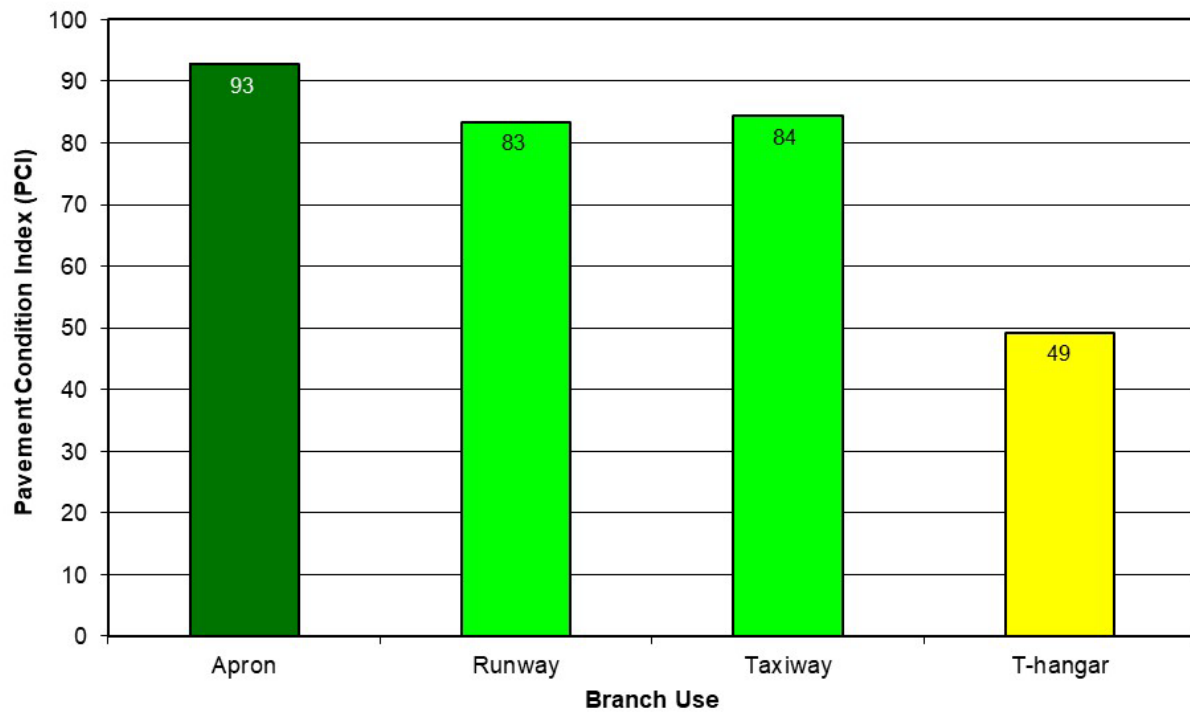
Figure 7. Area-weighted PCI by branch use at Harlan Municipal Airport.

(Values on chart are area weighted.)

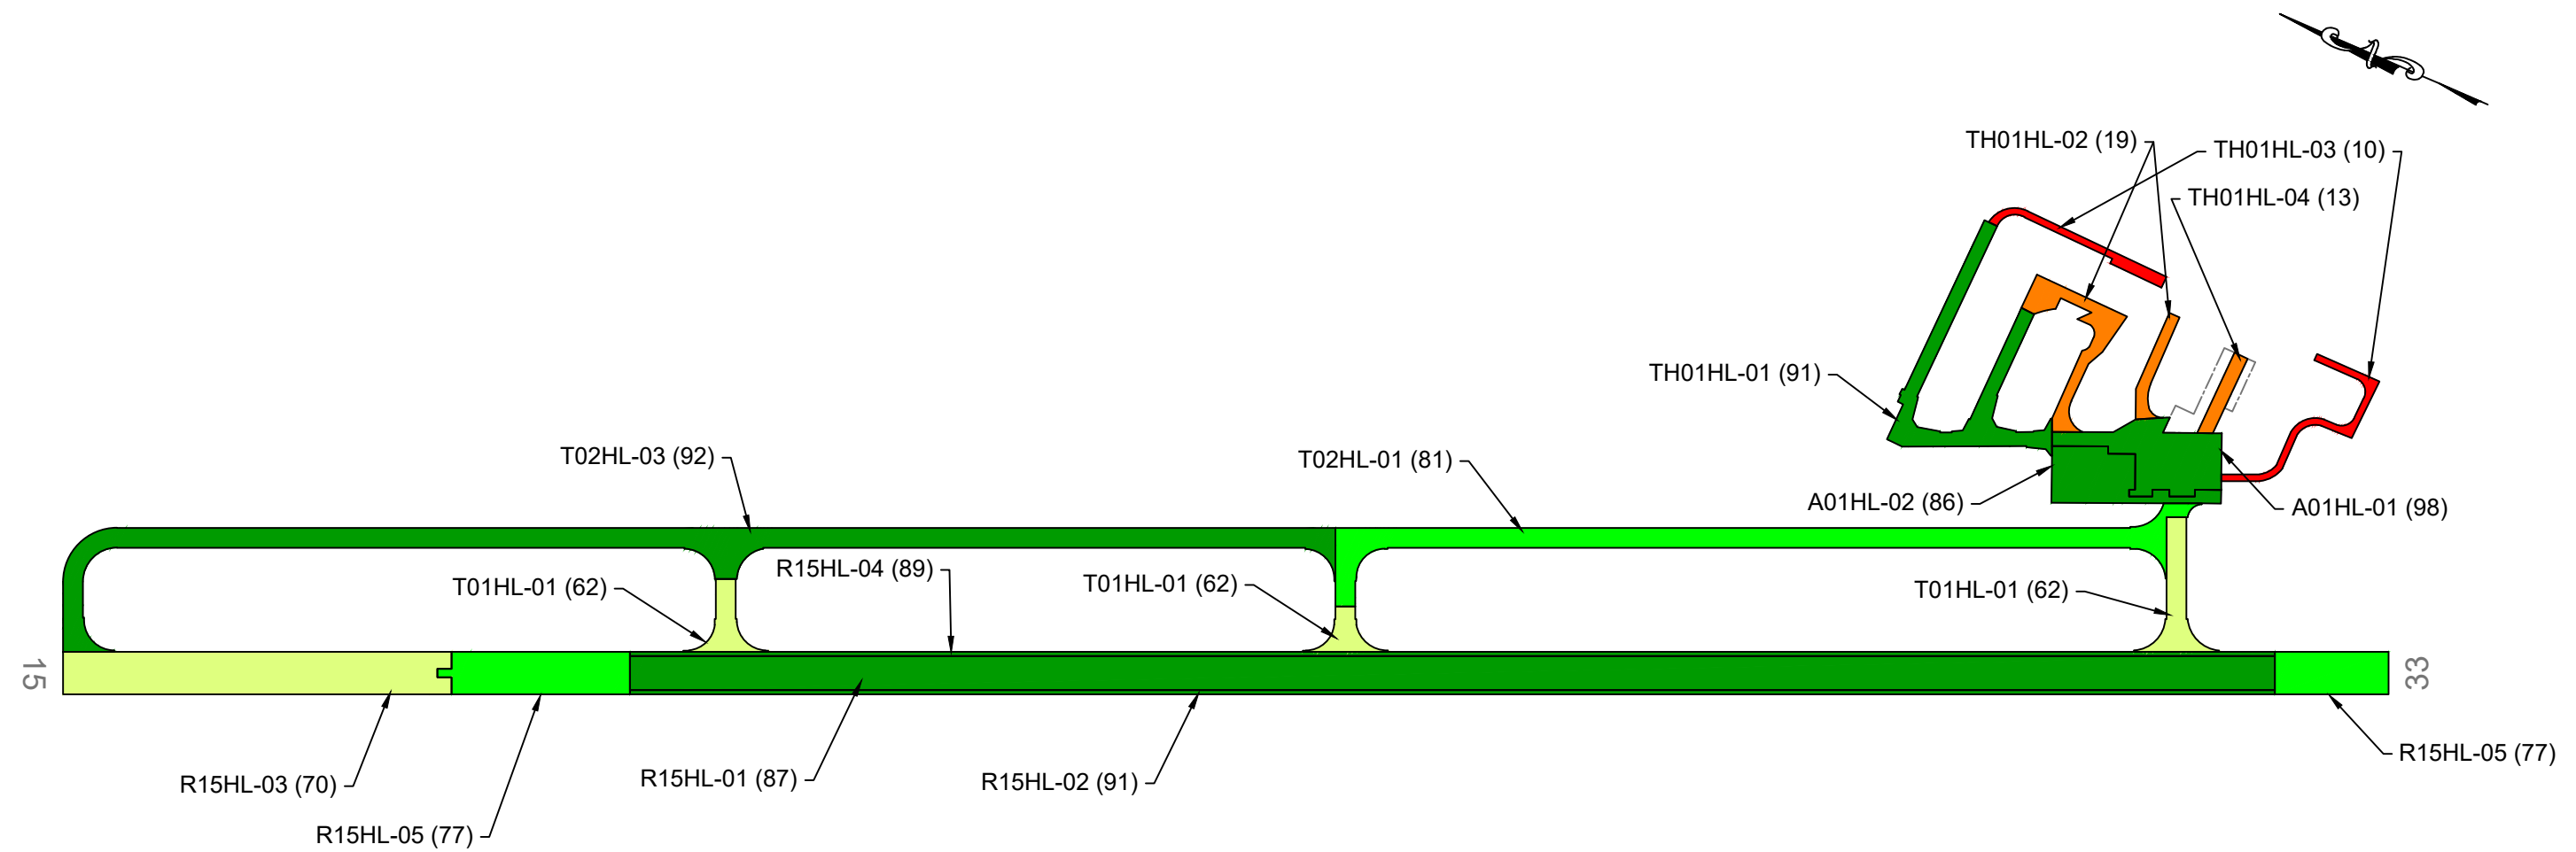
FIGURE 8. PCI MAP.

Figure 6 summarizes the overall condition of the pavements at Harlan Municipal Airport, and Figure 7 presents area-weighted condition (average PCI adjusted to account for the relative size of the pavement sections) by branch use. Figure 8 is a map that displays the condition of the evaluated pavements. Table 1 summarizes the results of the pavement evaluation. Appendix B presents photographs taken during the PCI inspection, and Appendix C contains detailed information on the distress types observed during the visual survey. Appendix D includes detailed work history information that was collected during the record review process.
