# Humboldt Municipal Airport

## Pavement Management Report

**AUGUST 2026**

# HUMBOLDT MUNICIPAL AIRPORT PAVEMENT MANAGEMENT REPORT

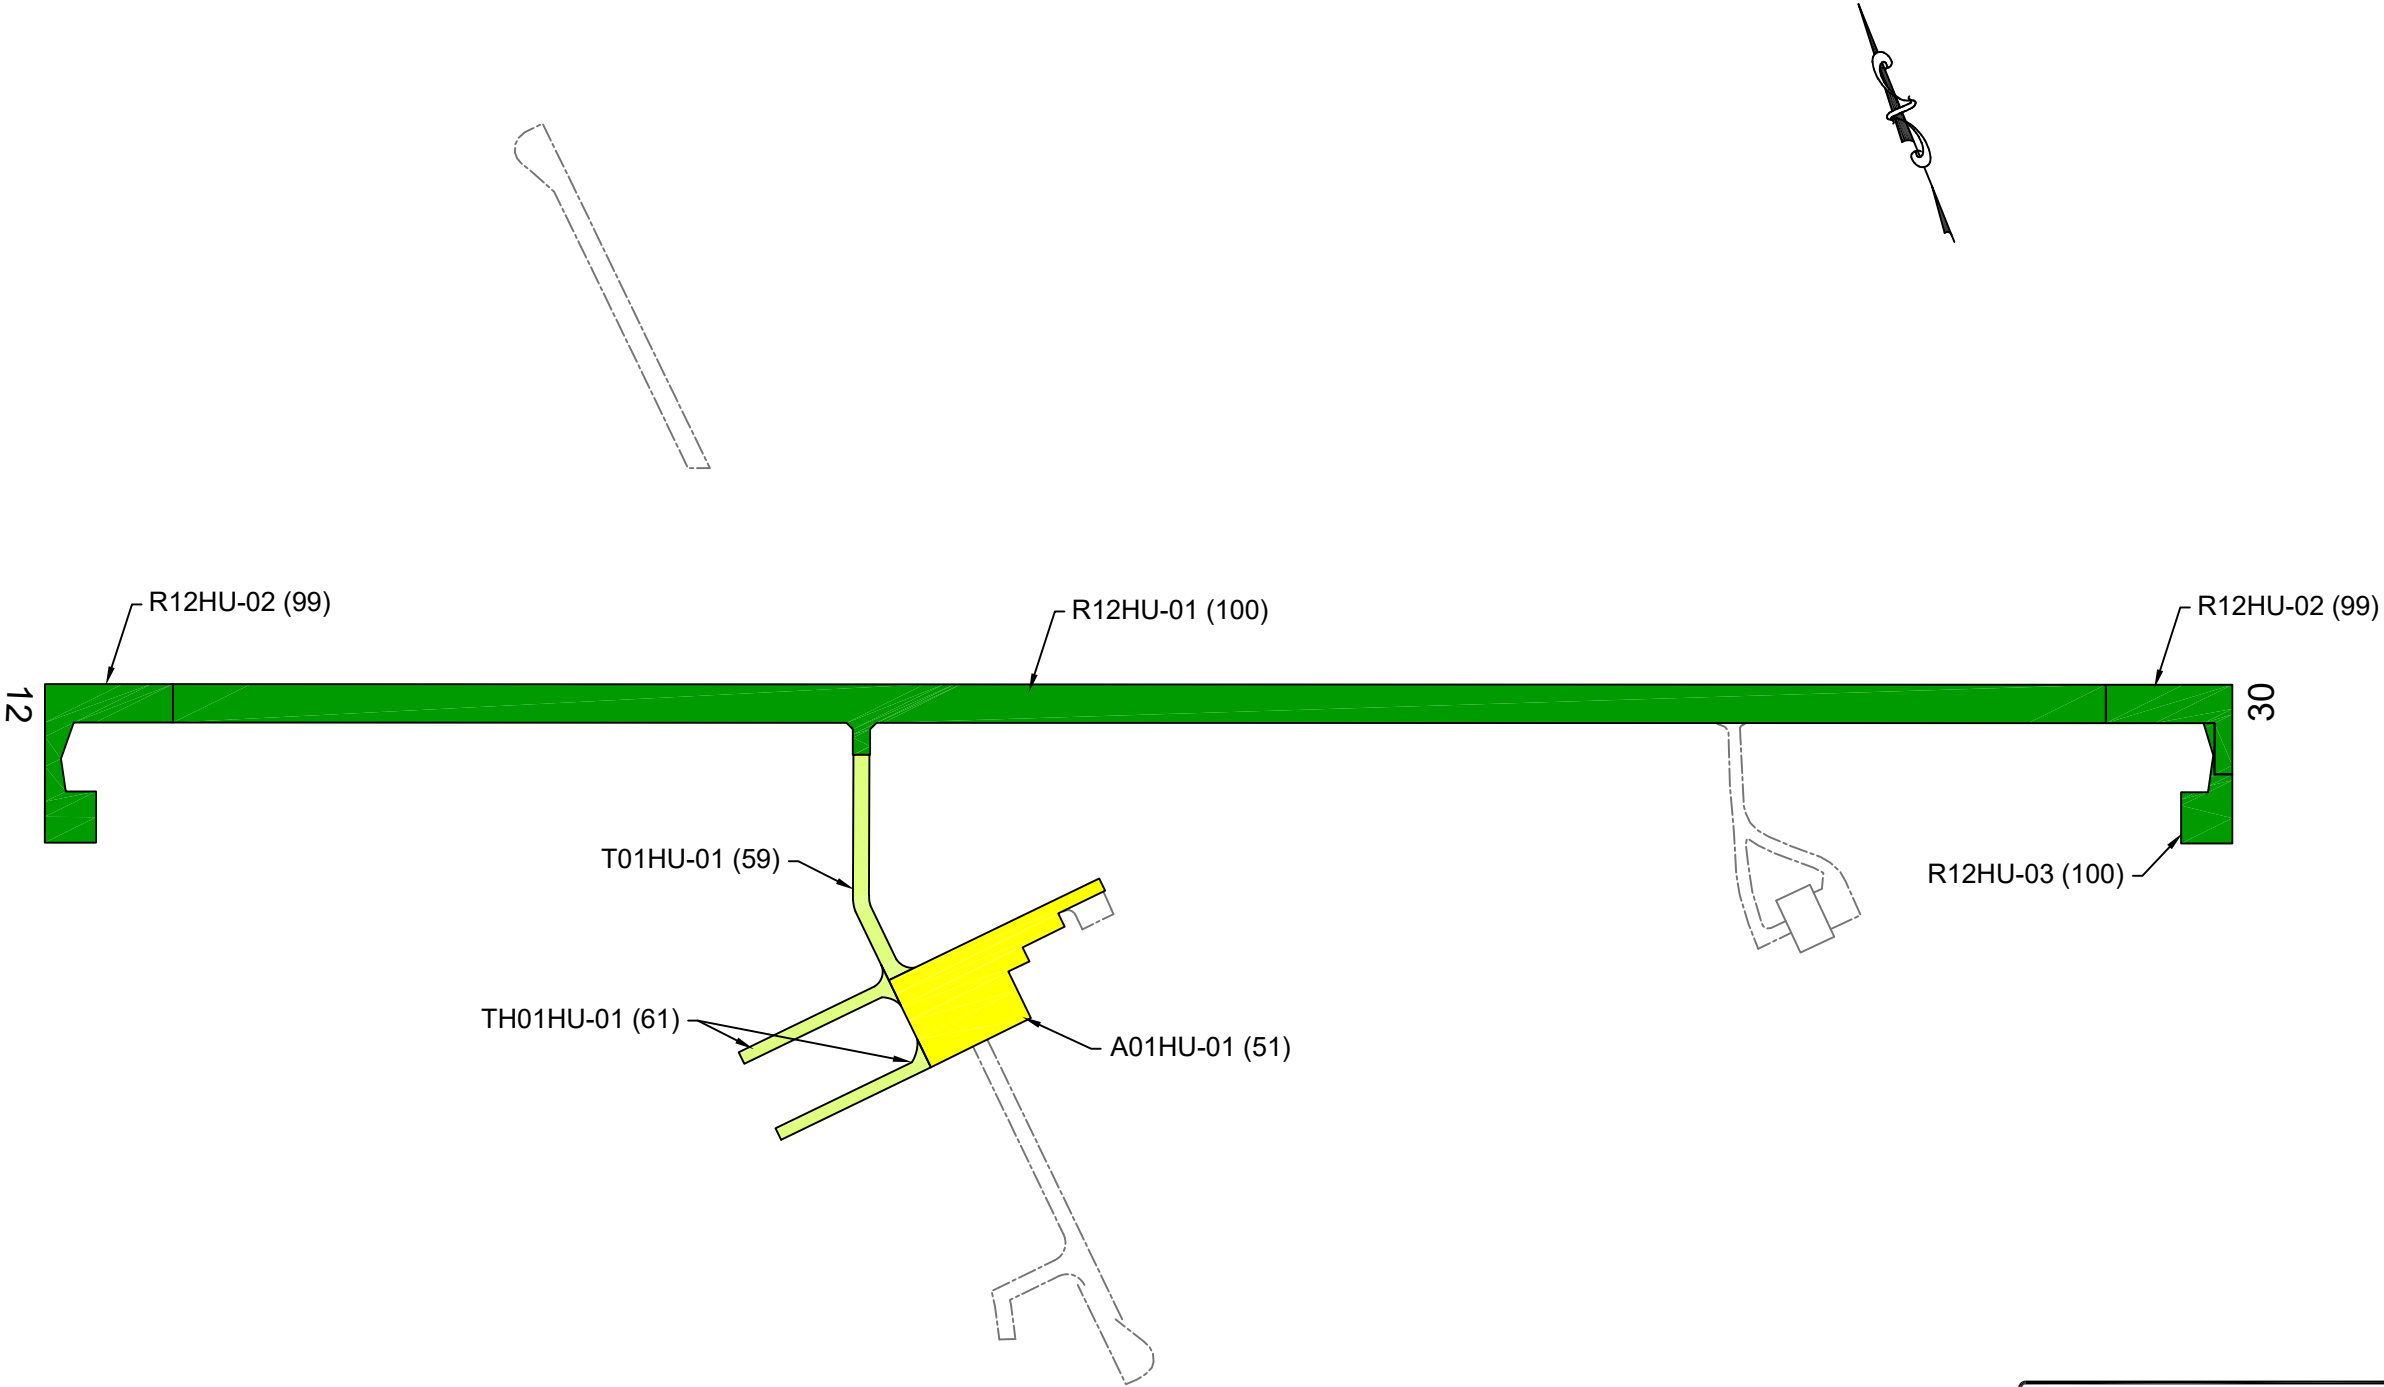
FIGURE 8. PCI MAP.

The pavements at Humboldt Municipal Airport were inspected in March 2026. The 2026 area-weighted condition of Humboldt Municipal Airport is 91, with conditions ranging from 51 to 100 (on a scale of 0 [*Failed*] to 100 [*Excellent*]). During the previous pavement inspection in 2022, the area-weighted PCI of the airport was 58.

Figure 6 summarizes the overall condition of the pavements at Humboldt Municipal Airport, and Figure 7 presents area-weighted condition (average PCI adjusted to account for the relative size of the pavement sections) by branch use. Figure 8 is a map that displays the condition of the evaluated pavements. Table 1 summarizes the results of the pavement evaluation. Appendix B presents photographs taken during the PCI inspection, and Appendix C contains detailed information on the distress types observed during the visual survey. Appendix D includes detailed work history information that was collected during the record review process.
