# Ida Grove Municipal Airport

## Pavement Management Report

**AUGUST 2025**

# IDA GROVE MUNICIPAL AIRPORT PAVEMENT MANAGEMENT REPORT

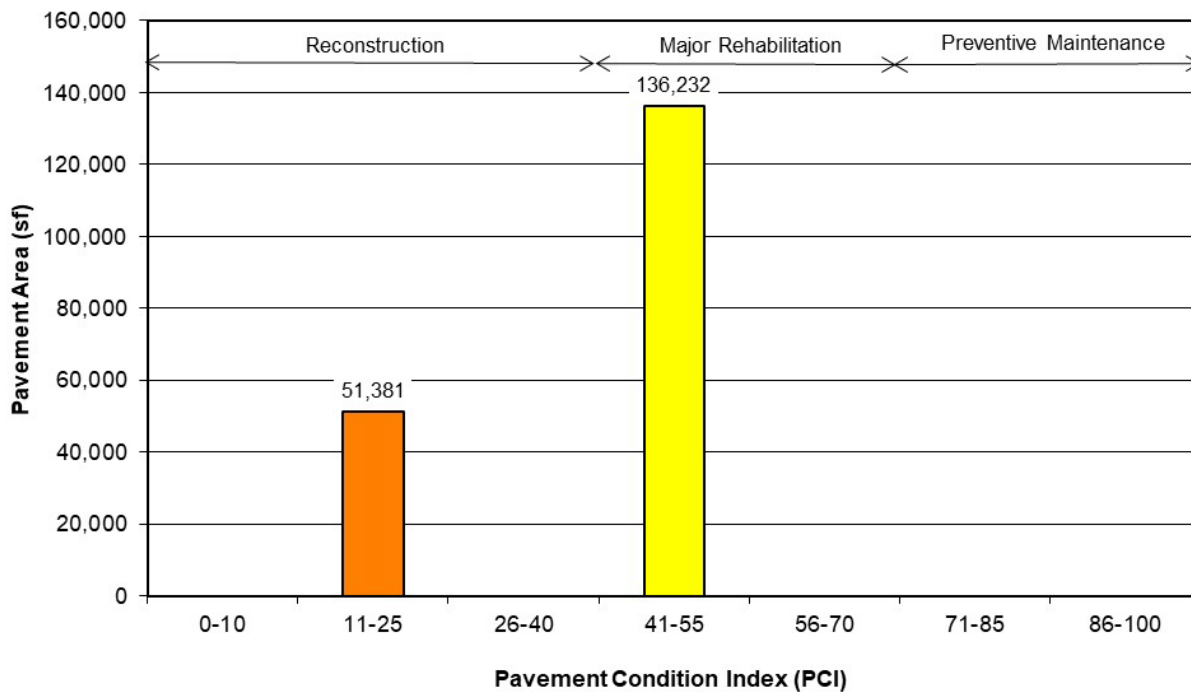
Figure 6. Pavement area by PCI range at Ida Grove Municipal Airport.

The pavements at Ida Grove Municipal Airport were inspected in March 2025. The 2025 area-weighted condition of Ida Grove Municipal Airport is 39, with conditions ranging from 14 to 54 (on a scale of 0 [failed] to 100 [excellent]). During the previous pavement inspection in 2018, the area-weighted PCI of the airport was 58.

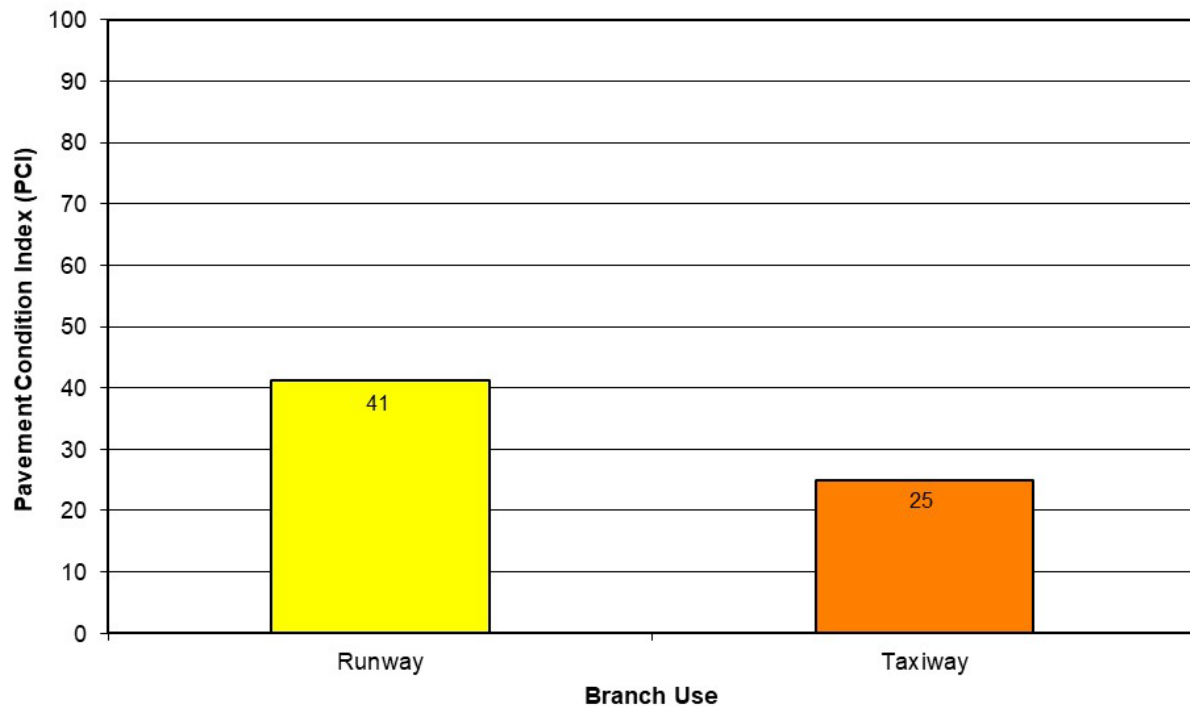
Figure 7. Area-weighted PCI by branch use at Ida Grove Municipal Airport.

(Values on chart are area weighted.)
