James H Connell Field at Independence Municipal Airport

Pavement Management Report

JULY 2023

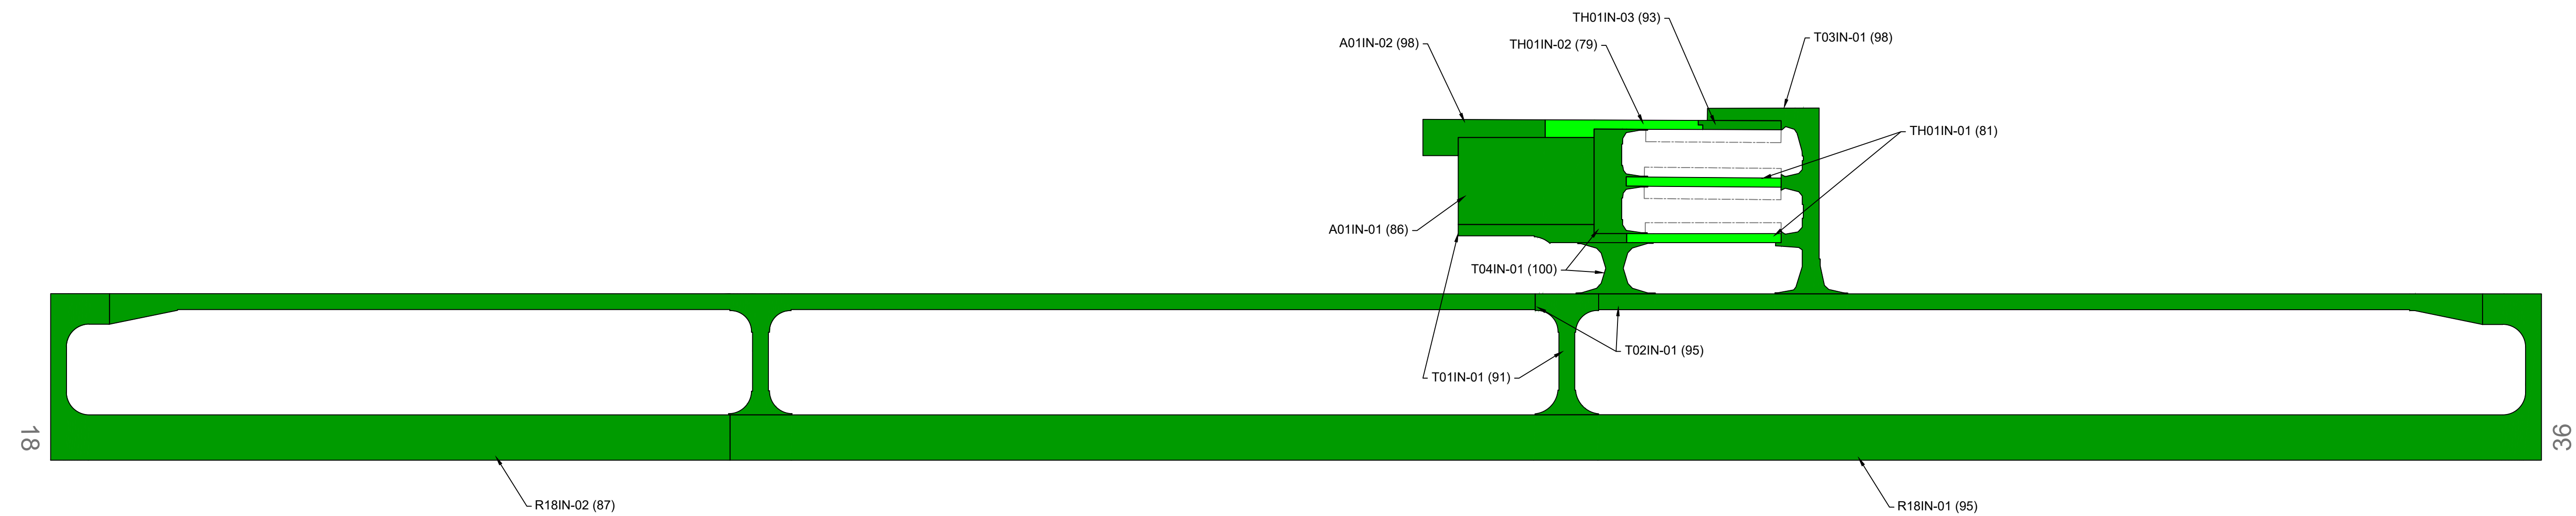
FIGURE 8. PCI MAP.

The pavements at James H. Connell Field at Independence Municipal Airport were inspected in November 2022. The 2022 area-weighted condition of James H. Connell Field at Independence Municipal Airport is 93, with conditions ranging from 79 to 100 (on a scale of 0 [failed] to 100 [excellent]). During the previous pavement inspection in 2019, the area-weighted PCI of the airport was 88.

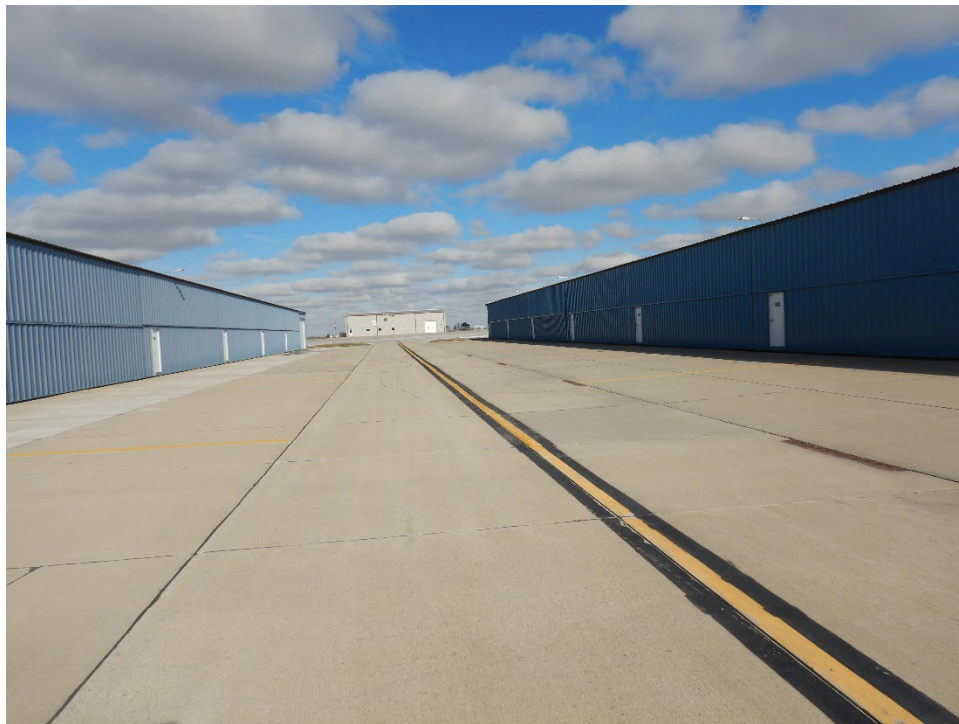
TH01IN-01. Overview.

TH01IN	01	PCC	13,716	6/1/2004	81	89	8	3	Corner Break, Joint Spalling, Joint Seal Damage, LTD Cracking
TH01IN	02	PCC	8,891	6/1/2007	79	67	28	5	Corner Break, Joint Seal Damage, LTD Cracking, Shattered Slab, Shrinkage Cracking, Small Patch
TH01IN	03	PCC	3,560	10/1/2010	93	73	27	0	Joint Seal Damage, LTD Cracking
