# James H Connell Field at Independence Municipal Airport

## Pavement Management Report

**AUGUST 2026**

# JAMES H CONNELL FIELD AT INDEPENDENCE MUNICIPAL AIRPORT PAVEMENT MANAGEMENT REPORT

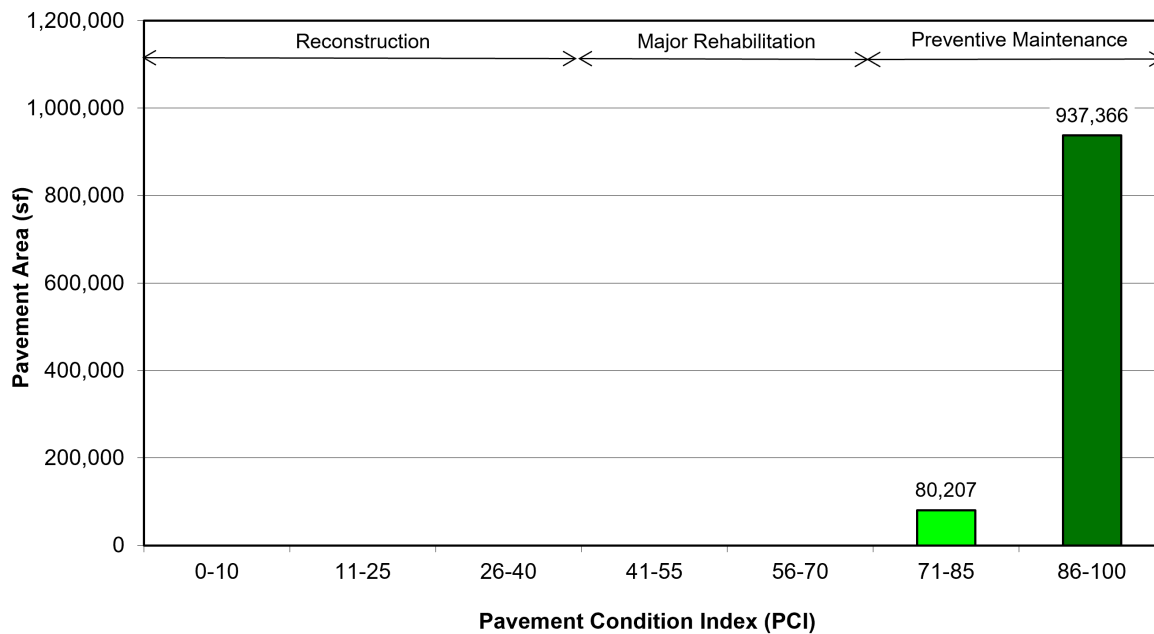
Figure 6. Pavement area by PCI range at James H Connell Field at Independence Municipal Airport.

The pavements at James H Connell Field at Independence Municipal Airport were inspected in February 2026. The 2026 area-weighted condition of James H Connell Field at Independence Municipal Airport is 93, with conditions ranging from 76 to 99 (on a scale of 0 [*Failed*] to 100 [*Excellent*]). During the previous pavement inspection in 2022, the area-weighted PCI of the airport was 93.

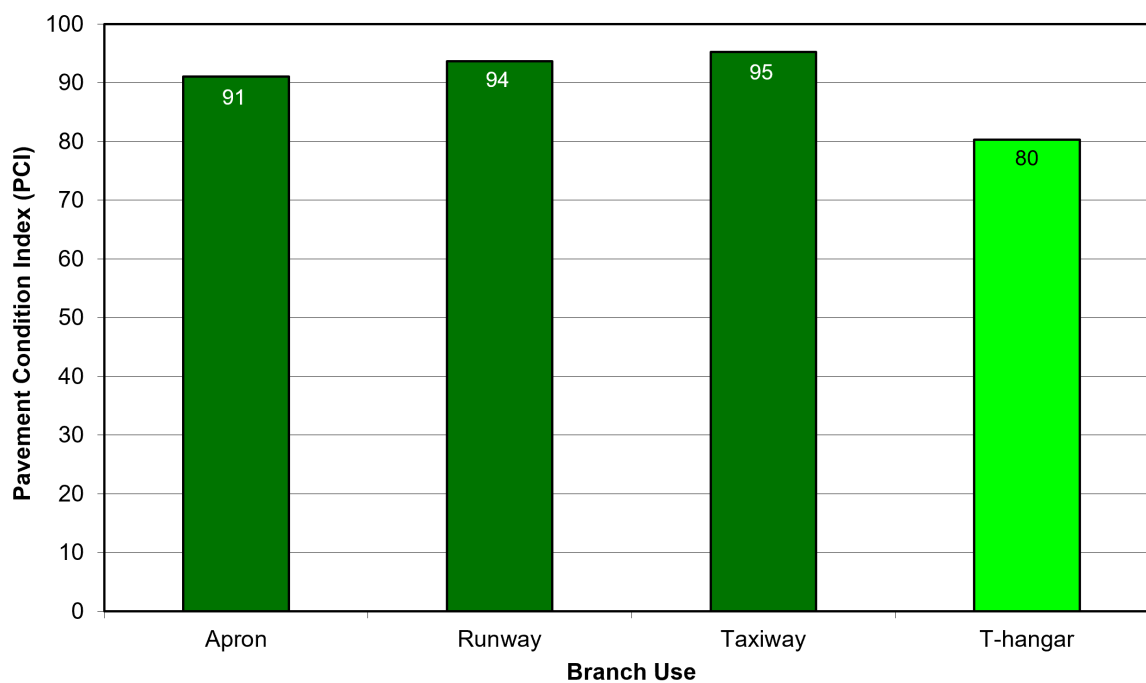
Figure 7. Area-weighted PCI by branch use at James H Connell Field at Independence Municipal Airport.

(Values on chart are area weighted.)

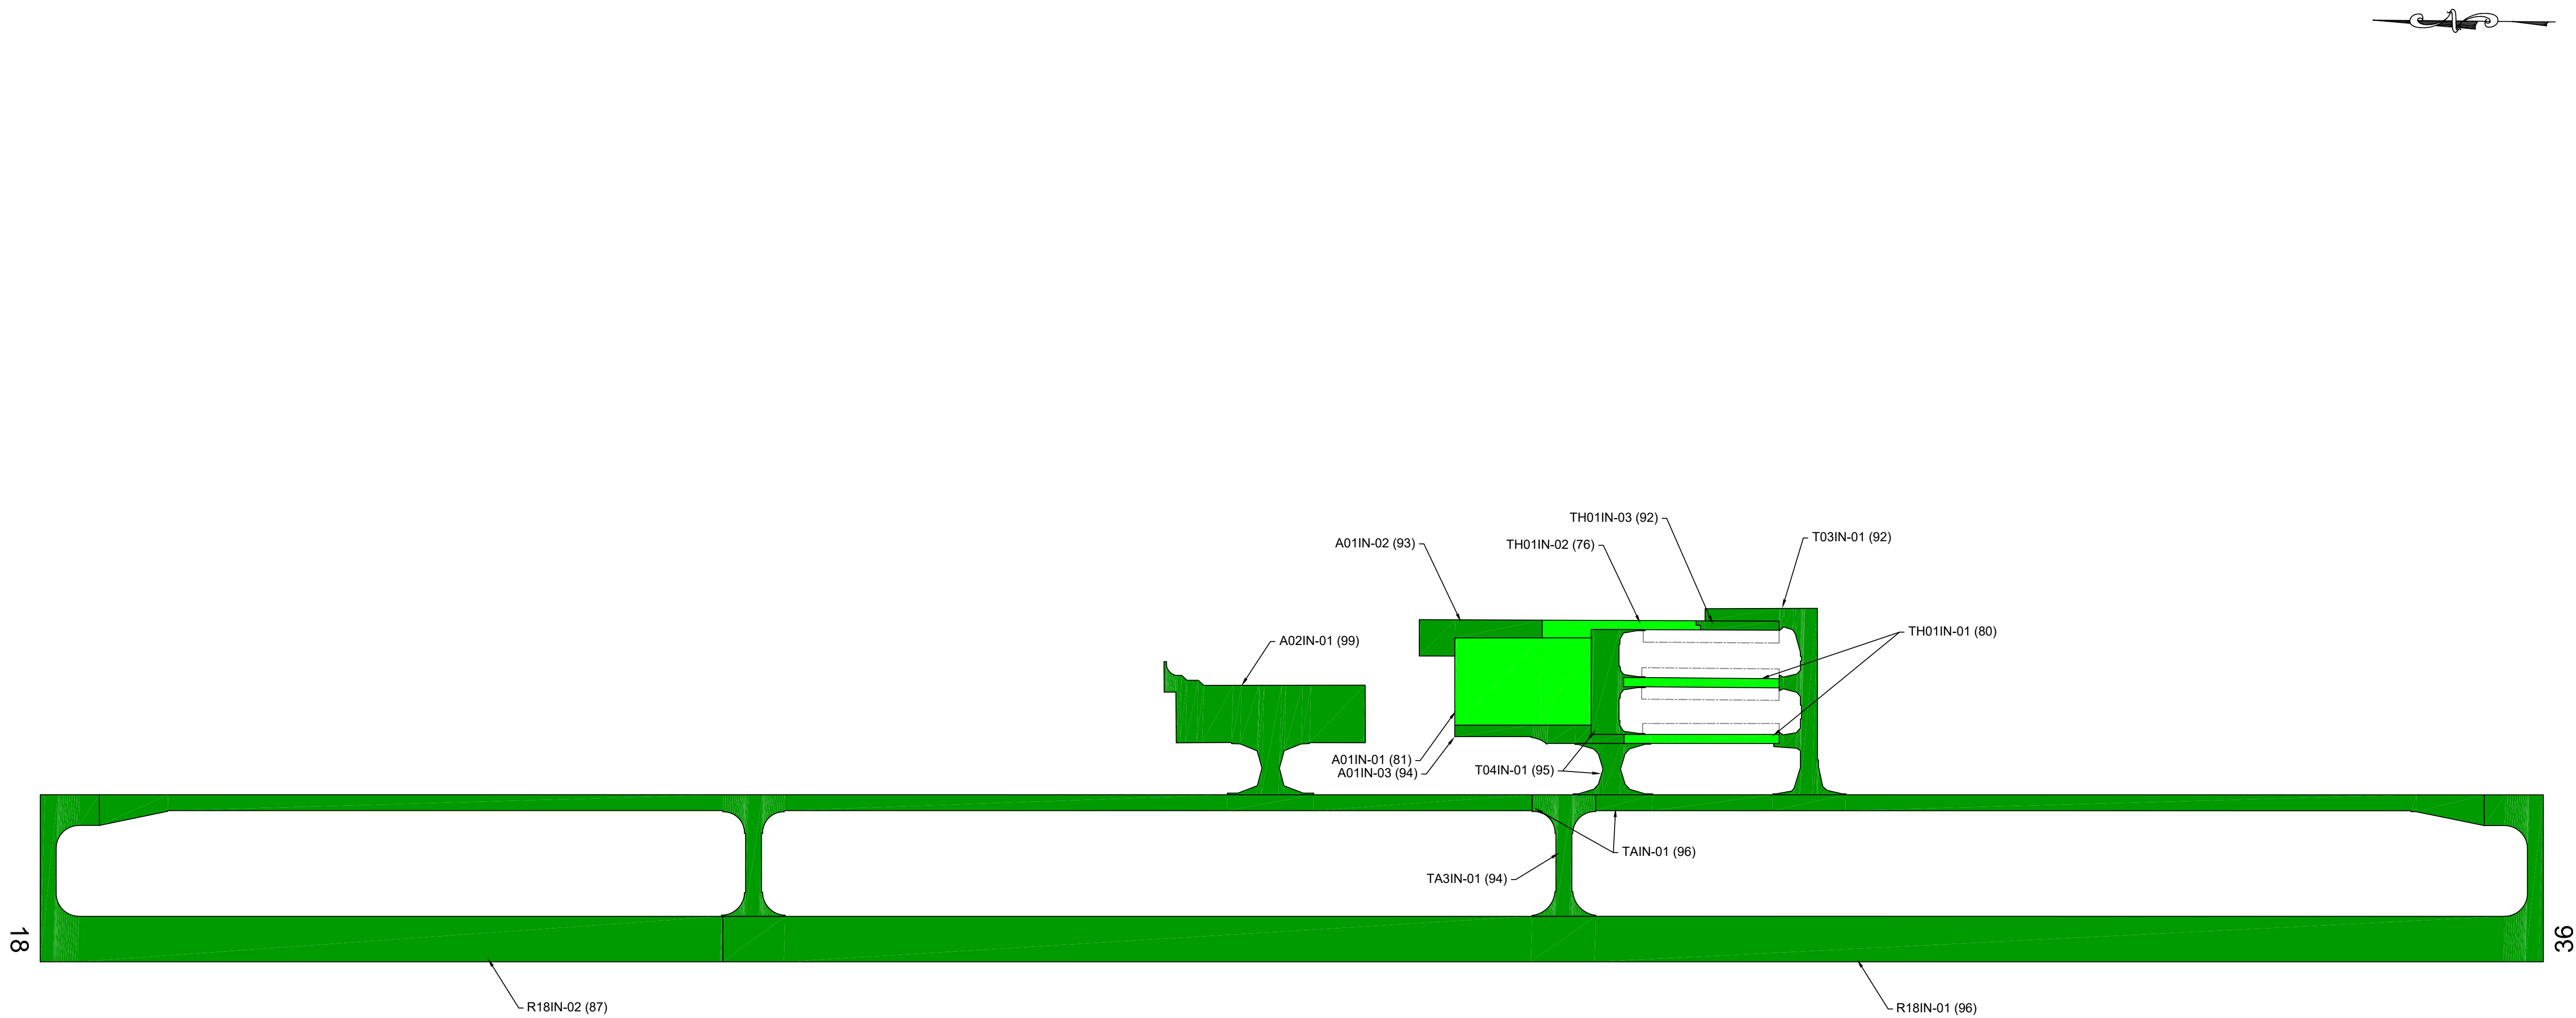
FIGURE 8. PCI MAP.

Figure 6 summarizes the overall condition of the pavements at James H Connell Field at Independence Municipal Airport, and Figure 7 presents area-weighted condition (average PCI adjusted to account for the relative size of the pavement sections) by branch use. Figure 8 is a map that displays the condition of the evaluated pavements. Table 1 summarizes the results of the pavement evaluation. Appendix B presents photographs taken during the PCI inspection, and Appendix C contains detailed information on the distress types observed during the visual
