# Jefferson Municipal Airport

## Pavement Management Report

**AUGUST 2025**

# JEFFERSON MUNICIPAL AIRPORT PAVEMENT MANAGEMENT REPORT

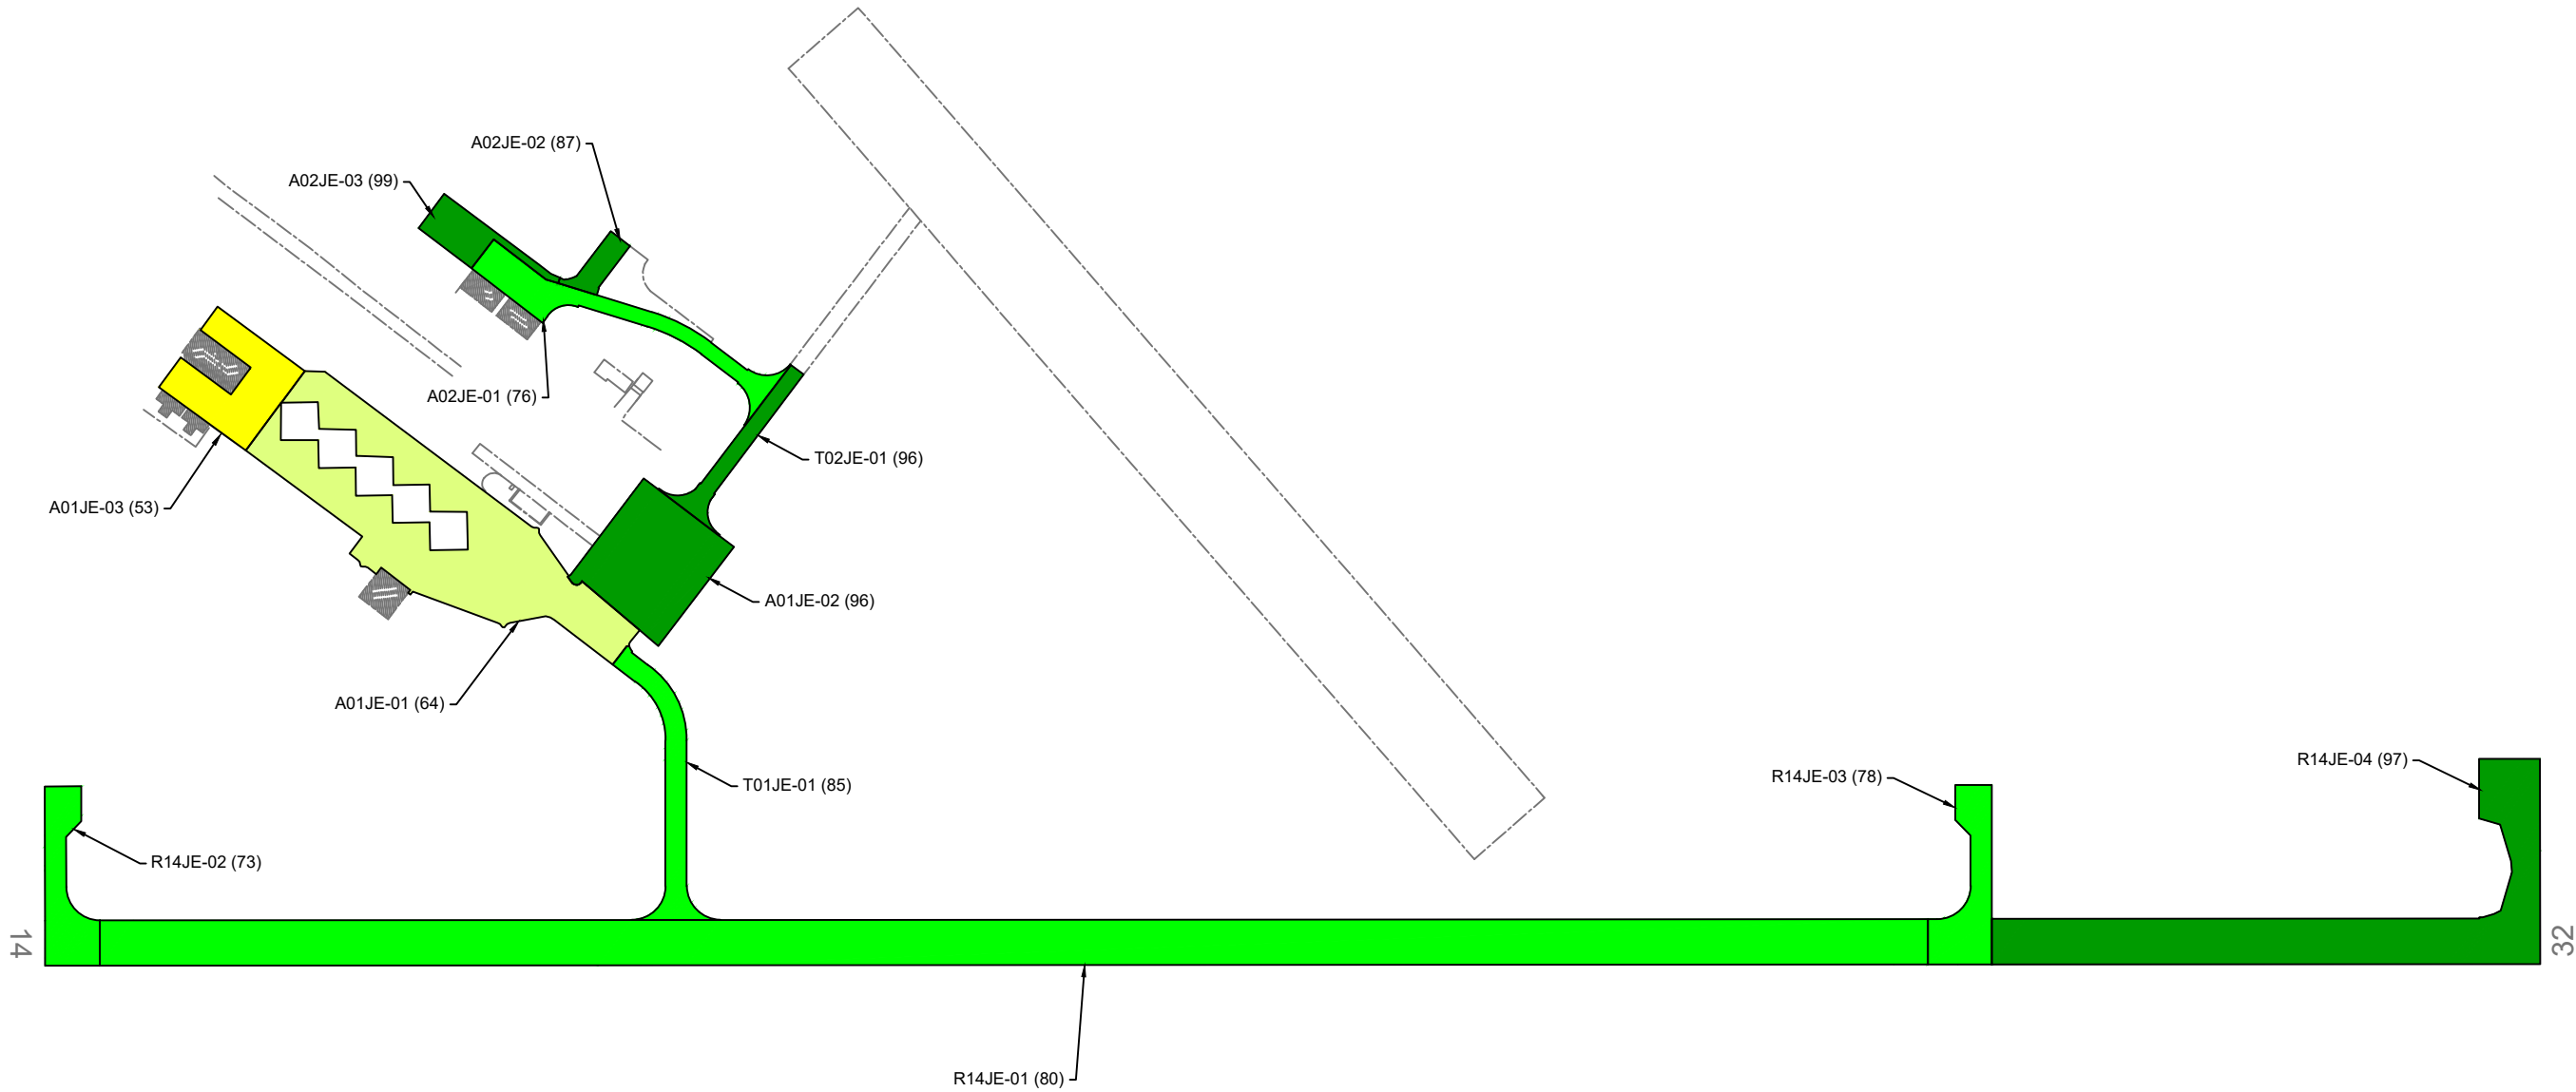
FIGURE 8. PCI MAP.

The pavements at Jefferson Municipal Airport were inspected in March 2025. The 2025 area-weighted condition of Jefferson Municipal Airport is 80, with conditions ranging from 53 to 99 (on a scale of 0 [failed] to 100 [excellent]). During the previous pavement inspection in 2021, the area-weighted PCI of the airport was 83.

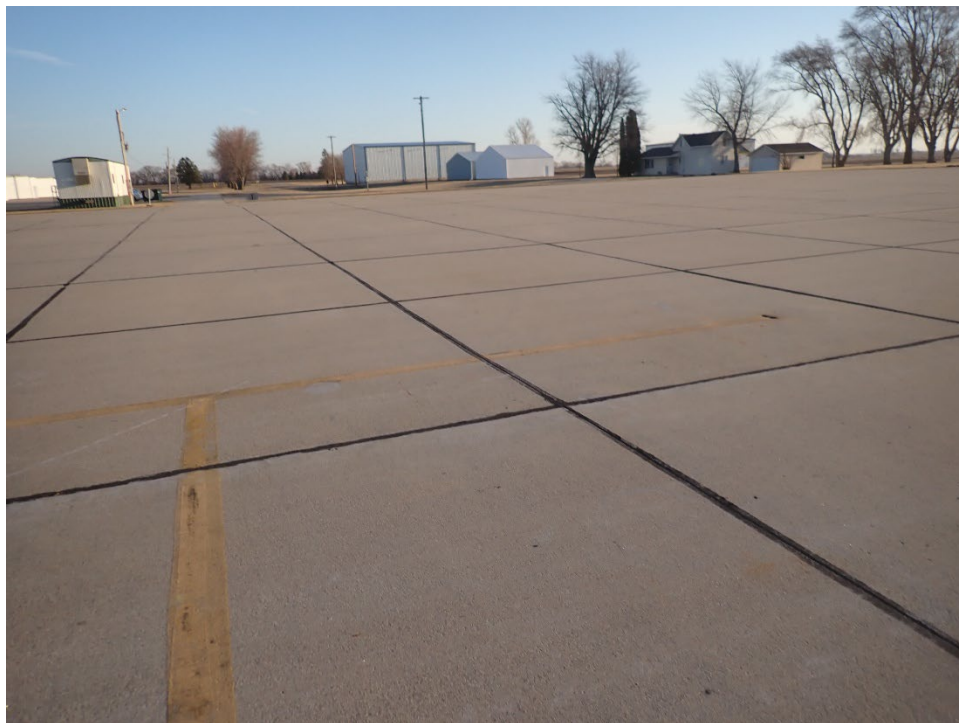
A01JE-02. Overview.

| Branch | Section | Surface Type | Section Area (sf) | LCD | 2025 PCI | % Distress Due to Load | % Distress Due to Climate/Durability | % Distress Due to Other | Type of Distress |
|---|---|---|---|---|---|---|---|---|---|
| A01JE | 02 | PCC | 37,530 | 12/2/2005 | 96 | 18 | 44 | 38 | Corner Break, Faulting, Joint Seal Damage |

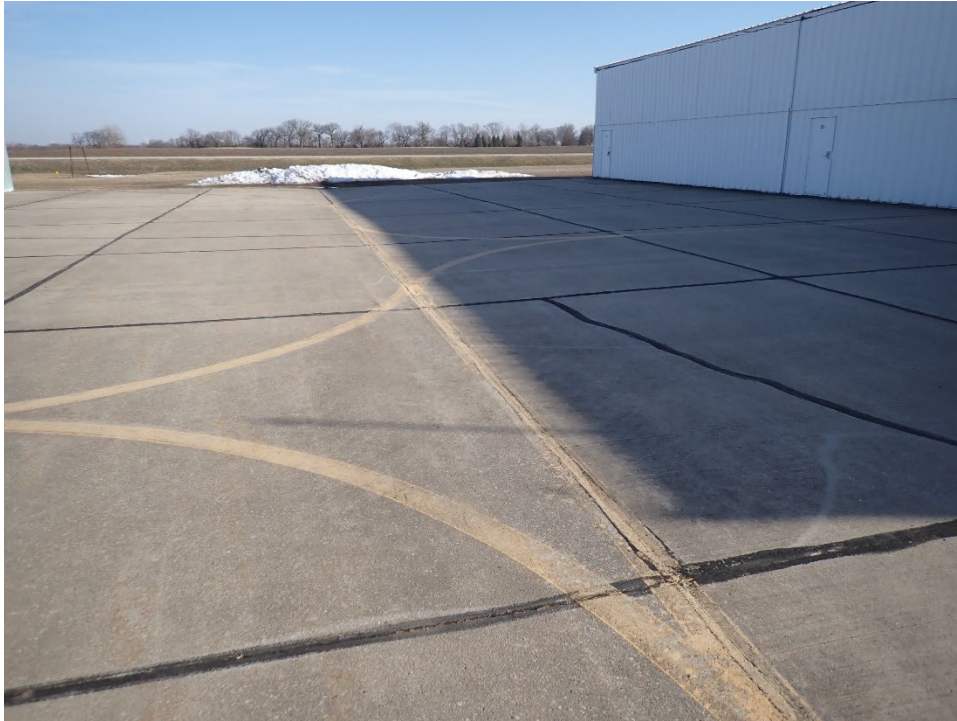
A01JE-03. Overview.

| Branch | Section | Surface Type | Section Area (sf) | LCD | 2025 PCI | % Distress Due to Load | % Distress Due to Climate/Durability | % Distress Due to Other | Type of Distress |
|---|---|---|---|---|---|---|---|---|---|
| A01JE | 03 | PCC | 23,296 | 1/1/1994 | 53 | 92 | 3 | 5 | Corner Break, Corner Spalling, Faulting, Joint Spalling, Joint Seal Damage, LTD Cracking, Shattered Slab, Shrinkage Cracking |

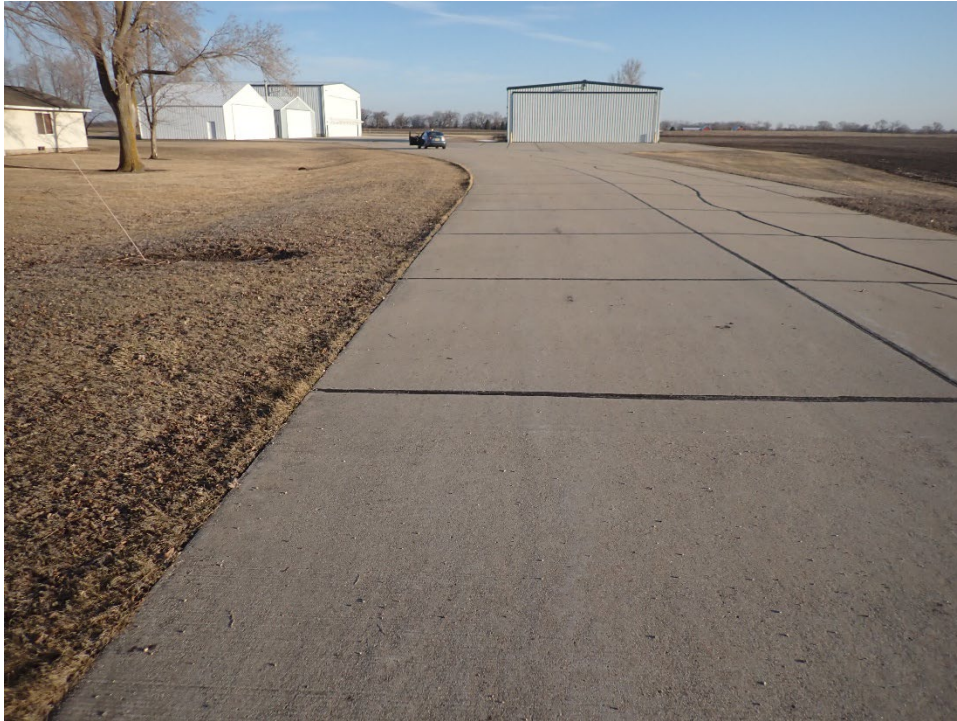
A02JE-01. Overview.

| Branch | Section | Surface Type | Section Area (sf) | LCD | 2025 PCI | % Distress Due to Load | % Distress Due to Climate/Durability | % Distress Due to Other | Type of Distress |
|---|---|---|---|---|---|---|---|---|---|
| A02JE | 01 | PCC | 20,178 | 6/1/2001 | 76 | 59 | 23 | 18 | Corner Break, Corner Spalling, Faulting, Joint Spalling, Joint Seal Damage, LTD Cracking, Small Patch |
