# Knoxville Municipal Airport

## Pavement Management Report

**AUGUST 2025**

# KNOXVILLE MUNICIPAL AIRPORT PAVEMENT MANAGEMENT REPORT

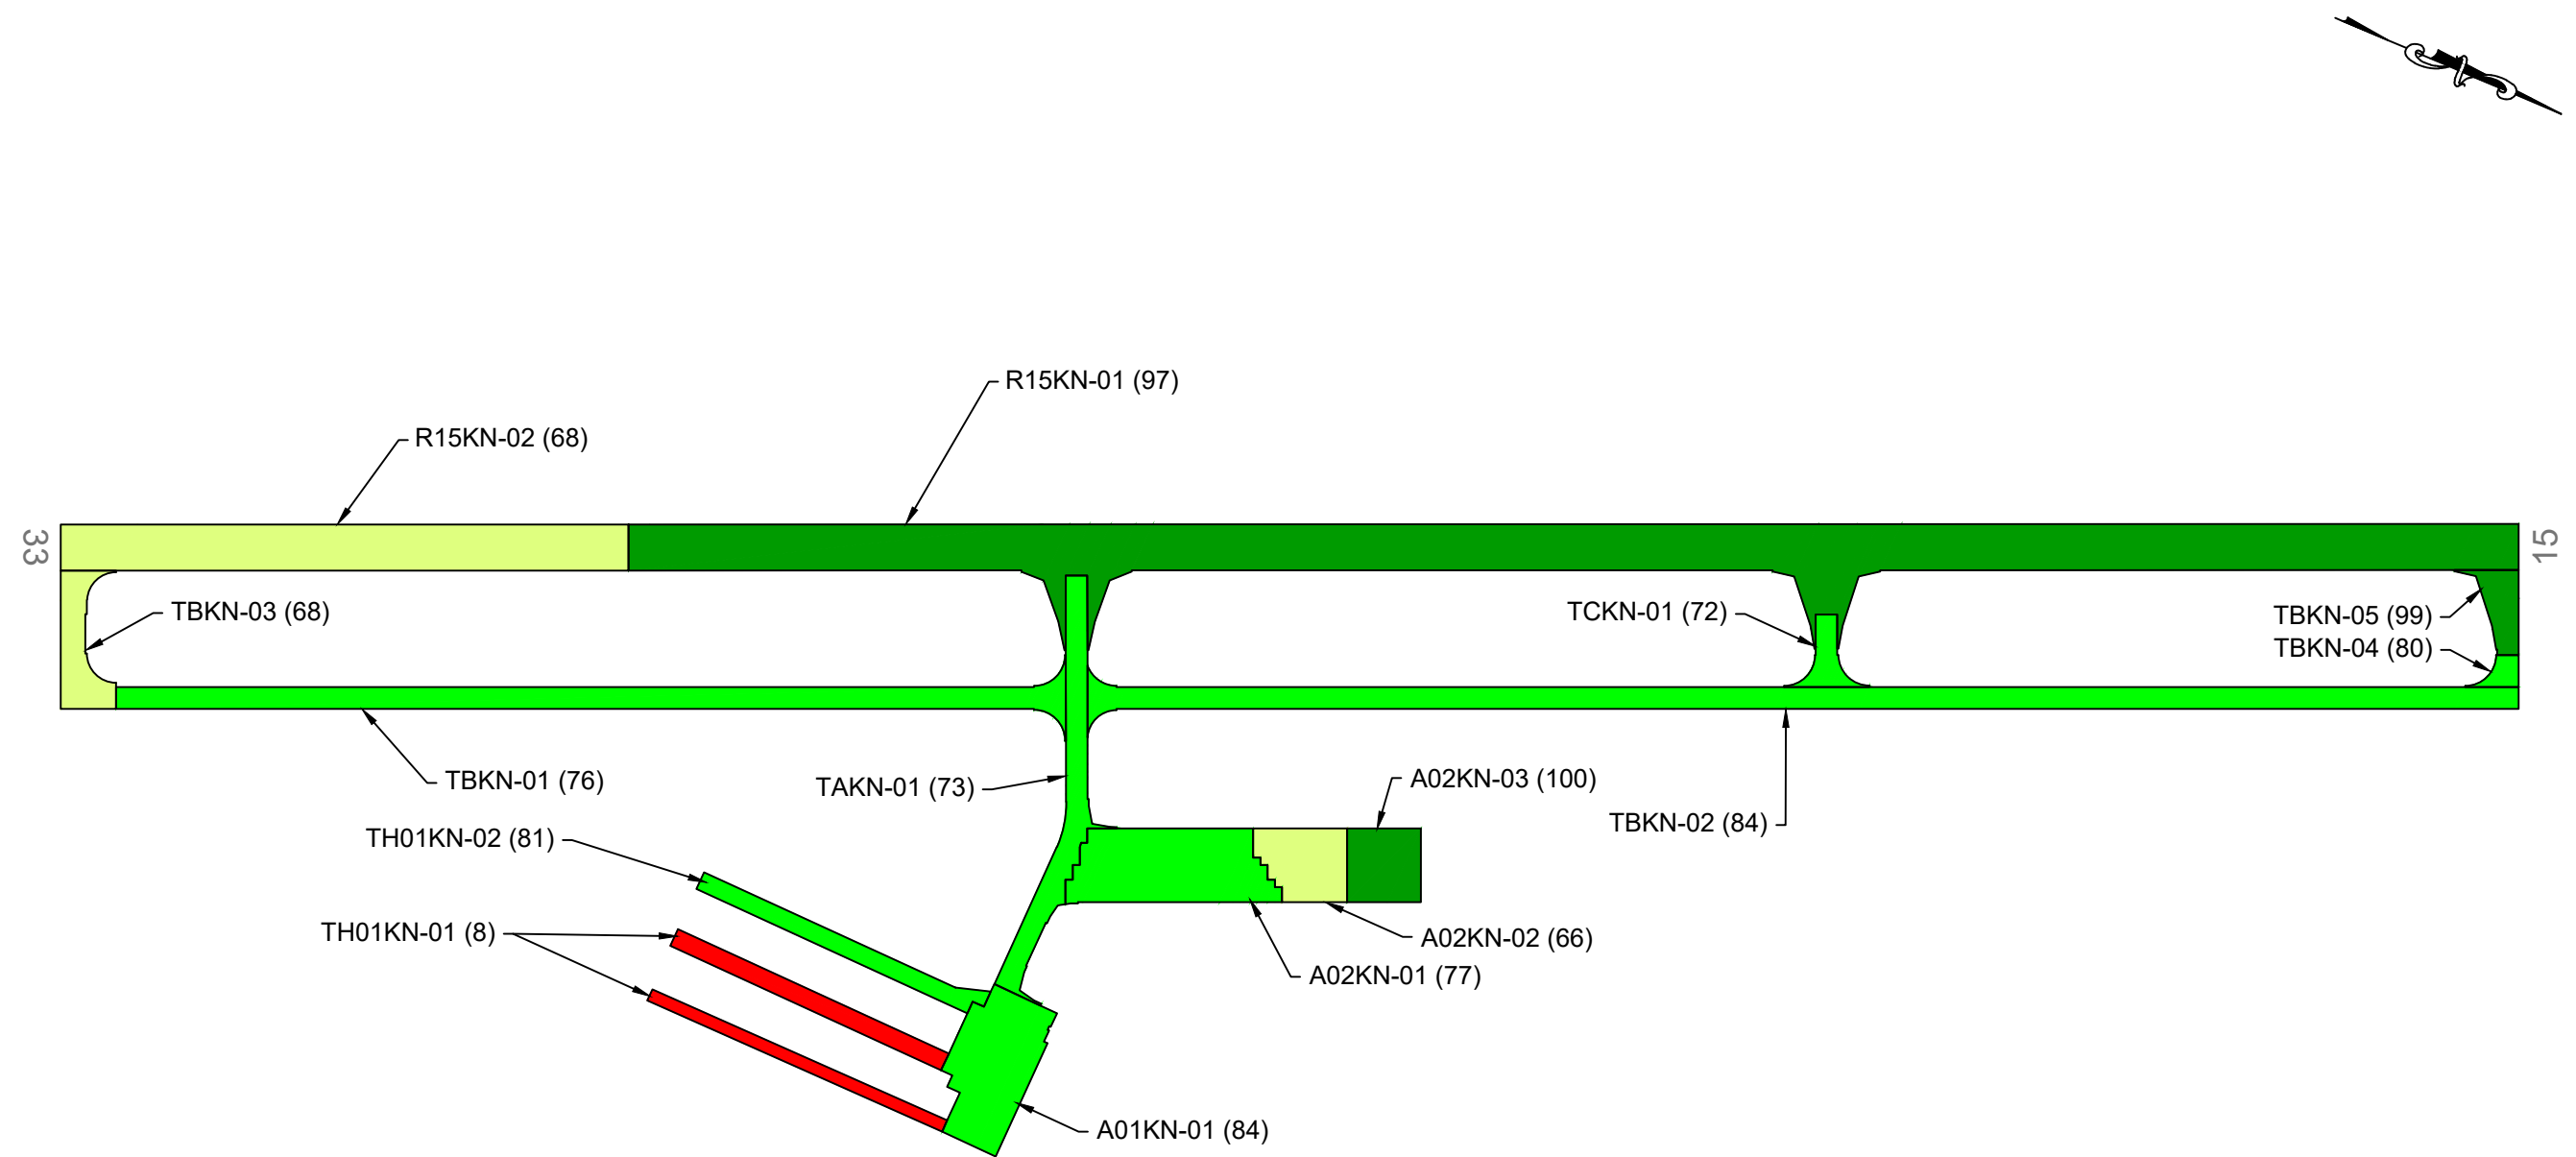
FIGURE 8. PCI MAP.

The pavements at Knoxville Municipal Airport were inspected in March 2025. The 2025 area-weighted condition of Knoxville Municipal Airport is 82, with conditions ranging from 8 to 100 (on a scale of 0 [failed] to 100 [excellent]). During the previous pavement inspection in 2021, the area-weighted PCI of the airport was 89.

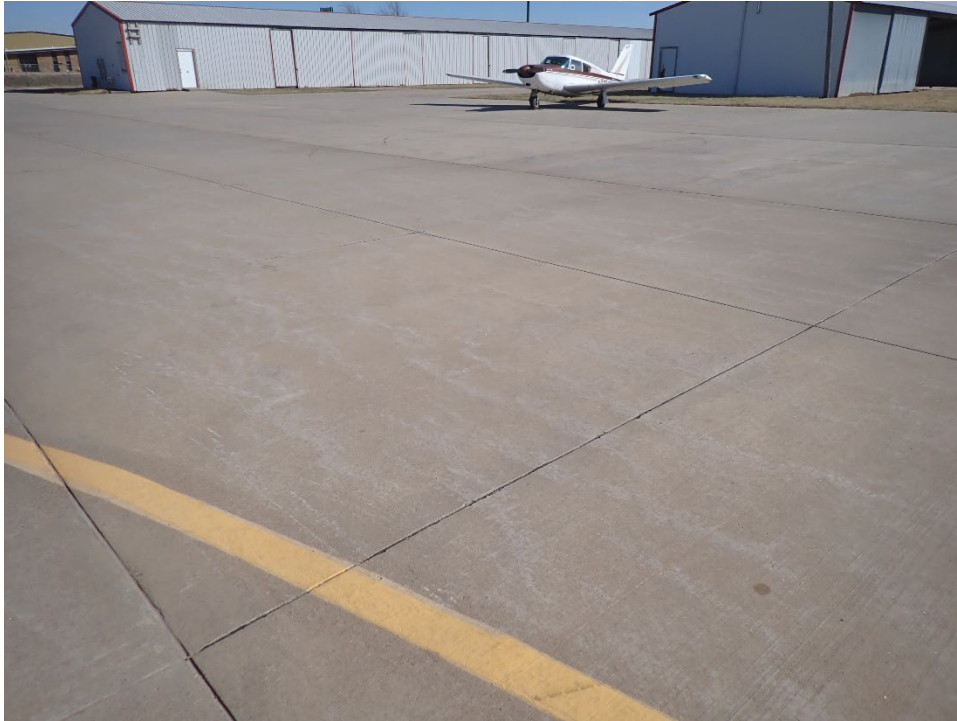
A01KN-01. Overview.

| Branch | Section | Surface Type | Section Area (sf) | LCD | 2025 PCI | % Distress Due to Load | % Distress Due to Climate/ Durability | % Distress Due to Other | Type of Distress |
|---|---|---|---|---|---|---|---|---|---|
| A01KN | 01 | PCC | 30,703 | 3/3/2015 | 84 | 25 | 61 | 14 | ASR, Corner Spalling, Joint Spalling, Joint Seal Damage, LTD Cracking, Shattered Slab |

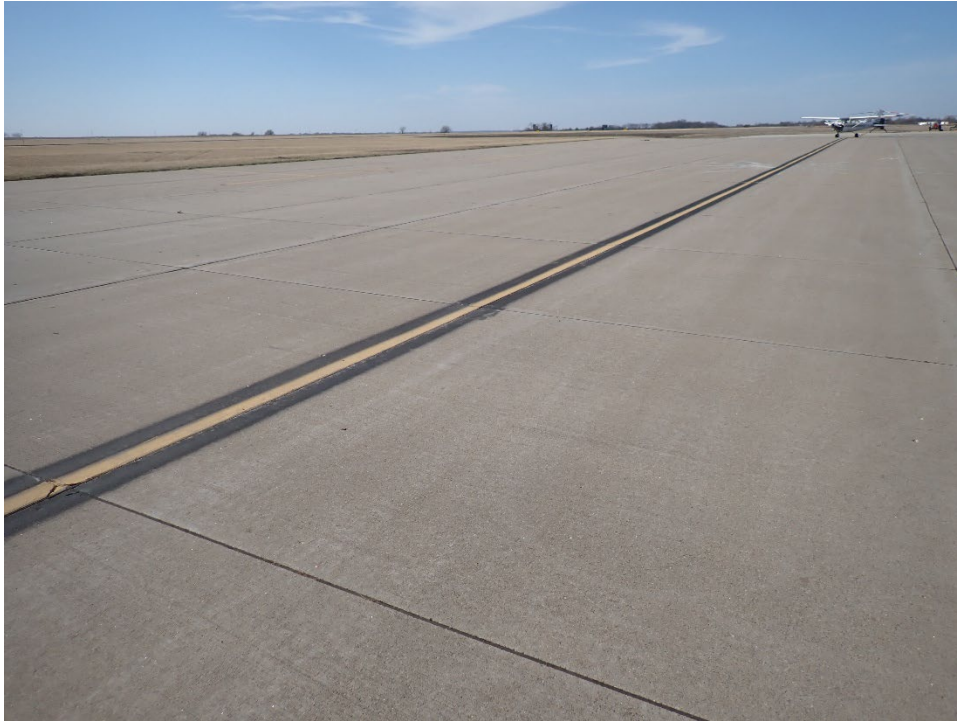
A02KN-01. Overview.

| Branch | Section | Surface Type | Section Area (sf) | LCD | 2025 PCI | % Distress Due to Load | % Distress Due to Climate/ Durability | % Distress Due to Other | Type of Distress |
|---|---|---|---|---|---|---|---|---|---|
| A02KN | 01 | PCC | 37,012 | 6/1/1991 | 77 | 32 | 25 | 43 | Corner Break, Corner Spalling, Faulting, Joint Spalling, Joint Seal Damage, LTD Cracking |

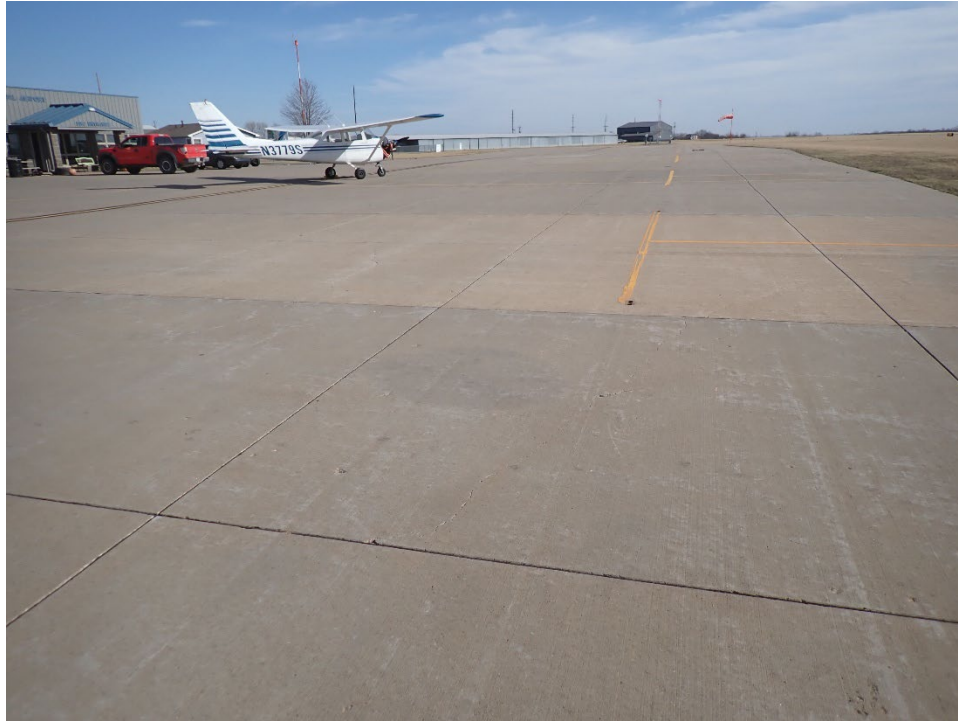
A02KN-02. Overview.

| Branch | Section | Surface Type | Section Area (sf) | LCD | 2025 PCI | % Distress Due to Load | % Distress Due to Climate/ Durability | % Distress Due to Other | Type of Distress |
|---|---|---|---|---|---|---|---|---|---|
| A02KN | 02 | PCC | 16,055 | 1/3/2012 | 66 | 76 | 14 | 10 | Corner Break, Corner Spalling, Joint Spalling, Joint Seal Damage, LTD Cracking, Shattered Slab, Shrinkage Cracking |

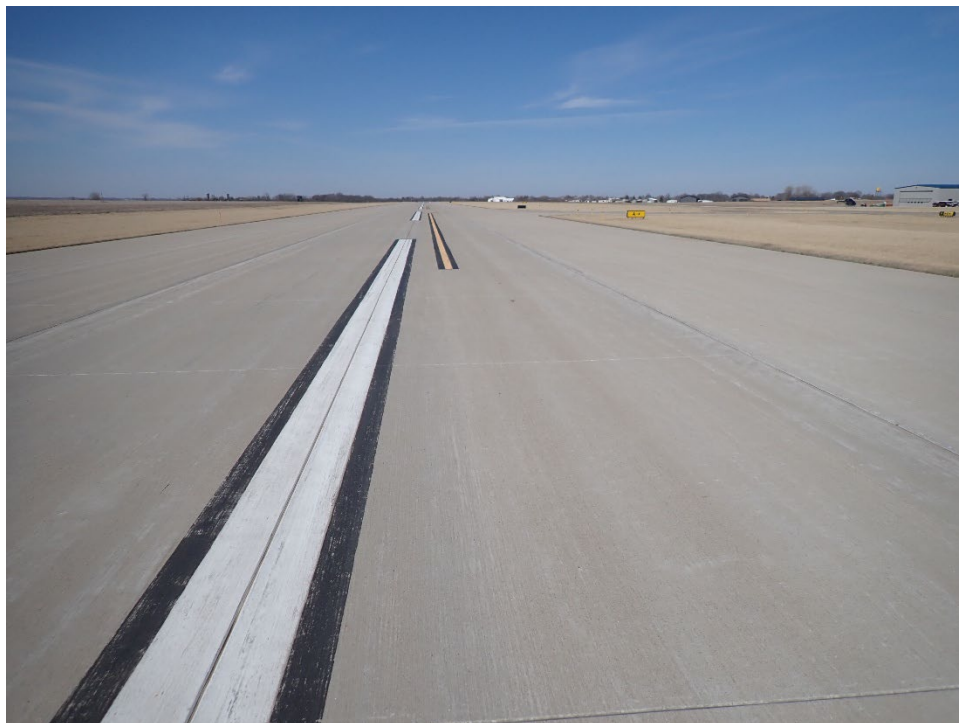
R15KN-01. Overview.

| Branch | Section | Surface Type | Section Area (sf) | LCD | 2025 PCI | % Distress Due to Load | % Distress Due to Climate/ Durability | % Distress Due to Other | Type of Distress |
|---|---|---|---|---|---|---|---|---|---|
| R15KN | 01 | PCC | 244,244 | 3/3/2020 | 97 | 35 | 32 | 33 | Faulting, Joint Spalling, Joint Seal Damage, LTD Cracking, Small Patch |
