# Lamoni Municipal Airport

## PAVEMENT MANAGEMENT REPORT

**JULY 2022**

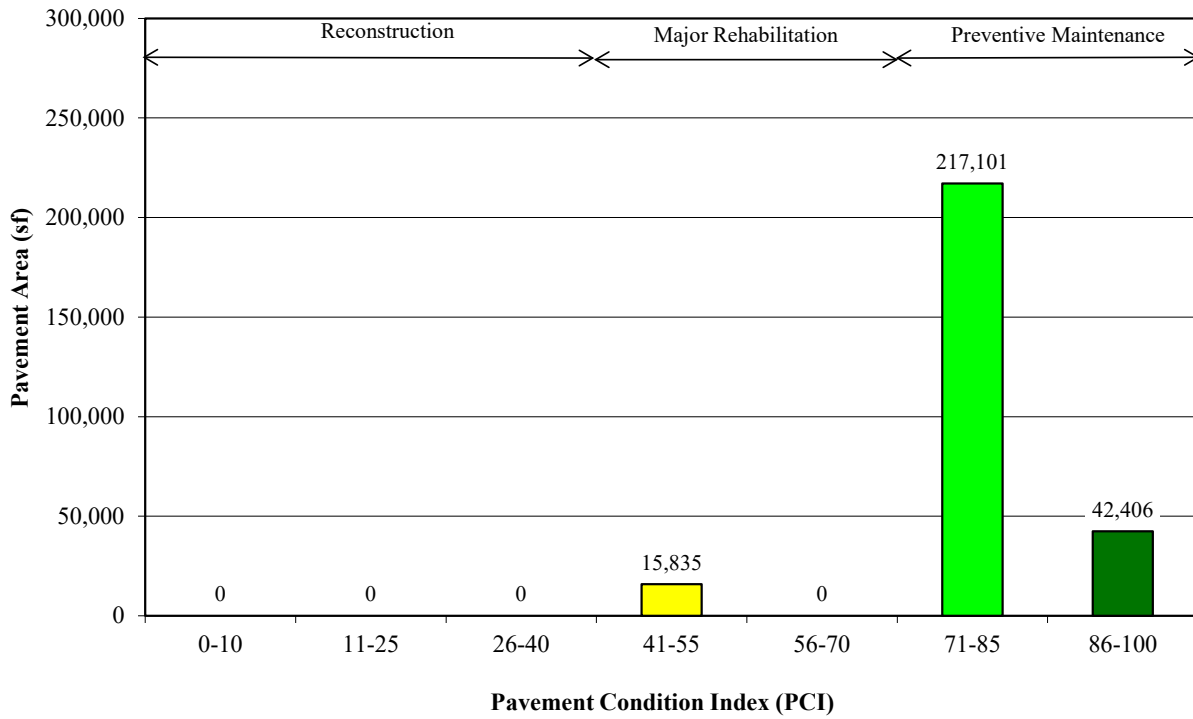
Figure 6. Pavement area by PCI range at Lamoni Municipal Airport.

The pavements at Lamoni Municipal Airport were inspected in November 2021. The 2021 area-weighted condition of Lamoni Municipal Airport is 82, with conditions ranging from 47 to 92 (on a scale of 0 [failed] to 100 [excellent]). During the previous pavement inspection in 2018, the area-weighted PCI of the airport was 86.

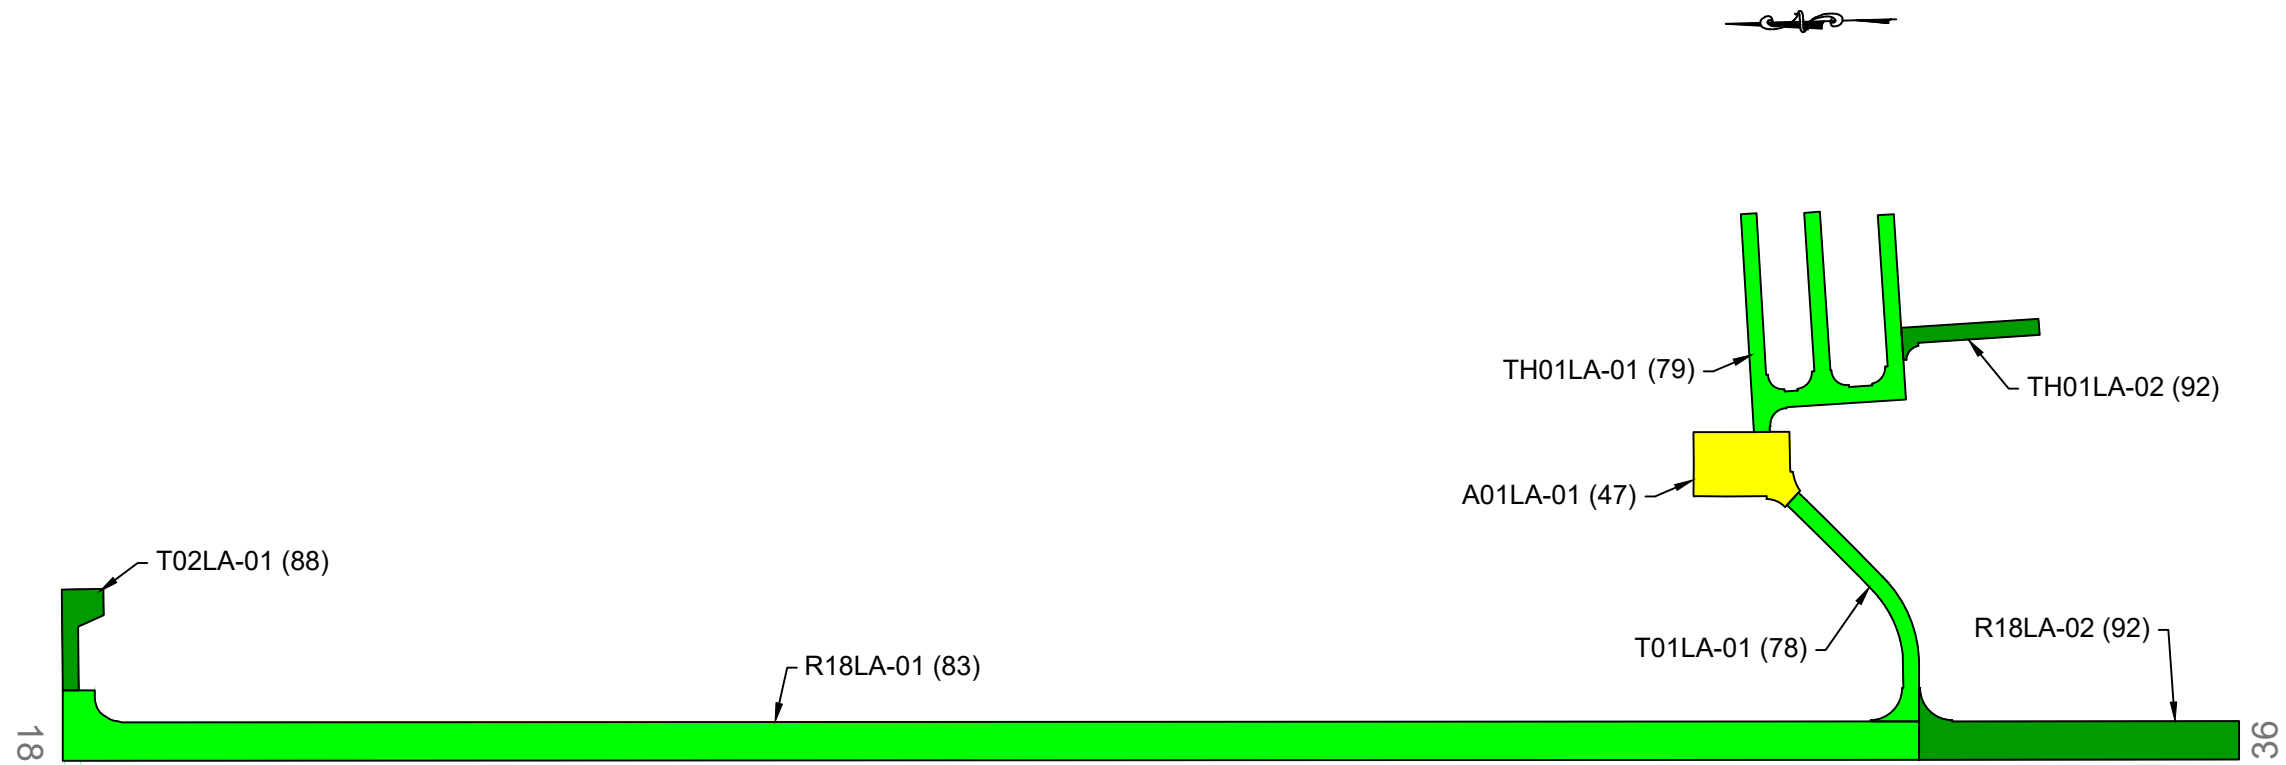
FIGURE 8. PCI MAP.

Figure 6 summarizes the overall condition of the pavements at Lamoni Municipal Airport, and Figure 7 presents area-weighted condition (average PCI adjusted to account for the relative size of the pavement sections) by branch use. Figure 8 is a map that displays the condition of the evaluated pavements. Table 1 summarizes the results of the pavement evaluation. Appendix B presents photographs taken during the PCI inspection, and Appendix C contains detailed information on the distress types observed during the visual survey. Appendix D includes detailed work history information that was collected during the record review process.
