# Lamoni Municipal Airport

## Pavement Management Report

**AUGUST 2025**

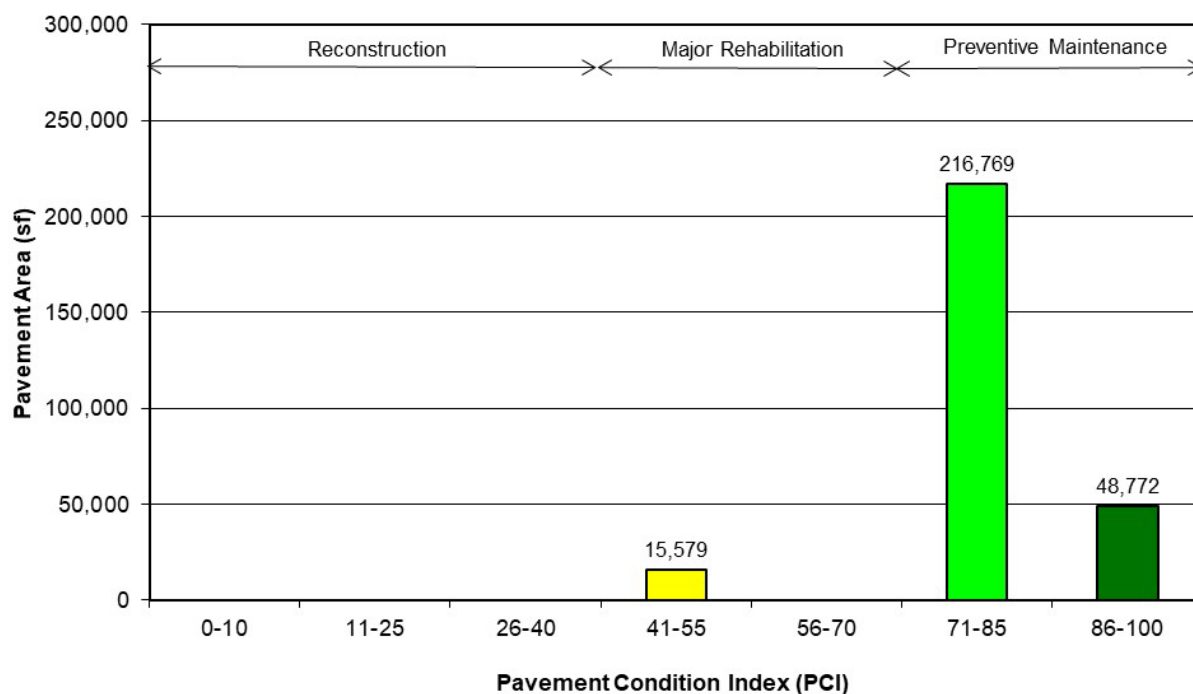
Figure 6. Pavement area by PCI range at Lamoni Municipal Airport.

Figure 6 summarizes the overall condition of the pavements at Lamoni Municipal Airport, and Figure 7 presents area-weighted condition (average PCI adjusted to account for the relative size of the pavement sections) by branch use. Figure 8 is a map that displays the condition of the evaluated pavements. Table 1 summarizes the results of the pavement evaluation. Appendix B presents photographs taken during the PCI inspection, and Appendix C contains detailed information on the distress types observed during the visual survey. Appendix D includes detailed work history information that was collected during the record review process.

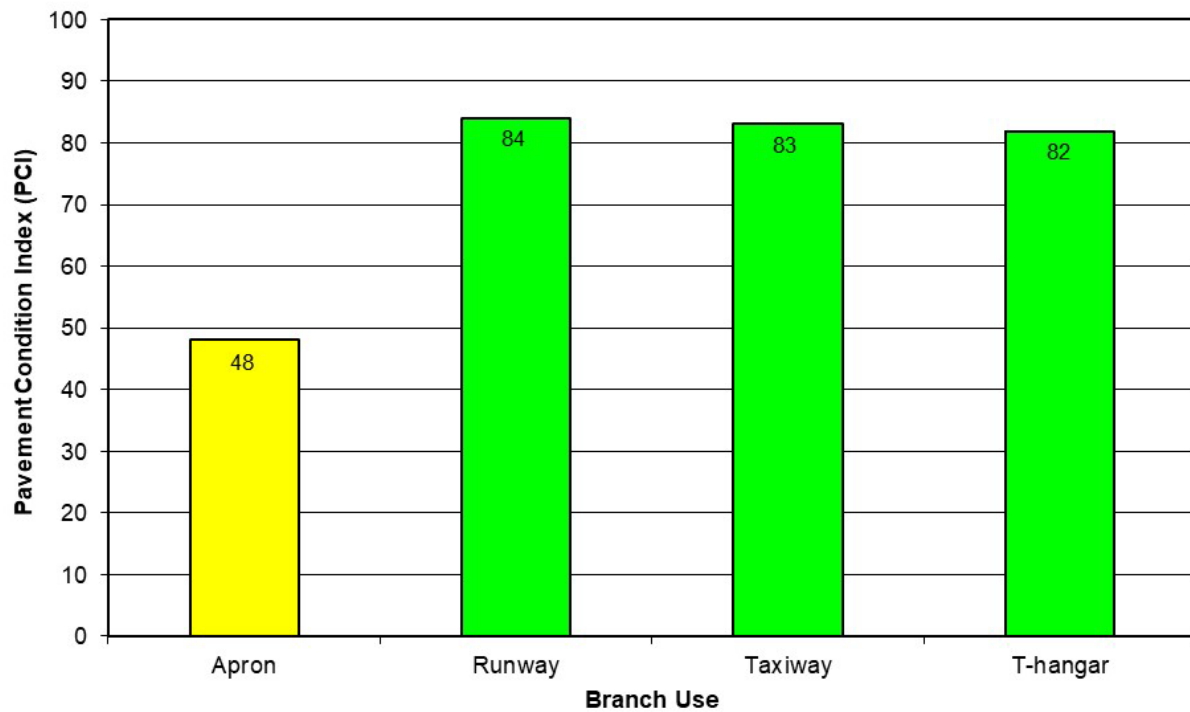
Figure 7. Area-weighted PCI by branch use at Lamoni Municipal Airport.

(Values on chart are area weighted.)

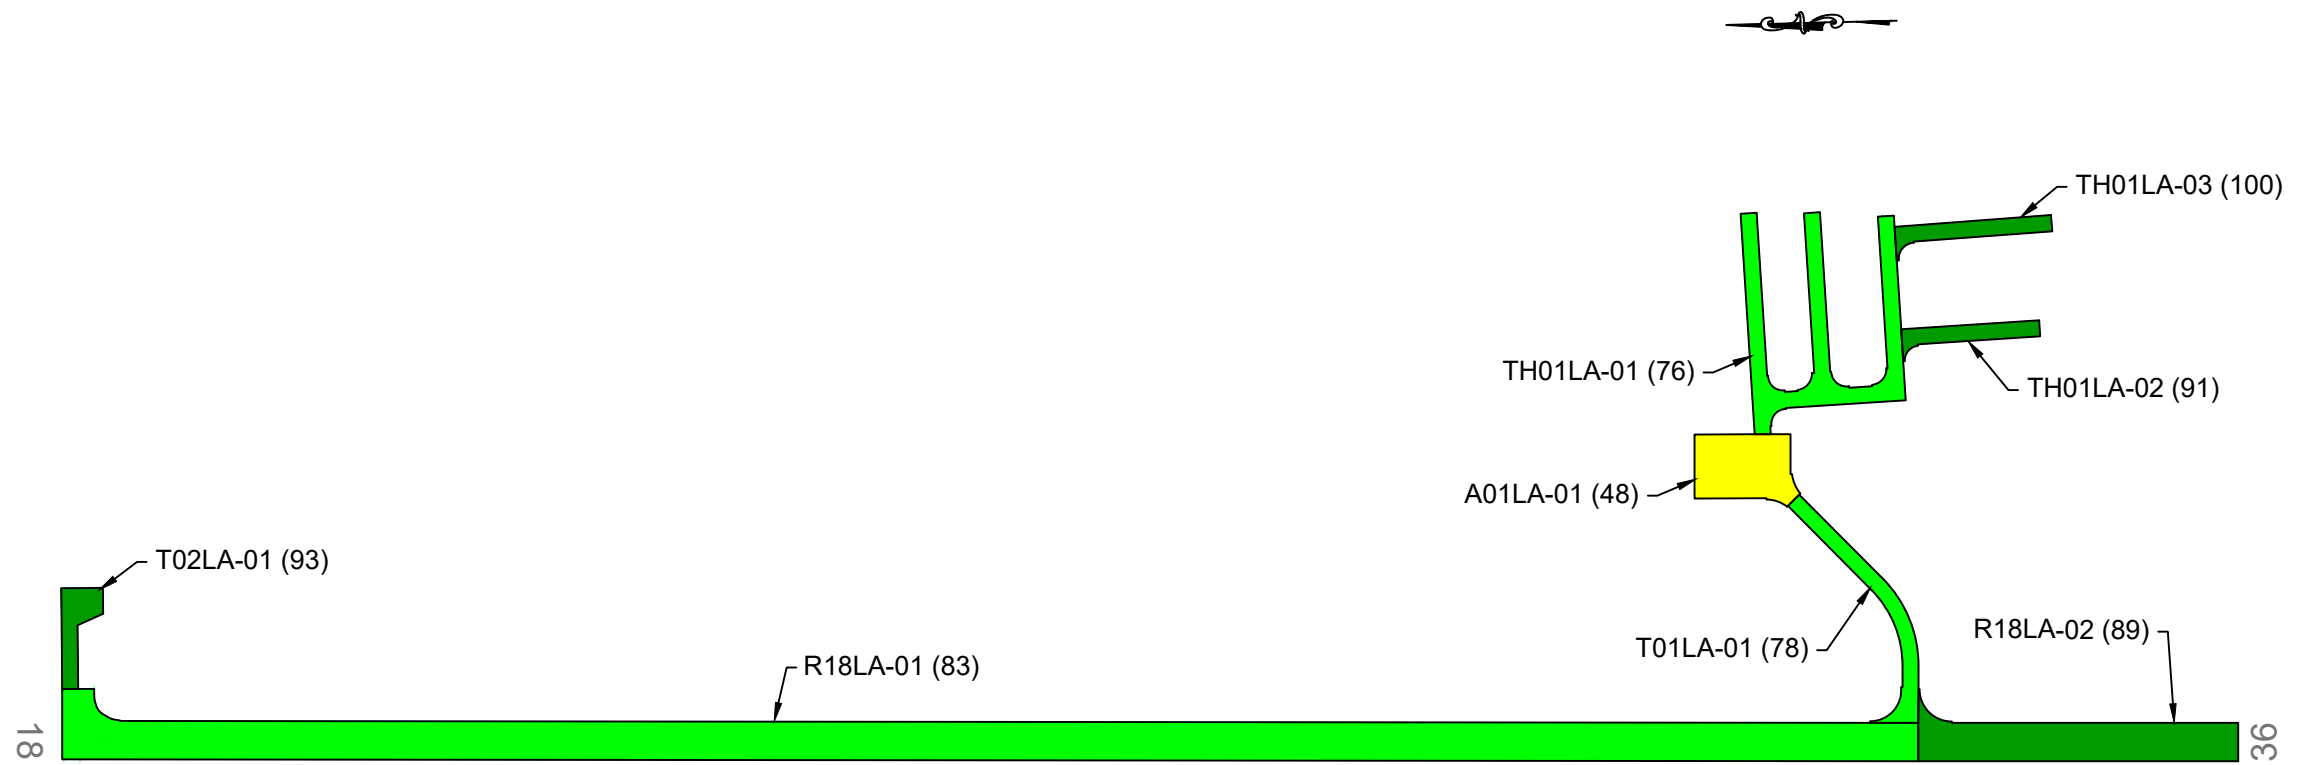
FIGURE 8. PCI MAP.

The pavements at Lamoni Municipal Airport were inspected in March 2025. The 2025 area-weighted condition of Lamoni Municipal Airport is 82, with conditions ranging from 48 to 100 (on a scale of 0 [failed] to 100 [excellent]). During the previous pavement inspection in 2021, the area-weighted PCI of the airport was 82.
