# Le Mars Municipal Airport

## Pavement Management Report

**AUGUST 2026**

# LE MARS MUNICIPAL AIRPORT PAVEMENT MANAGEMENT REPORT

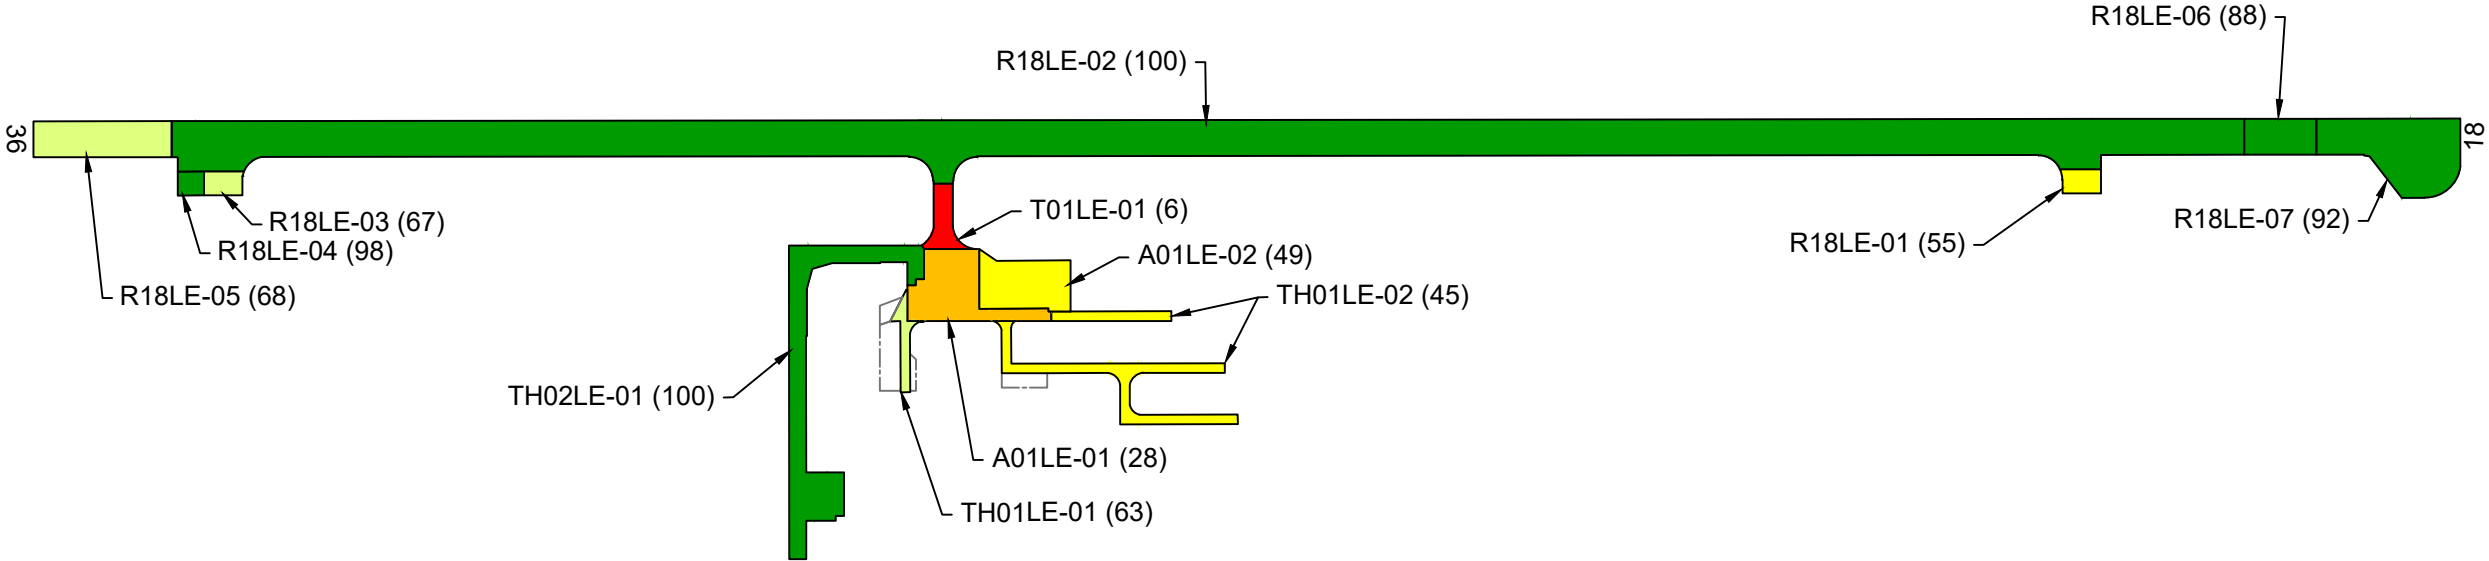
FIGURE 8. PCI MAP.

The pavements at Le Mars Municipal Airport were inspected in March 2026. The 2026 area-weighted condition of Le Mars Municipal Airport is 88, with conditions ranging from 6 to 100 (on a scale of 0 [*Failed*] to 100 [*Excellent*]). During the previous pavement inspection in 2022, the area-weighted PCI of the airport was 88.

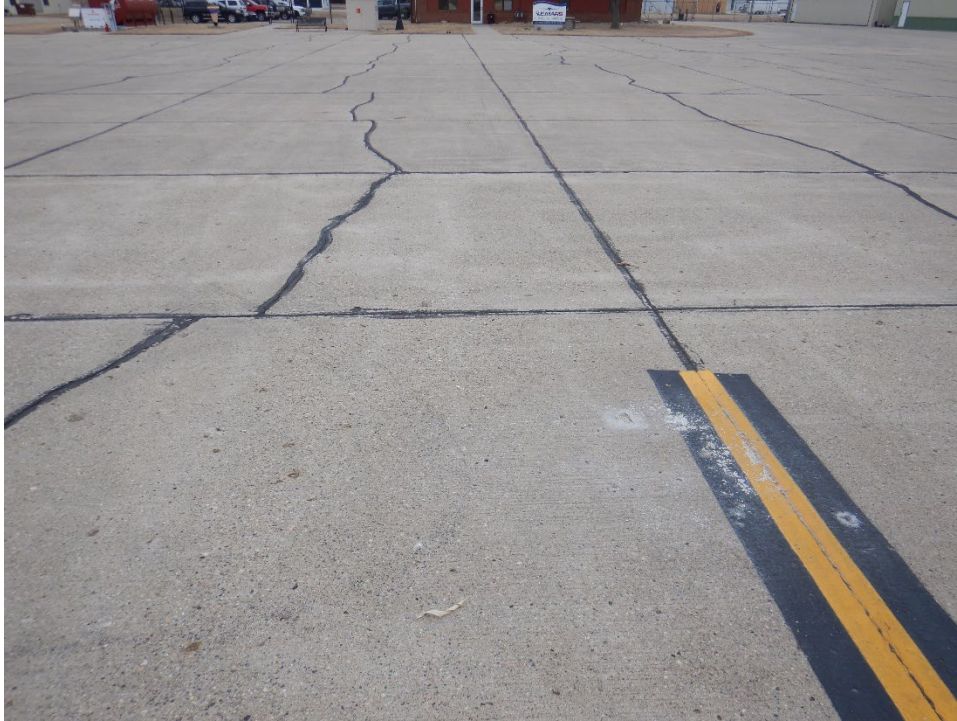
A01LE-01. Overview.

| Branch | Section | Surface Type | Section Area (sf) | LCD | 2026 PCI | % Distress Due to Load | % Distress Due to Climate/Durability | % Distress Due to Other | Type of Distress |
|---|---|---|---|---|---|---|---|---|---|
| A01LE | 01 | PCC | 24,194 | 5/1/1980 | 28 | 85 | 2 | 13 | Corner Break, Corner Spalling, Joint Spalling, Joint Seal Damage, Large Patch, LTD Cracking, Popouts, Shattered Slab, Shrinkage Cracking |

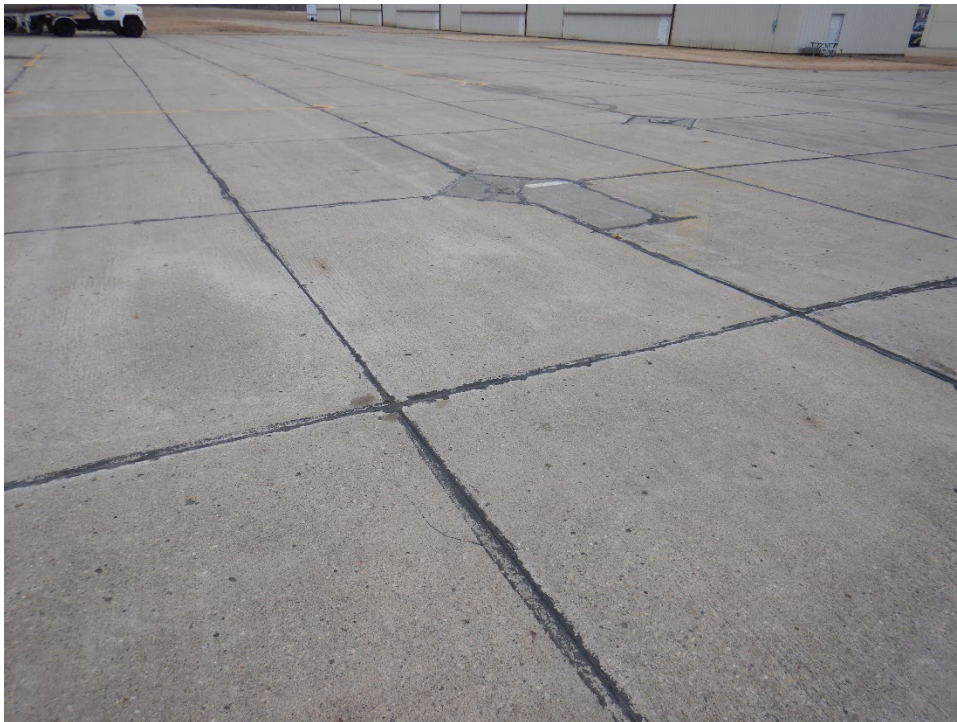
A01LE-02. Overview.

| Branch | Section | Surface Type | Section Area (sf) | LCD | 2026 PCI | % Distress Due to Load | % Distress Due to Climate/Durability | % Distress Due to Other | Type of Distress |
|---|---|---|---|---|---|---|---|---|---|
| A01LE | 02 | PCC | 19,673 | 5/1/1984 | 49 | 48 | 22 | 30 | Corner Break, Corner Spalling, Durability Cracking, Joint Spalling, Joint Seal Damage, Large Patch, LTD Cracking, Popouts, Shattered Slab, Shrinkage Cracking, Small Patch |

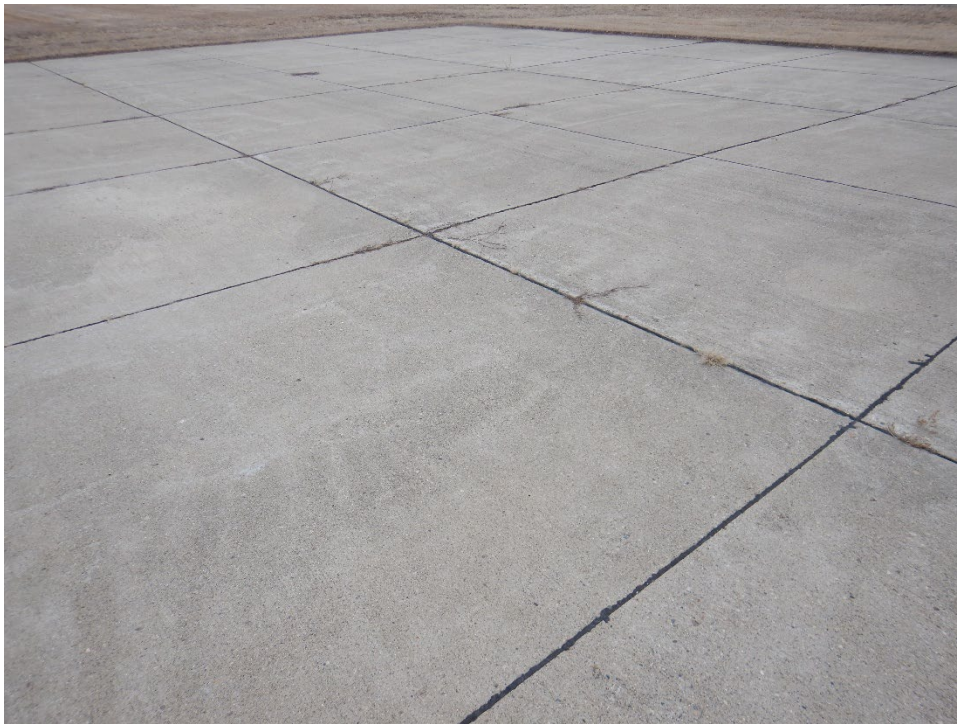
R18LE-01. Overview.

| Branch | Section | Surface Type | Section Area (sf) | LCD | 2026 PCI | % Distress Due to Load | % Distress Due to Climate/Durability | % Distress Due to Other | Type of Distress |
|---|---|---|---|---|---|---|---|---|---|
| R18LE | 01 | PCC | 4,060 | 5/1/1980 | 55 | 21 | 17 | 62 | ASR, Corner Break, Corner Spalling, Joint Seal Damage, LTD Cracking, Popouts |

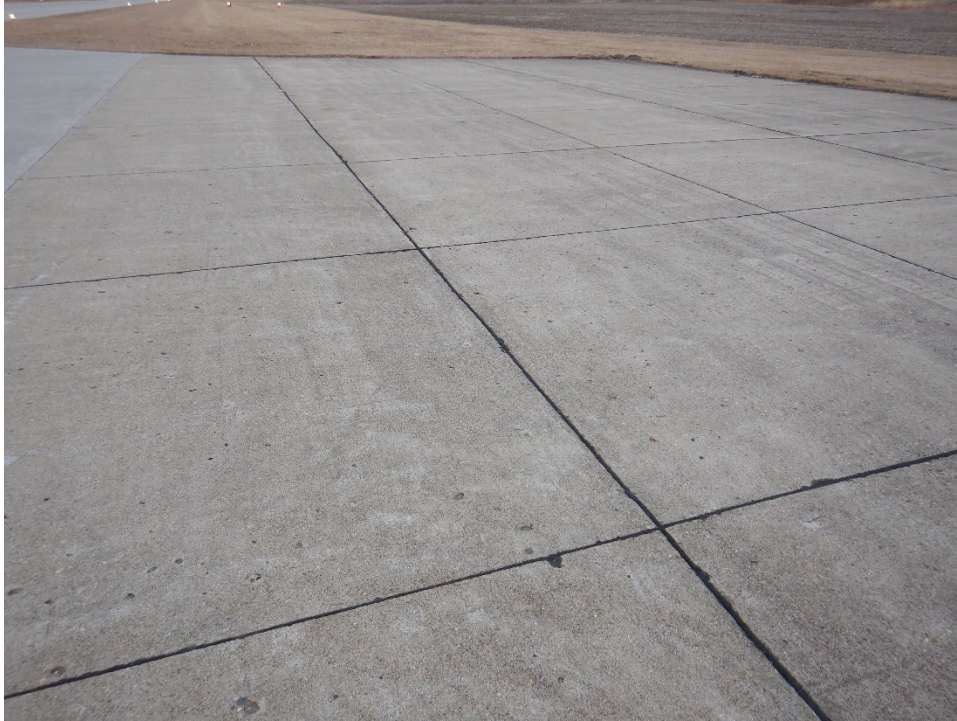
R18LE-03. Overview.

| Branch | Section | Surface Type | Section Area (sf) | LCD | 2026 PCI | % Distress Due to Load | % Distress Due to Climate/Durability | % Distress Due to Other | Type of Distress |
|---|---|---|---|---|---|---|---|---|---|
| R18LE | 03 | PCC | 4,012 | 5/1/1980 | 67 | 10 | 27 | 63 | Corner Break, Corner Spalling, Joint Spalling, Joint Seal Damage, Popouts, Shrinkage Cracking |

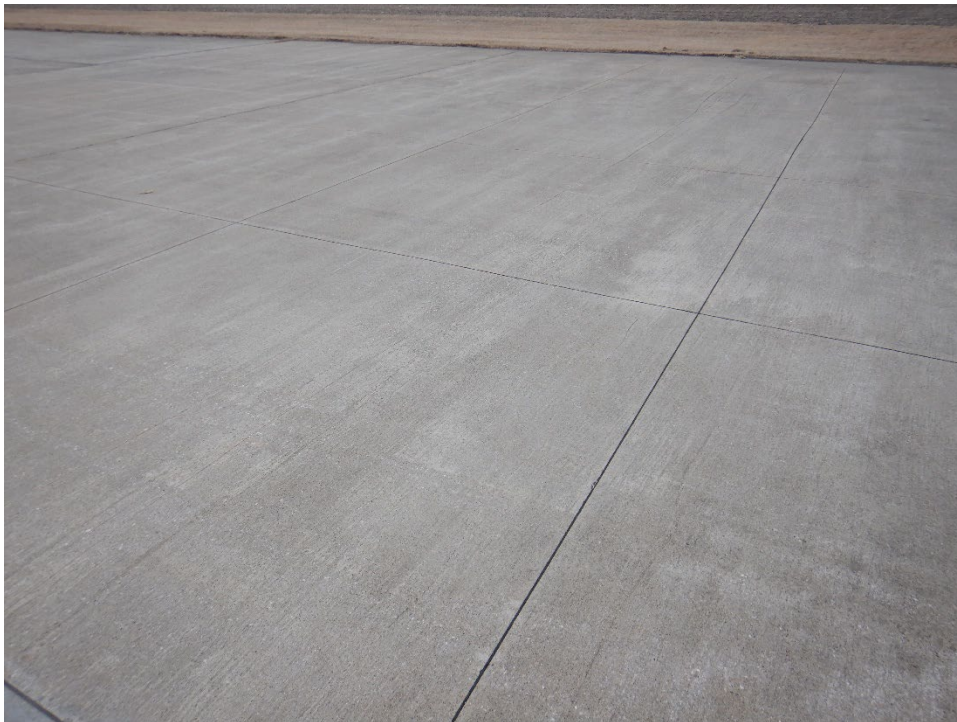
R18LE-04. Overview.

| Branch | Section | Surface Type | Section Area (sf) | LCD | 2026 PCI | % Distress Due to Load | % Distress Due to Climate/Durability | % Distress Due to Other | Type of Distress |
|---|---|---|---|---|---|---|---|---|---|
| R18LE | 04 | PCC | 2,750 | 5/1/1996 | 98 | 0 | 100 | 0 | Joint Seal Damage |

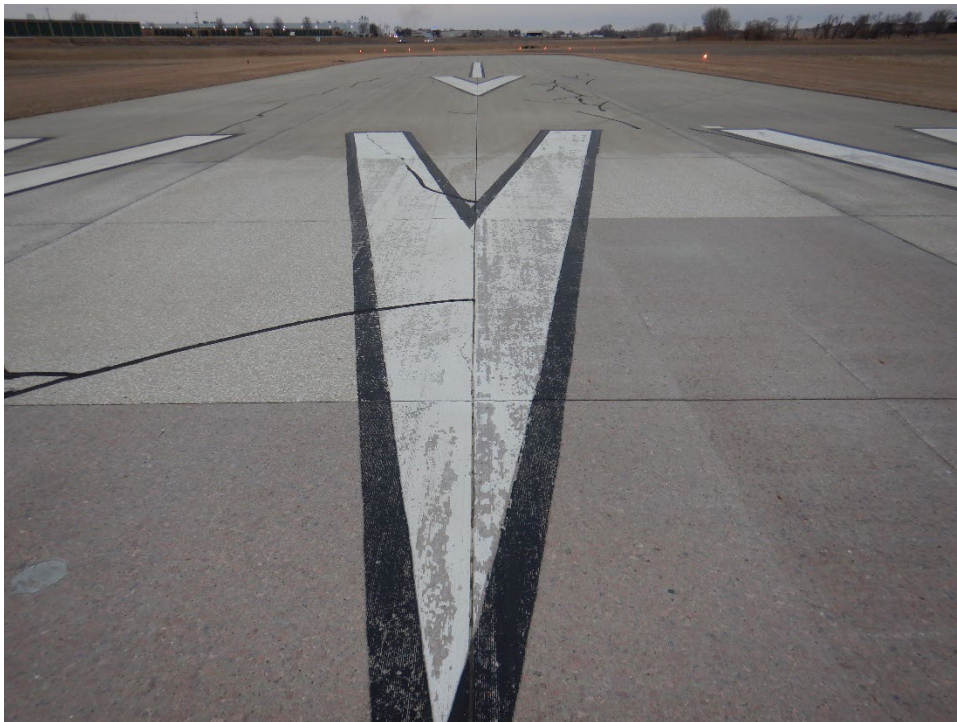
R18LE-05. Overview.

| Branch | Section | Surface Type | Section Area (sf) | LCD | 2026 PCI | % Distress Due to Load | % Distress Due to Climate/Durability | % Distress Due to Other | Type of Distress |
|---|---|---|---|---|---|---|---|---|---|
| R18LE | 05 | PCC | 21,562 | 7/1/2007 | 68 | 64 | 23 | 13 | Corner Break, Corner Spalling, Durability Cracking, Faulting, Joint Spalling, Joint Seal Damage, LTD Cracking, Shattered Slab |

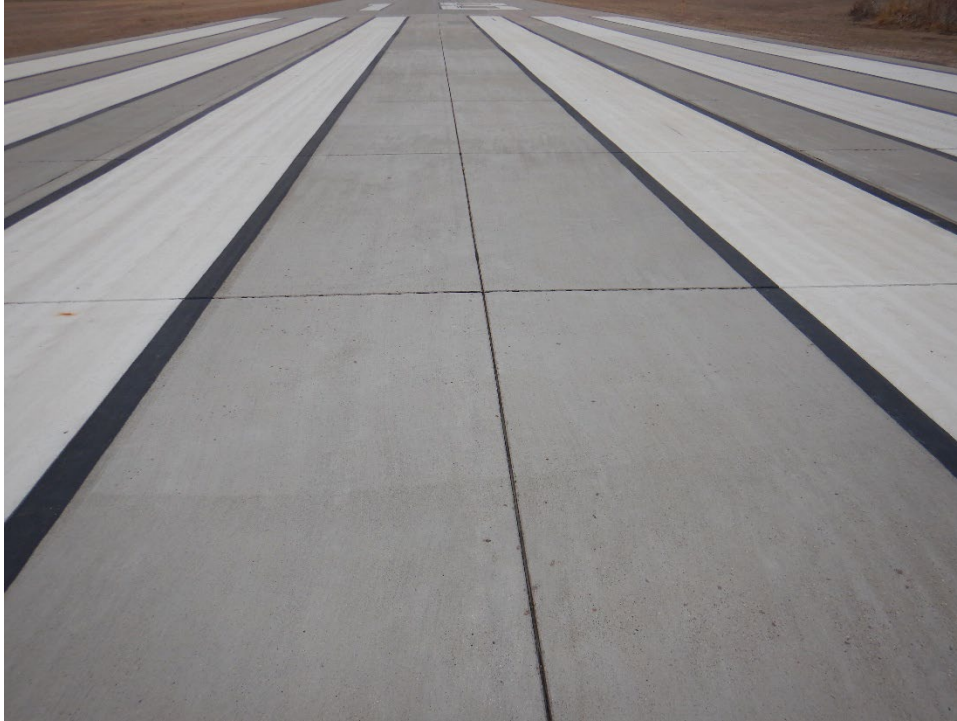
R18LE-06. Overview.

| Branch | Section | Surface Type | Section Area (sf) | LCD | 2026 PCI | % Distress Due to Load | % Distress Due to Climate/Durability | % Distress Due to Other | Type of Distress |
|---|---|---|---|---|---|---|---|---|---|
| R18LE | 06 | PCC | 11,250 | 5/3/2018 | 88 | 0 | 100 | 0 | Joint Seal Damage |

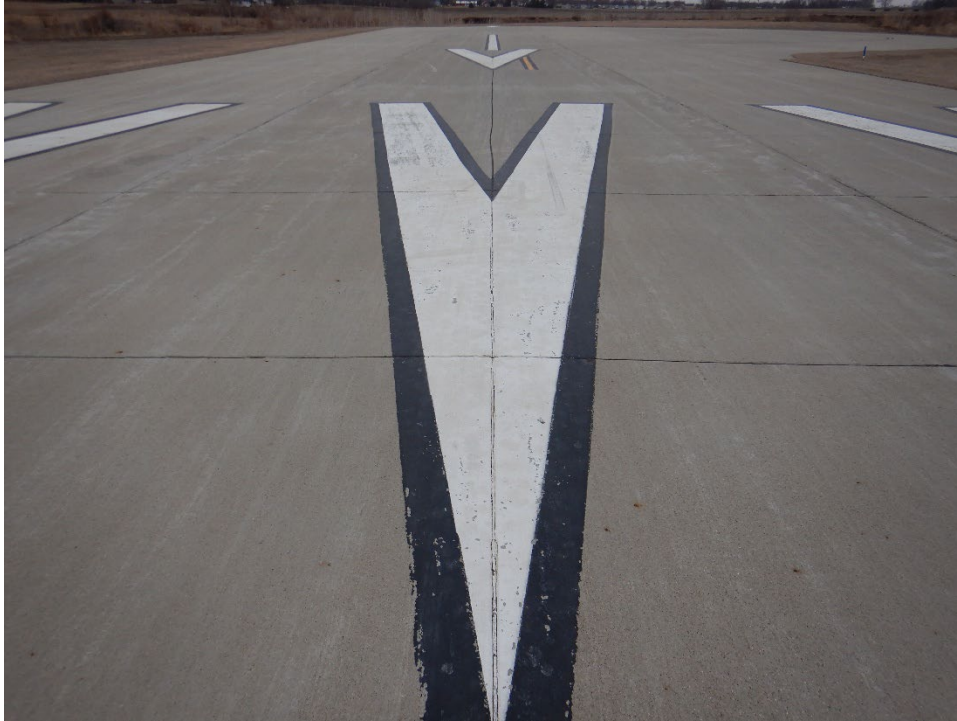
R18LE-07. Overview.

| Branch | Section | Surface Type | Section Area (sf) | LCD | 2026 PCI | % Distress Due to Load | % Distress Due to Climate/Durability | % Distress Due to Other | Type of Distress |
|---|---|---|---|---|---|---|---|---|---|
| R18LE | 07 | PCC | 35,518 | 8/3/2018 | 92 | 15 | 53 | 32 | Faulting, Joint Spalling, Joint Seal Damage, LTD Cracking |

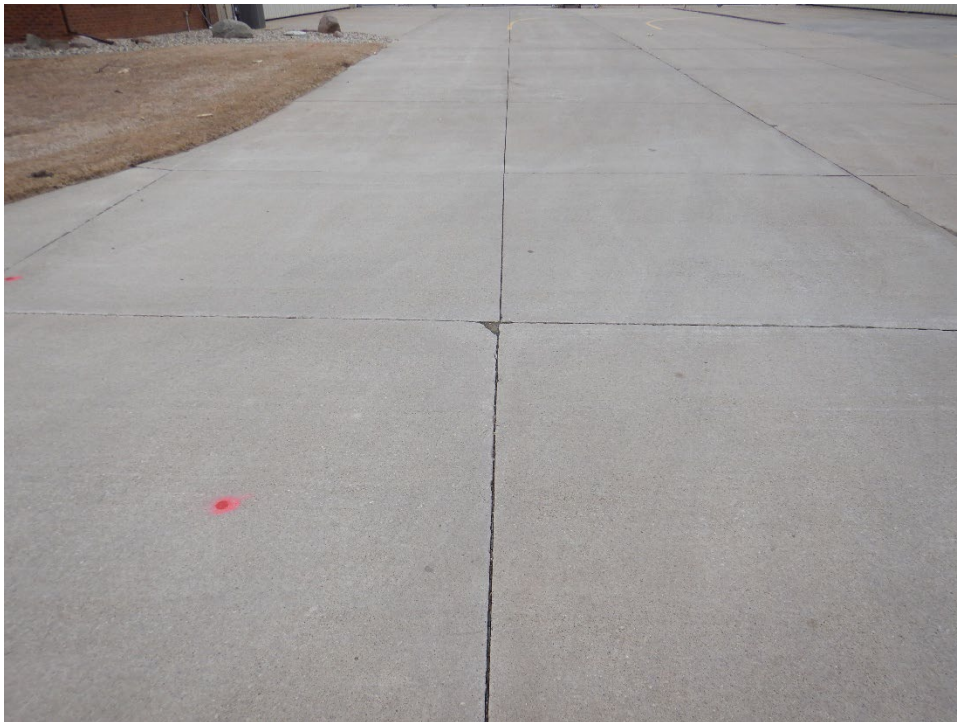
TH01LE-01. Overview.

| Branch | Section | Surface Type | Section Area (sf) | LCD | 2026 PCI | % Distress Due to Load | % Distress Due to Climate/Durability | % Distress Due to Other | Type of Distress |
|---|---|---|---|---|---|---|---|---|---|
| TH01LE | 01 | PCC | 4,403 | 1/1/1994 | 63 | 0 | 22 | 78 | Corner Spalling, Faulting, Joint Spalling, Joint Seal Damage |

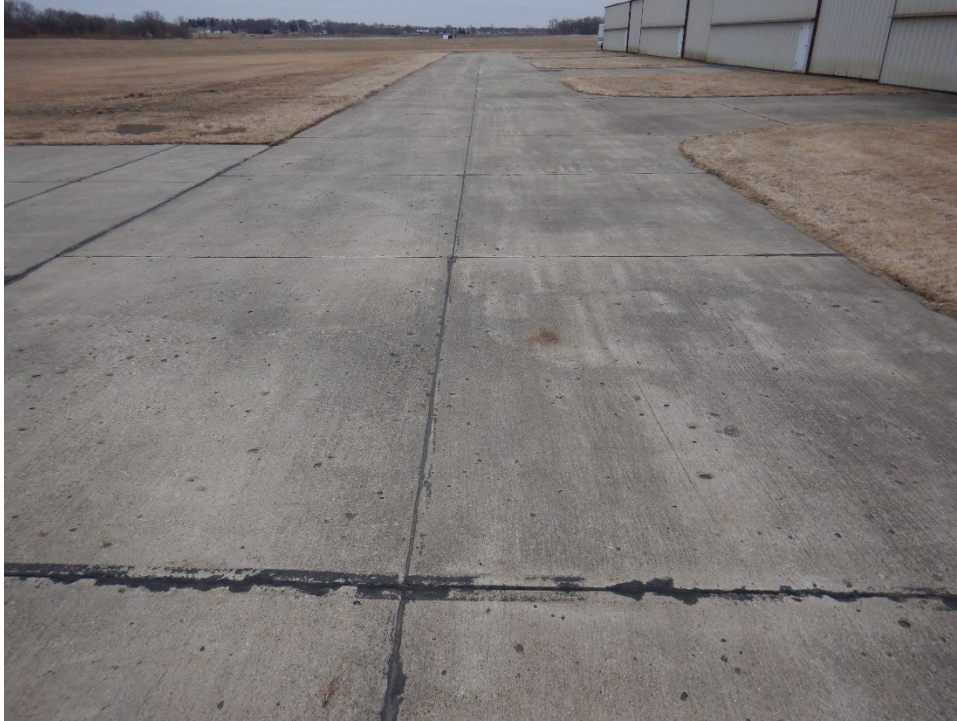
TH01LE-02. Overview.

| Branch | Section | Surface Type | Section Area (sf) | LCD | 2026 PCI | % Distress Due to Load | % Distress Due to Climate/ Durability | % Distress Due to Other | Type of Distress |
|---|---|---|---|---|---|---|---|---|---|
| TH01LE | 02 | PCC | 23,367 | 1/1/1994 | 45 | 53 | 9 | 38 | Corner Break, Corner Spalling, Joint Spalling, Joint Seal Damage, Large Patch, LTD Cracking, Popouts, Shattered Slab, Shrinkage Cracking, Small Patch |
