# Manchester Municipal Airport

## Pavement Management Report

**AUGUST 2025**

# MANCHESTER MUNICIPAL AIRPORT PAVEMENT MANAGEMENT REPORT

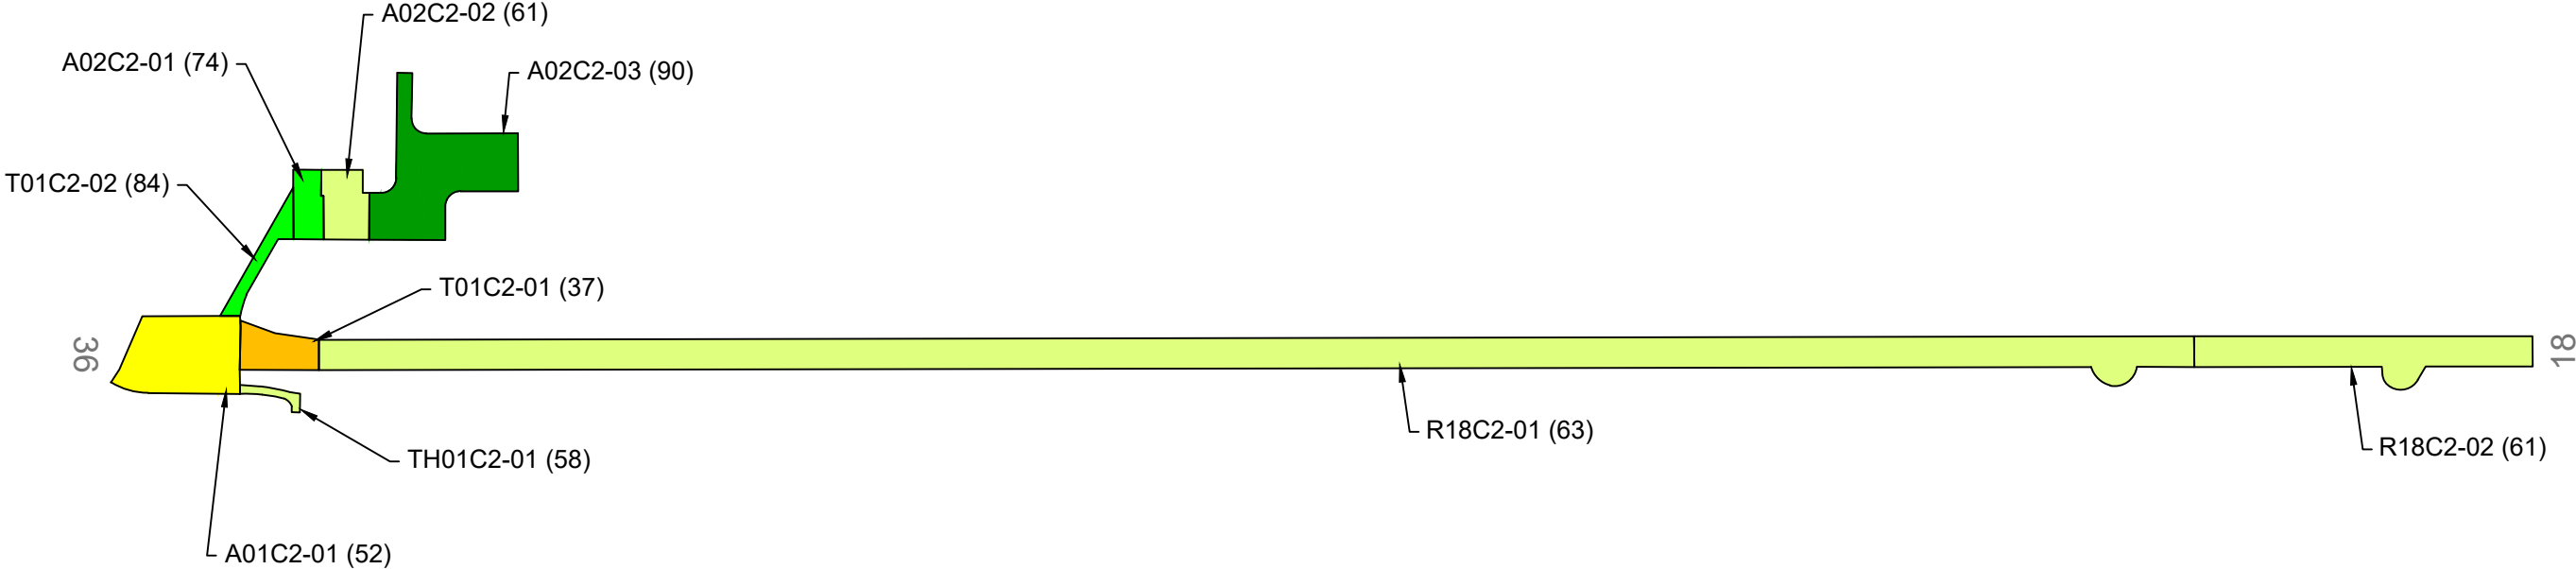
FIGURE 8. PCI MAP.

Figure 6 summarizes the overall condition of the pavements at Manchester Municipal Airport, and Figure 7 presents area-weighted condition (average PCI adjusted to account for the relative size of the pavement sections) by branch use. Figure 8 is a map that displays the condition of the evaluated pavements. Table 1 summarizes the results of the pavement evaluation.
