# Mapleton-James G Whiting Memorial Field Airport

## Pavement Management Report

**JULY 2024**

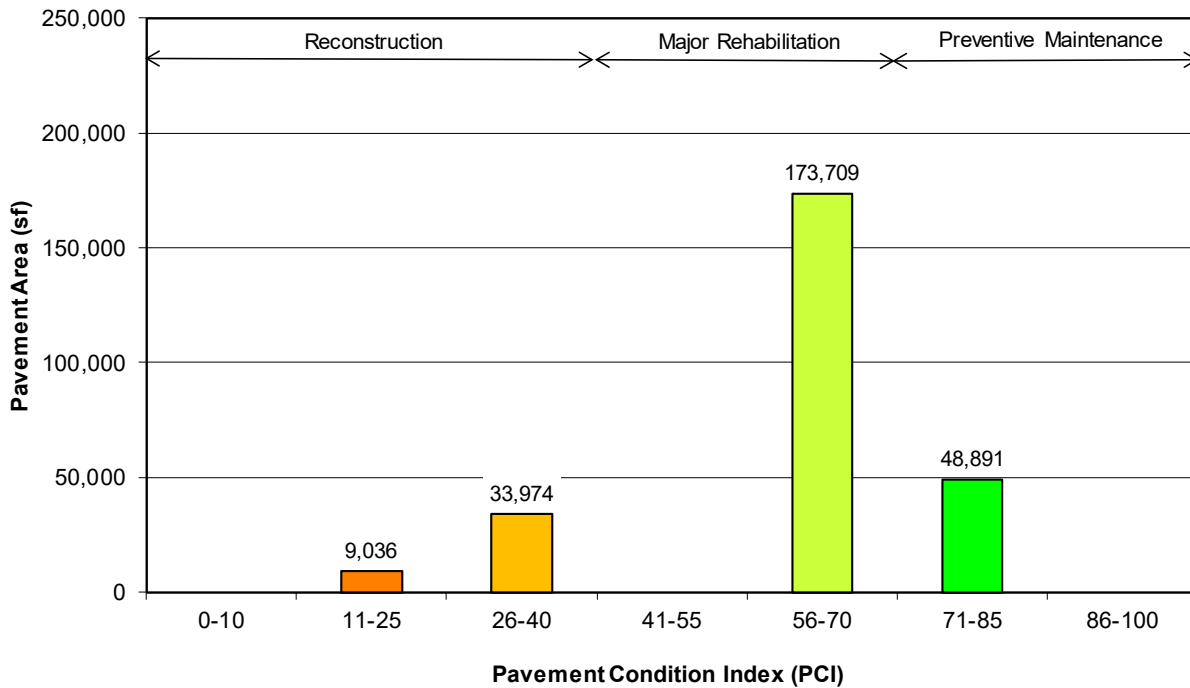
Figure 6. Pavement area by PCI range at Mapleton-James G Whiting Memorial Field Airport.

The pavements at Mapleton-James G Whiting Memorial Field Airport were inspected in November 2023. The 2023 area-weighted condition of Mapleton-James G Whiting Memorial Field Airport is 58, with conditions ranging from 17 to 83 (on a scale of 0 [failed] to 100 [excellent]). During the previous pavement inspection in 2020, the area-weighted PCI of the airport was 68.

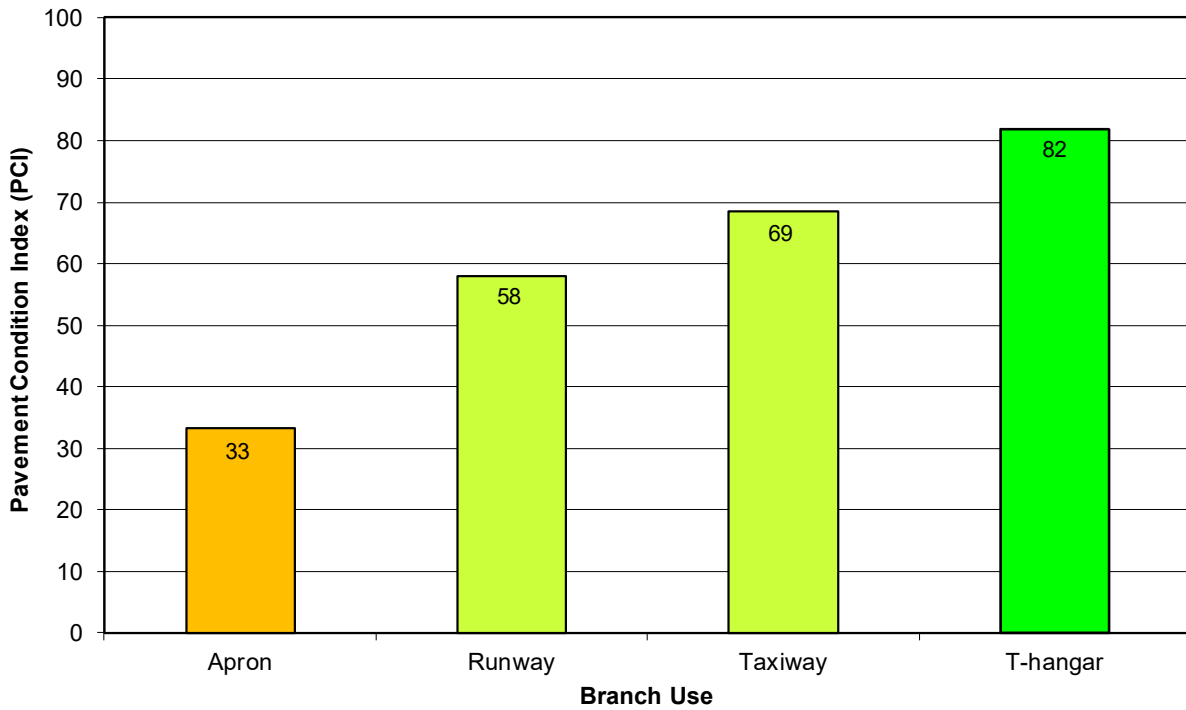
Figure 7. Area-weighted PCI by branch use at Mapleton-James G Whiting Memorial Field Airport.

Figure 6 summarizes the overall condition of the pavements at Mapleton-James G Whiting Memorial Field Airport, and Figure 7 presents area-weighted condition (average PCI adjusted to account for the relative size of the pavement sections) by branch use. Figure 8 is a map that displays the condition of the evaluated pavements. Table 1 summarizes the results of the pavement evaluation. Appendix B presents photographs taken during the PCI inspection, and Appendix C contains detailed information on the distress types observed during the visual survey. Appendix D includes detailed work history information that was collected during the record review process.
