# Marion Airport

## Pavement Management Report

**AUGUST 2025**

## PAVEMENT MANAGEMENT REPORT

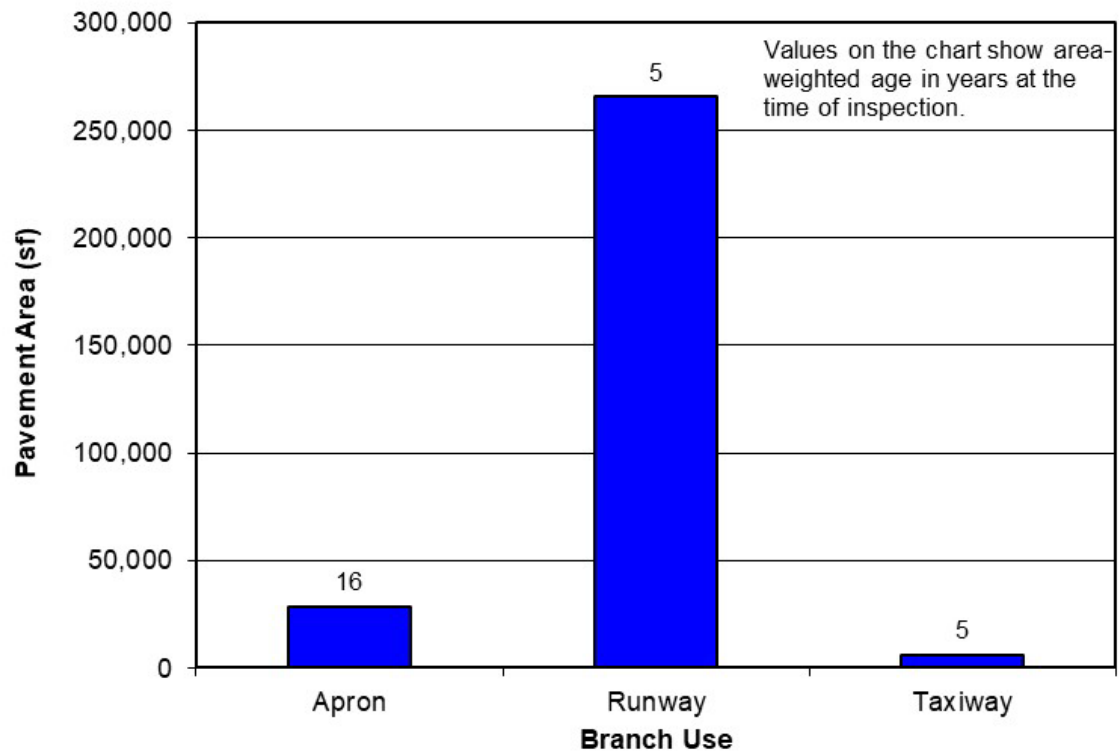
Figure 2. Pavement area by branch use at Marion Airport.

Approximately 300,000 square feet of pavement were evaluated at Marion Airport, as illustrated in Figure 2. This figure also shows the area-weighted age in years of the pavements at the time of the inspection. Figure 3 provides a map that details how the pavement network was divided into management units and identifies the sample units that were evaluated during the pavement inspection at Marion Airport.

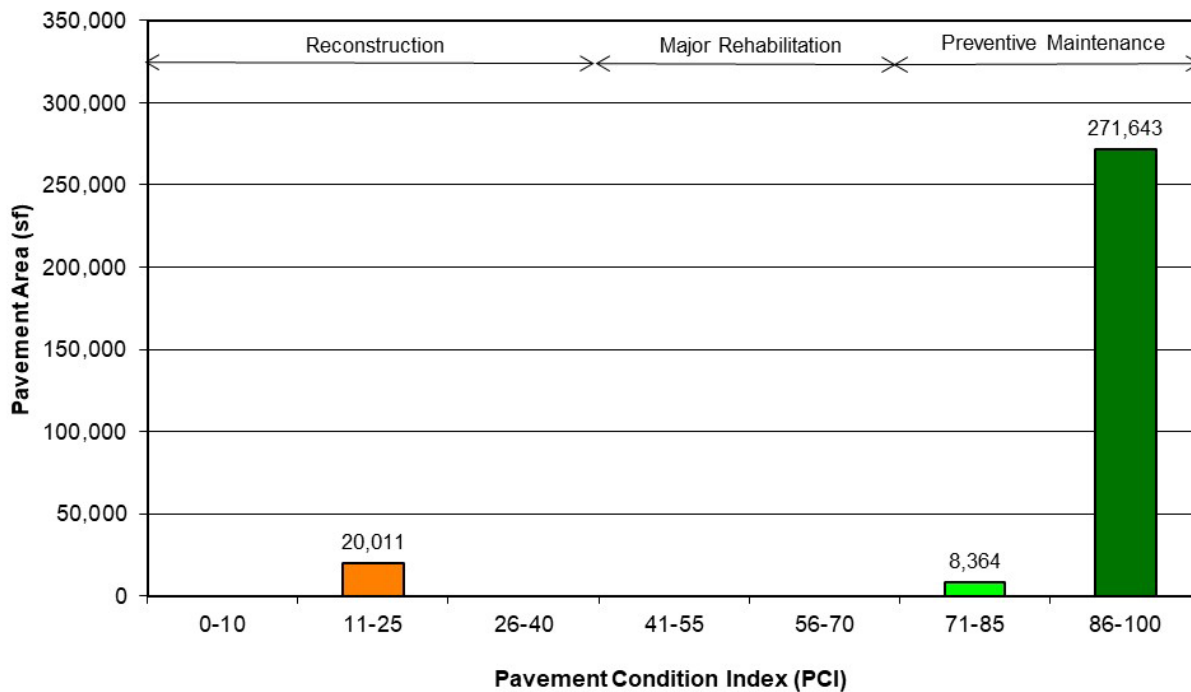
Figure 6. Pavement area by PCI range at Marion Airport.

The pavements at Marion Airport were inspected in March 2025. The 2025 area-weighted condition of Marion Airport is 87, with conditions ranging from 20 to 94 (on a scale of 0 [failed] to 100 [excellent]). During the previous pavement inspection in 0, the area-weighted PCI of the airport was 0.

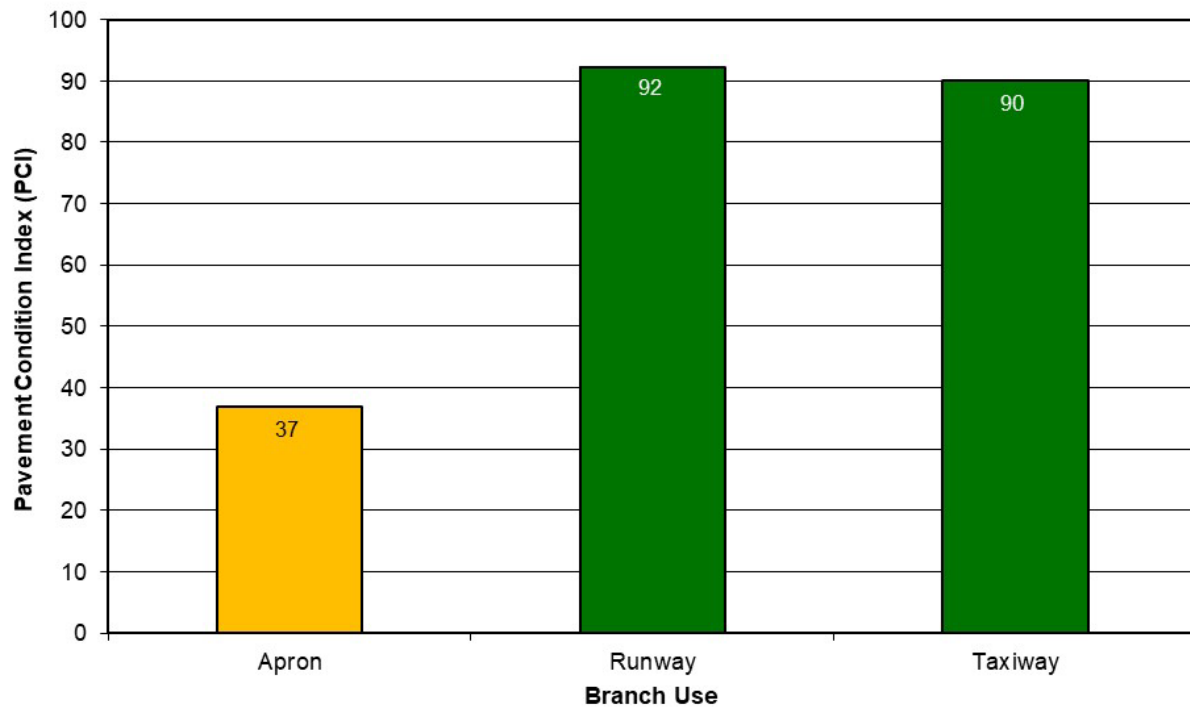
Figure 7. Area-weighted PCI by branch use at Marion Airport.

Figure 6 summarizes the overall condition of the pavements at Marion Airport, and Figure 7 presents area-weighted condition (average PCI adjusted to account for the relative size of the pavement sections) by branch use. Figure 8 is a map that displays the condition of the evaluated pavements. Table 1 summarizes the results of the pavement evaluation. Appendix B presents photographs taken during the PCI inspection, and Appendix C contains detailed information on the distress types observed during the visual survey. Appendix D includes detailed work history information that was collected during the record review process.
