# Milford-Fuller Airport

## Pavement Management Report

**AUGUST 2025**

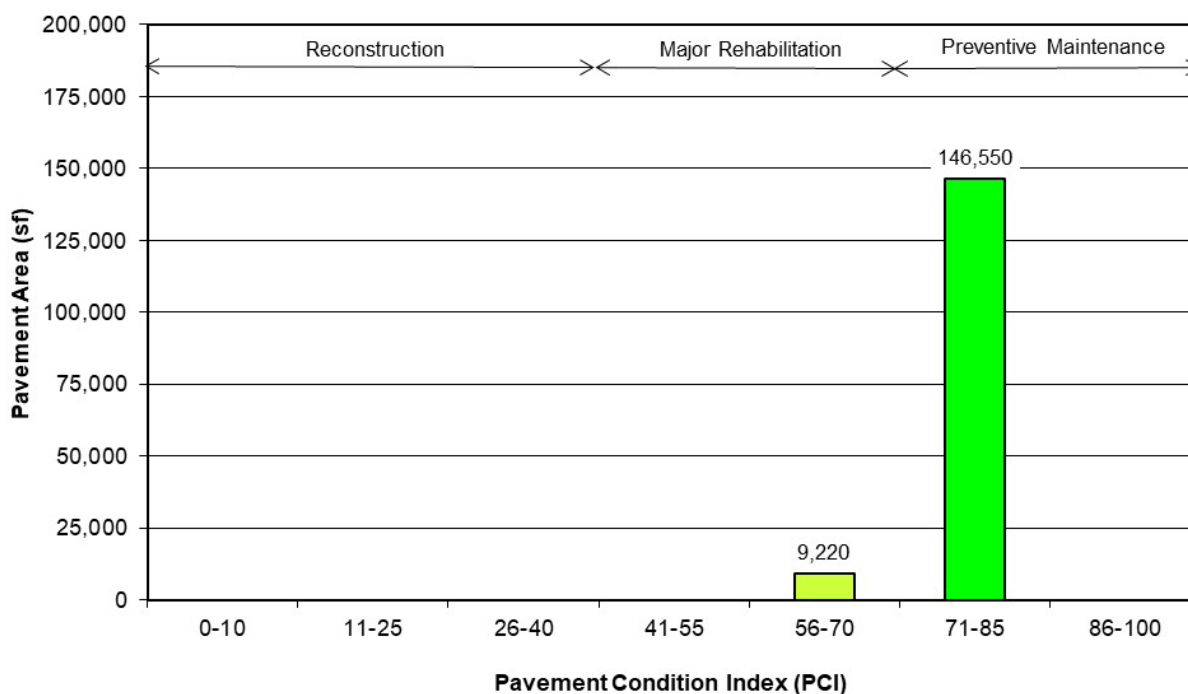
Figure 6. Pavement area by PCI range at Milford-Fuller Airport.

Figure 6 summarizes the overall condition of the pavements at Milford-Fuller Airport, and Figure 7 presents area-weighted condition (average PCI adjusted to account for the relative size of the pavement sections) by branch use. Figure 8 is a map that displays the condition of the evaluated pavements. Table 1 summarizes the results of the pavement evaluation. Appendix B presents photographs taken during the PCI inspection, and Appendix C contains detailed information on the distress types observed during the visual survey. Appendix D includes detailed work history information that was collected during the record review process.

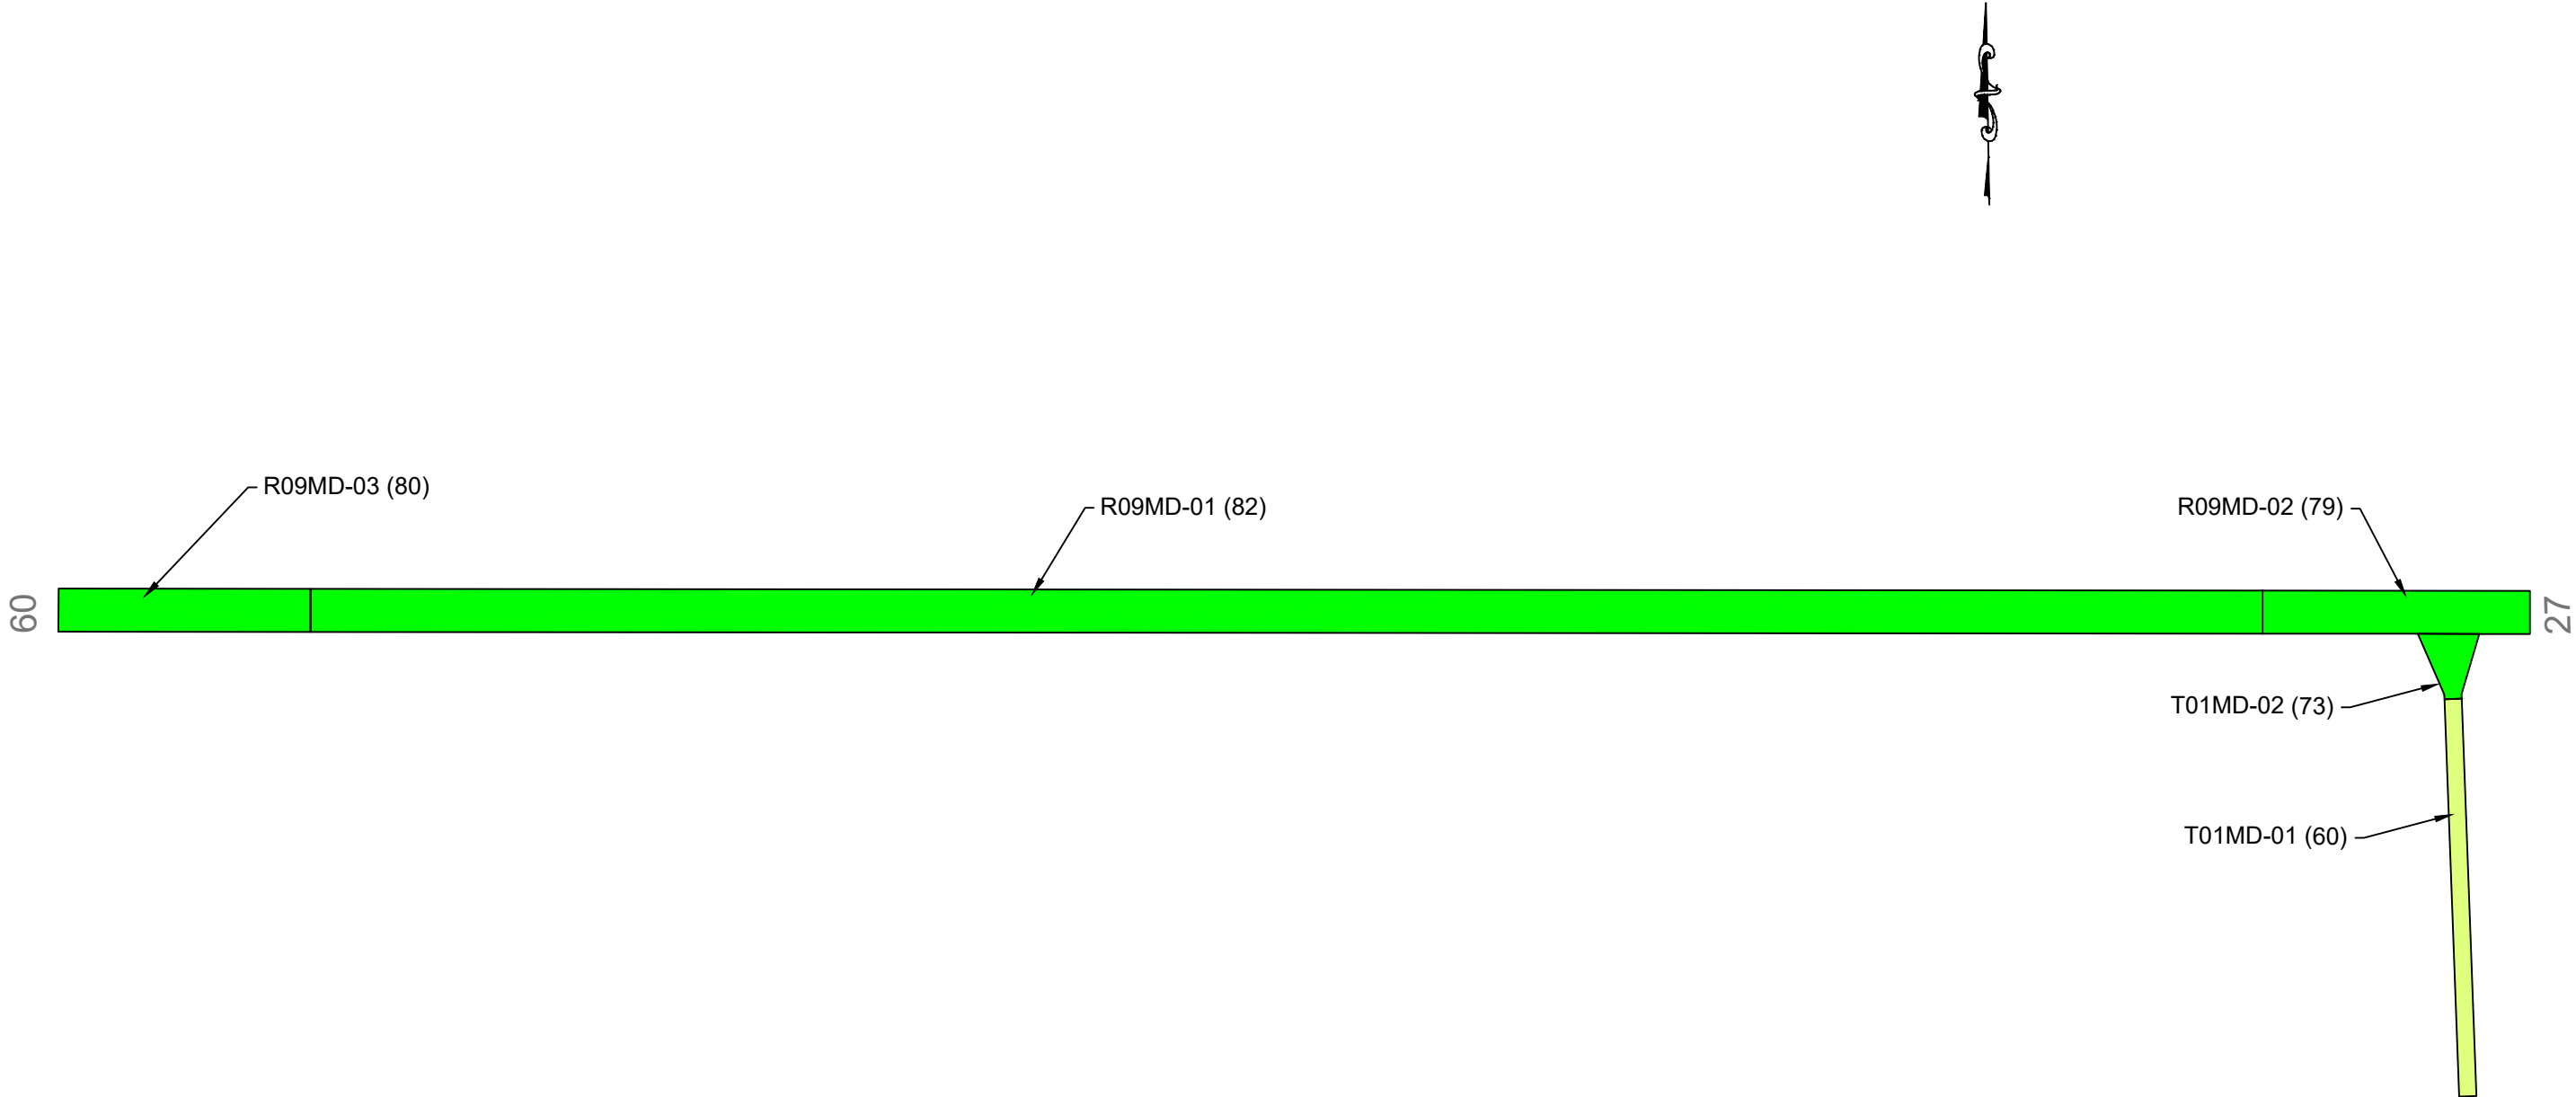
FIGURE 8. PCI MAP.

The pavements at Milford-Fuller Airport were inspected in March 2025. The 2025 area-weighted condition of Milford-Fuller Airport is 80, with conditions ranging from 61 to 82 (on a scale of 0 [failed] to 100 [excellent]). During the previous pavement inspection in 2018, the area-weighted PCI of the airport was 83.
