# Newton Municipal Airport - Earl Johnson Field

## Pavement Management Report

**AUGUST 2025**

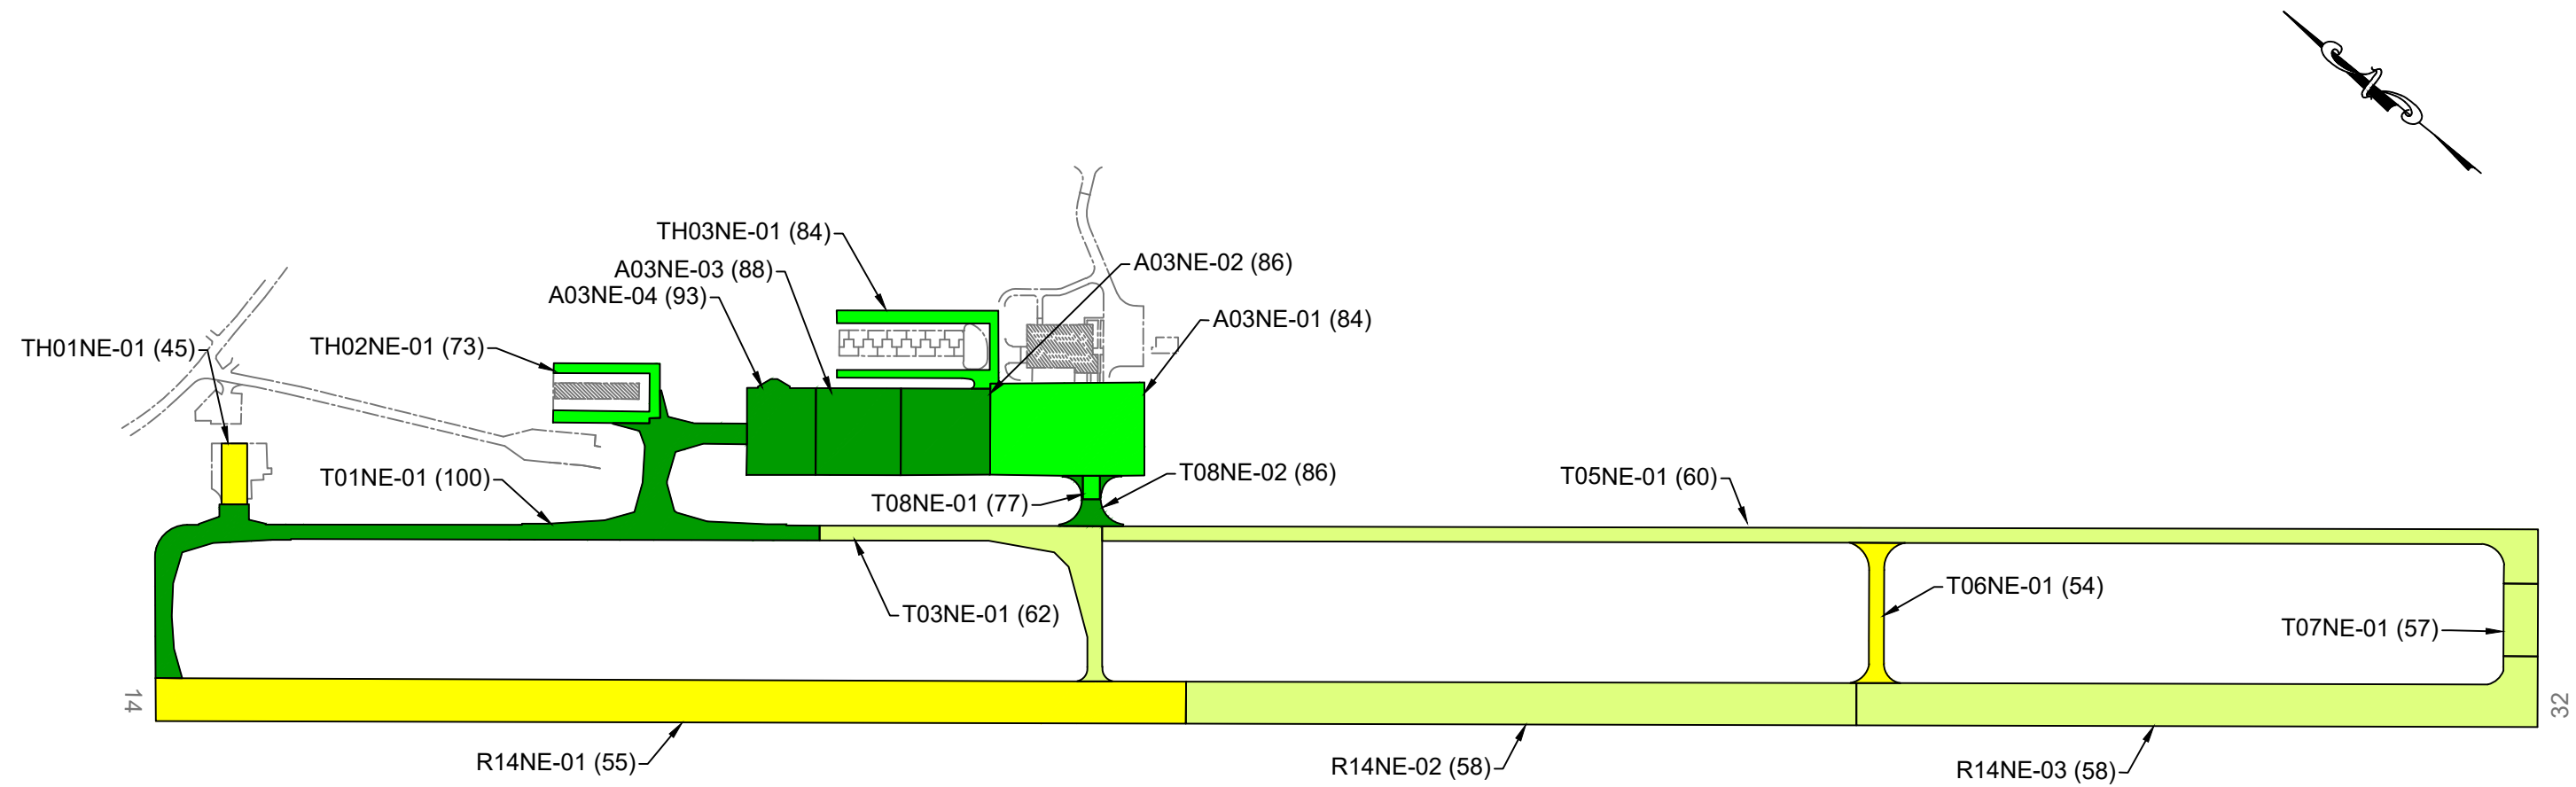
FIGURE 8. PCI MAP.

The pavements at Newton Municipal Airport - Earl Johnson Field were inspected in March 2025. The 2025 area-weighted condition of Newton Municipal Airport - Earl Johnson Field is 68, with conditions ranging from 45 to 100 (on a scale of 0 [failed] to 100 [excellent]). During the previous pavement inspection in 2021, the area-weighted PCI of the airport was 70.

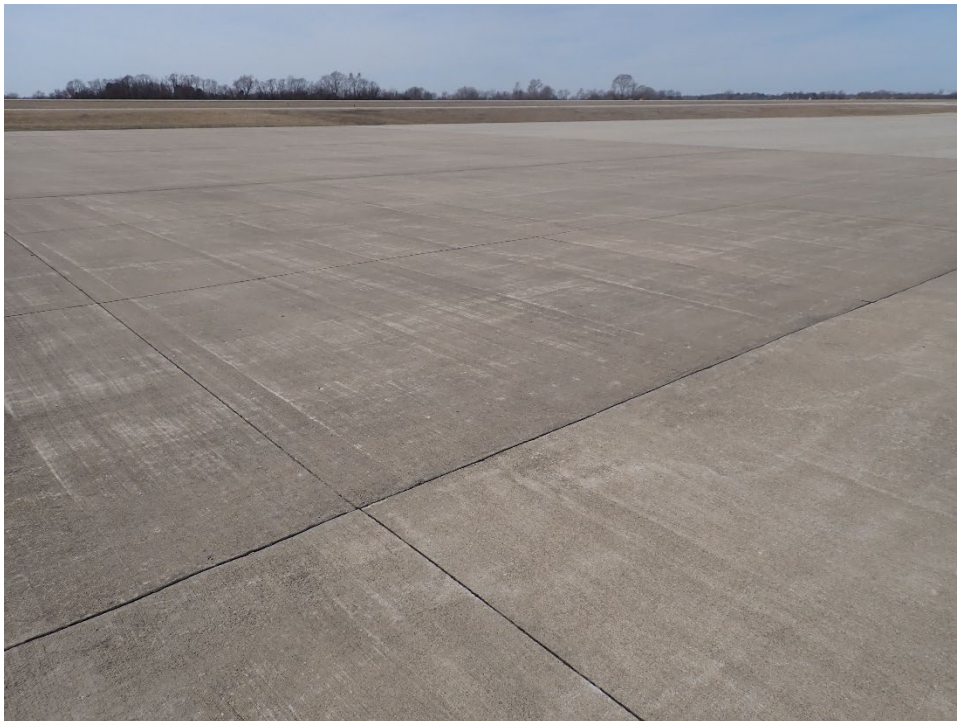
| Branch | Section | Surface Type | Section Area (sf) | LCD | 2025 PCI | % Distress Due to Load | % Distress Due to Climate/ Durability | % Distress Due to Other | Type of Distress |
|---|---|---|---|---|---|---|---|---|---|
| A03NE | 02 | PCC | 42,840 | 6/3/2010 | 86 | 0 | 78 | 22 | Faulting, Joint Spalling, Joint Seal Damage, Shrinkage Cracking |

A03NE-02. Faulting (Sample Unit No. 06).

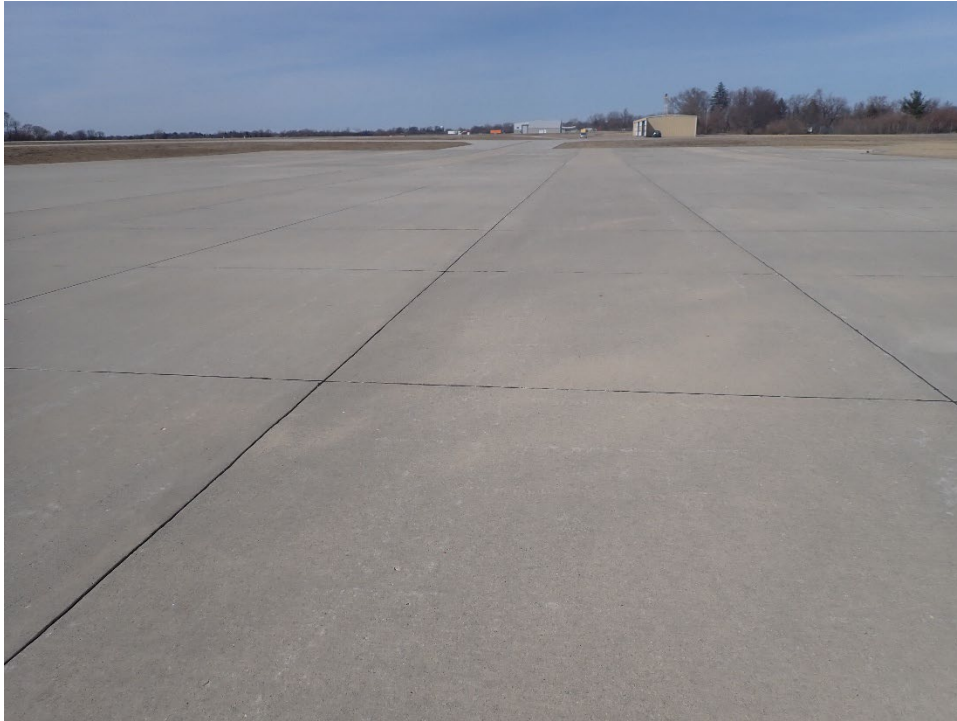
| Branch | Section | Surface Type | Section Area (sf) | LCD | 2025 PCI | % Distress Due to Load | % Distress Due to Climate/ Durability | % Distress Due to Other | Type of Distress |
|---|---|---|---|---|---|---|---|---|---|
| A03NE | 03 | PCC | 40,800 | 6/3/2013 | 88 | 0 | 94 | 6 | Corner Spalling, Joint Seal Damage |

A03NE-03. Corner Spalling (Sample Unit No. 04).

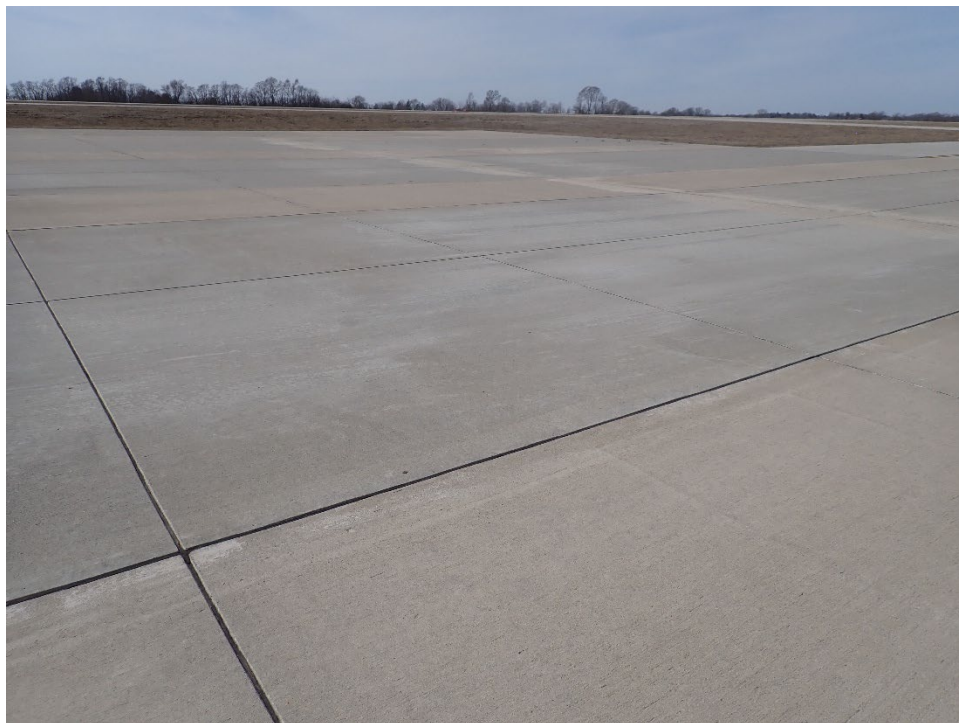
| Branch | Section | Surface Type | Section Area (sf) | LCD | 2025 PCI | % Distress Due to Load | % Distress Due to Climate/ Durability | % Distress Due to Other | Type of Distress |
|---|---|---|---|---|---|---|---|---|---|
| A03NE | 04 | PCC | 34,110 | 5/3/2019 | 93 | 0 | 100 | 0 | Joint Seal Damage |

A03NE-04. Joint Seal Damage (Sample Unit No. 03).

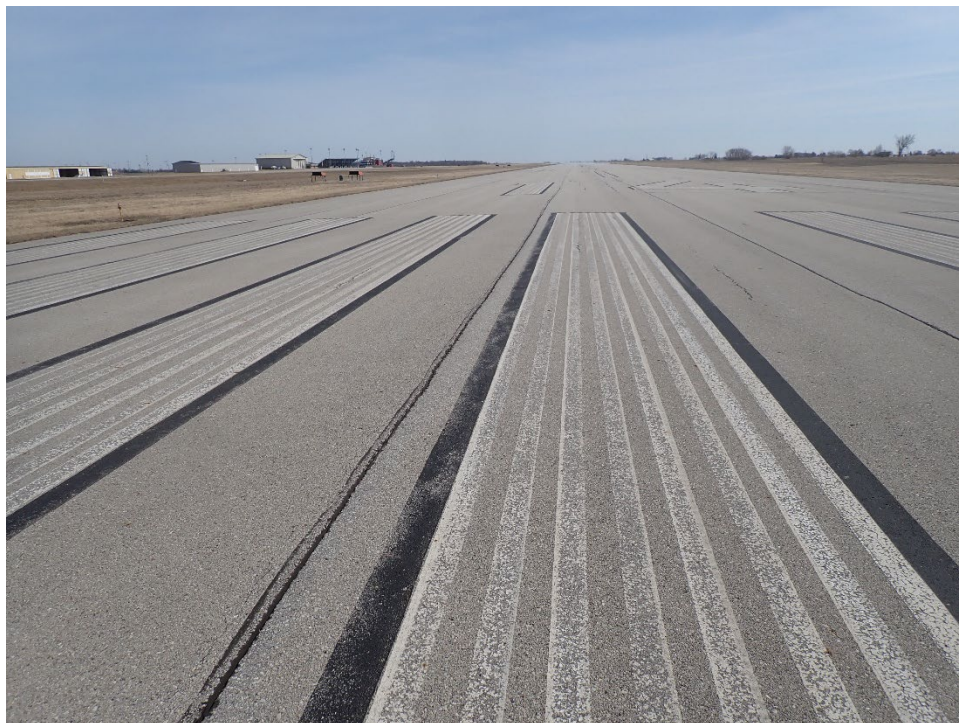
| Branch | Section | Surface Type | Section Area (sf) | LCD | 2025 PCI | % Distress Due to Load | % Distress Due to Climate/ Durability | % Distress Due to Other | Type of Distress |
|---|---|---|---|---|---|---|---|---|---|
| R14NE | 01 | AAC | 242,000 | 5/1/2010 | 55 | 8 | 92 | 0 | Alligator Cracking, L&T Cracking, Weathering |

R14NE-01. L&T Cracking (Sample Unit No. 01).

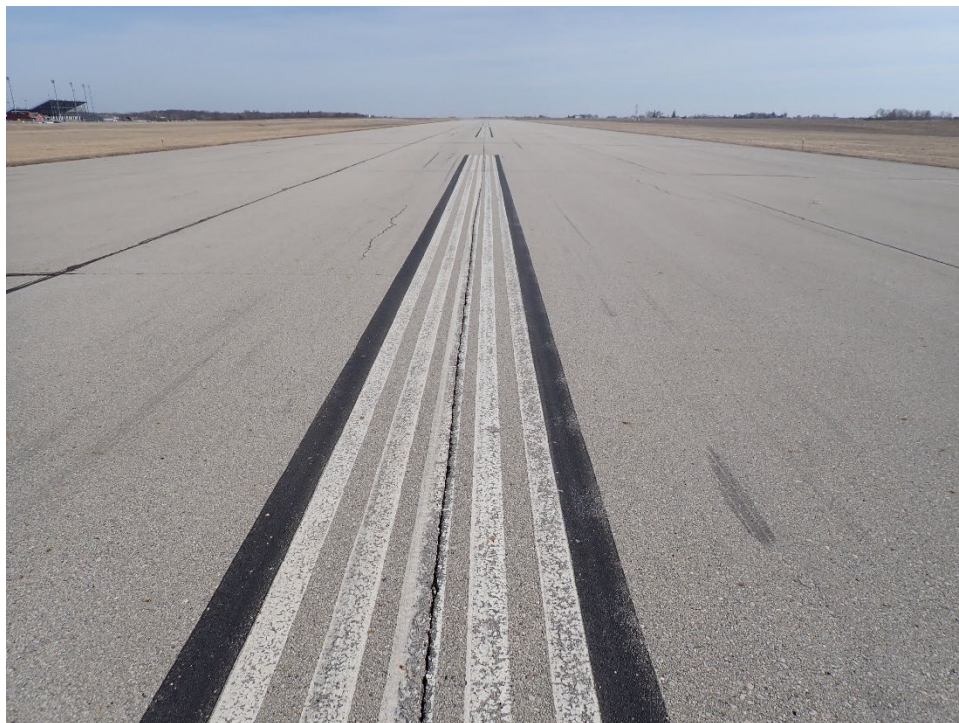
| Branch | Section | Surface Type | Section Area (sf) | LCD | 2025 PCI | % Distress Due to Load | % Distress Due to Climate/ Durability | % Distress Due to Other | Type of Distress |
|---|---|---|---|---|---|---|---|---|---|
| R14NE | 02 | AAC | 155,807 | 5/1/2010 | 58 | 0 | 100 | 0 | L&T Cracking, Weathering |

R14NE-02. L&T Cracking (Sample Unit No. 02).

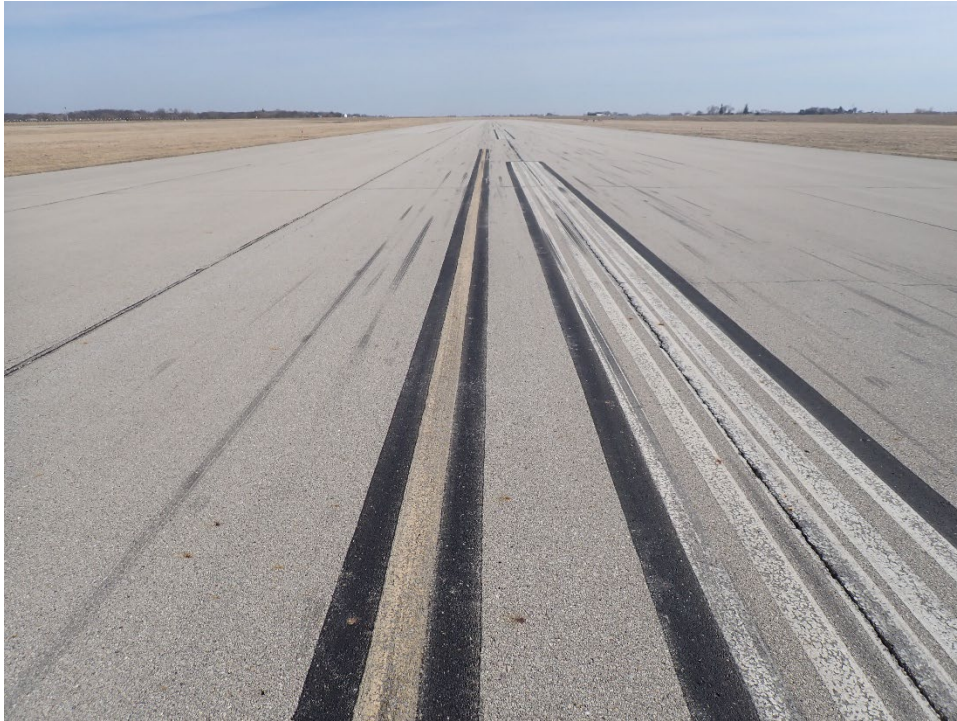
| Branch | Section | Surface Type | Section Area (sf) | LCD | 2025 PCI | % Distress Due to Load | % Distress Due to Climate/ Durability | % Distress Due to Other | Type of Distress |
|---|---|---|---|---|---|---|---|---|---|
| R14NE | 03 | AAC | 165,142 | 4/1/2010 | 58 | 11 | 89 | 0 | Alligator Cracking, L&T Cracking, Raveling, Weathering |

R14NE-03. Alligator Cracking (Sample Unit No. 04).

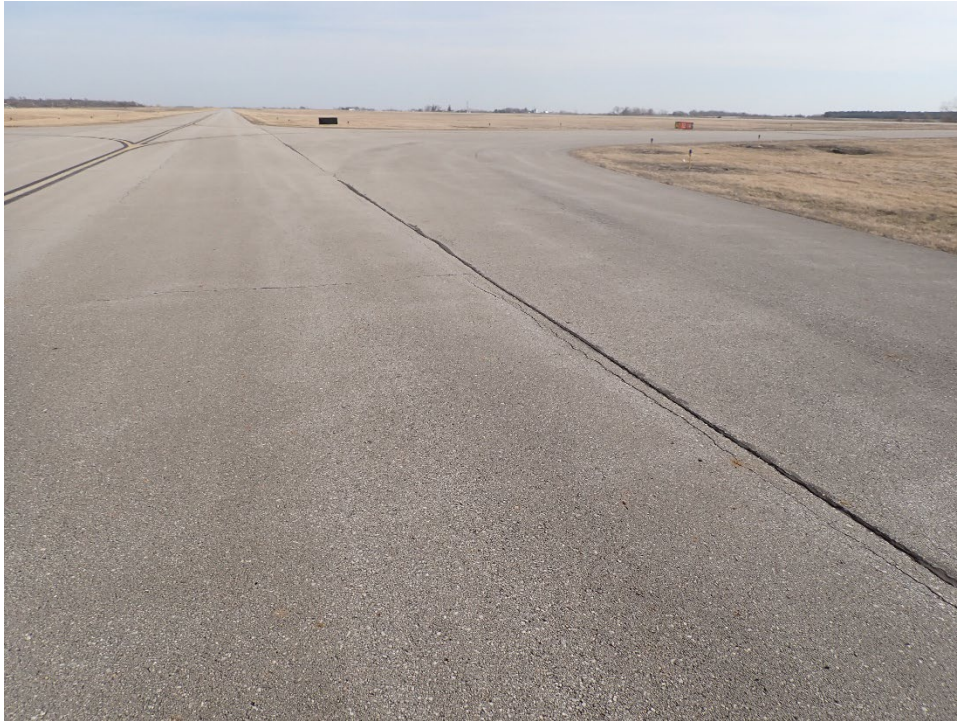
| Branch | Section | Surface Type | Section Area (sf) | LCD | 2025 PCI | % Distress Due to Load | % Distress Due to Climate/ Durability | % Distress Due to Other | Type of Distress |
|---|---|---|---|---|---|---|---|---|---|
| T03NE | 01 | AAC | 44,928 | 4/1/2010 | 62 | 17 | 83 | 0 | Alligator Cracking, L&T Cracking, Raveling, Weathering |

T03NE-01. Alligator Cracking (Sample Unit No. 01).

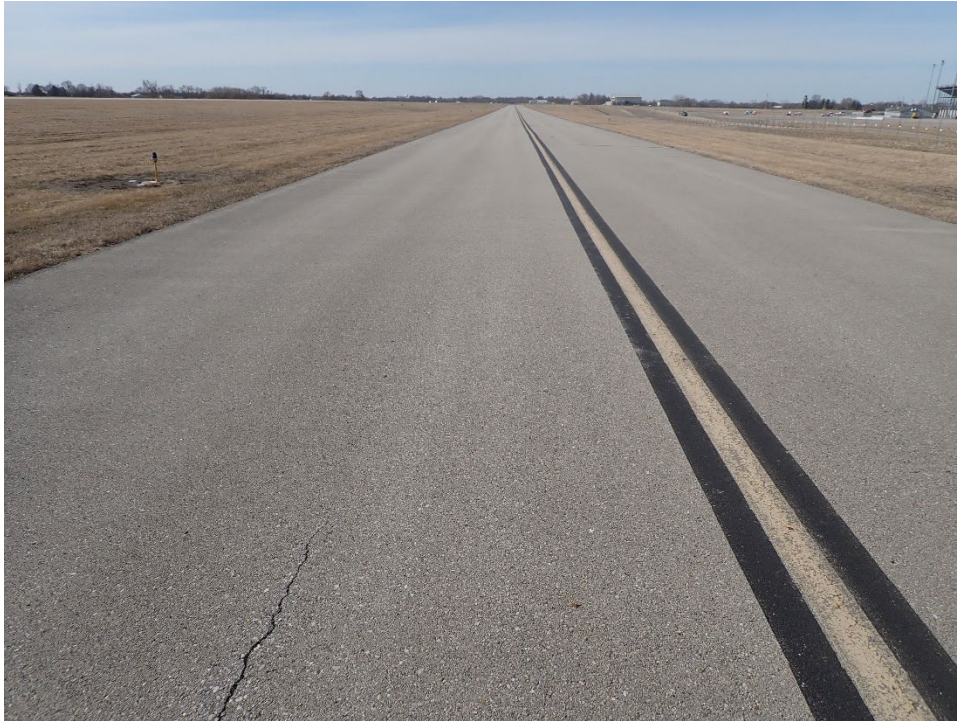
| Branch | Section | Surface Type | Section Area (sf) | LCD | 2025 PCI | % Distress Due to Load | % Distress Due to Climate/ Durability | % Distress Due to Other | Type of Distress |
|---|---|---|---|---|---|---|---|---|---|
| T05NE | 01 | AAC | 126,127 | 4/1/2010 | 60 | 30 | 70 | 0 | Alligator Cracking, L&T Cracking, Weathering |

T05NE-01. Alligator Cracking (Sample Unit No. 10).

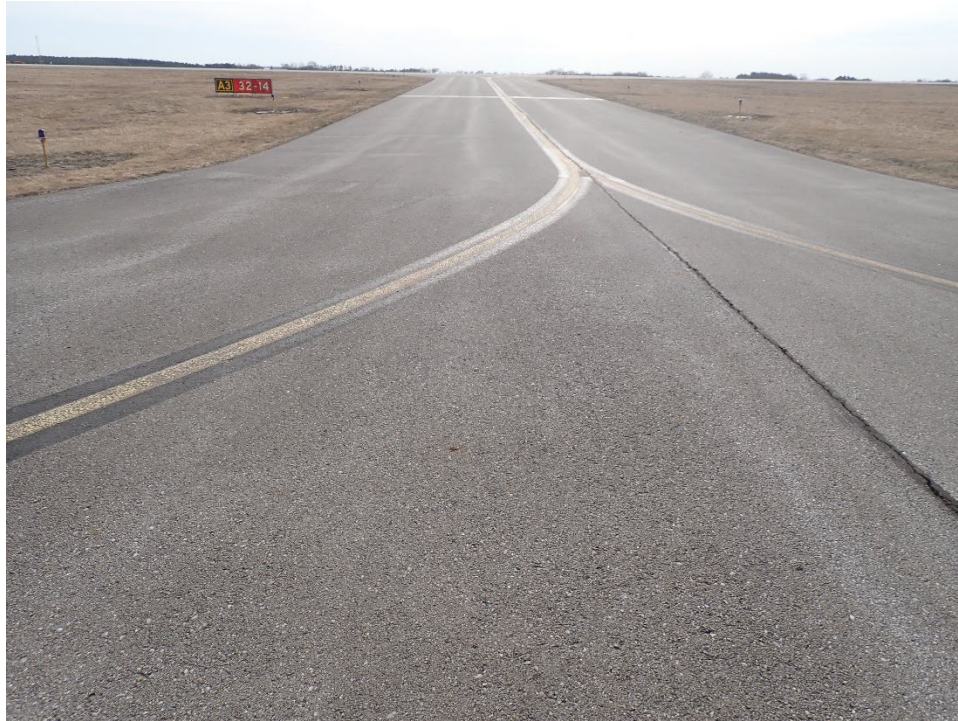
| Branch | Section | Surface Type | Section Area (sf) | LCD | 2025 PCI | % Distress Due to Load | % Distress Due to Climate/ Durability | % Distress Due to Other | Type of Distress |
|---|---|---|---|---|---|---|---|---|---|
| T06NE | 01 | AAC | 14,033 | 4/1/2010 | 54 | 23 | 77 | 0 | Alligator Cracking, L&T Cracking, Weathering |

T06NE-01. L&T Cracking (Sample Unit No. 01).

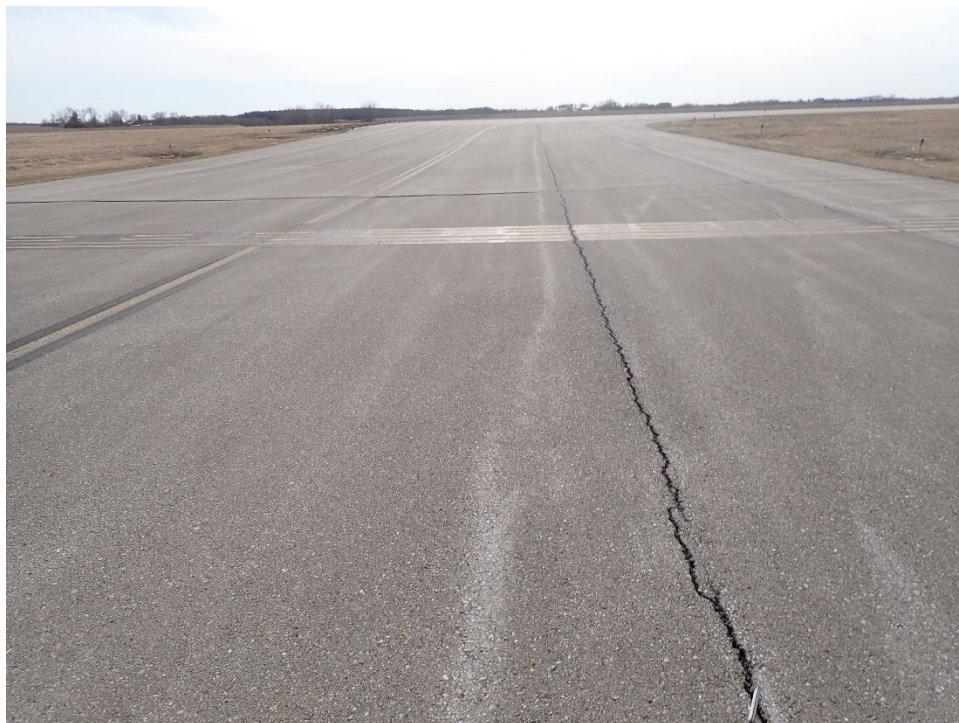
| Branch | Section | Surface Type | Section Area (sf) | LCD | 2025 PCI | % Distress Due to Load | % Distress Due to Climate/ Durability | % Distress Due to Other | Type of Distress |
|---|---|---|---|---|---|---|---|---|---|
| T07NE | 01 | AAC | 13,745 | 4/1/2010 | 57 | 16 | 76 | 8 | Alligator Cracking, Depression, L&T Cracking, Weathering |

T07NE-01. L&T Cracking (Sample Unit No. 01).

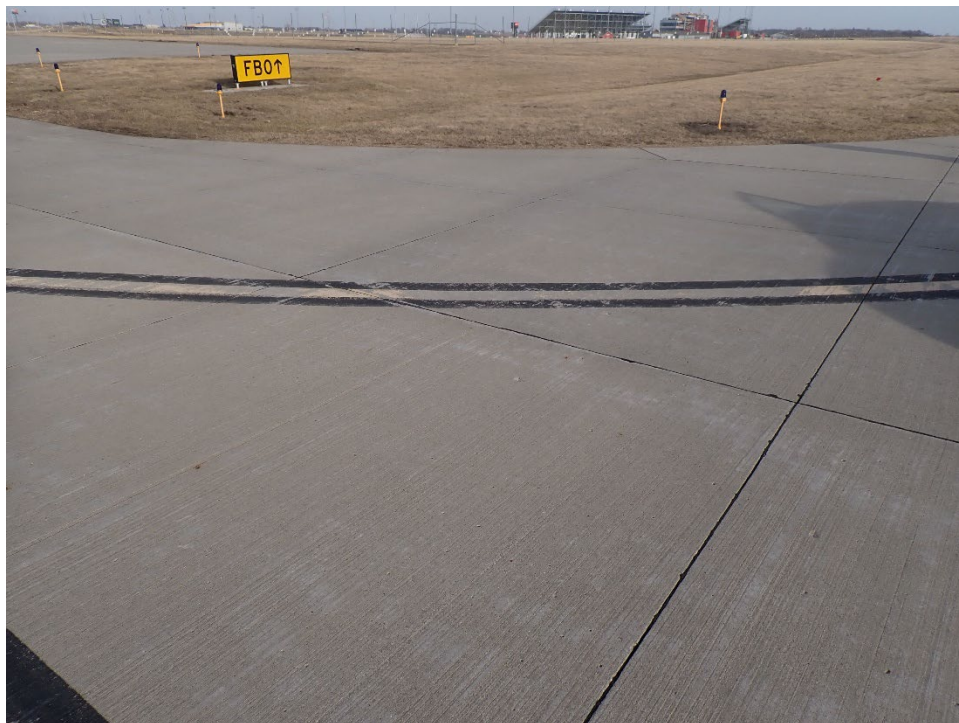
| Branch | Section | Surface Type | Section Area (sf) | LCD | 2025 PCI | % Distress Due to Load | % Distress Due to Climate/ Durability | % Distress Due to Other | Type of Distress |
|---|---|---|---|---|---|---|---|---|---|
| T08NE | 01 | PCC | 2,200 | 6/1/2003 | 77 | 0 | 52 | 48 | Corner Spalling, Joint Spalling, Joint Seal Damage, Shrinkage Cracking |

T08NE-01. Joint Seal Damage (Sample Unit No. 01).

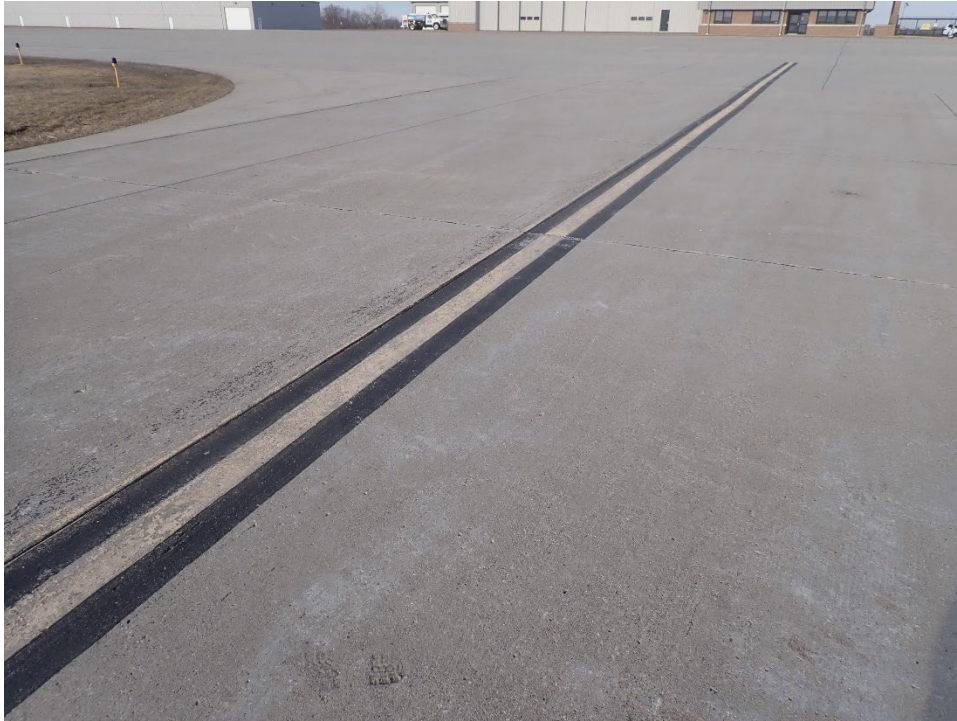
T08NE-02. LTD Cracking (Sample Unit No. 01).

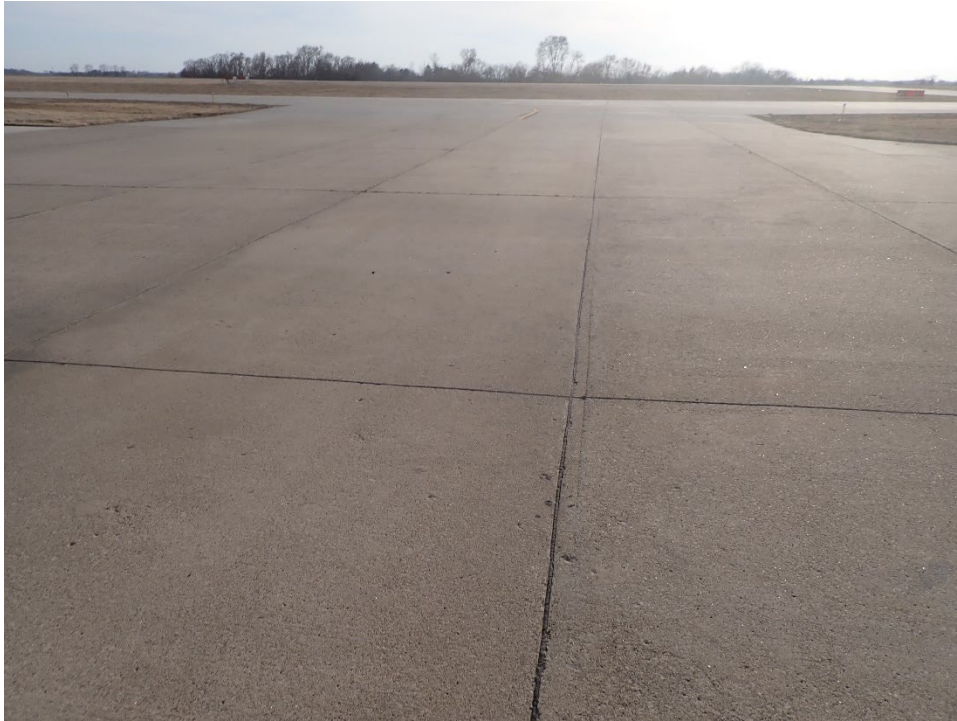
TH01NE-01. ASR (Sample Unit No. 03).

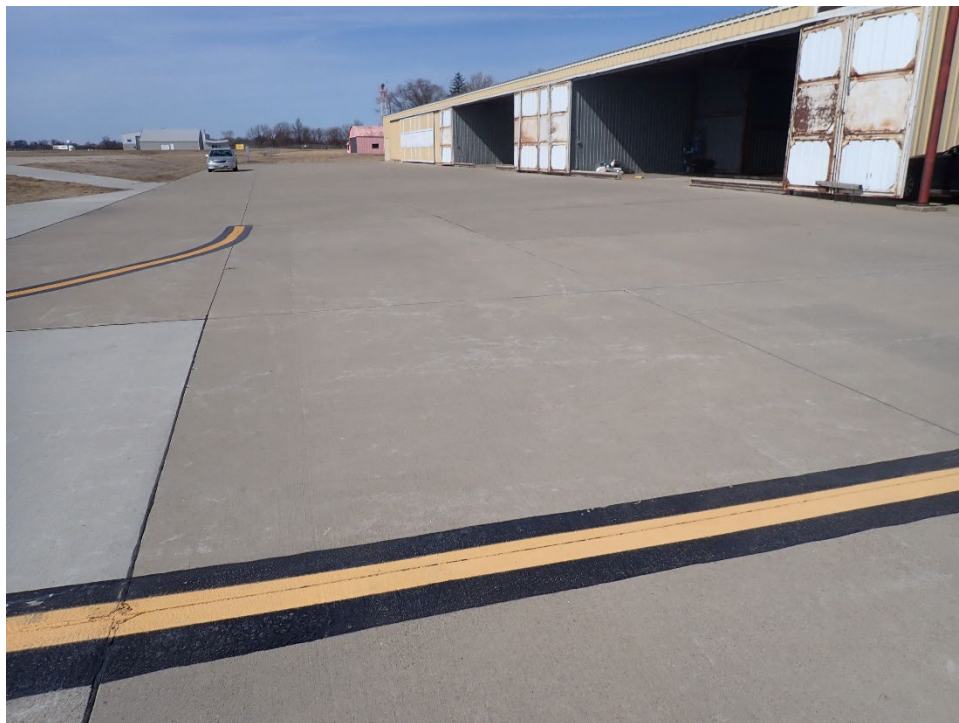
TH02NE-01. Faulting (Sample Unit No. 04).

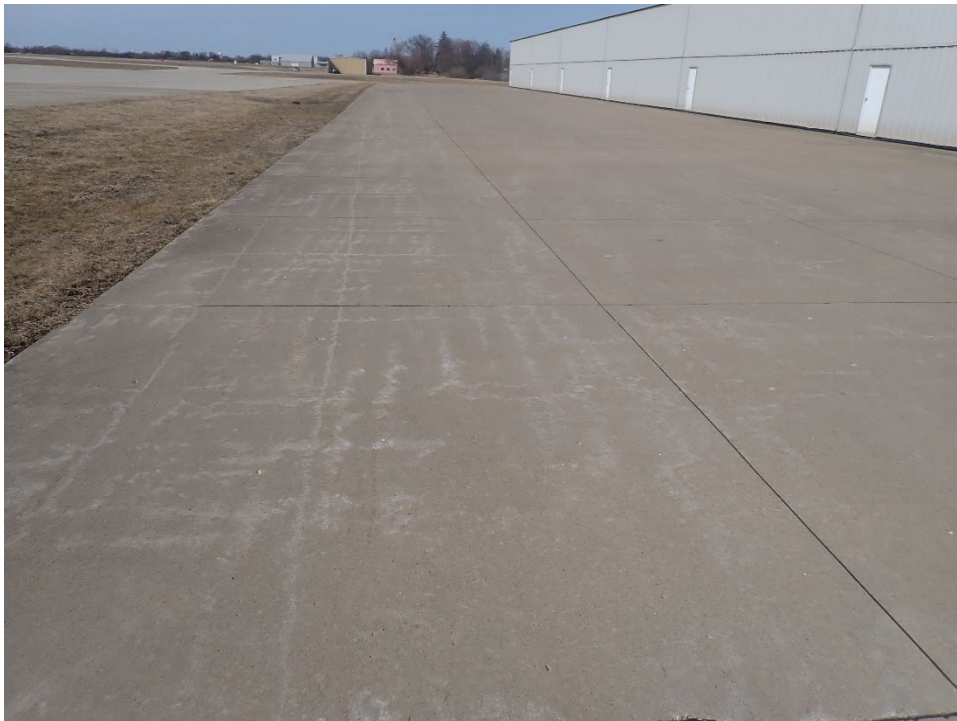
TH03NE-01. Joint Seal Damage (Sample Unit No. 02).
