# Northeast Iowa Regional Airport

## Pavement Management Report

**AUGUST 2026**

# NORTHEAST IOWA REGIONAL AIRPORT PAVEMENT MANAGEMENT REPORT

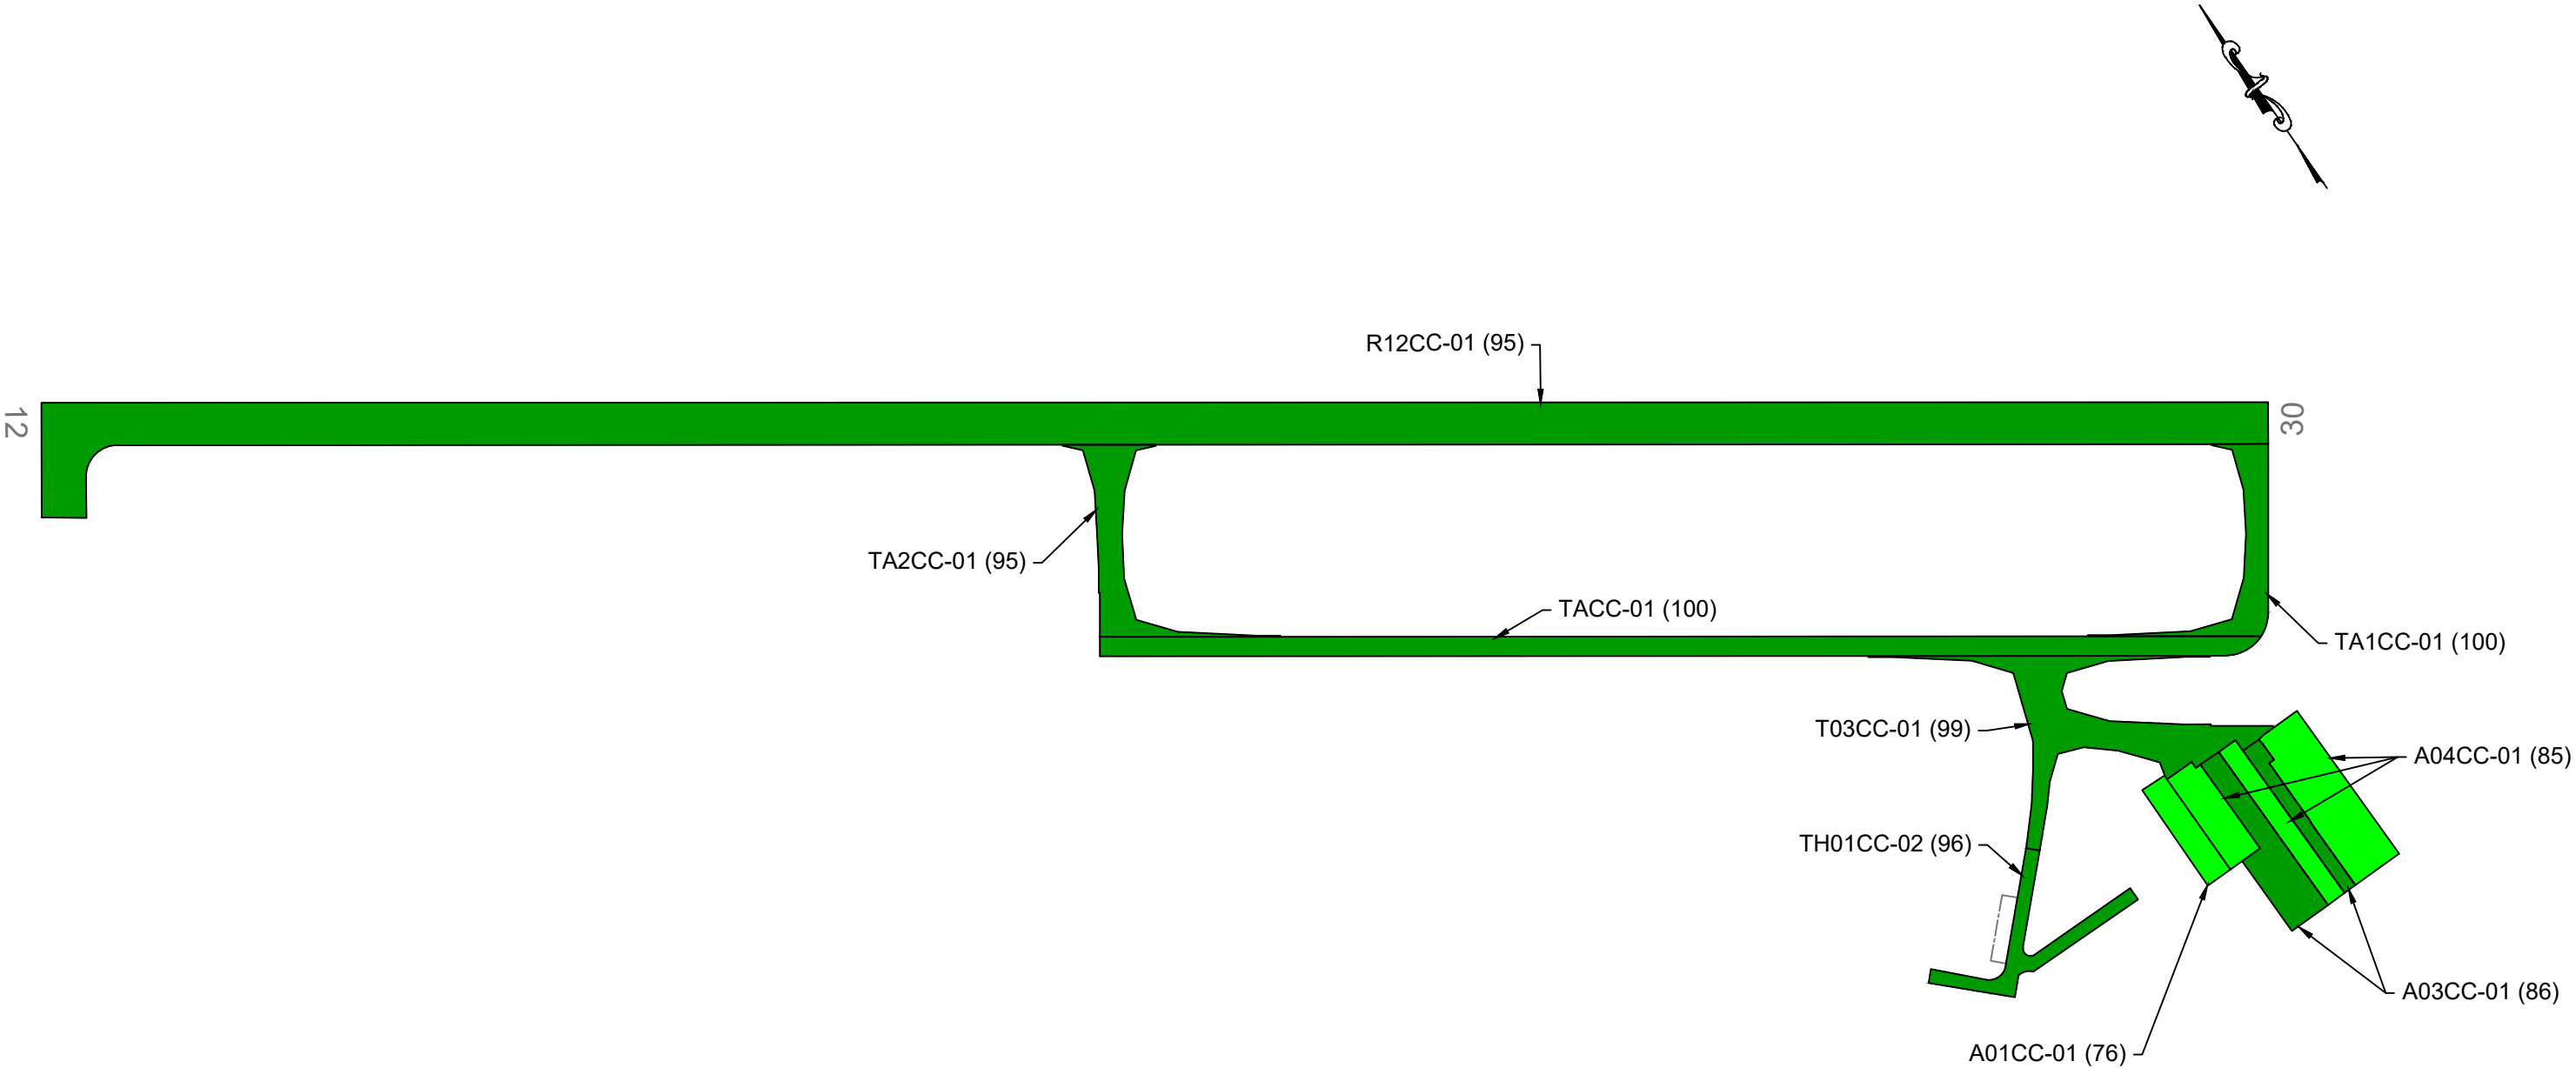
FIGURE 8. PCI MAP.

The pavements at Northeast Iowa Regional Airport were inspected in February 2026. The 2026 area-weighted condition of Northeast Iowa Regional Airport is 94, with conditions ranging from 76 to 100 (on a scale of 0 [*Failed*] to 100 [*Excellent*]). During the previous pavement inspection in 2022, the area-weighted PCI of the airport was 91.

Figure 6 summarizes the overall condition of the pavements at Northeast Iowa Regional Airport, and Figure 7 presents area-weighted condition (average PCI adjusted to account for the relative size of the pavement sections) by branch use. Figure 8 is a map that displays the condition of the evaluated pavements. Table 1 summarizes the results of the pavement evaluation. Appendix B presents photographs taken during the PCI inspection, and Appendix C contains detailed information on the distress types observed during the visual survey. Appendix D includes detailed work history information that was collected during the record review process.
