# Oelwein Municipal Airport

## Pavement Management Report

# OELWEIN MUNICIPAL AIRPORT PAVEMENT MANAGEMENT REPORT

As part of this project, pavement conditions at Oelwein Municipal Airport were visually assessed in February 2026 using the Pavement Condition Index (PCI) procedure. During a PCI inspection, the types, severities, and amounts of distress present on the pavement surface are quantified. This information is then used to develop a composite index that represents the overall condition of the pavement in numerical terms, ranging from 0 (*Failed*) to 100 (*Excellent*). The PCI provides an overall measure of condition and an indication of the level of work that will be required to maintain or repair a pavement. The distress information also provides insight into what is causing the pavement to deteriorate, which is the first step in selecting the appropriate repair action to correct the problem.

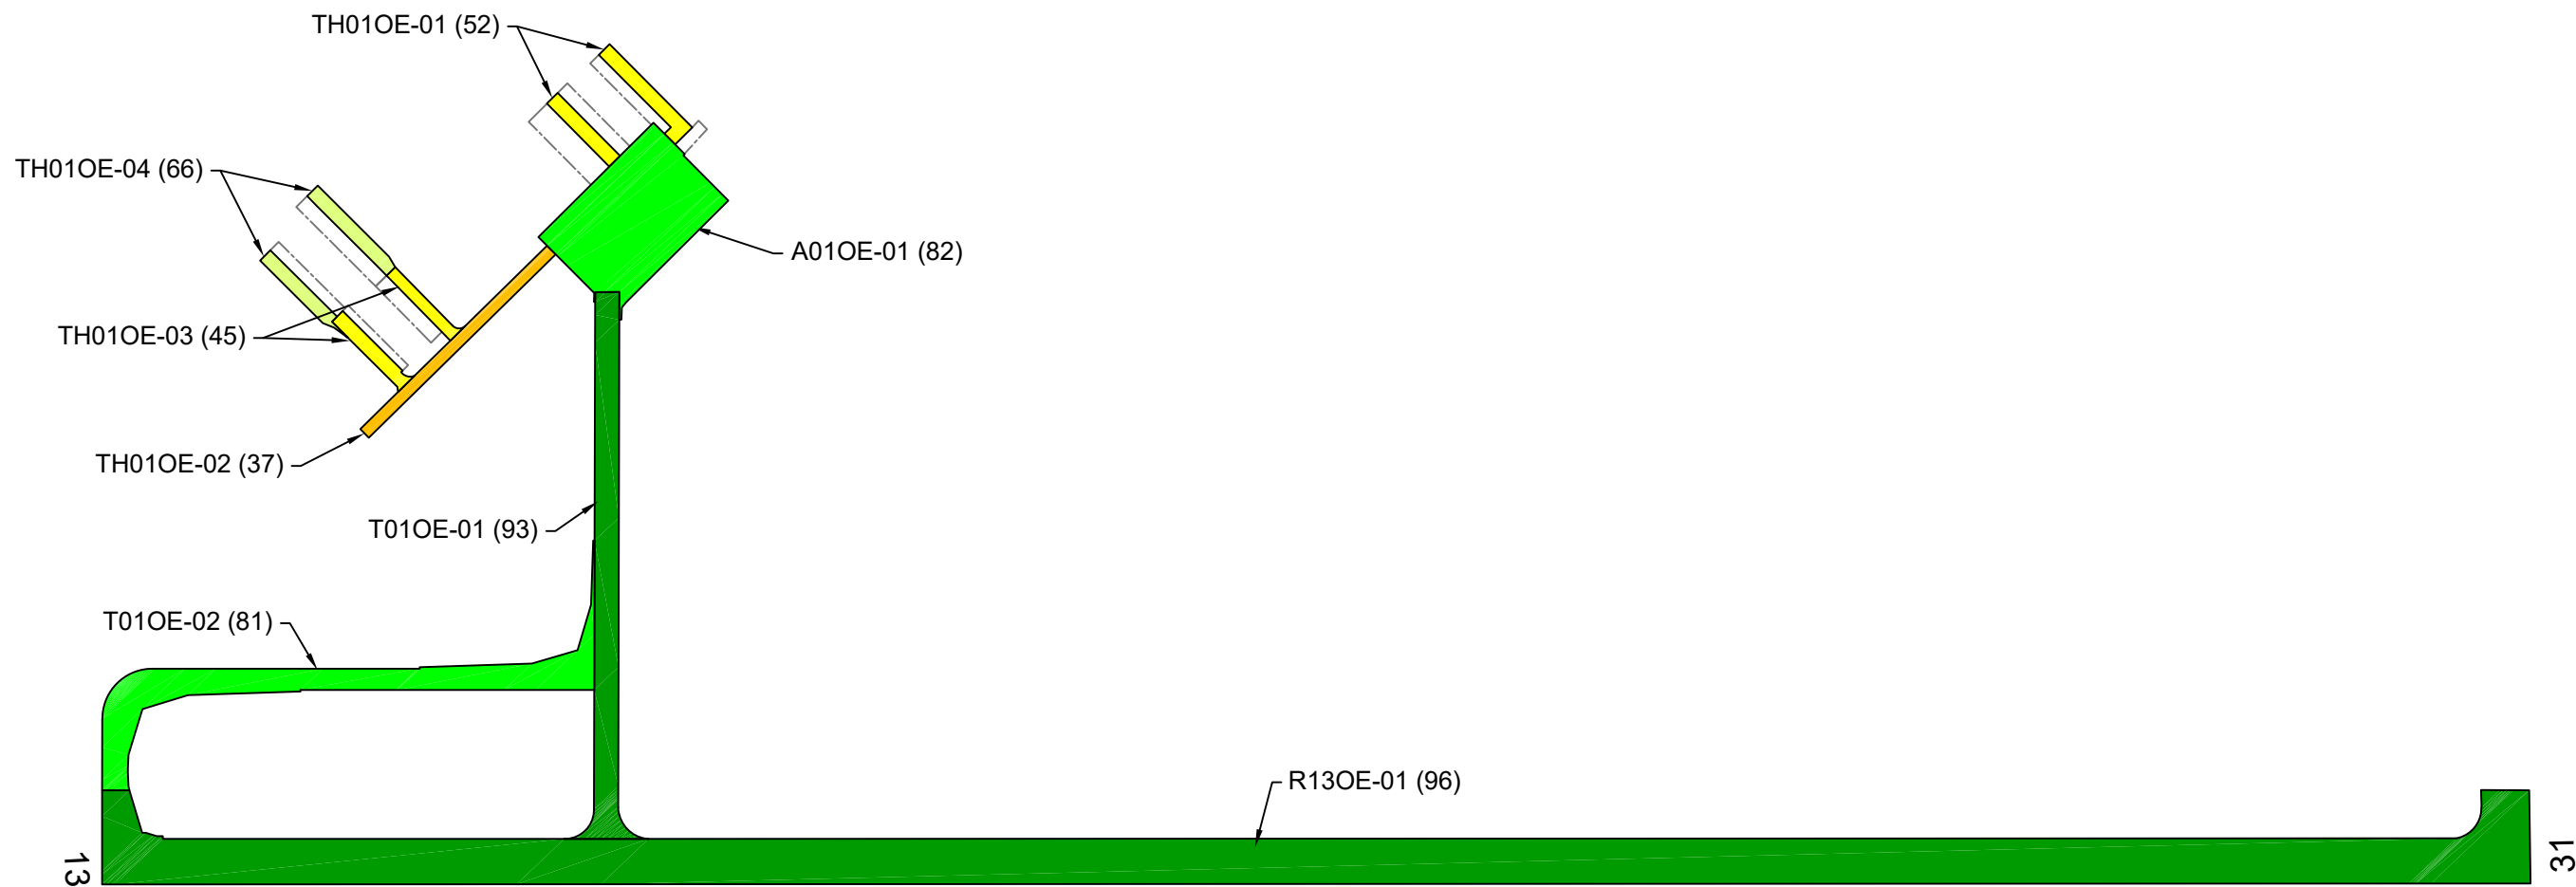
FIGURE 8. PCI MAP.

The pavements at Oelwein Municipal Airport were inspected in February 2026. The 2026 area-weighted condition of Oelwein Municipal Airport is 90, with conditions ranging from 37 to 96 (on a scale of 0 [*Failed*] to 100 [*Excellent*]). During the previous pavement inspection in 2022, the area-weighted PCI of the airport was 91.

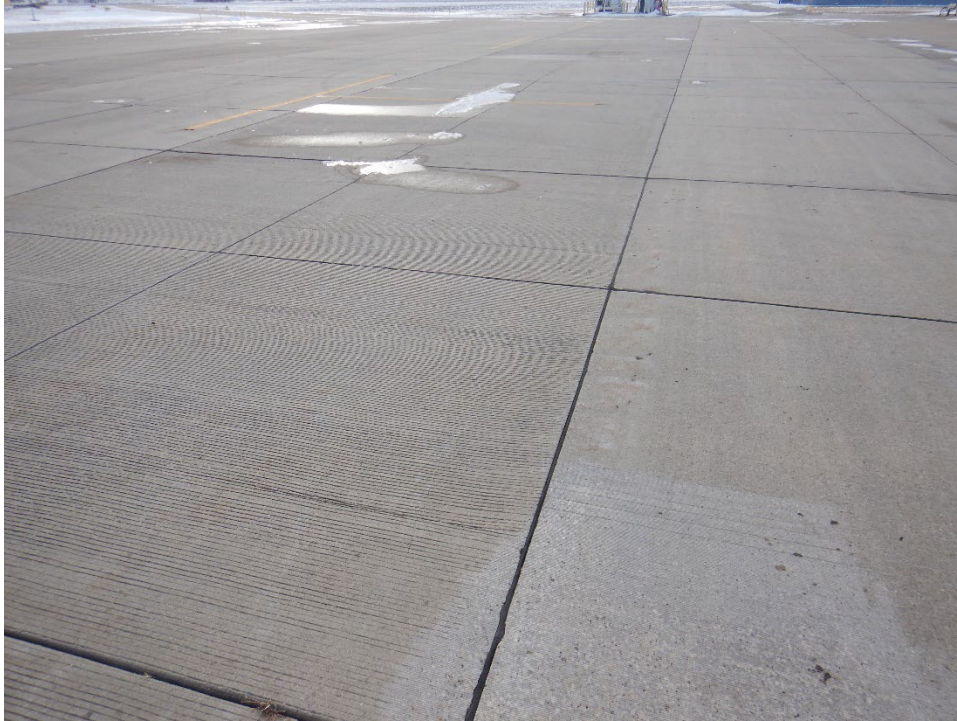
A01OE-01. Overview.

The apron area contained one section. Section 01 had areas of low-severity corner break, corner spalling, faulting, joint seal damage, joint spalling, large patching, and small patching; low- and medium-severity LTD cracking; and shrinkage cracking observed during the inspection.

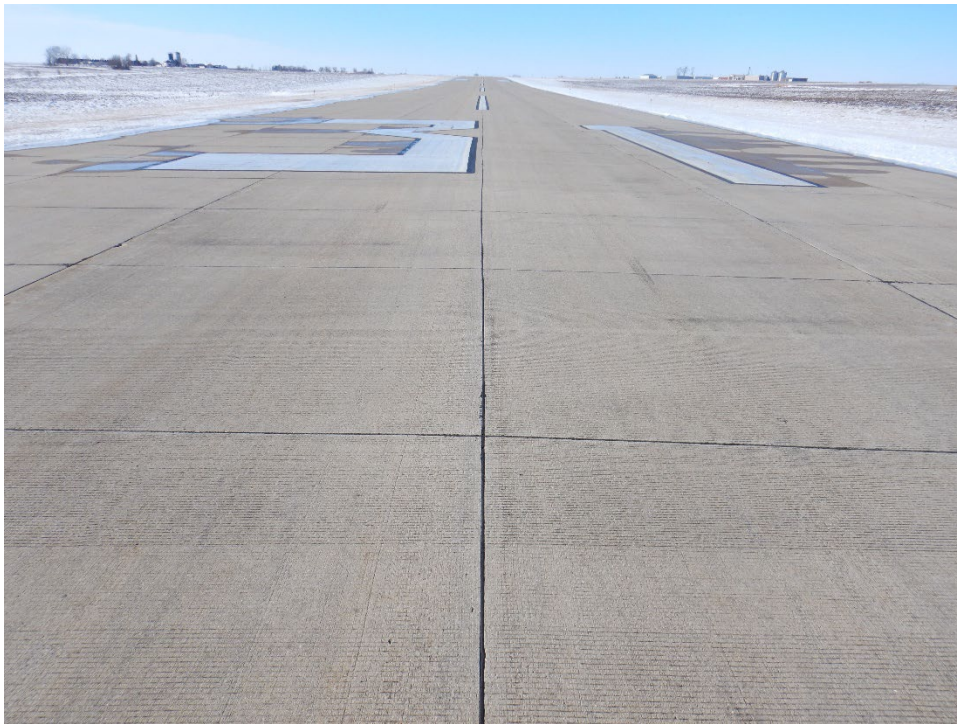
R13OE-01. Overview.

Runway 13/31 was defined by one section in *Excellent* condition. Areas of low- and medium-severity joint spalling and low-severity corner spalling, joint seal damage, small patching, and large patching were identified in Section 01. Atypical areas of low-severity longitudinal, transverse, and diagonal (LTD) cracking were observed and recorded as additional sample units in accordance with ASTM D5340.

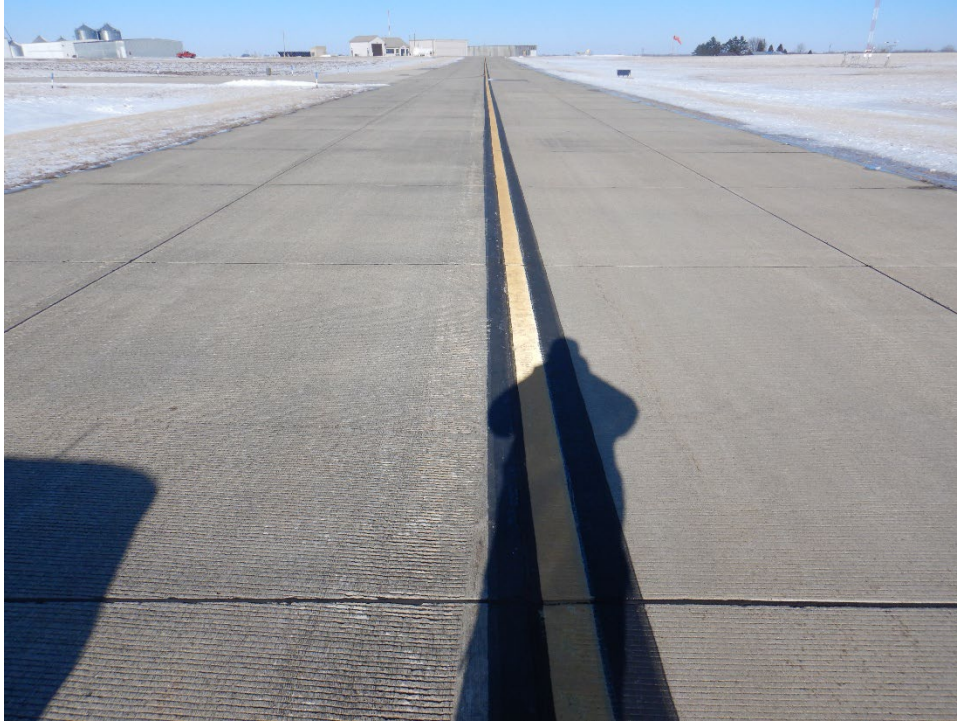
T01OE-01. Overview.

The taxiway consisted of two sections. Medium-severity LTD cracking and low-severity corner spalling, joint seal damage, large patching, and small patching were observed in Section 01. Section 02 contained low- and medium-severity longitudinal and transverse (L&T) cracking and low-severity weathering. The low-severity L&T cracking was unsealed, and the medium-severity L&T cracking was recorded where unsealed crack widths were greater than ¼ inch.

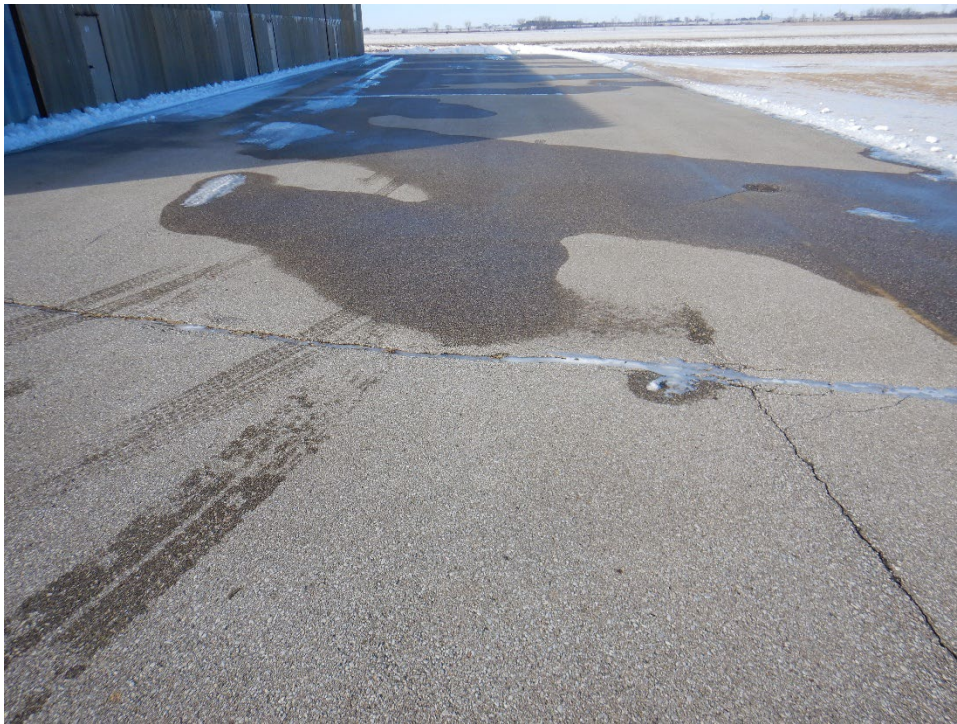
TH01OE-01. Overview.

| Branch | Section | Surface Type | Section Area (sf) | LCD | 2026 PCI | % Distress Due to Load | % Distress Due to Climate/ Durability | % Distress Due to Other | Type of Distress |
|---|---|---|---|---|---|---|---|---|---|
| TH01OE | 01 | AC | 8,858 | 6/1/2004 | 52 | 34 | 66 | 0 | Alligator Cracking, Block Cracking, L&T Cracking, Weathering |

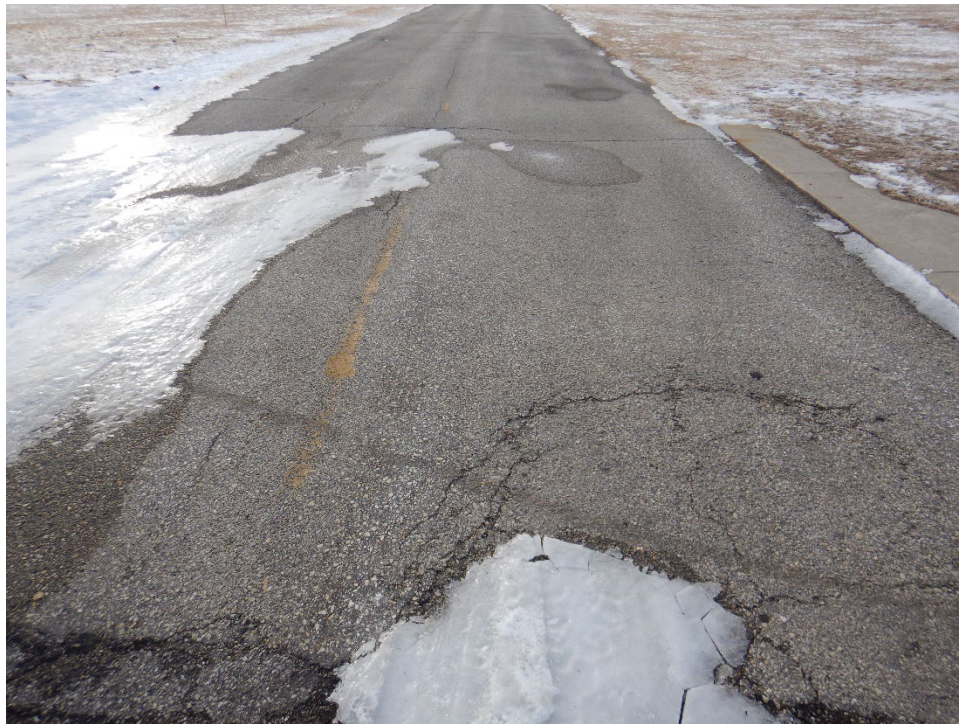
TH01OE-02. Overview.

| Branch | Section | Surface Type | Section Area (sf) | LCD | 2026 PCI | % Distress Due to Load | % Distress Due to Climate/ Durability | % Distress Due to Other | Type of Distress |
|---|---|---|---|---|---|---|---|---|---|
| TH01OE | 02 | AC | 8,660 | 1/1/1994 | 37 | 36 | 51 | 13 | Alligator Cracking, Depression, L&T Cracking, Patching, Rutting, Swelling, Weathering |

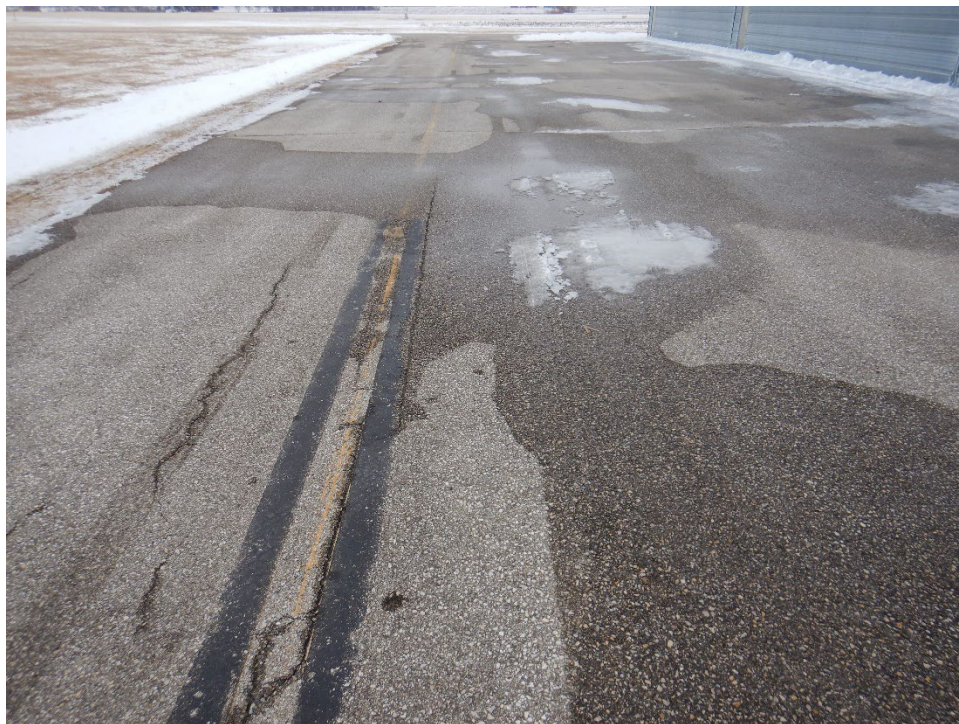
TH01OE-03. Overview.

| Branch | Section | Surface Type | Section Area (sf) | LCD | 2026 PCI | % Distress Due to Load | % Distress Due to Climate/ Durability | % Distress Due to Other | Type of Distress |
|---|---|---|---|---|---|---|---|---|---|
| TH01OE | 03 | AC | 7,044 | 6/1/1994 | 45 | 23 | 77 | 0 | Alligator Cracking, Block Cracking, Depression, L&T Cracking, Weathering |

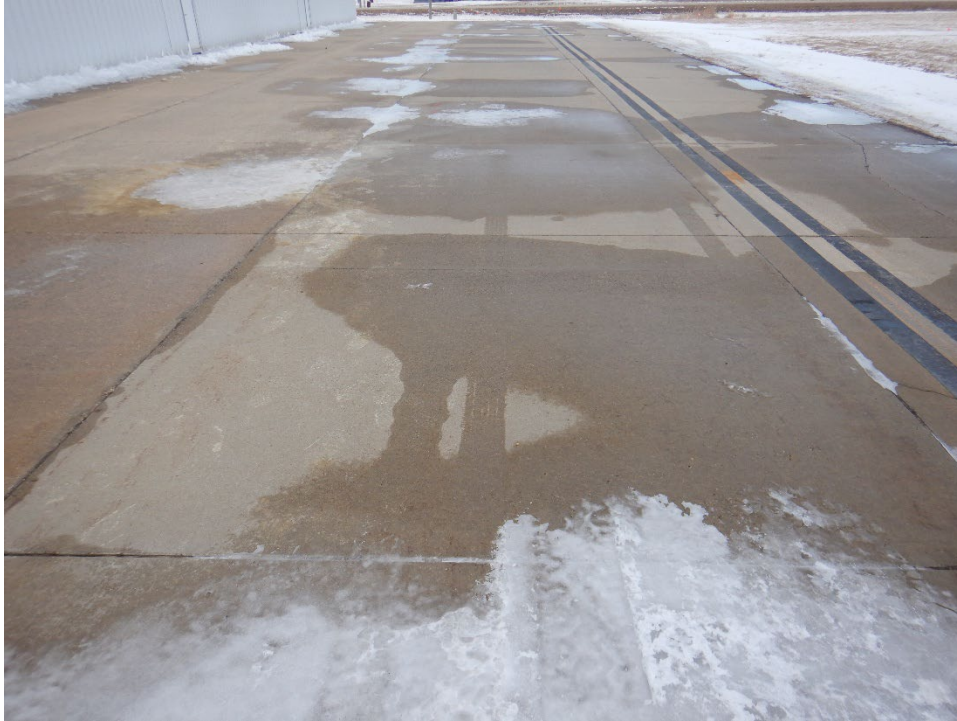
TH01OE-04. Overview.

| Branch | Section | Surface Type | Section Area (sf) | LCD | 2026 PCI | % Distress Due to Load | % Distress Due to Climate/ Durability | % Distress Due to Other | Type of Distress |
|---|---|---|---|---|---|---|---|---|---|
| TH01OE | 04 | PCC | 8,315 | 11/1/2008 | 66 | 73 | 24 | 3 | Corner Break, Corner Spalling, Joint Seal Damage, LTD Cracking |
