# Osage Municipal Airport

## Pavement Management Report

**AUGUST 2025**

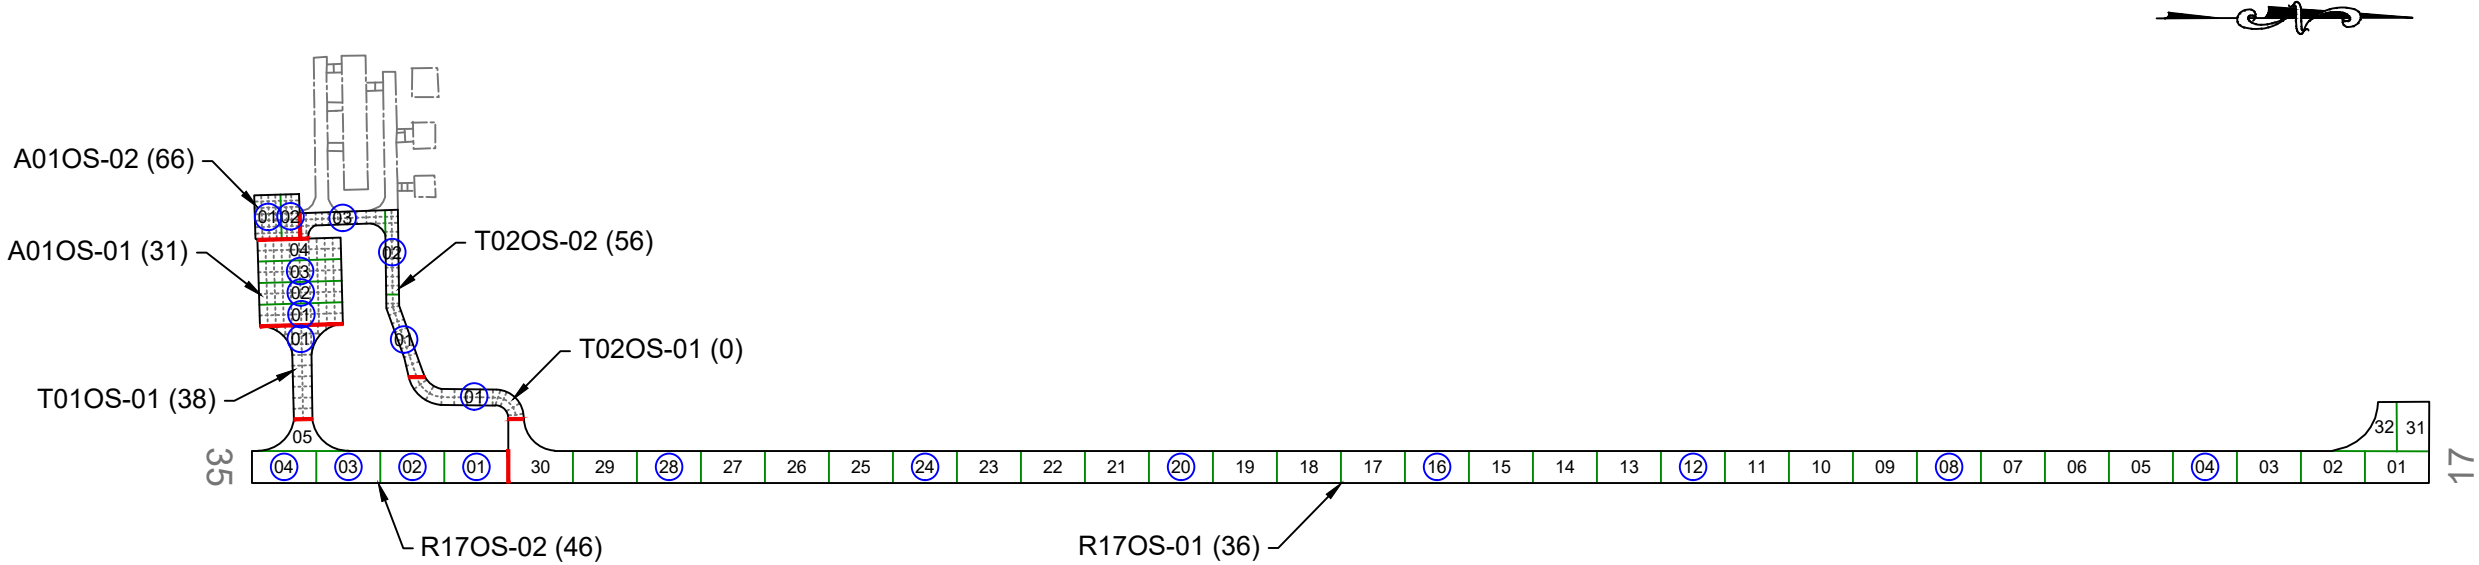
FIGURE 3. NETWORK DEFINITION MAP.

Approximately 223,600 square feet of pavement were evaluated at Osage Municipal Airport, as illustrated in Figure 2. This figure also shows the area-weighted age in years of the pavements at the time of the inspection. Figure 3 provides a map that details how the pavement network was divided into management units and identifies the sample units that were evaluated during the pavement inspection at Osage Municipal Airport.

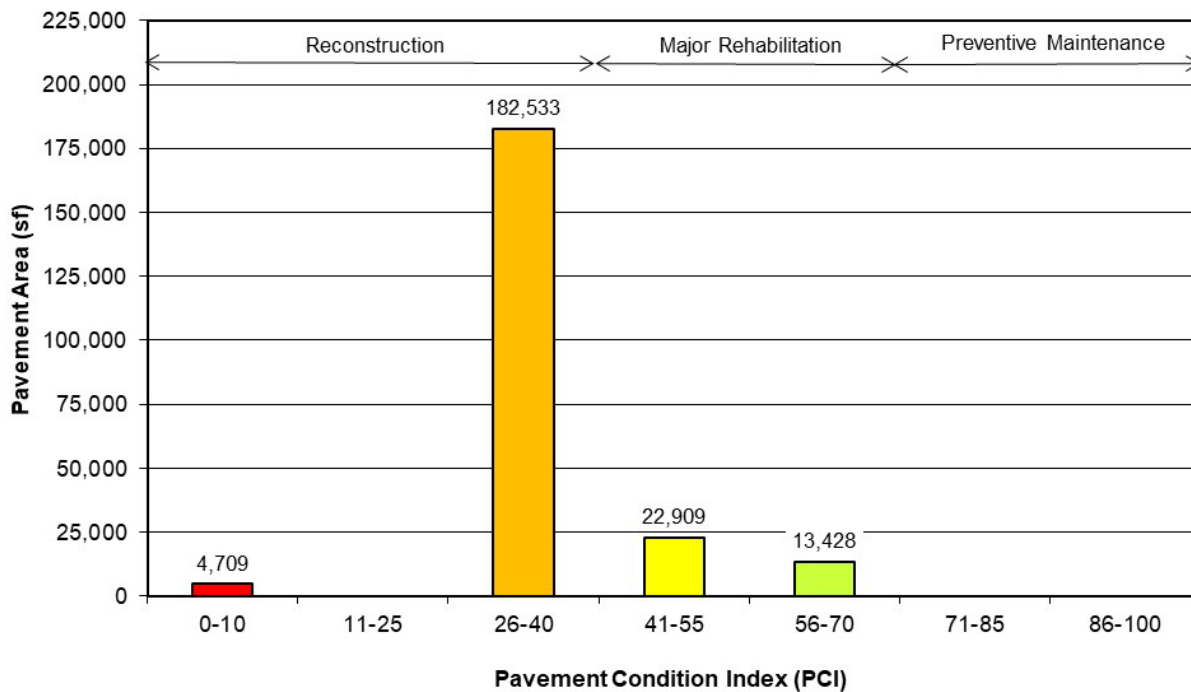
Figure 6. Pavement area by PCI range at Osage Municipal Airport.

The pavements at Osage Municipal Airport were inspected in March 2025. The 2025 area-weighted condition of Osage Municipal Airport is 37, with conditions ranging from 0 to 66 (on a scale of 0 [failed] to 100 [excellent]). During the previous pavement inspection in 2018, the area-weighted PCI of the airport was 43.

Figure 6 summarizes the overall condition of the pavements at Osage Municipal Airport, and Figure 7 presents area-weighted condition (average PCI adjusted to account for the relative size of the pavement sections) by branch use. Figure 8 is a map that displays the condition of the evaluated pavements. Table 1 summarizes the results of the pavement evaluation. Appendix B presents photographs taken during the PCI inspection, and Appendix C contains detailed information on the distress types observed during the visual survey. Appendix D includes detailed work history information that was collected during the record review process.
