# Osceola Municipal Airport

## Pavement Management Report

**AUGUST 2025**

# OSCEOLA MUNICIPAL AIRPORT PAVEMENT MANAGEMENT REPORT

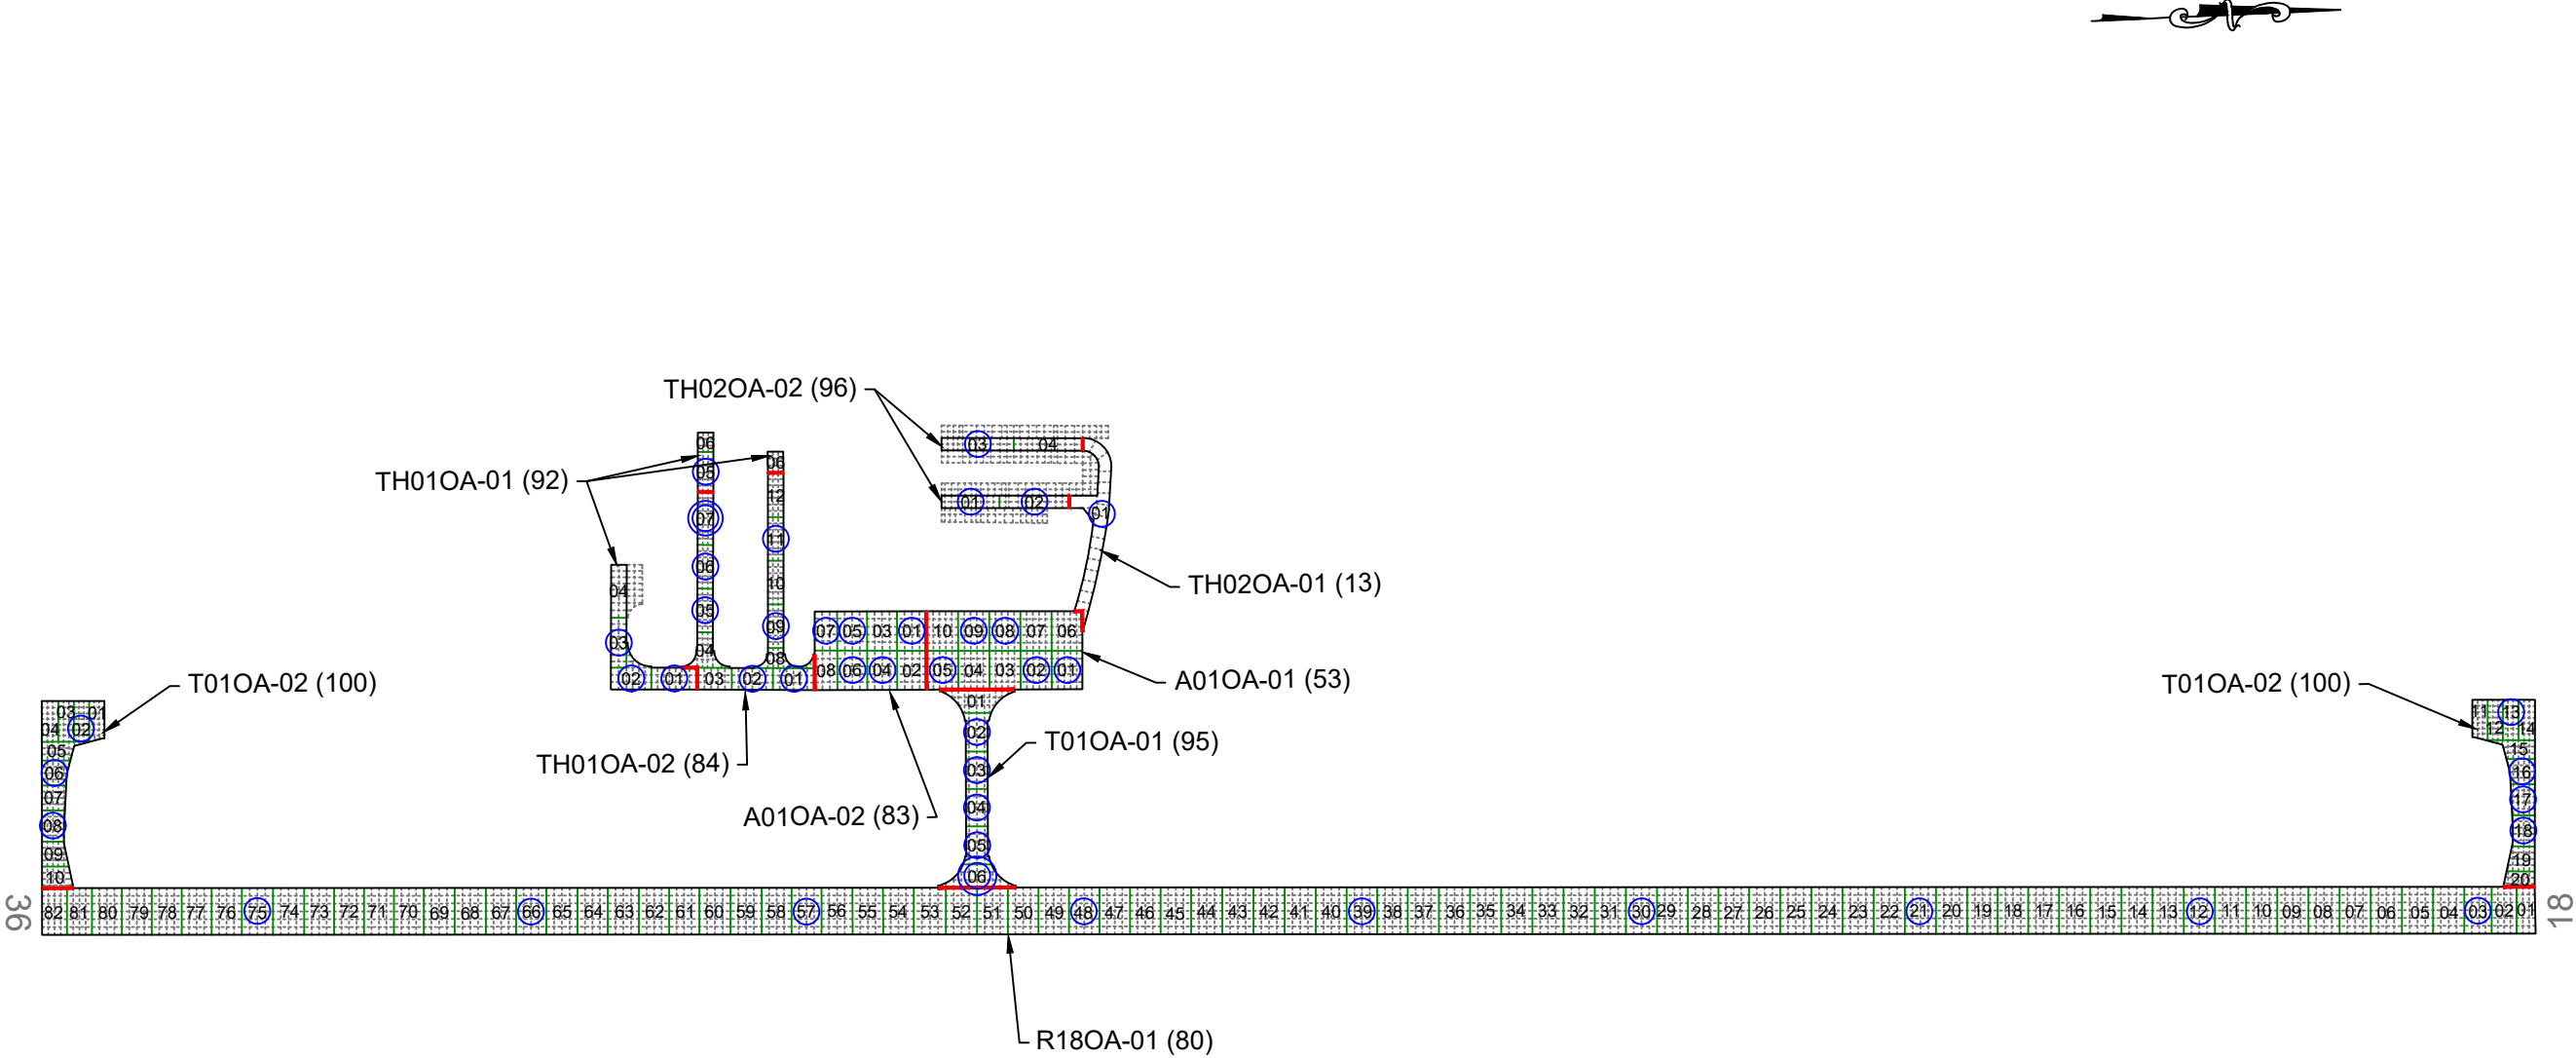
FIGURE 3. NETWORK DEFINITION MAP.

Approximately 451,800 square feet of pavement were evaluated at Osceola Municipal Airport, as illustrated in Figure 2. This figure also shows the area-weighted age in years of the pavements at the time of the inspection. Figure 3 provides a map that details how the pavement network was divided into management units and identifies the sample units that were evaluated during the pavement inspection at Osceola Municipal Airport.

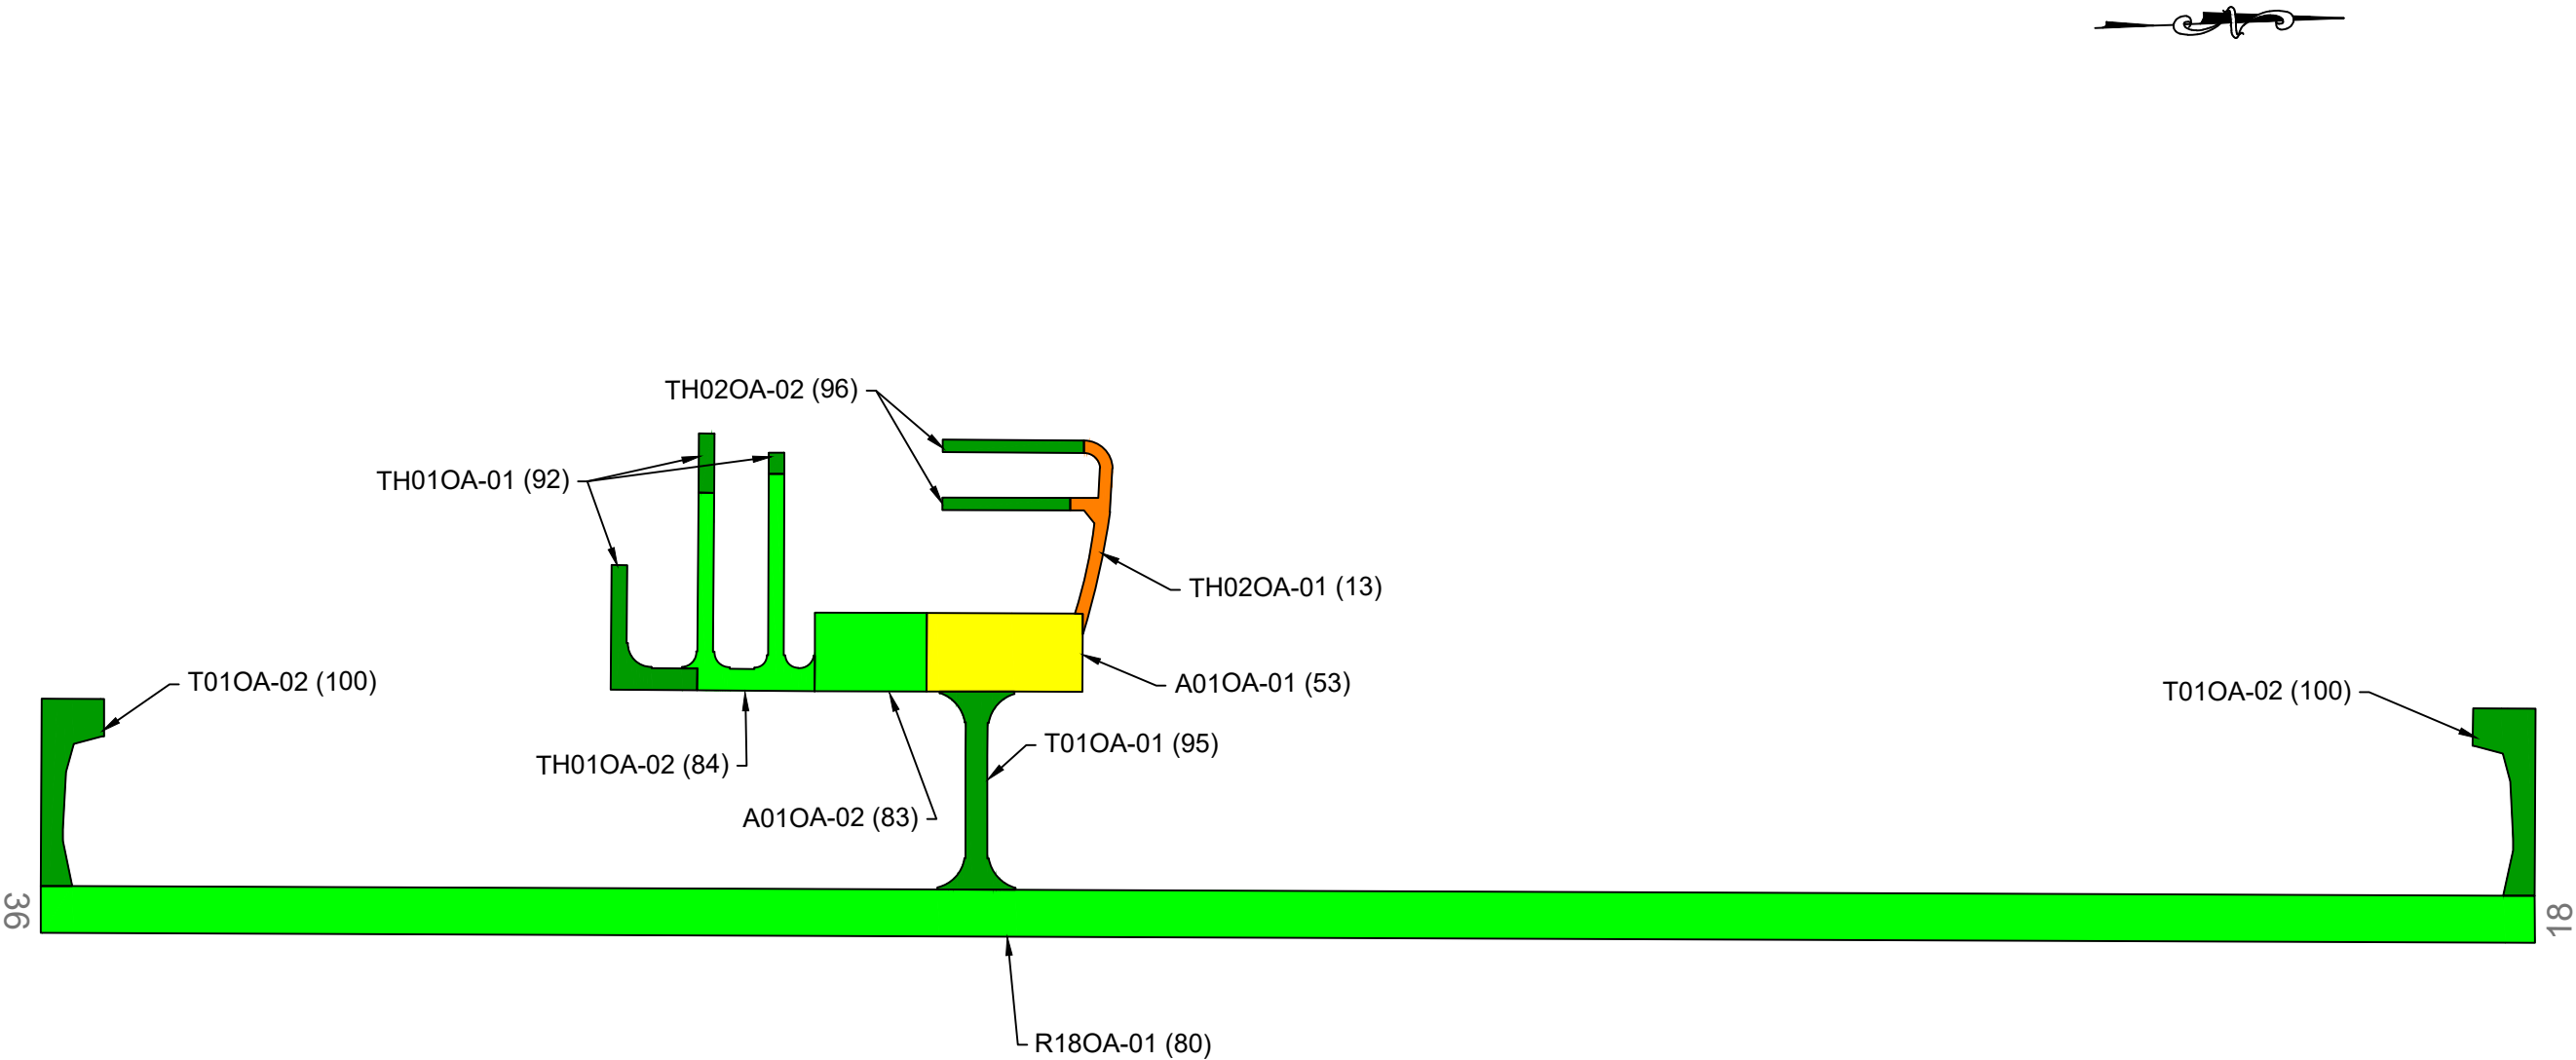
FIGURE 8. PCI MAP.

The pavements at Osceola Municipal Airport were inspected in March 2025. The 2025 area-weighted condition of Osceola Municipal Airport is 80, with conditions ranging from 13 to 100 (on a scale of 0 [failed] to 100 [excellent]). During the previous pavement inspection in 2021, the area-weighted PCI of the airport was 81.

Figure 6 summarizes the overall condition of the pavements at Osceola Municipal Airport, and Figure 7 presents area-weighted condition (average PCI adjusted to account for the relative size of the pavement sections) by branch use. Figure 8 is a map that displays the condition of the evaluated pavements. Table 1 summarizes the results of the pavement evaluation. Appendix B presents photographs taken during the PCI inspection, and Appendix C contains detailed information on the distress types observed during the visual survey. Appendix D includes detailed work history information that was collected during the record review process.
