# Oskaloosa Municipal Airport

## Pavement Management Report

**AUGUST 2025**

# OSKALOOSA MUNICIPAL AIRPORT PAVEMENT MANAGEMENT REPORT

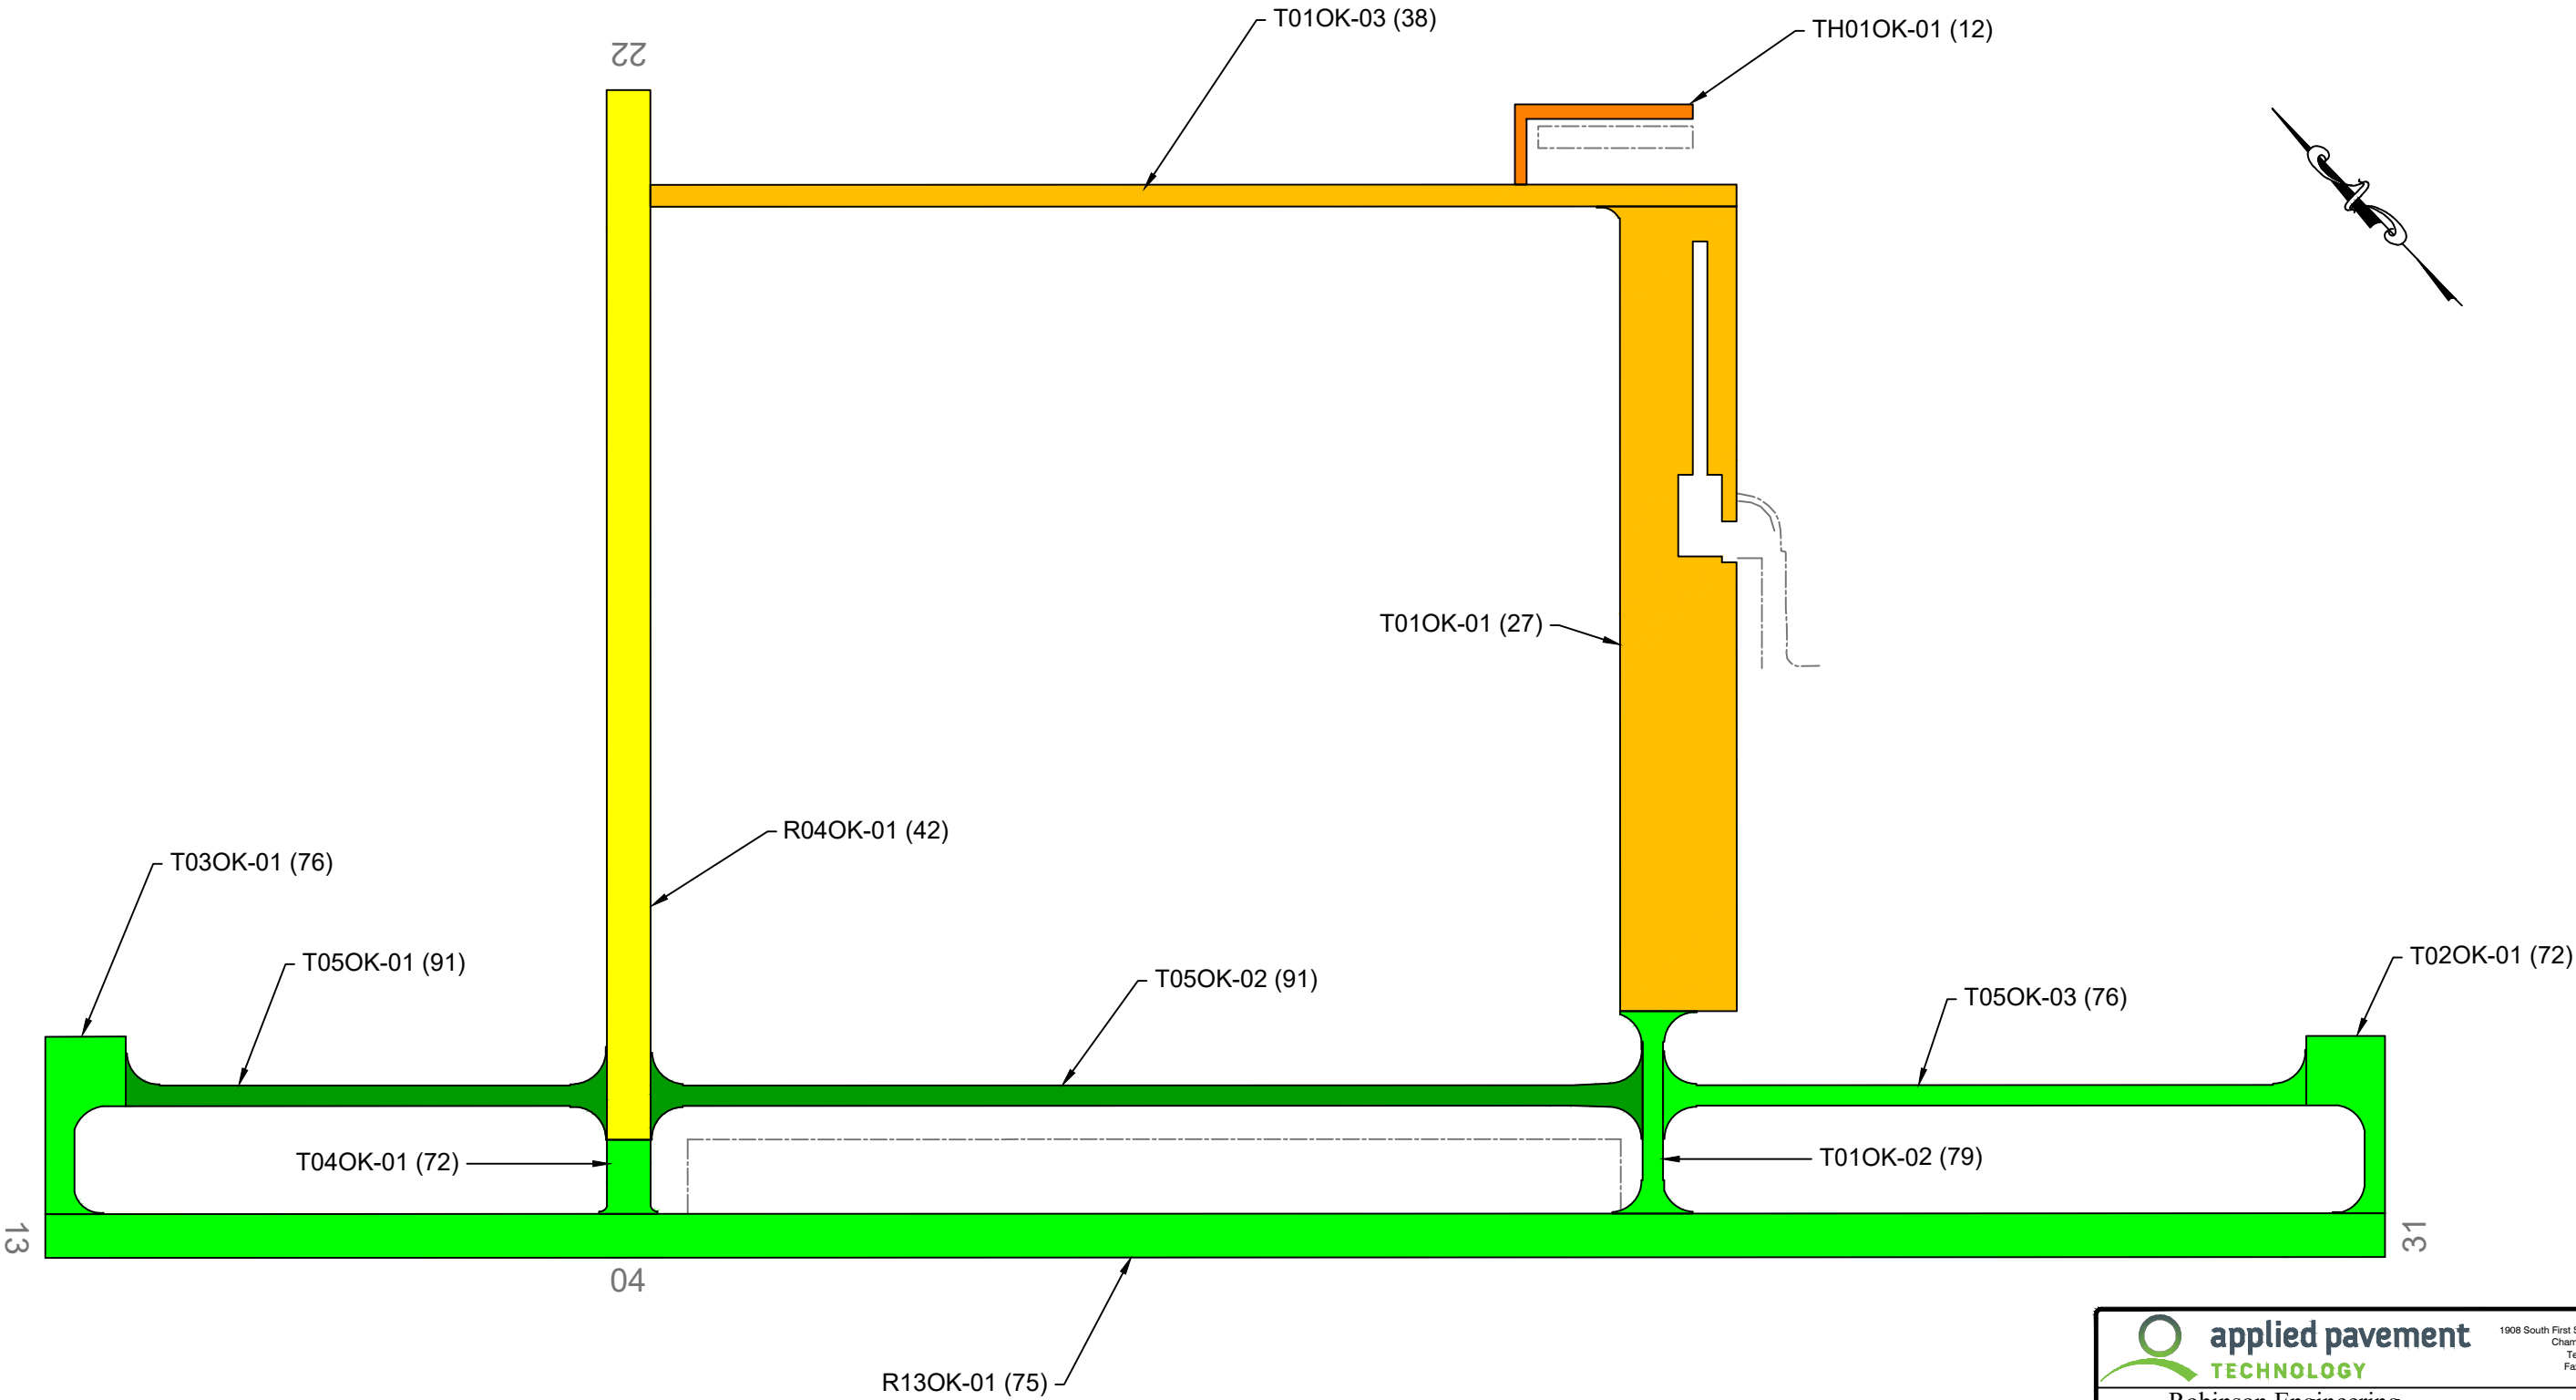
FIGURE 8. PCI MAP.

Figure 6 summarizes the overall condition of the pavements at Oskaloosa Municipal Airport, and Figure 7 presents area-weighted condition (average PCI adjusted to account for the relative size of the pavement sections) by branch use. Figure 8 is a map that displays the condition of the evaluated pavements. Table 1 summarizes the results of the pavement evaluation. Appendix B presents photographs taken during the PCI inspection, and Appendix C contains detailed information on the distress types observed during the visual survey. Appendix D includes detailed work history information that was collected during the record review process.
