# Pella Municipal Airport

## Pavement Management Report

**AUGUST 2025**

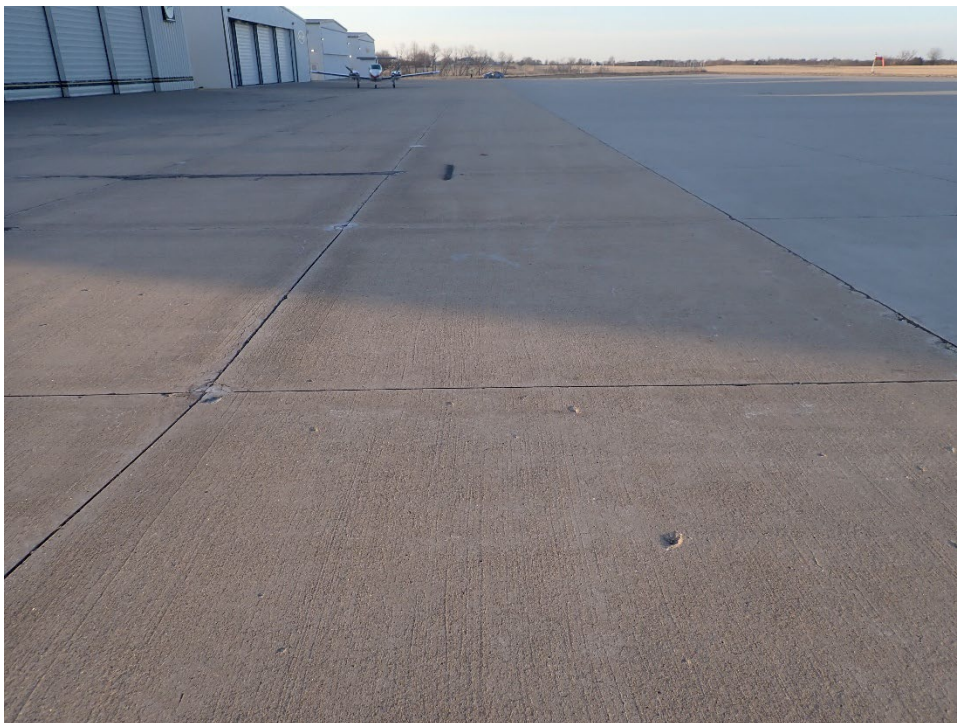
A01PE-02. Overview.

| Branch | Section | Surface Type | Section Area (sf) | LCD | 2025 PCI | % Distress Due to Load | % Distress Due to Climate/Durability | % Distress Due to Other | Type of Distress |
|---|---|---|---|---|---|---|---|---|---|
| A01PE | 02 | PCC | 15,000 | 1/1/2000 | 17 | 0 | 10 | 90 | ASR, Joint Seal Damage, Large Patch, Small Patch |

A01PE-02. ASR (Sample Unit No. 01).

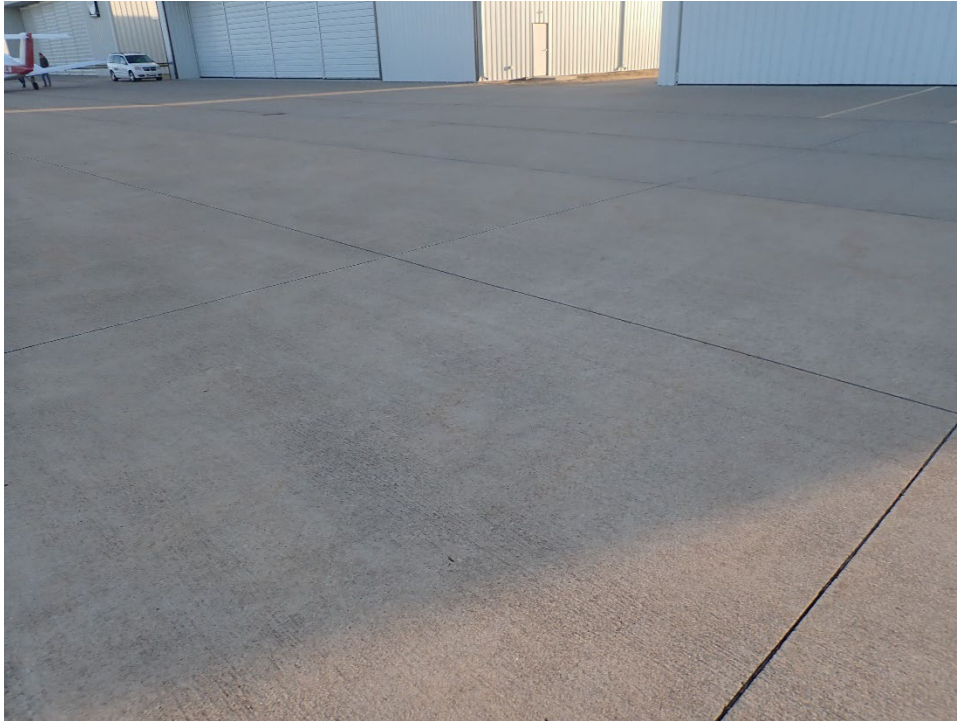
A01PE-03. Overview.

| Branch | Section | Surface Type | Section Area (sf) | LCD | 2025 PCI | % Distress Due to Load | % Distress Due to Climate/Durability | % Distress Due to Other | Type of Distress |
|---|---|---|---|---|---|---|---|---|---|
| A01PE | 03 | PCC | 16,500 | 1/1/2000 | 78 | 26 | 41 | 33 | Corner Spalling, Faulting, Joint Spalling, Joint Seal Damage, Large Patch, LTD Cracking |

A01PE-03. Faulting (Sample Unit No. 03).

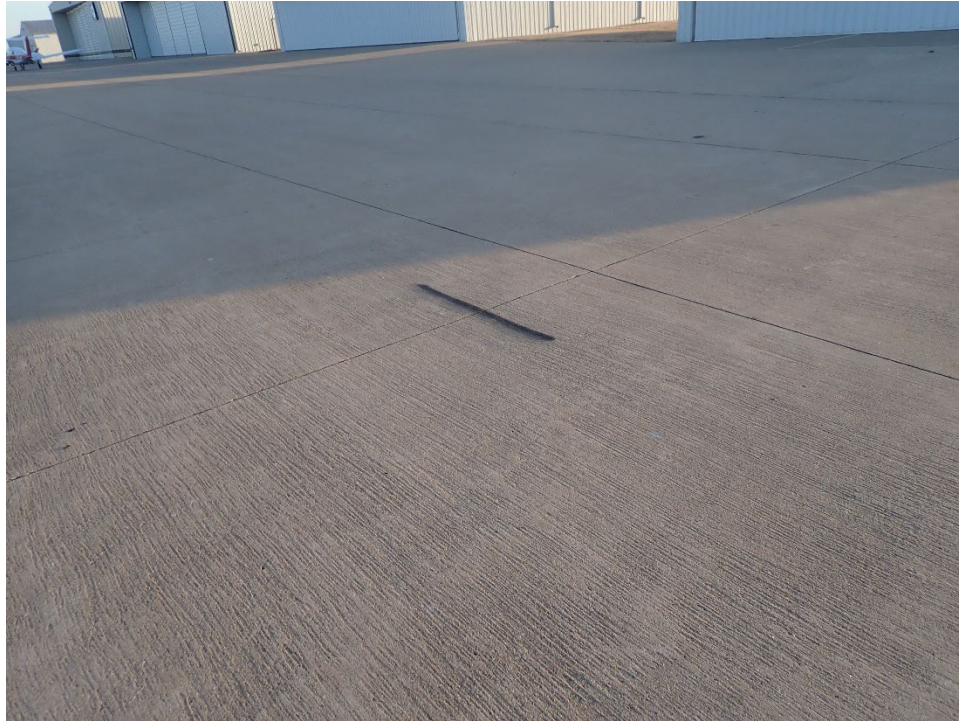
A01PE-04. Overview.

| Branch | Section | Surface Type | Section Area (sf) | LCD | 2025 PCI | % Distress Due to Load | % Distress Due to Climate/Durability | % Distress Due to Other | Type of Distress |
|---|---|---|---|---|---|---|---|---|---|
| A01PE | 04 | PCC | 8,230 | 1/1/2000 | 85 | 0 | 77 | 23 | Corner Spalling, Joint Spalling, Joint Seal Damage, Small Patch |

A01PE-04. Joint Seal Damage (Sample Unit No. 02).

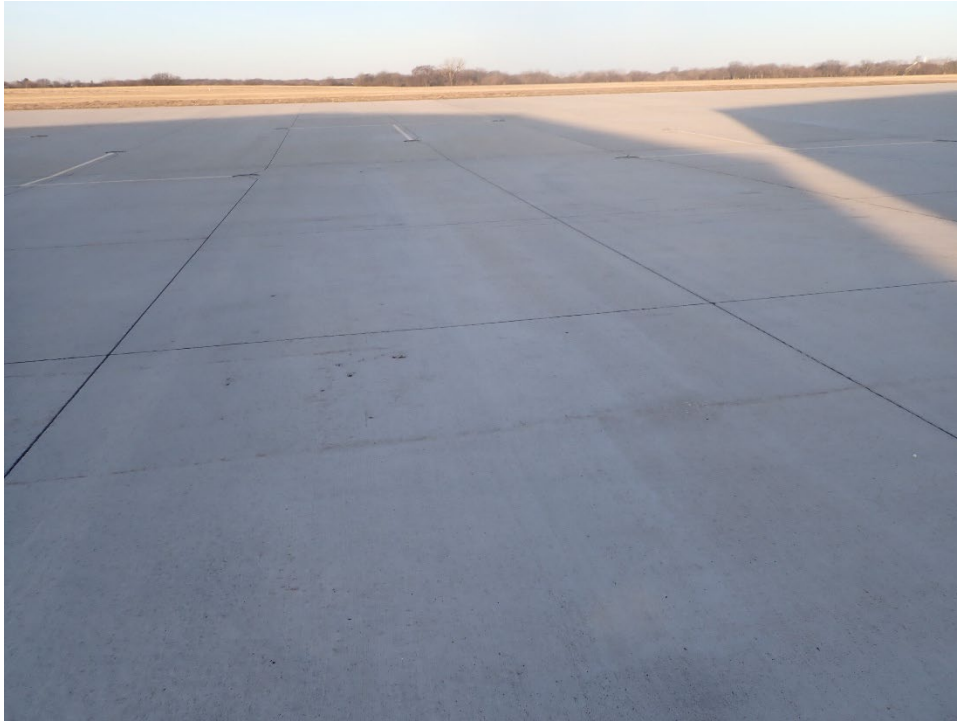
A01PE-05. Overview.

| Branch | Section | Surface Type | Section Area (sf) | LCD | 2025 PCI | % Distress Due to Load | % Distress Due to Climate/Durability | % Distress Due to Other | Type of Distress |
|---|---|---|---|---|---|---|---|---|---|
| A01PE | 05 | PCC | 80,309 | 7/3/2023 | 97 | 36 | 64 | 0 | Corner Break, Joint Seal Damage |

A01PE-05. Corner Break (Sample Unit No. 07).

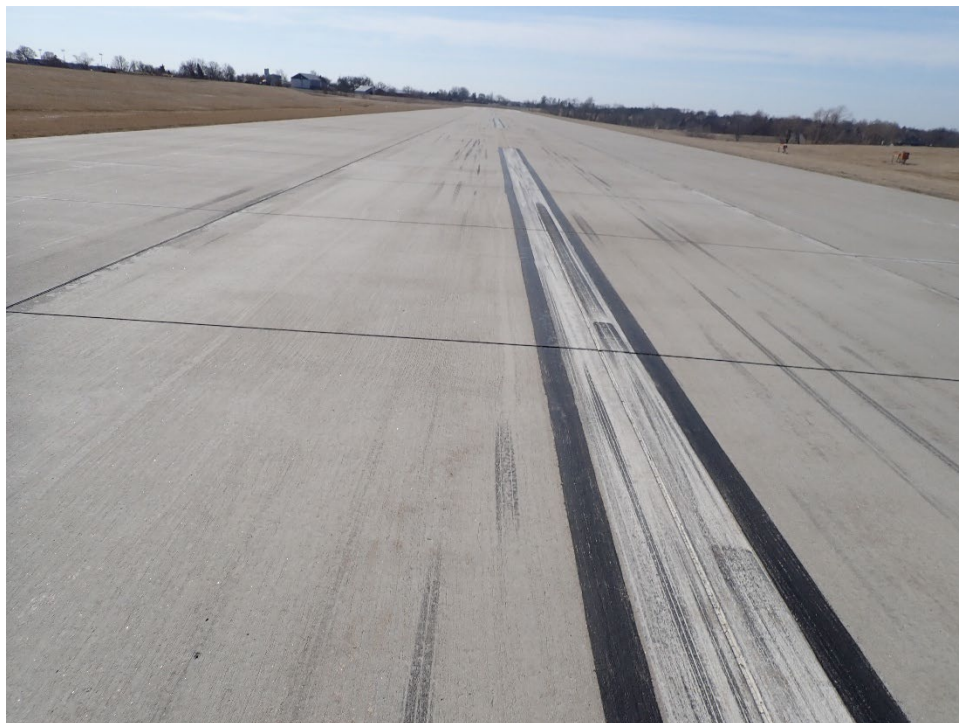
R16PE-01. Overview.

| Branch | Section | Surface Type | Section Area (sf) | LCD | 2025 PCI | % Distress Due to Load | % Distress Due to Climate/Durability | % Distress Due to Other | Type of Distress |
|---|---|---|---|---|---|---|---|---|---|
| R16PE | 01 | PCC | 148,196 | 11/3/2020 | 98 | 0 | 100 | 0 | Joint Seal Damage |

R16PE-01. Joint Seal Damage (Sample Unit No. 12).

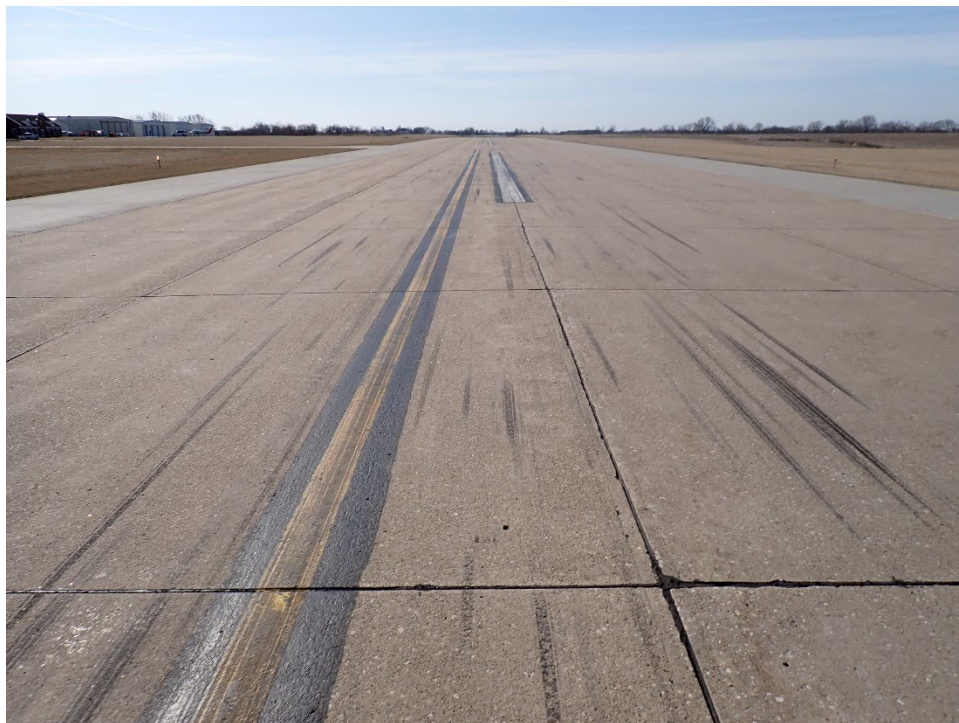
R16PE-03. Overview.

| Branch | Section | Surface Type | Section Area (sf) | LCD | 2025 PCI | % Distress Due to Load | % Distress Due to Climate/Durability | % Distress Due to Other | Type of Distress |
|---|---|---|---|---|---|---|---|---|---|
| R16PE | 03 | PCC | 139,475 | 10/2/1969 | 82 | 29 | 8 | 63 | ASR, Corner Spalling, Joint Seal Damage, Large Patch, LTD Cracking, Shrinkage Cracking, Small Patch |

R16PE-03. LTD Cracking (Sample Unit No. 31).

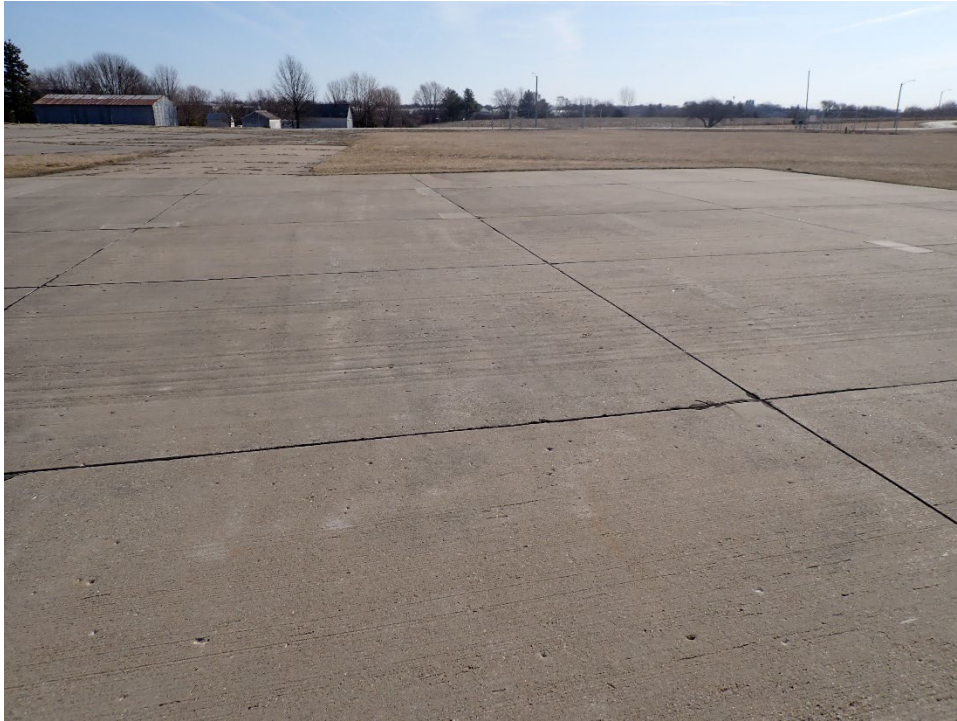
R16PE-05. Overview.

| Branch | Section | Surface Type | Section Area (sf) | LCD | 2025 PCI | % Distress Due to Load | % Distress Due to Climate/Durability | % Distress Due to Other | Type of Distress |
|---|---|---|---|---|---|---|---|---|---|
| R16PE | 05 | PCC | 5,765 | 6/1/1989 | 38 | 11 | 13 | 76 | ASR, Joint Seal Damage, Large Patch, LTD Cracking, Small Patch |

R16PE-05. ASR (Sample Unit No. 01) (1).

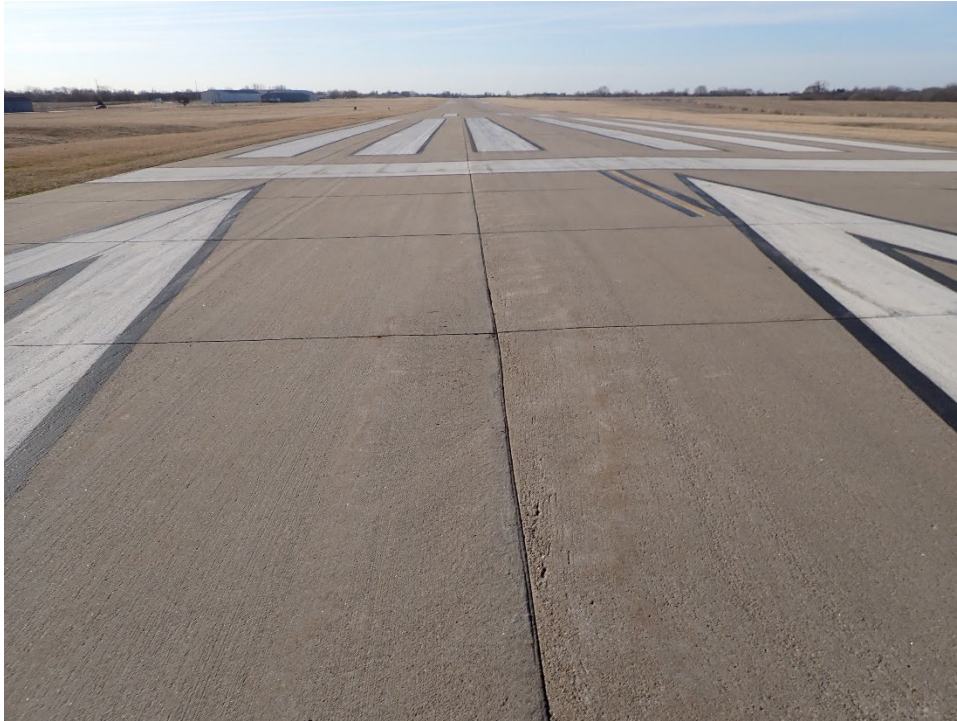
R16PE-06. Overview.

| Branch | Section | Surface Type | Section Area (sf) | LCD | 2025 PCI | % Distress Due to Load | % Distress Due to Climate/Durability | % Distress Due to Other | Type of Distress |
|---|---|---|---|---|---|---|---|---|---|
| R16PE | 06 | PCC | 82,427 | 6/1/1989 | 89 | 6 | 47 | 47 | Corner Spalling, Faulting, Joint Spalling, Joint Seal Damage, Large Patch, LTD Cracking, Small Patch |

R16PE-06. Joint Seal Damage (Sample Unit No. 20).

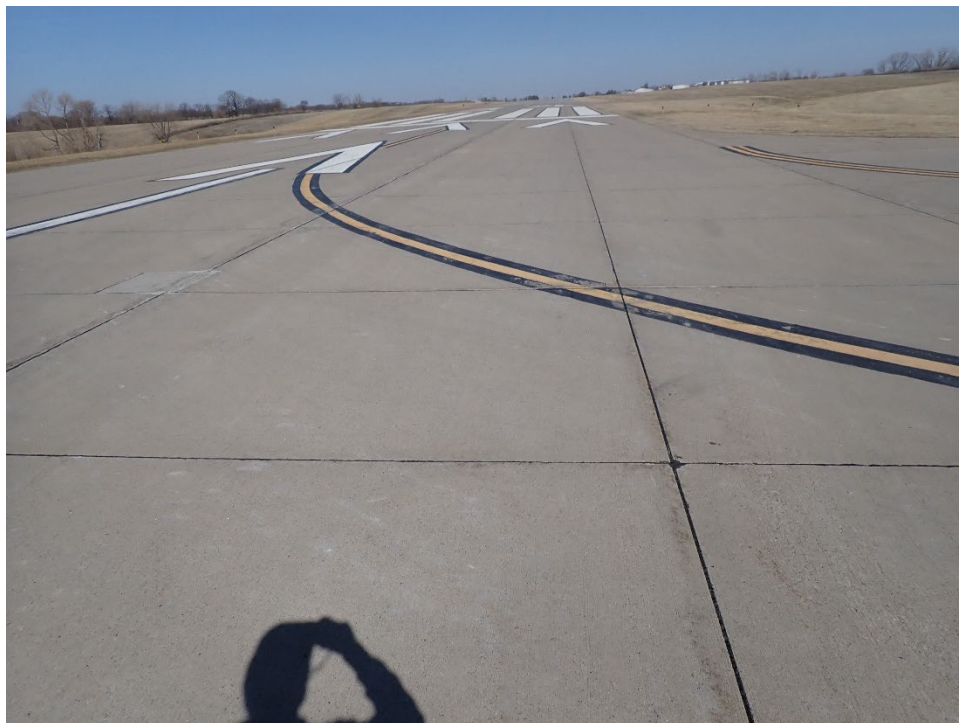
R16PE-07. Overview.

| Branch | Section | Surface Type | Section Area (sf) | LCD | 2025 PCI | % Distress Due to Load | % Distress Due to Climate/Durability | % Distress Due to Other | Type of Distress |
|---|---|---|---|---|---|---|---|---|---|
| R16PE | 07 | PCC | 36,341 | 6/1/1989 | 85 | 11 | 38 | 51 | ASR, Corner Spalling, Faulting, Joint Spalling, Joint Seal Damage, Large Patch, LTD Cracking, Small Patch |

R16PE-07. Corner Spalling (Sample Unit No. 04).

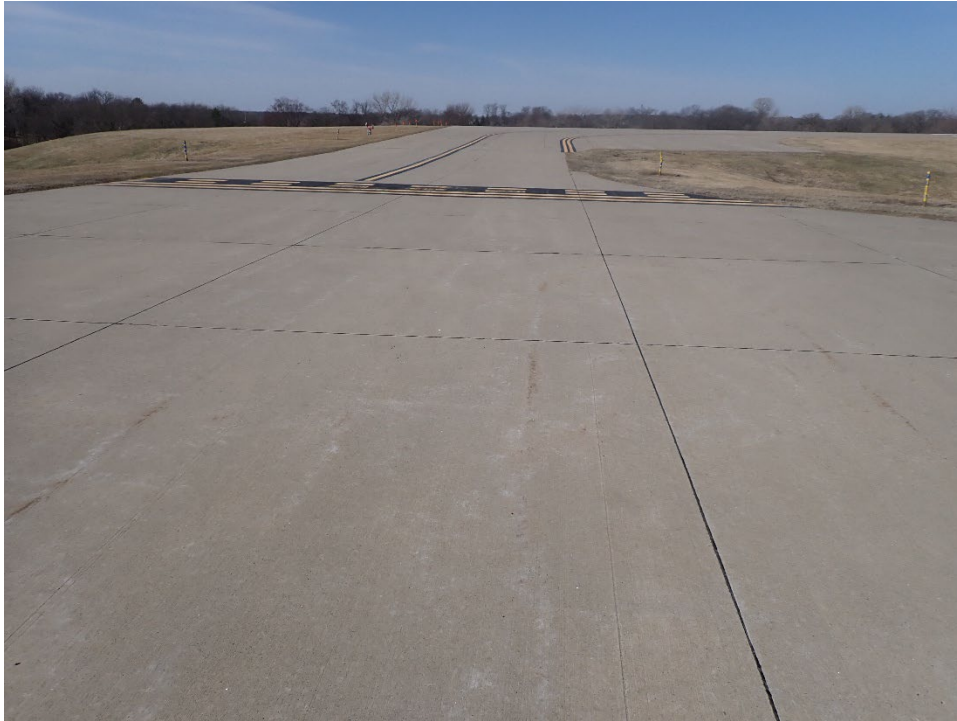
R16PE-08. Overview.

| Branch | Section | Surface Type | Section Area (sf) | LCD | 2025 PCI | % Distress Due to Load | % Distress Due to Climate/Durability | % Distress Due to Other | Type of Distress |
|---|---|---|---|---|---|---|---|---|---|
| R16PE | 08 | PCC | 10,953 | 10/10/2004 | 93 | 0 | 100 | 0 | Joint Seal Damage |

R16PE-08. Joint Seal Damage (Sample Unit No. 01).

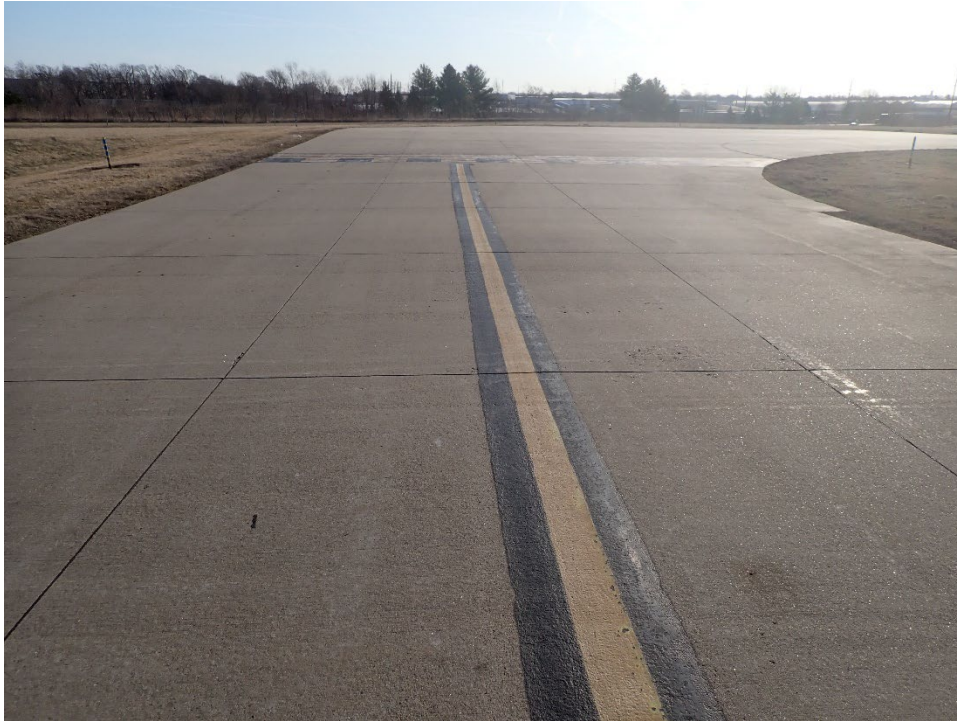
R16PE-09. Overview.

| Branch | Section | Surface Type | Section Area (sf) | LCD | 2025 PCI | % Distress Due to Load | % Distress Due to Climate/Durability | % Distress Due to Other | Type of Distress |
|---|---|---|---|---|---|---|---|---|---|
| R16PE | 09 | PCC | 12,832 | 10/10/2004 | 86 | 0 | 85 | 15 | Faulting, Joint Spalling, Joint Seal Damage |

R16PE-09. Faulting (Sample Unit No. 05).

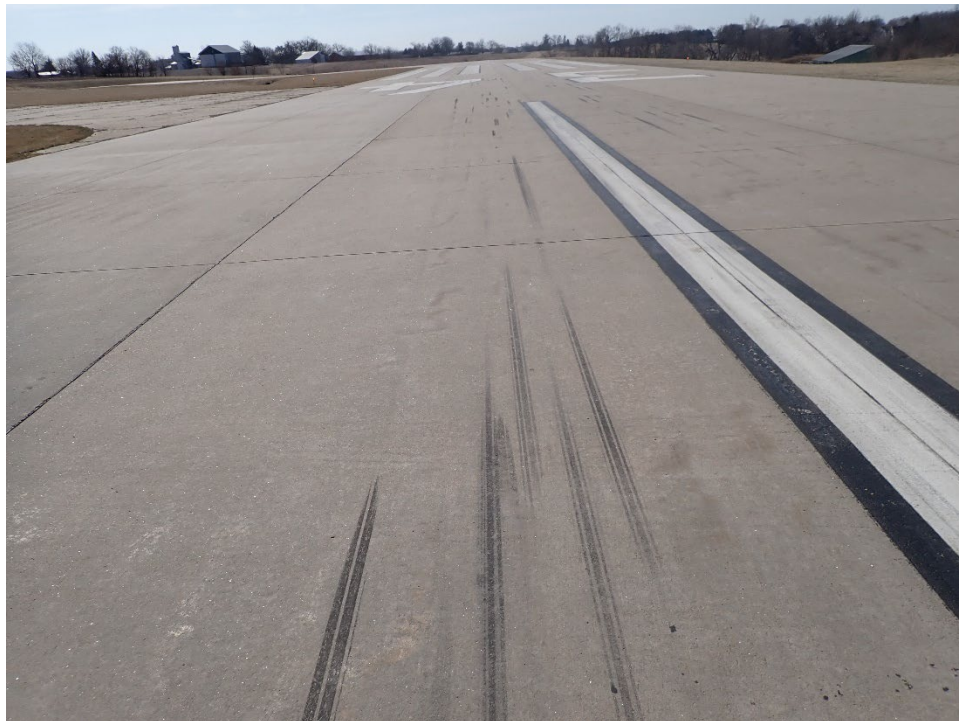
R16PE-10. Overview.

R16PE-10. Joint Seal Damage (Sample Unit No. 02).

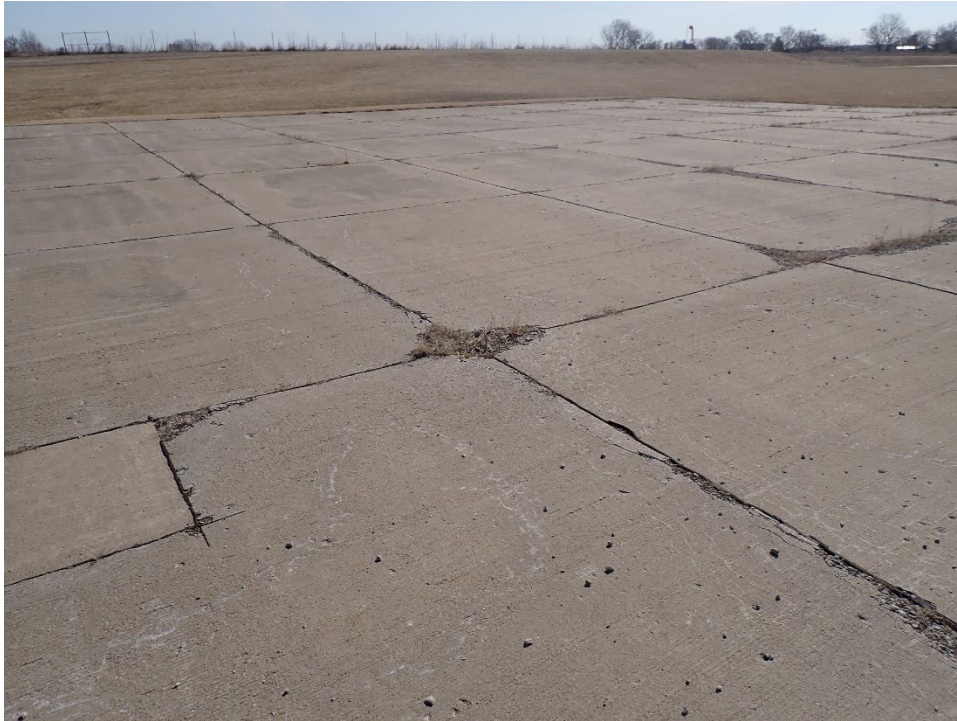
R16PE-11. Overview.

R16PE-11. ASR (Sample Unit No. 03).

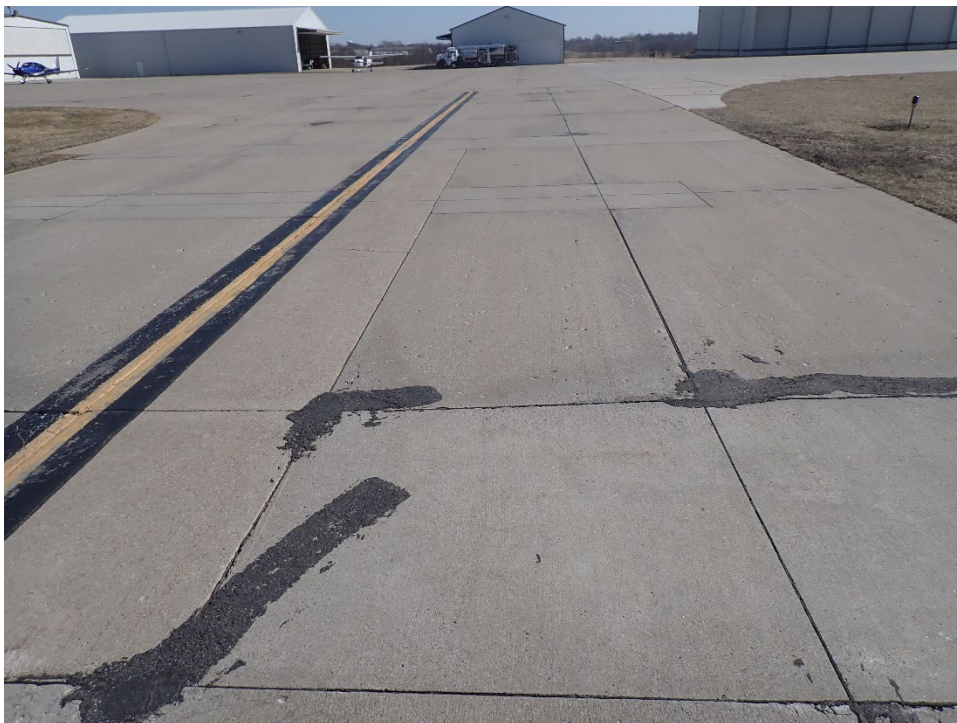
T01PE-01. Overview.

T01PE-01. ASR (Sample Unit No. 01).

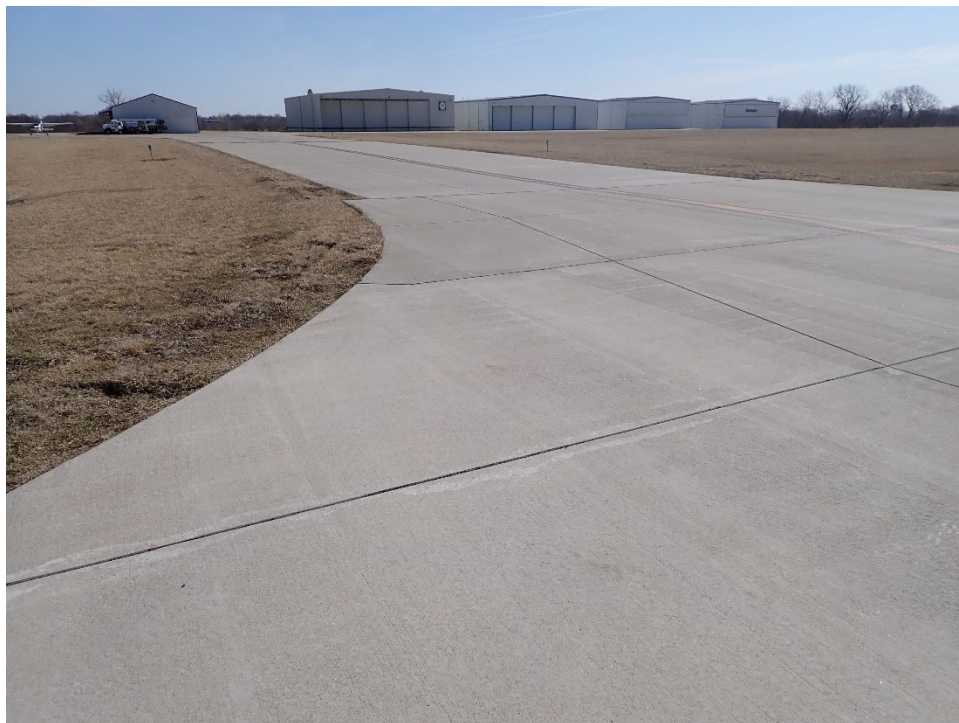
T01PE-02. Overview.

| Branch | Section | Surface Type | Section Area (sf) | LCD | 2025 PCI | % Distress Due to Load | % Distress Due to Climate/ Durability | % Distress Due to Other | Type of Distress |
|---|---|---|---|---|---|---|---|---|---|
| T01PE | 02 | PCC | 7,625 | 11/3/2020 | 96 | 0 | 51 | 49 | ASR, Joint Seal Damage |

T01PE-02. ASR (Sample Unit No. 01).

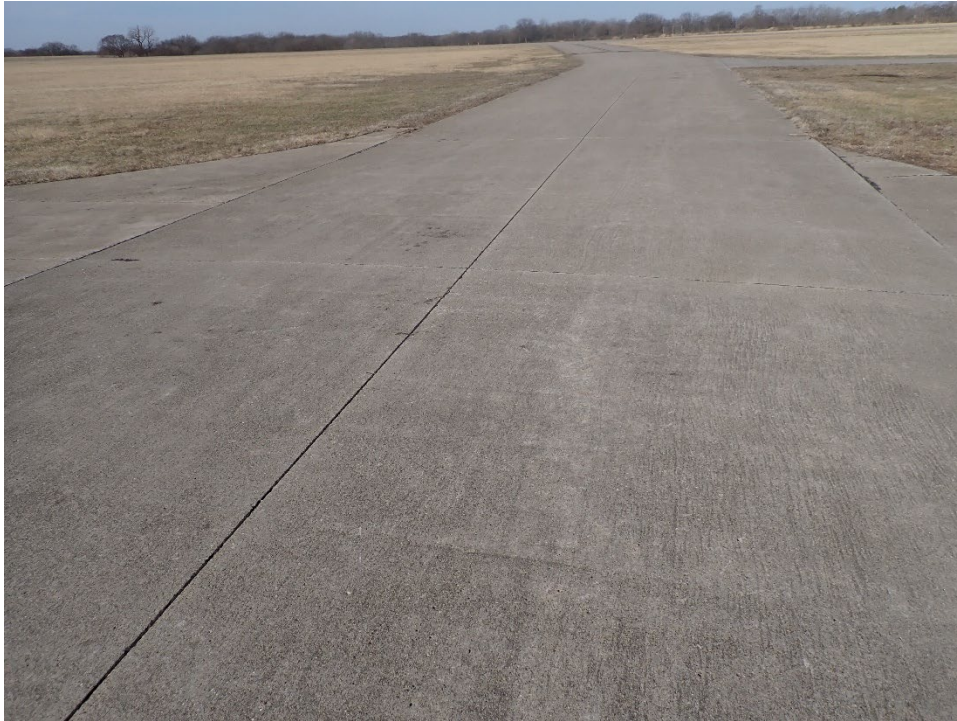
TH01PE-01. Overview.

TH01PE-01. Corner Break (Sample Unit No. 09).

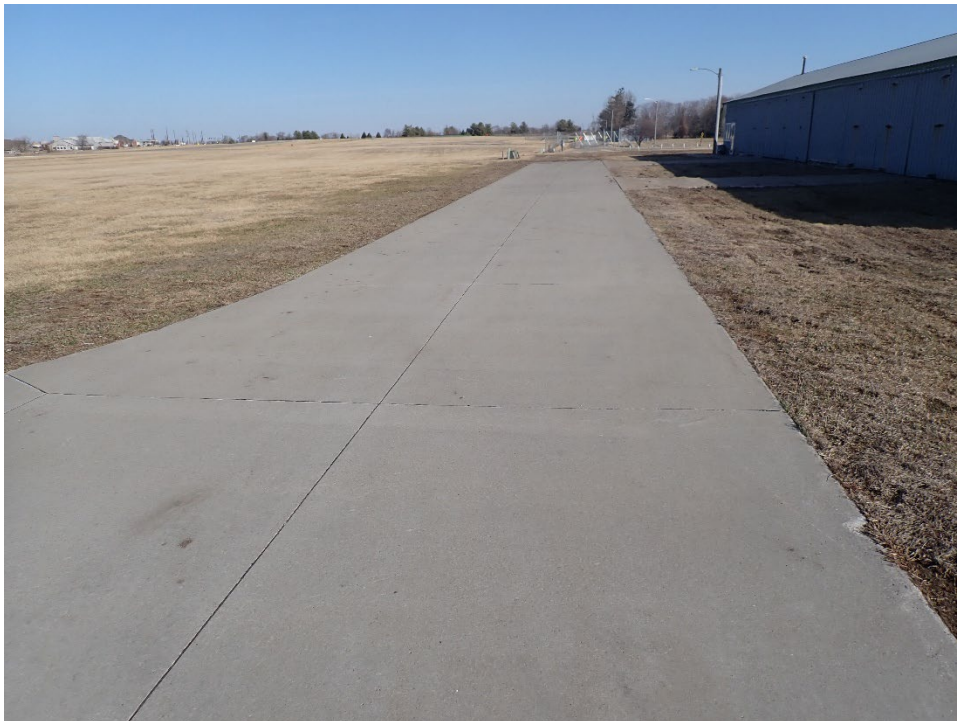
TH01PE-02. Overview.

TH01PE-02. Corner Spalling (Sample Unit No. 02).
