# Pocahontas Municipal Airport

## Pavement Management Report

# POCAHONTAS MUNICIPAL AIRPORT PAVEMENT MANAGEMENT REPORT

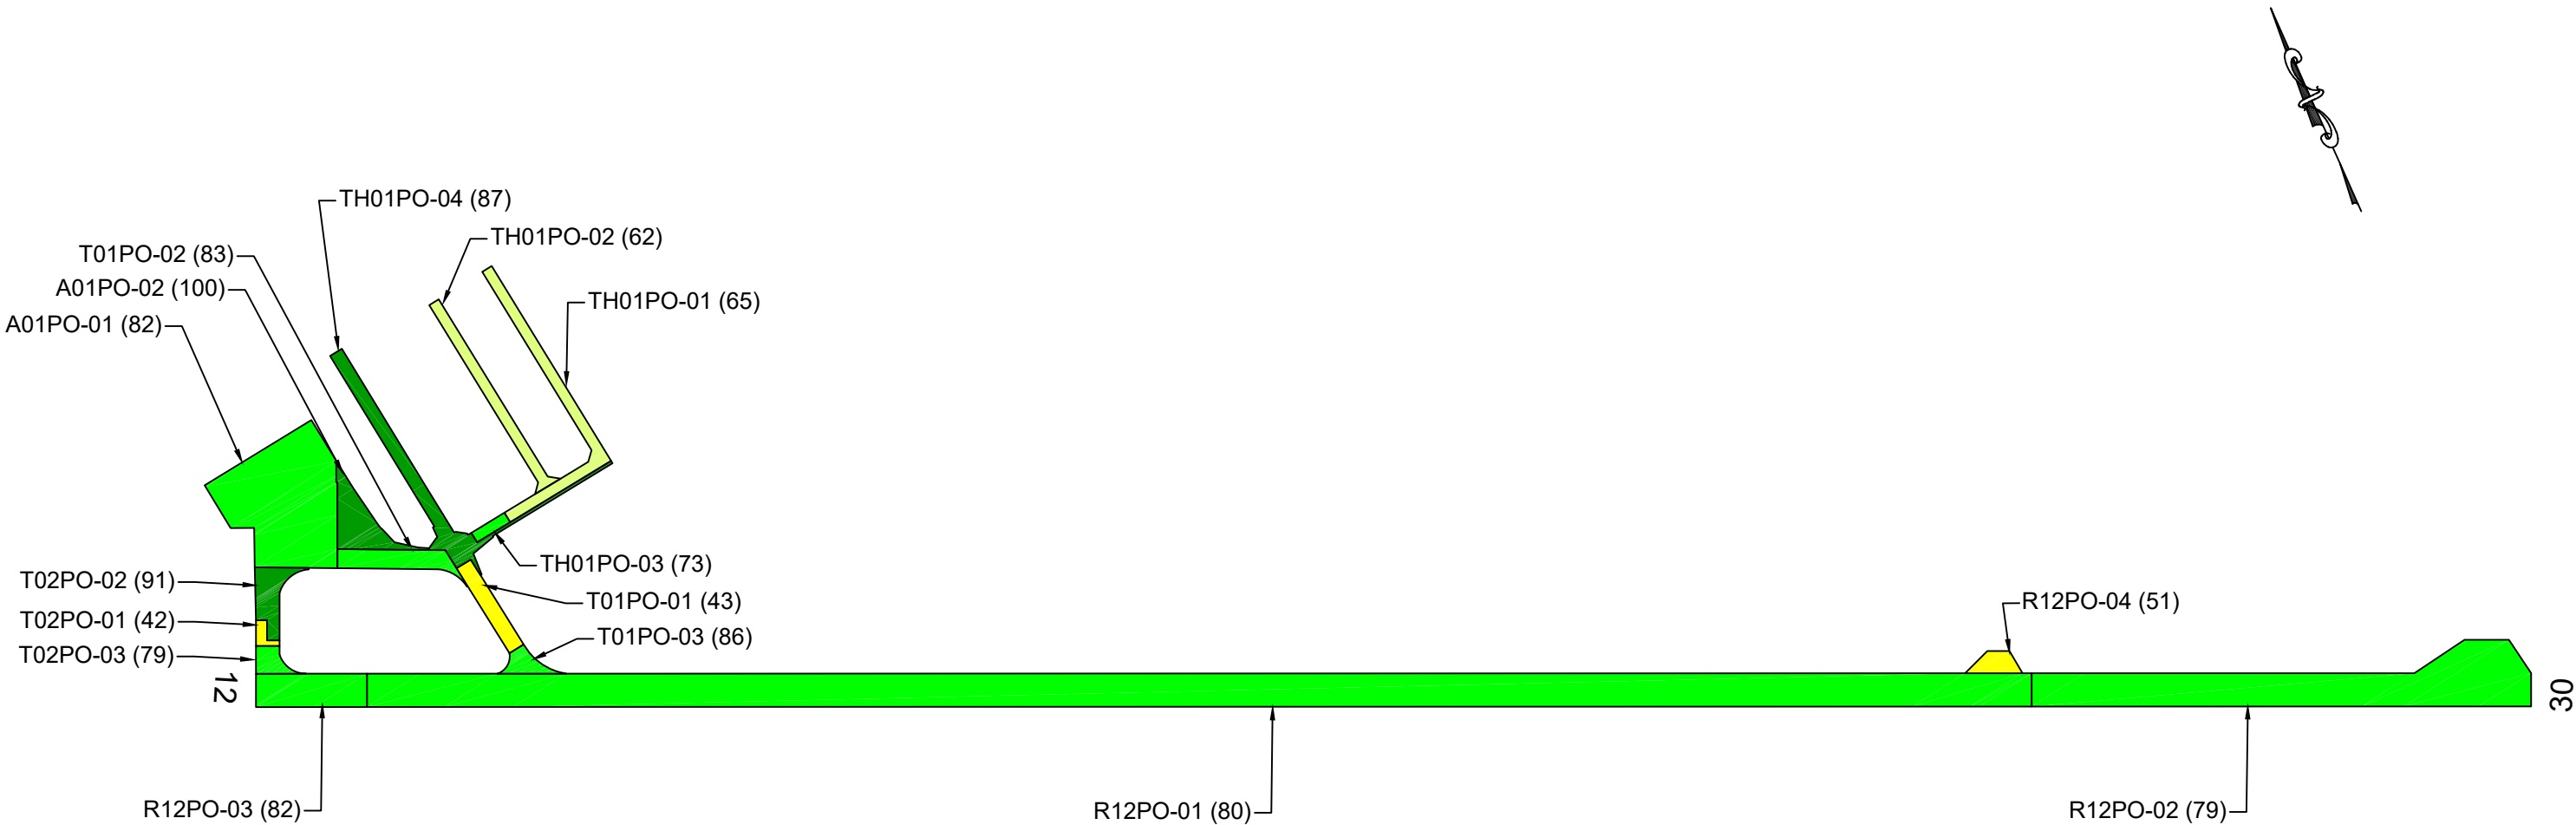
FIGURE 8. PCI MAP.

The pavements at Pocahontas Municipal Airport were inspected in March 2026. The 2026 area-weighted condition of Pocahontas Municipal Airport is 79, with conditions ranging from 42 to 100 (on a scale of 0 [*Failed*] to 100 [*Excellent*]). During the previous pavement inspection in 2022, the area-weighted PCI of the airport was 87.
