Sac City Municipal Airport

Pavement Management Report

JULY 2023

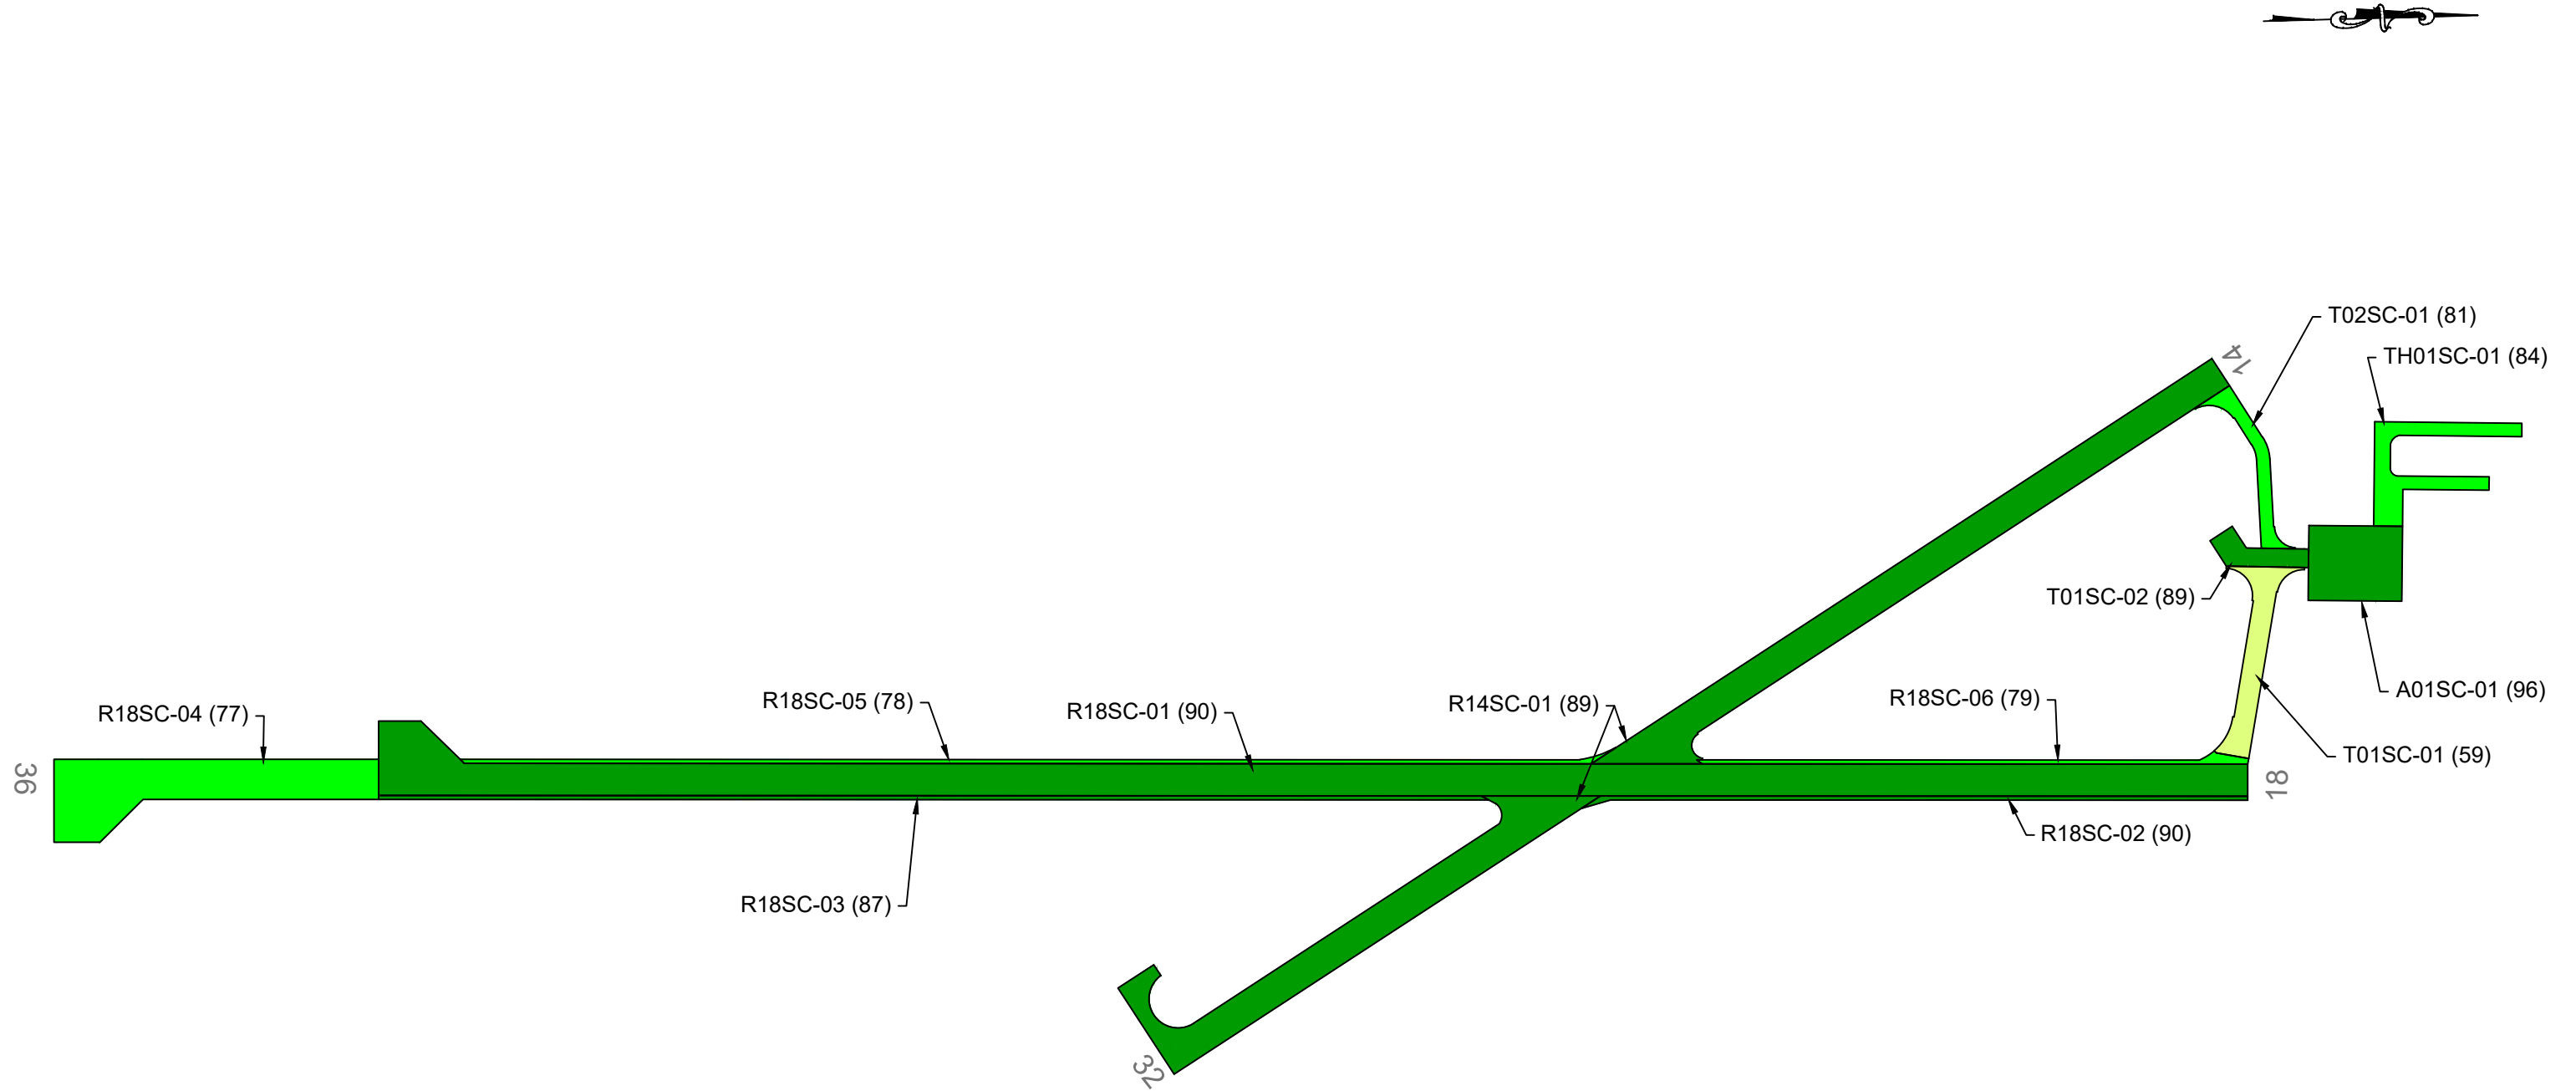
FIGURE 8. PCI MAP.

The pavements at Sac City Municipal Airport were inspected in November 2022. The 2022 area-weighted condition of Sac City Municipal Airport is 87, with conditions ranging from 59 to 96 (on a scale of 0 [failed] to 100 [excellent]). During the previous pavement inspection in 2019, the area-weighted PCI of the airport was 93.

Figure 6 summarizes the overall condition of the pavements at Sac City Municipal Airport, and Figure 7 presents area-weighted condition (average PCI adjusted to account for the relative size of the pavement sections) by branch use. Figure 8 is a map that displays the condition of the evaluated pavements. Table 1 summarizes the results of the pavement evaluation. Appendix B presents photographs taken during the PCI inspection, and Appendix C contains detailed information on the distress types observed during the visual survey. Appendix D includes detailed work history information that was collected during the record review process.
