# Sac City Municipal Airport

## Pavement Management Report

**AUGUST 2026**

# SAC CITY MUNICIPAL AIRPORT PAVEMENT MANAGEMENT REPORT

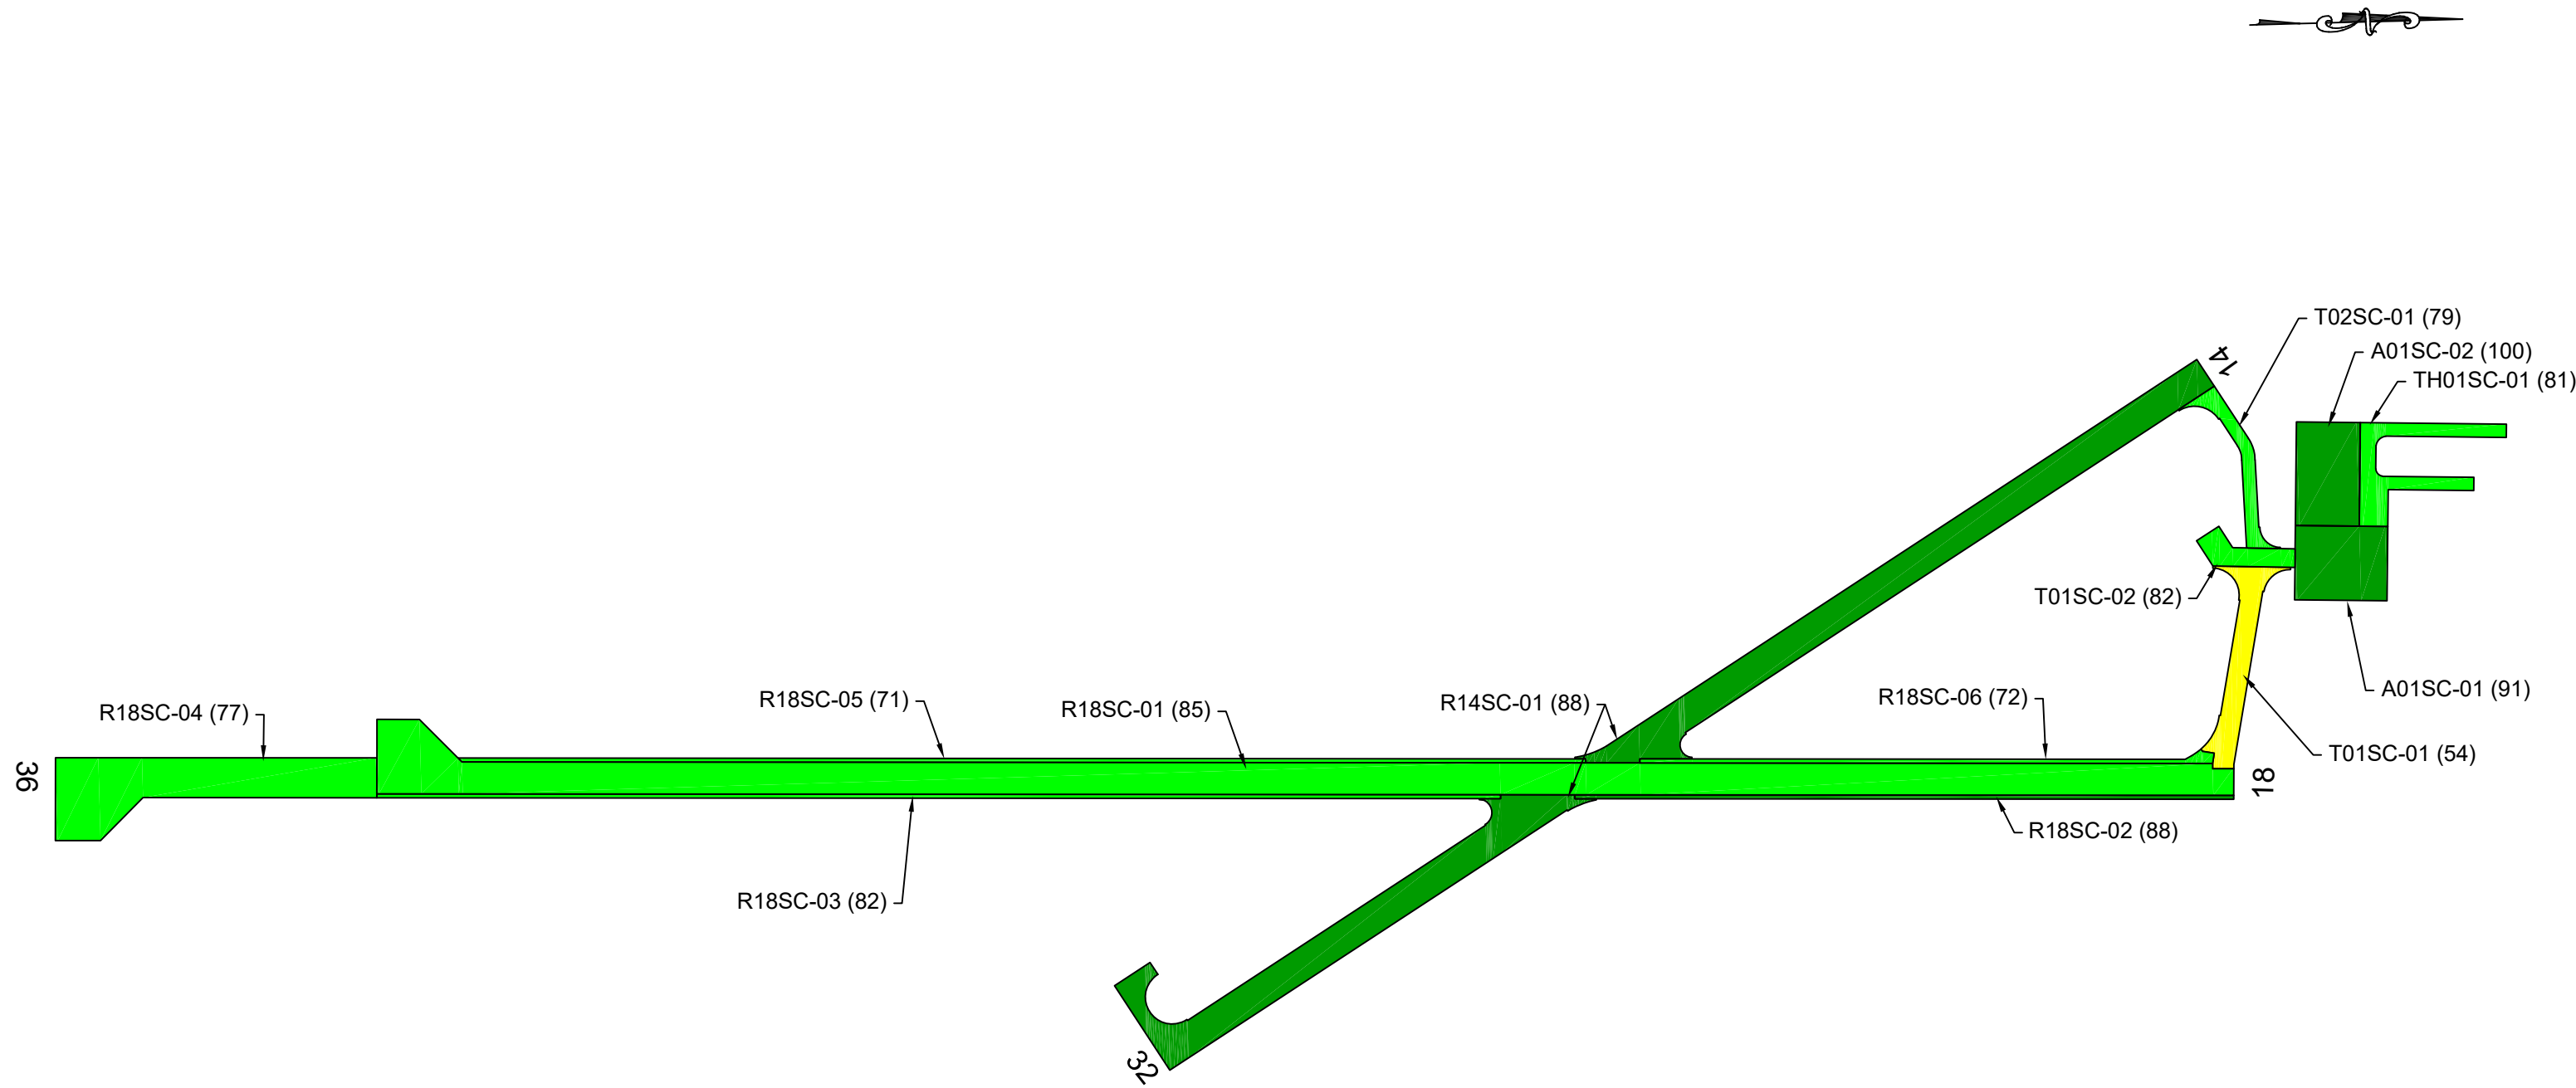
FIGURE 8. PCI MAP.

The pavements at Sac City Municipal Airport were inspected in March 2026. The 2026 area-weighted condition of Sac City Municipal Airport is 84, with conditions ranging from 54 to 100 (on a scale of 0 [*Failed*] to 100 [*Excellent*]). During the previous pavement inspection in 2022, the area-weighted PCI of the airport was 87.

Figure 6 summarizes the overall condition of the pavements at Sac City Municipal Airport, and Figure 7 presents area-weighted condition (average PCI adjusted to account for the relative size of the pavement sections) by branch use. Figure 8 is a map that displays the condition of the evaluated pavements. Table 1 summarizes the results of the pavement evaluation. Appendix B presents photographs taken during the PCI inspection, and Appendix C contains detailed information on the distress types observed during the visual survey. Appendix D includes detailed work history information that was collected during the record review process.

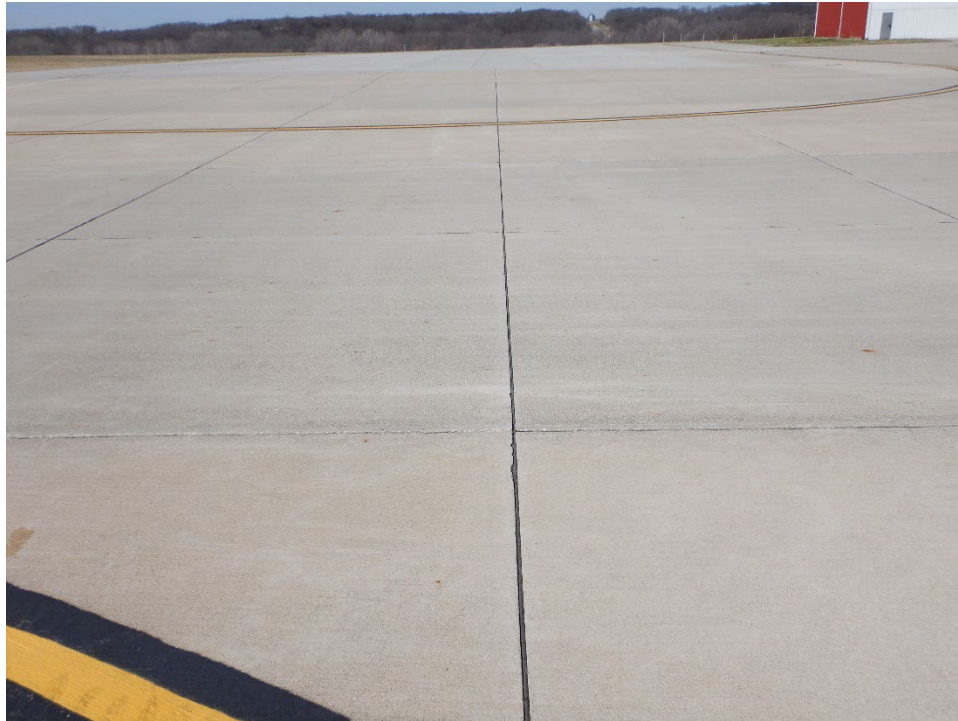
A01SC-01. Overview.

| Branch | Section | Surface Type | Section Area (sf) | LCD | 2026 PCI | % Distress Due to Load | % Distress Due to Climate/Durability | % Distress Due to Other | Type of Distress |
|---|---|---|---|---|---|---|---|---|---|
| A01SC | 01 | PCC | 24,500 | 6/1/2004 | 91 | 29 | 64 | 7 | Corner Spalling, Joint Seal Damage, LTD Cracking, Shrinkage Cracking |

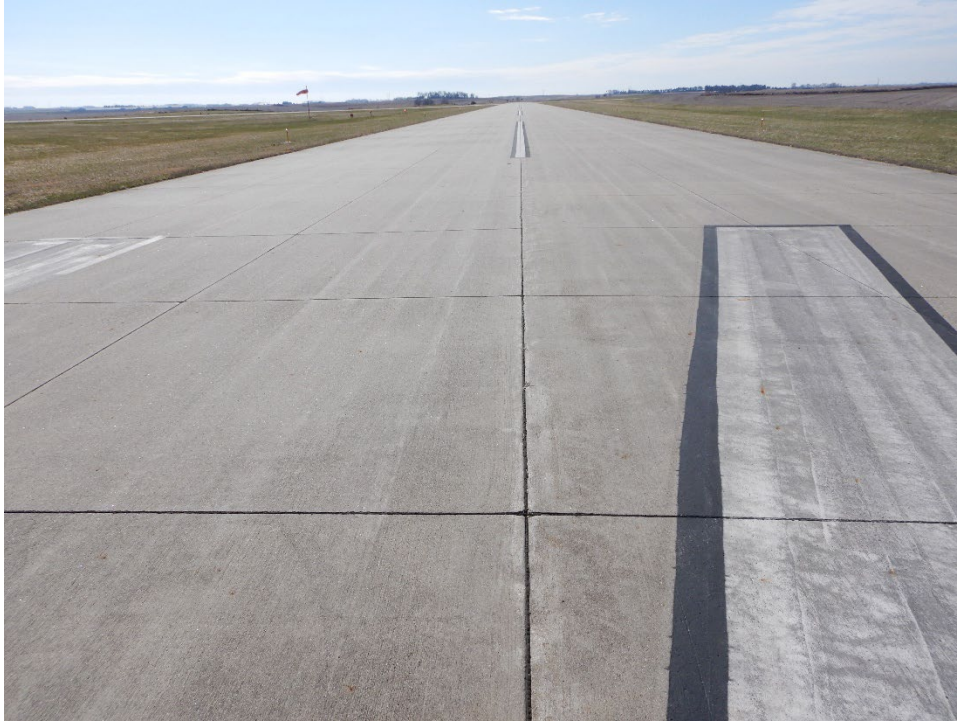
R14SC-01. Overview.

| Branch | Section | Surface Type | Section Area (sf) | LCD | 2026 PCI | % Distress Due to Load | % Distress Due to Climate/Durability | % Distress Due to Other | Type of Distress |
|---|---|---|---|---|---|---|---|---|---|
| R14SC | 01 | PCC | 145,655 | 6/1/2004 | 88 | 11 | 83 | 6 | Corner Spalling, Faulting, Joint Seal Damage, LTD Cracking |

Runway 14/32 was defined by one section. Low-severity corner spalling and faulting, medium- and high-severity joint seal damage, and medium-severity LTD cracking were observed in Section 01.

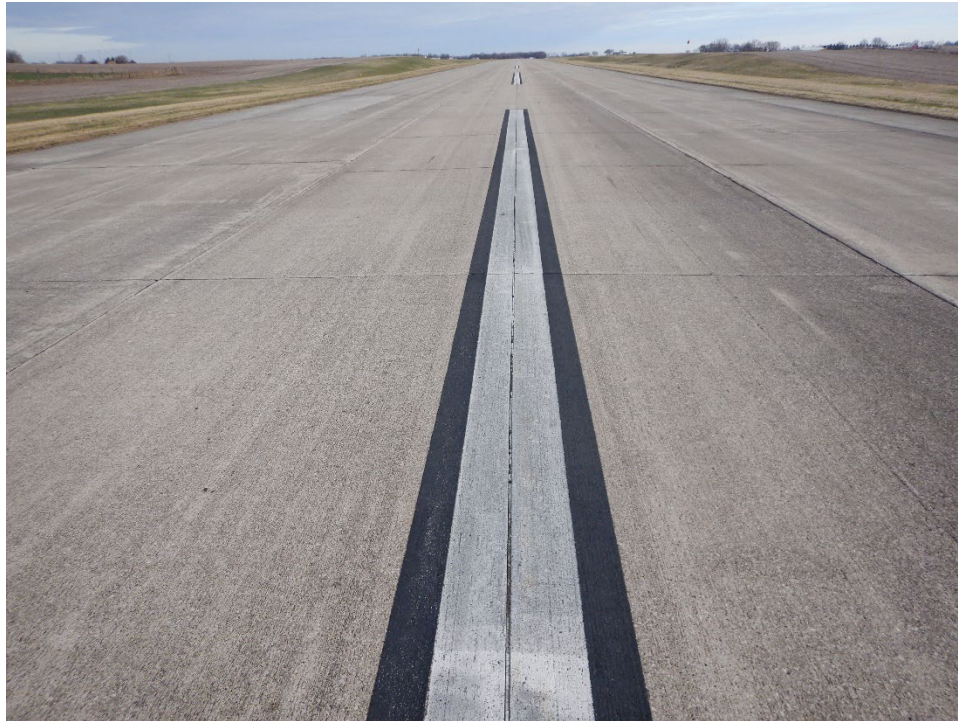
R18SC-01. Overview.

| Branch | Section | Surface Type | Section Area (sf) | LCD | 2026 PCI | % Distress Due to Load | % Distress Due to Climate/Durability | % Distress Due to Other | Type of Distress |
|---|---|---|---|---|---|---|---|---|---|
| R18SC | 01 | PCC | 219,445 | 5/1/1977 | 85 | 27 | 33 | 40 | Corner Break, Corner Spalling, Faulting, Joint Spalling, Joint Seal Damage, Large Patch, LTD Cracking |

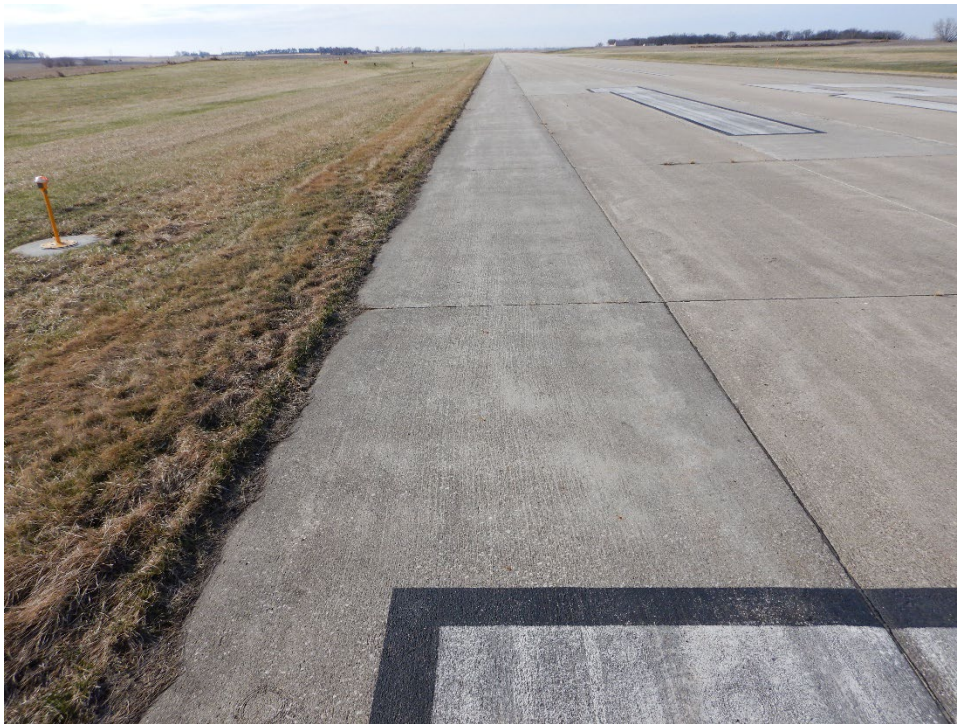
R18SC-02. Overview.

| Branch | Section | Surface Type | Section Area (sf) | LCD | 2026 PCI | % Distress Due to Load | % Distress Due to Climate/Durability | % Distress Due to Other | Type of Distress |
|---|---|---|---|---|---|---|---|---|---|
| R18SC | 02 | PCC | 9,300 | 5/1/1993 | 88 | 0 | 52 | 48 | Faulting, Joint Spalling, Joint Seal Damage |

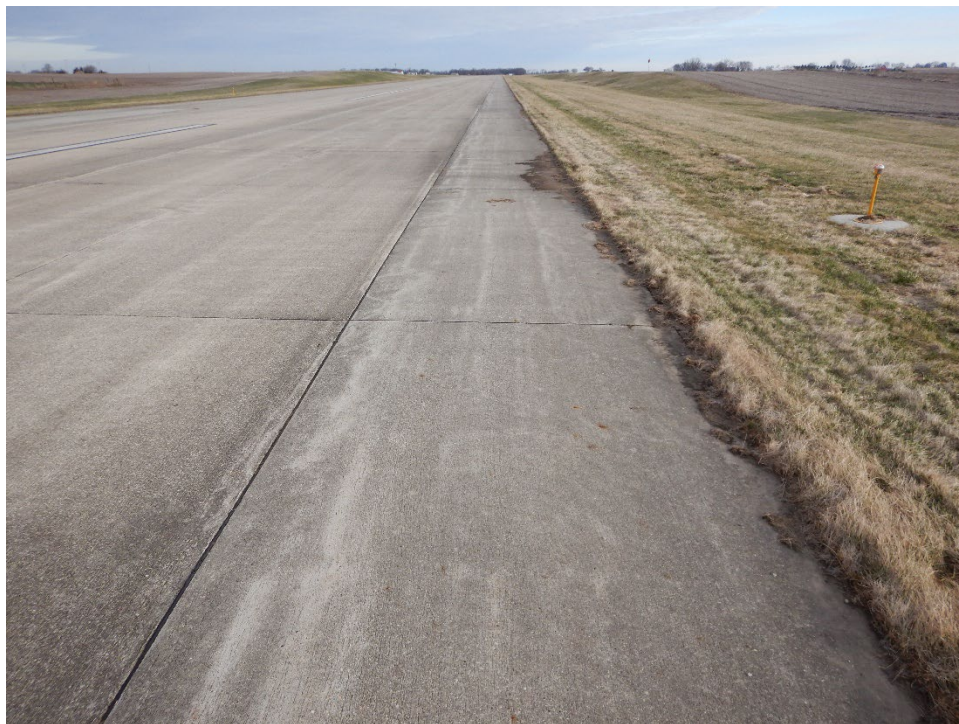
R18SC-03. Overview.

| Branch | Section | Surface Type | Section Area (sf) | LCD | 2026 PCI | % Distress Due to Load | % Distress Due to Climate/Durability | % Distress Due to Other | Type of Distress |
|---|---|---|---|---|---|---|---|---|---|
| R18SC | 03 | PCC | 15,862 | 5/1/1993 | 82 | 28 | 32 | 40 | Corner Spalling, Faulting, Joint Spalling, Joint Seal Damage, LTD Cracking |

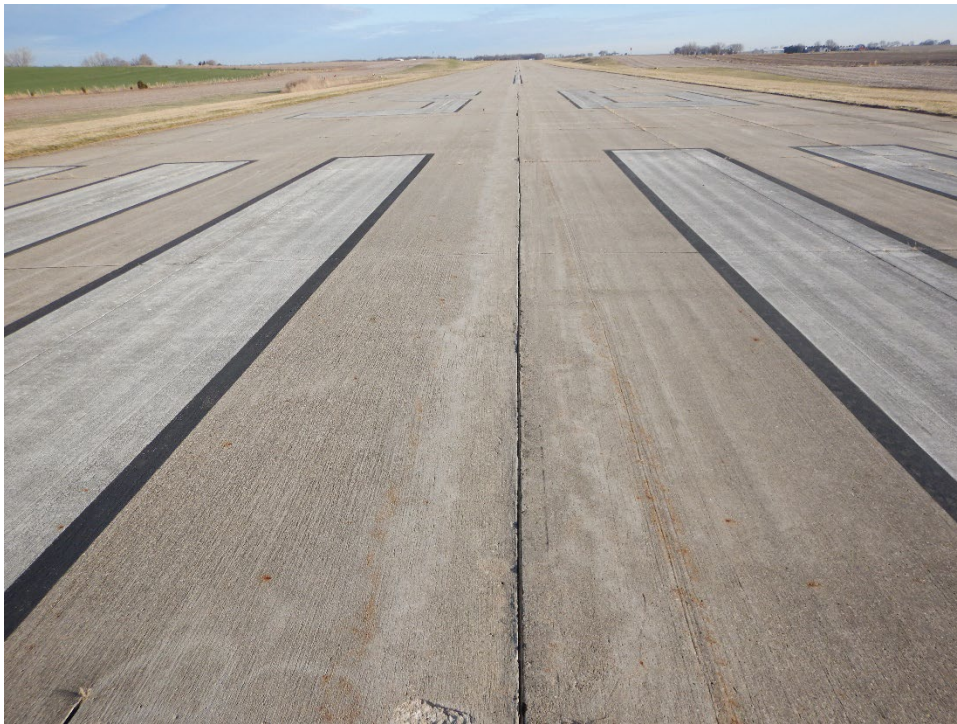
R18SC-04. Overview.

| Branch | Section | Surface Type | Section Area (sf) | LCD | 2026 PCI | % Distress Due to Load | % Distress Due to Climate/Durability | % Distress Due to Other | Type of Distress |
|---|---|---|---|---|---|---|---|---|---|
| R18SC | 04 | PCC | 55,253 | 5/2/1963 | 77 | 0 | 48 | 52 | Corner Spalling, Faulting, Joint Spalling, Joint Seal Damage, Large Patch, Shrinkage Cracking, Small Patch |

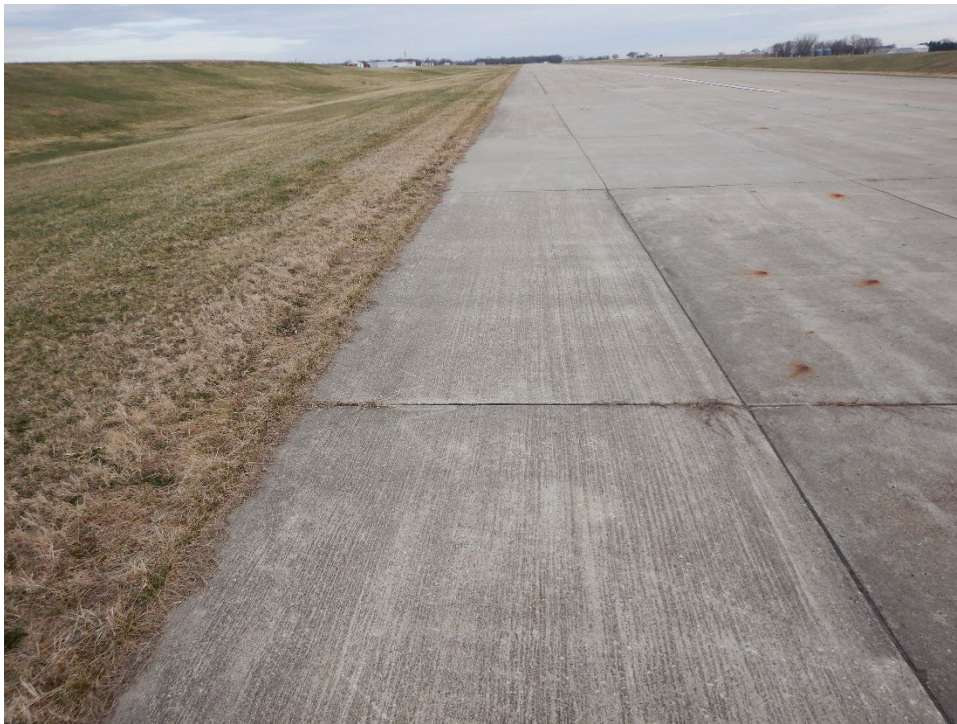
R18SC-05. Overview.

| Branch | Section | Surface Type | Section Area (sf) | LCD | 2026 PCI | % Distress Due to Load | % Distress Due to Climate/Durability | % Distress Due to Other | Type of Distress |
|---|---|---|---|---|---|---|---|---|---|
| R18SC | 05 | PCC | 15,891 | 5/1/1993 | 71 | 44 | 18 | 38 | Faulting, Joint Spalling, Joint Seal Damage, LTD Cracking |

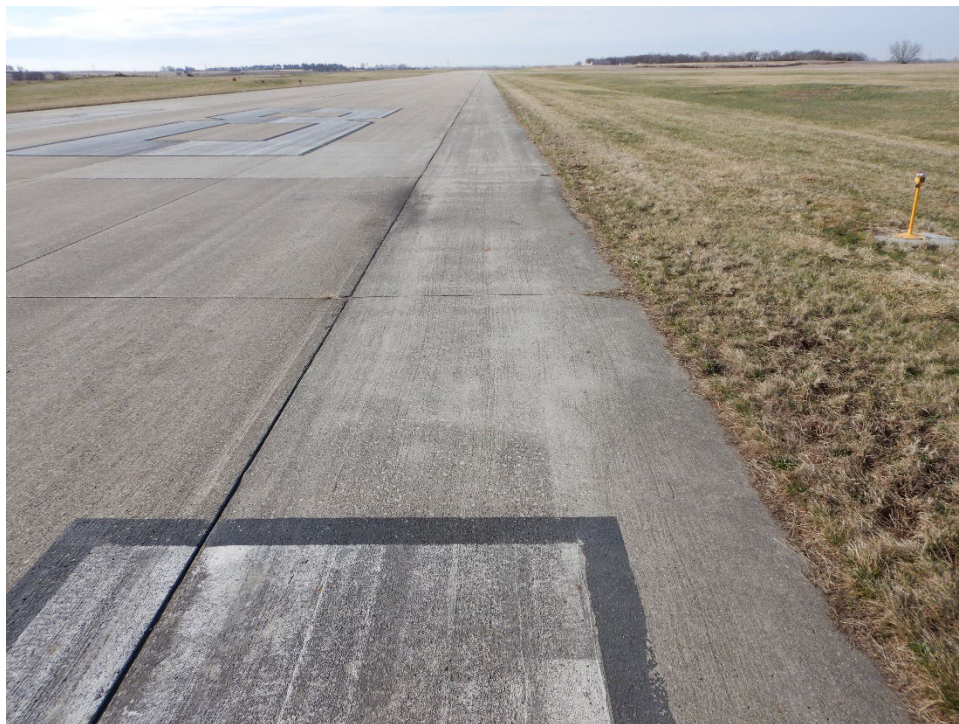
R18SC-06. Overview.

| Branch | Section | Surface Type | Section Area (sf) | LCD | 2026 PCI | % Distress Due to Load | % Distress Due to Climate/Durability | % Distress Due to Other | Type of Distress |
|---|---|---|---|---|---|---|---|---|---|
| R18SC | 06 | PCC | 8,693 | 5/1/1993 | 72 | 34 | 20 | 46 | Corner Spalling, Faulting, Joint Spalling, Joint Seal Damage, LTD Cracking |

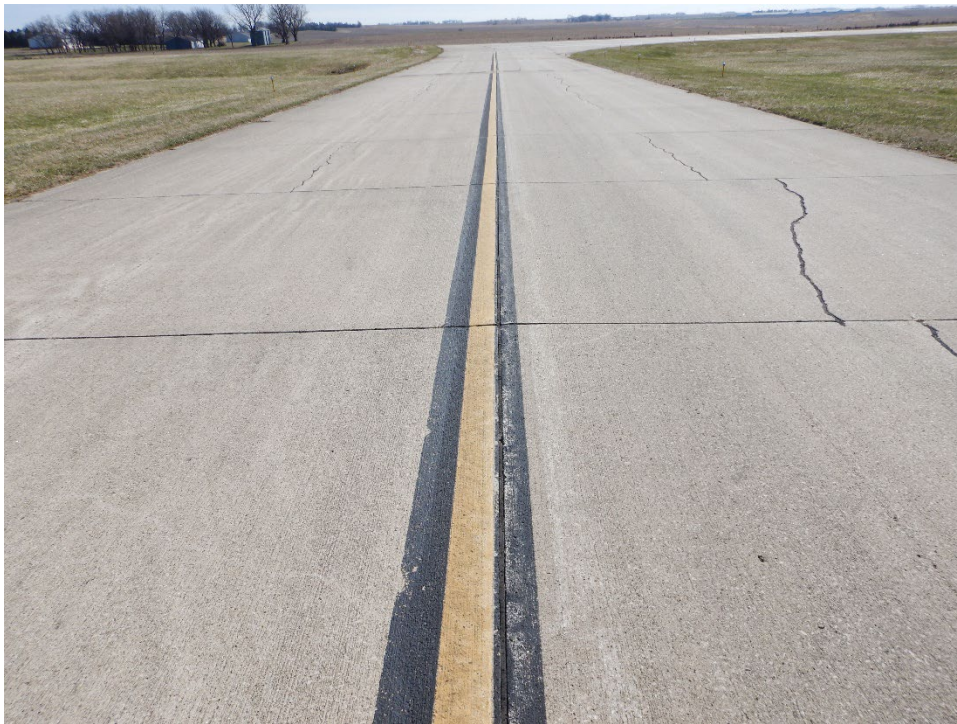
T01SC-01. Overview.

| Branch | Section | Surface Type | Section Area (sf) | LCD | 2026 PCI | % Distress Due to Load | % Distress Due to Climate/Durability | % Distress Due to Other | Type of Distress |
|---|---|---|---|---|---|---|---|---|---|
| T01SC | 01 | PCC | 17,926 | 5/1/1977 | 54 | 74 | 10 | 16 | Corner Break, Corner Spalling, Faulting, Joint Spalling, Joint Seal Damage, LTD Cracking, Shattered Slab, Shrinkage Cracking, Small Patch |

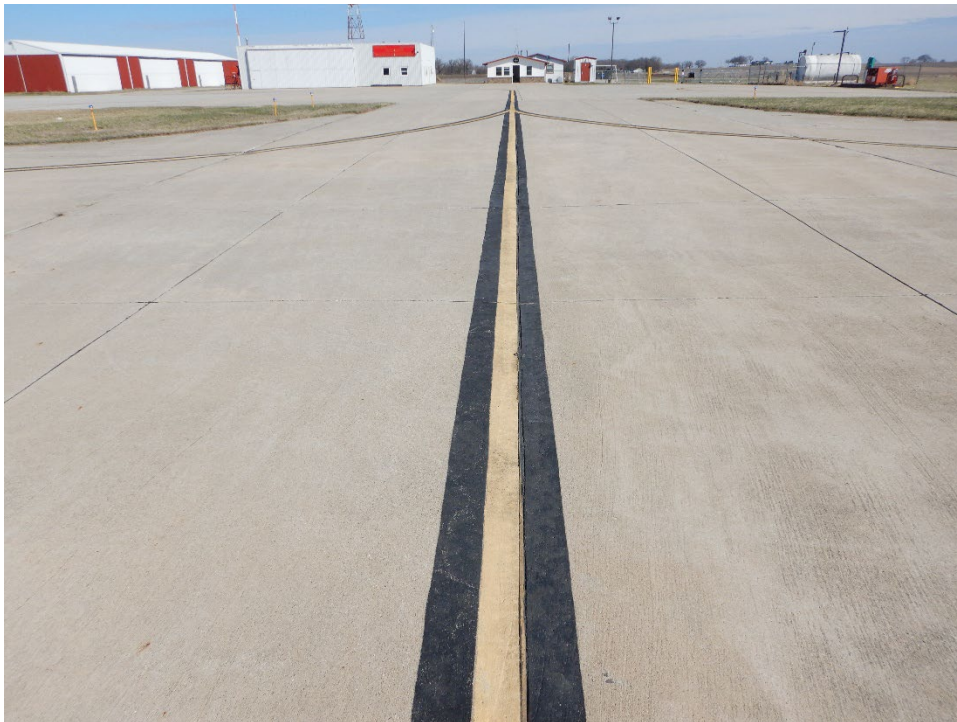
T01SC-02. Overview.

| Branch | Section | Surface Type | Section Area (sf) | LCD | 2026 PCI | % Distress Due to Load | % Distress Due to Climate/Durability | % Distress Due to Other | Type of Distress |
|---|---|---|---|---|---|---|---|---|---|
| T01SC | 02 | PCC | 7,360 | 5/1/2004 | 82 | 0 | 30 | 70 | Faulting, Joint Spalling, Joint Seal Damage |

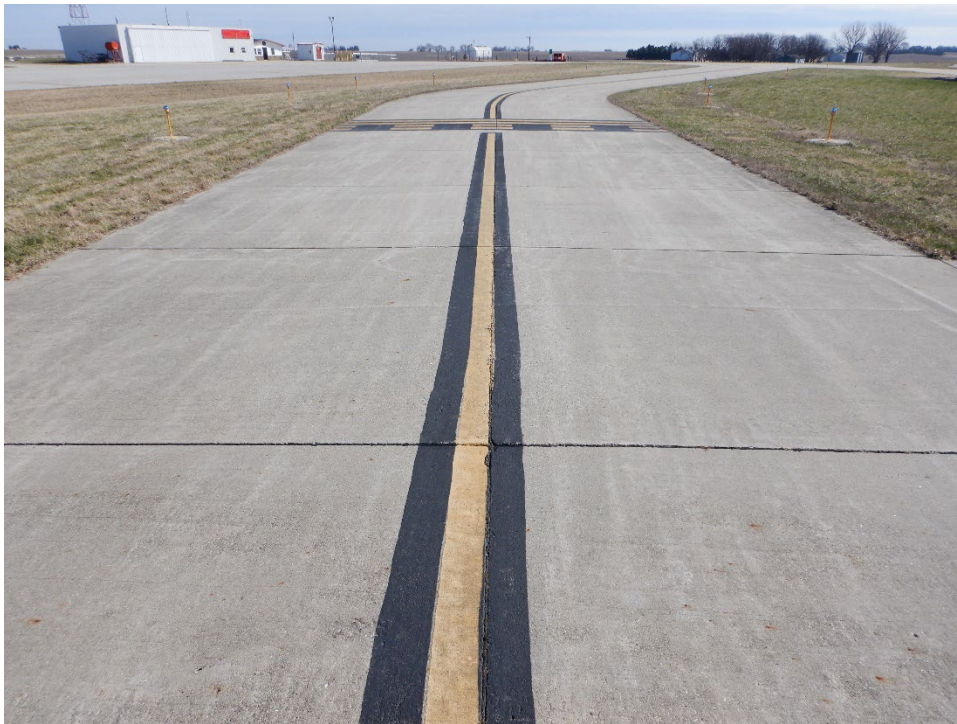
T02SC-01. Overview.

| Branch | Section | Surface Type | Section Area (sf) | LCD | 2026 PCI | % Distress Due to Load | % Distress Due to Climate/Durability | % Distress Due to Other | Type of Distress |
|---|---|---|---|---|---|---|---|---|---|
| T02SC | 01 | PCC | 9,257 | 6/1/2004 | 79 | 23 | 50 | 27 | Corner Break, Corner Spalling, Faulting, Joint Spalling, Joint Seal Damage, LTD Cracking, Shrinkage Cracking |

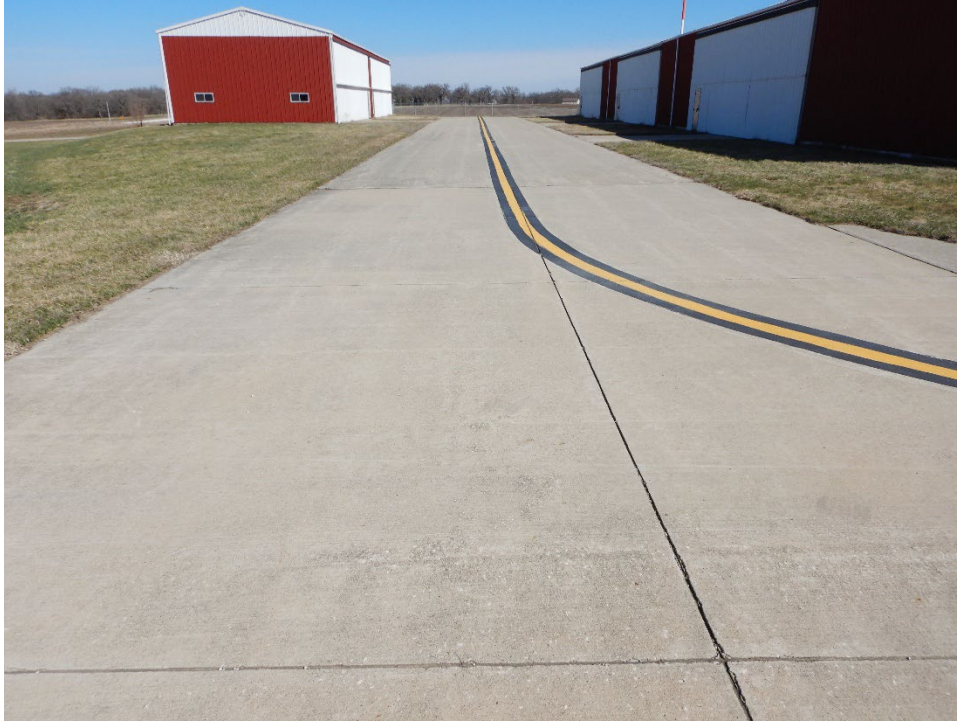
TH01SC-01. Overview.

| Branch | Section | Surface Type | Section Area (sf) | LCD | 2026 PCI | % Distress Due to Load | % Distress Due to Climate/Durability | % Distress Due to Other | Type of Distress |
|---|---|---|---|---|---|---|---|---|---|
| TH01SC | 01 | PCC | 18,380 | 6/1/2004 | 81 | 46 | 32 | 22 | Corner Break, Corner Spalling, Faulting, Joint Spalling, Joint Seal Damage, LTD Cracking, Shrinkage Cracking |
