Sheldon Regional Airport

Pavement Management Report

JULY 2023

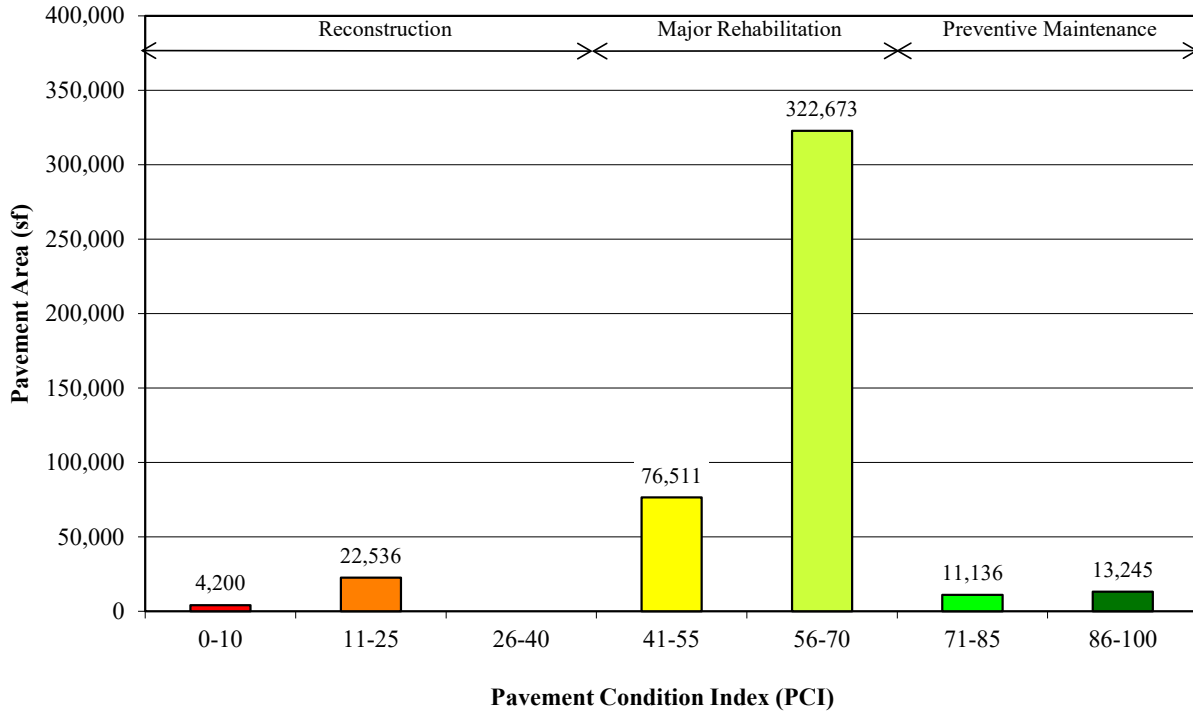
Figure 6. Pavement area by PCI range at Sheldon Regional Airport.

The pavements at Sheldon Regional Airport were inspected in November 2022. The 2022 area-weighted condition of Sheldon Regional Airport is 56, with conditions ranging from 3 to 89 (on a scale of 0 [failed] to 100 [excellent]). During the previous pavement inspection in 2019, the area-weighted PCI of the airport was 92.

Figure 6 summarizes the overall condition of the pavements at Sheldon Regional Airport, and Figure 7 presents area-weighted condition (average PCI adjusted to account for the relative size of the pavement sections) by branch use. Figure 8 is a map that displays the condition of the evaluated pavements. Table 1 summarizes the results of the pavement evaluation. Appendix B presents photographs taken during the PCI inspection, and Appendix C contains detailed information on the distress types observed during the visual survey. Appendix D includes detailed work history information that was collected during the record review process.
