# Sheldon Regional Airport

## Pavement Management Report

**AUGUST 2026**

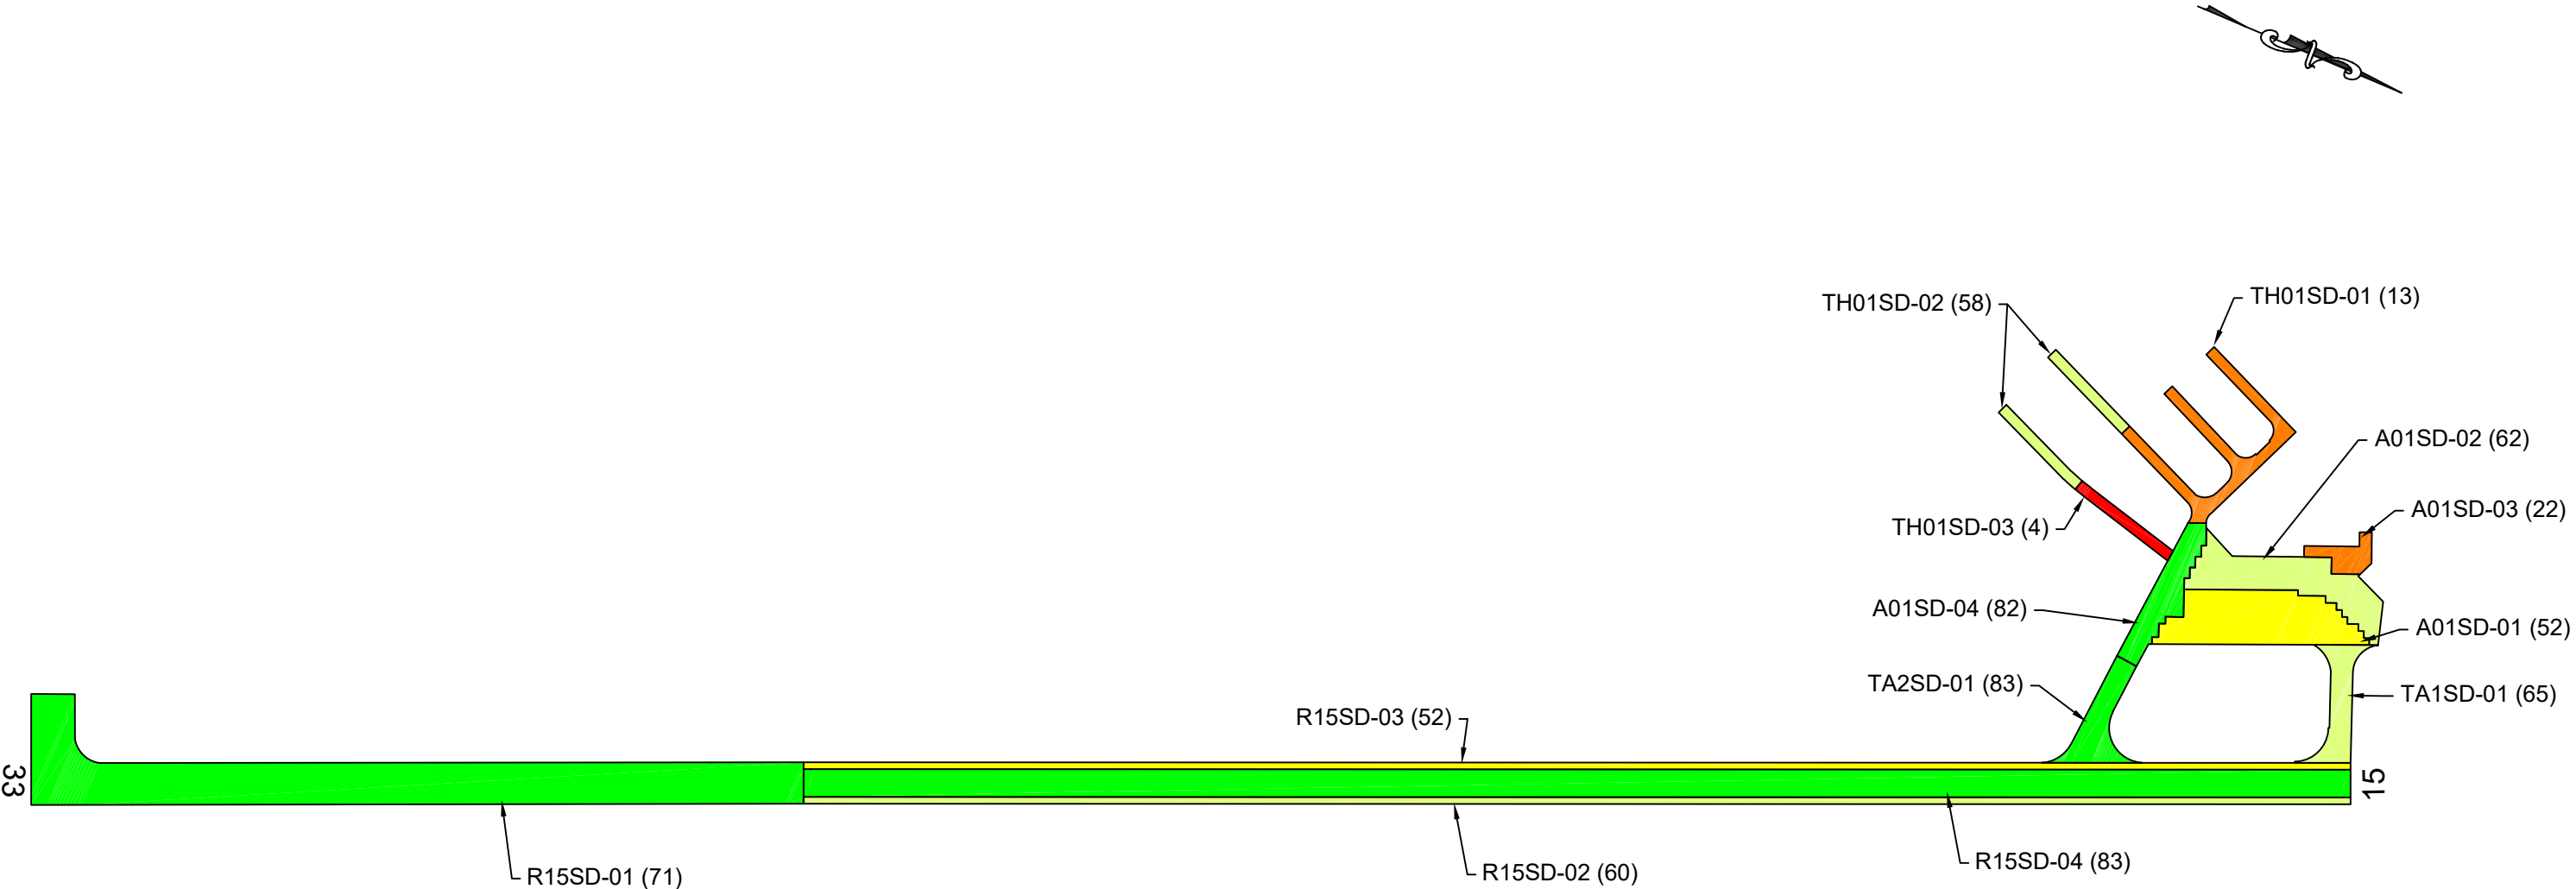
FIGURE 8. PCI MAP.

The pavements at Sheldon Regional Airport were inspected in March 2026. The 2026 area-weighted condition of Sheldon Regional Airport is 68, with conditions ranging from 4 to 83 (on a scale of 0 [*Failed*] to 100 [*Excellent*]). During the previous pavement inspection in 2022, the area-weighted PCI of the airport was 56.

Figure 6 summarizes the overall condition of the pavements at Sheldon Regional Airport, and Figure 7 presents area-weighted condition (average PCI adjusted to account for the relative size of the pavement sections) by branch use. Figure 8 is a map that displays the condition of the evaluated pavements. Table 1 summarizes the results of the pavement evaluation. Appendix B presents photographs taken during the PCI inspection, and Appendix C contains detailed information on the distress types observed during the visual survey. Appendix D includes detailed work history information that was collected during the record review process.

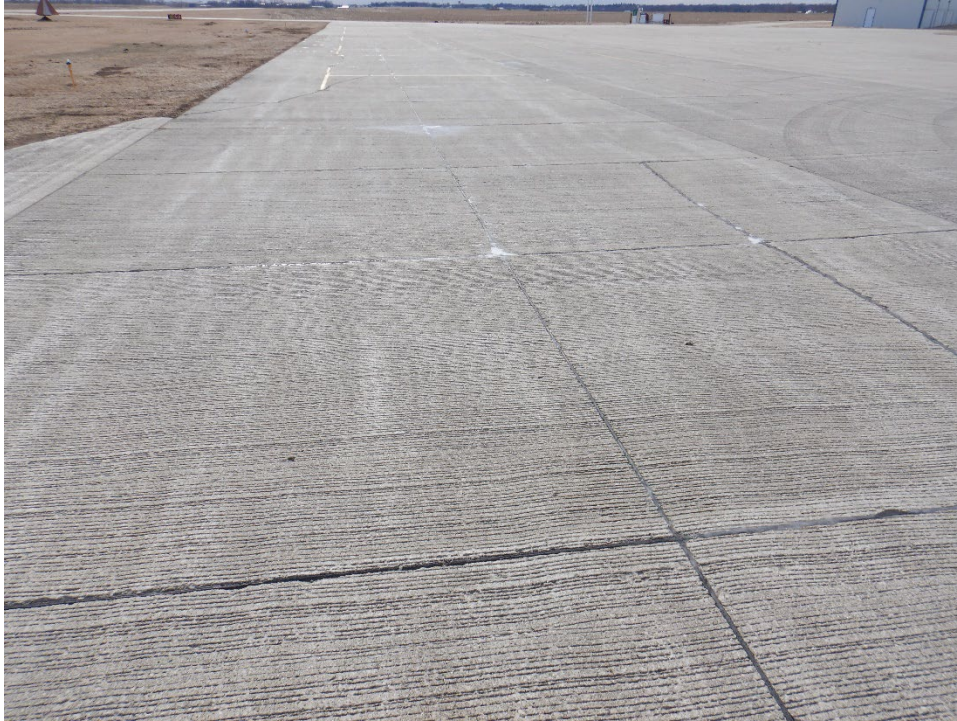
A01SD-01. Overview.

| Branch | Section | Surface Type | Section Area (sf) | LCD | 2026 PCI | % Distress Due to Load | % Distress Due to Climate/Durability | % Distress Due to Other | Type of Distress |
|---|---|---|---|---|---|---|---|---|---|
| A01SD | 01 | PCC | 30,939 | 6/1/1980 | 52 | 62 | 18 | 20 | Corner Break, Corner Spalling, Durability Cracking, Faulting, Joint Spalling, Joint Seal Damage, LTD Cracking, Shattered Slab, Shrinkage Cracking, Small Patch |

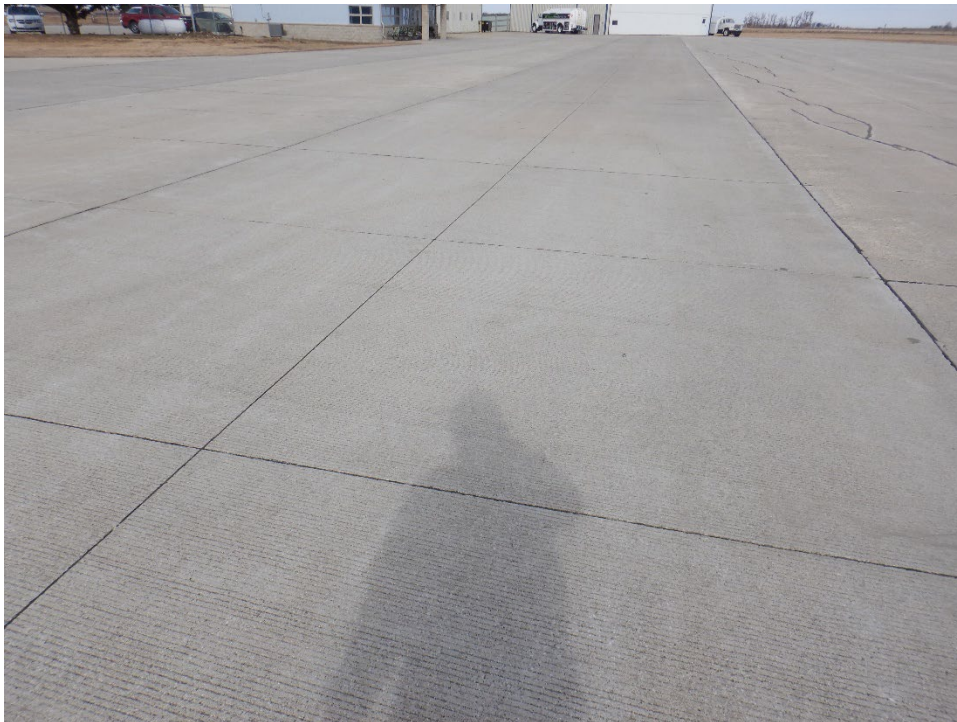
A01SD-02. Overview.

| Branch | Section | Surface Type | Section Area (sf) | LCD | 2026 PCI | % Distress Due to Load | % Distress Due to Climate/Durability | % Distress Due to Other | Type of Distress |
|---|---|---|---|---|---|---|---|---|---|
| A01SD | 02 | PCC | 25,082 | 6/1/2004 | 62 | 63 | 12 | 25 | Corner Break, Corner Spalling, Faulting, Joint Spalling, Joint Seal Damage, LTD Cracking, Shattered Slab |

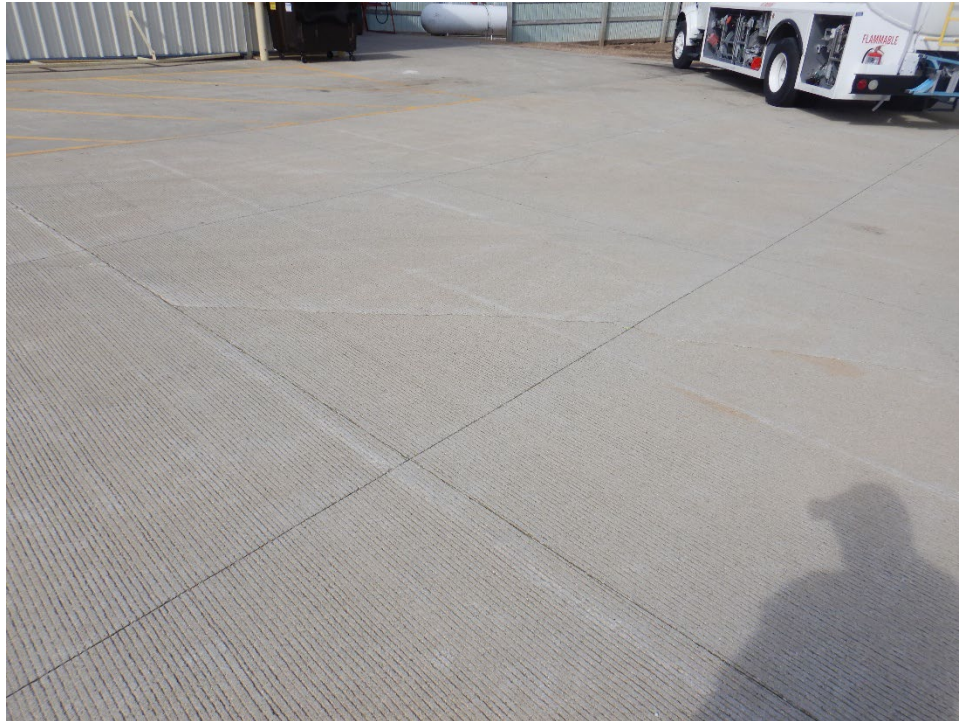
A01SD-03. Overview.

| Branch | Section | Surface Type | Section Area (sf) | LCD | 2026 PCI | % Distress Due to Load | % Distress Due to Climate/Durability | % Distress Due to Other | Type of Distress |
|---|---|---|---|---|---|---|---|---|---|
| A01SD | 03 | PCC | 4,996 | 6/3/2009 | 22 | 80 | 9 | 11 | Corner Break, Corner Spalling, Faulting, Joint Spalling, Joint Seal Damage, Large Patch, LTD Cracking, Shattered Slab |

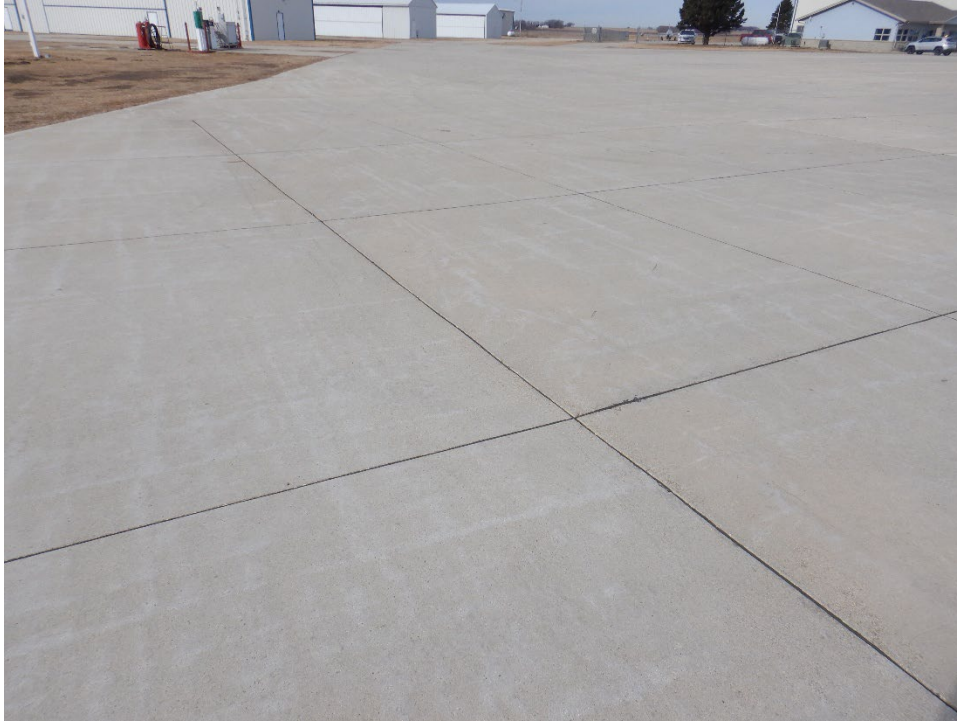
A01SD-04. Overview.

| Branch | Section | Surface Type | Section Area (sf) | LCD | 2026 PCI | % Distress Due to Load | % Distress Due to Climate/Durability | % Distress Due to Other | Type of Distress |
|---|---|---|---|---|---|---|---|---|---|
| A01SD | 04 | PCC | 13,245 | 6/3/2013 | 82 | 53 | 33 | 14 | Corner Break, Corner Spalling, Joint Spalling, Joint Seal Damage, LTD Cracking, Shattered Slab |

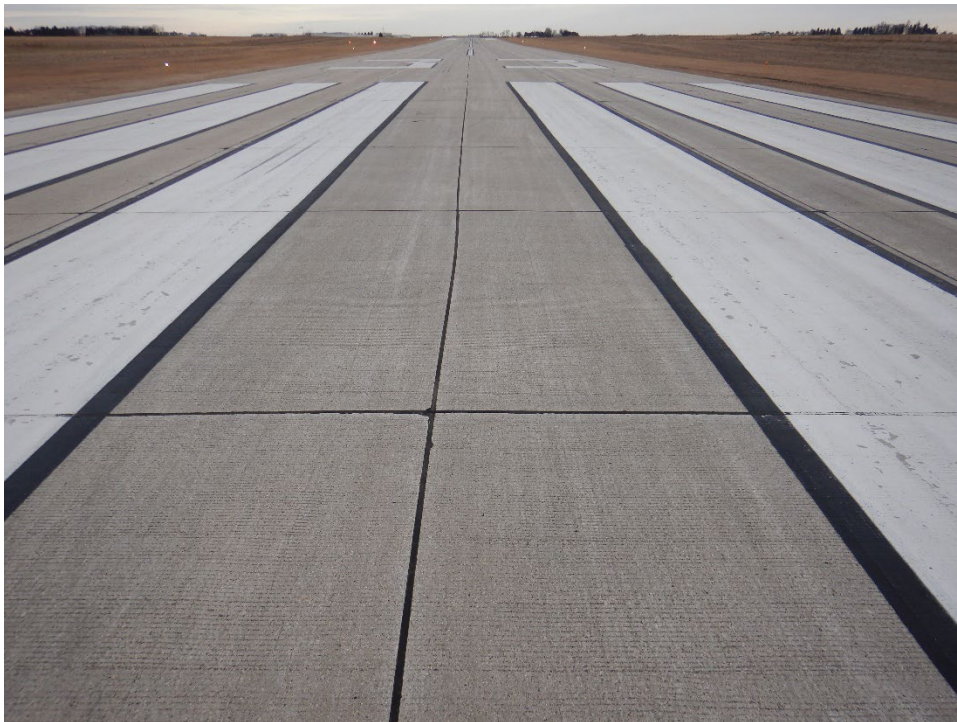
R15SD-01. Overview.

| Branch | Section | Surface Type | Section Area (sf) | LCD | 2026 PCI | % Distress Due to Load | % Distress Due to Climate/Durability | % Distress Due to Other | Type of Distress |
|---|---|---|---|---|---|---|---|---|---|
| R15SD | 01 | PCC | 114,791 | 6/1/1980 | 71 | 22 | 0 | 78 | Corner Spalling, Faulting, Joint Spalling, Large Patch, LTD Cracking, Shrinkage Cracking, Small Patch |

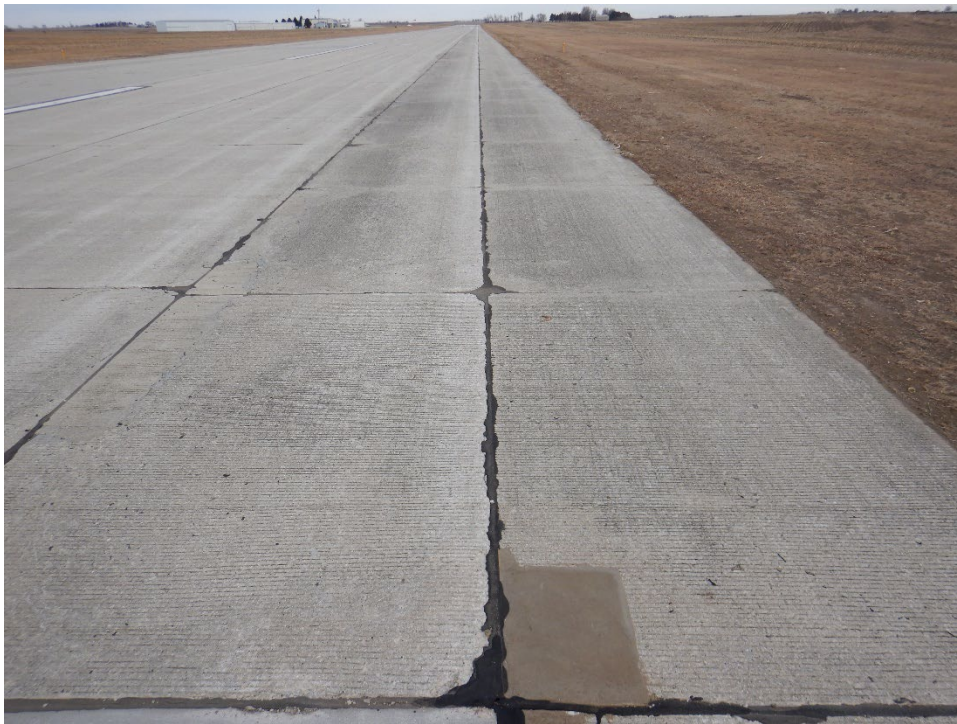
R15SD-02. Overview.

| Branch | Section | Surface Type | Section Area (sf) | LCD | 2026 PCI | % Distress Due to Load | % Distress Due to Climate/Durability | % Distress Due to Other | Type of Distress |
|---|---|---|---|---|---|---|---|---|---|
| R15SD | 02 | PCC | 35,000 | 6/1/1980 | 60 | 4 | 4 | 92 | Corner Break, Corner Spalling, Faulting, Joint Spalling, Joint Seal Damage, Large Patch, LTD Cracking, Shrinkage Cracking, Small Patch |

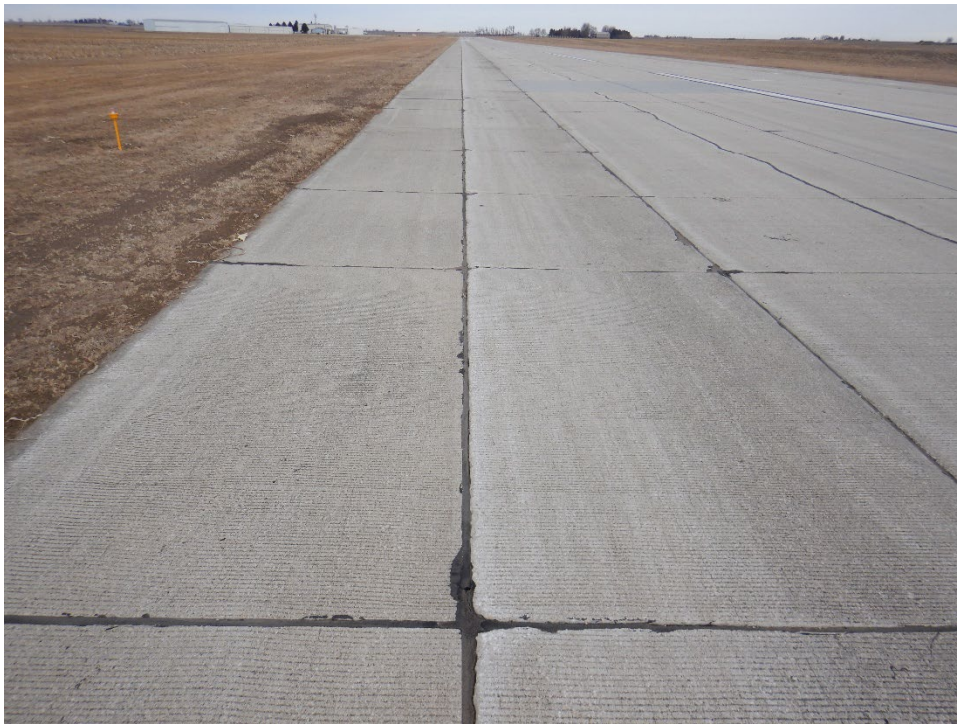
R15SD-03. Overview.

| Branch | Section | Surface Type | Section Area (sf) | LCD | 2026 PCI | % Distress Due to Load | % Distress Due to Climate/Durability | % Distress Due to Other | Type of Distress |
|---|---|---|---|---|---|---|---|---|---|
| R15SD | 03 | PCC | 35,000 | 6/1/1980 | 52 | 9 | 3 | 88 | Corner Break, Corner Spalling, Faulting, Joint Spalling, Joint Seal Damage, LTD Cracking, Small Patch |

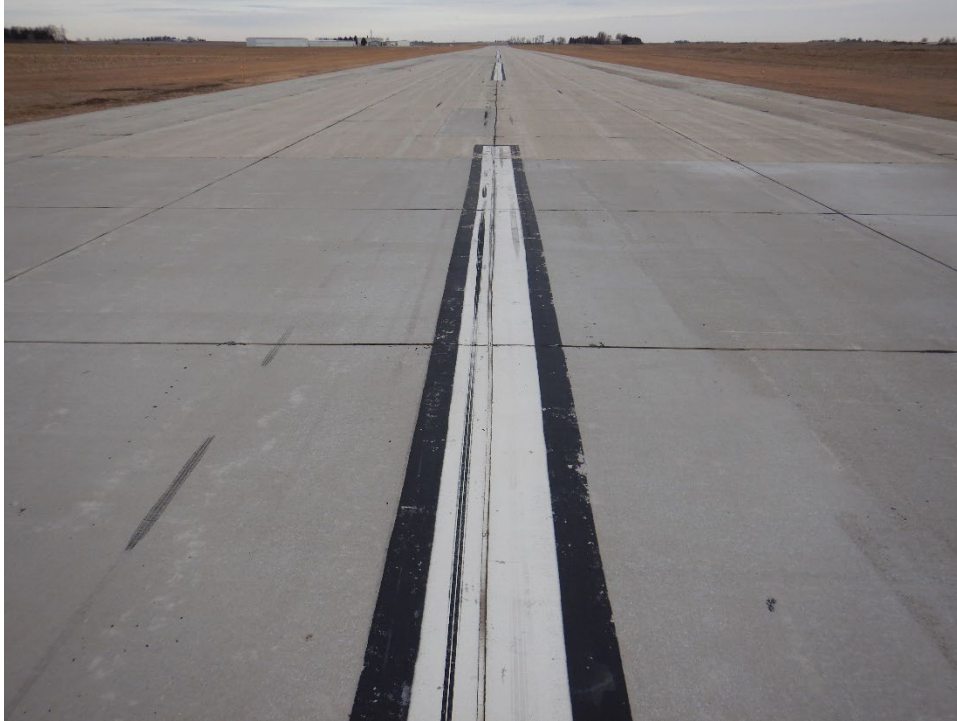
R15SD-04. Overview.

| Branch | Section | Surface Type | Section Area (sf) | LCD | 2026 PCI | % Distress Due to Load | % Distress Due to Climate/Durability | % Distress Due to Other | Type of Distress |
|---|---|---|---|---|---|---|---|---|---|
| R15SD | 04 | PCC | 140,000 | 4/22/1991 | 83 | 36 | 10 | 54 | Corner Spalling, Faulting, Joint Spalling, Joint Seal Damage, Large Patch, LTD Cracking, Small Patch |

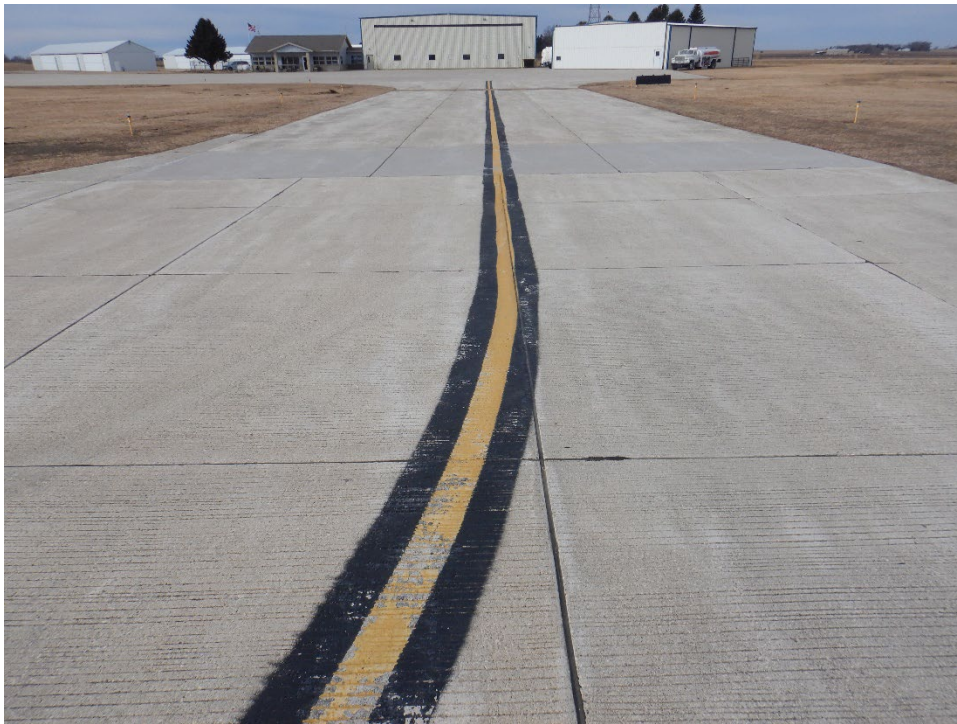
TA1SD-01. Overview.

| Branch | Section | Surface Type | Section Area (sf) | LCD | 2026 PCI | % Distress Due to Load | % Distress Due to Climate/Durability | % Distress Due to Other | Type of Distress |
|---|---|---|---|---|---|---|---|---|---|
| TA1SD | 01 | PCC | 10,572 | 6/1/1980 | 65 | 77 | 4 | 19 | Corner Break, Corner Spalling, Faulting, Joint Spalling, Joint Seal Damage, LTD Cracking, Shattered Slab, Shrinkage Cracking, Small Patch |

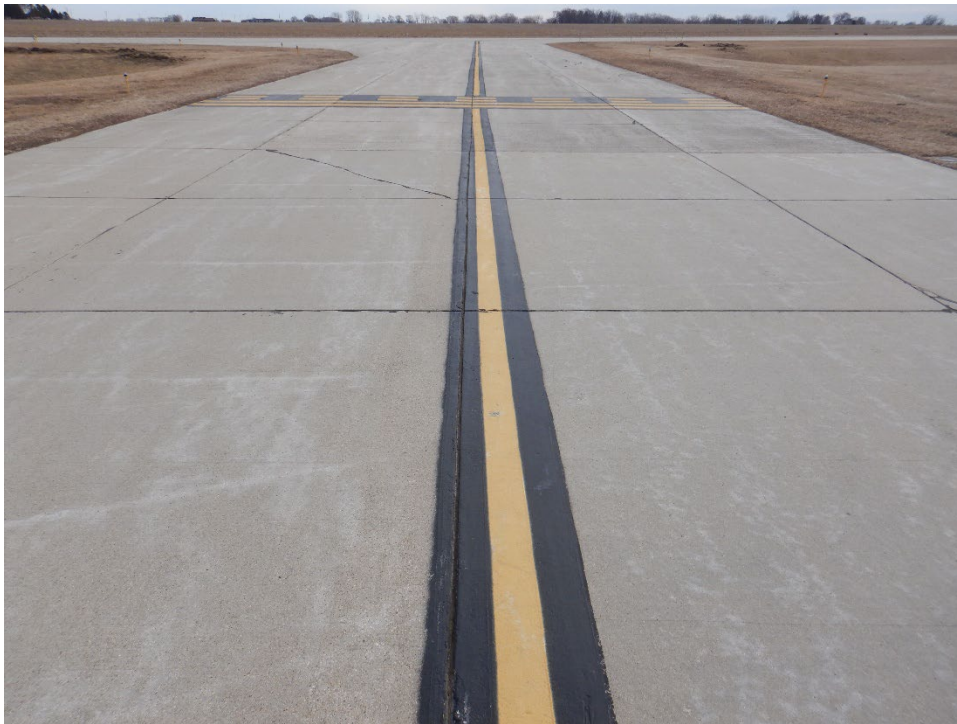
TA2SD-01. Overview.

| Branch | Section | Surface Type | Section Area (sf) | LCD | 2026 PCI | % Distress Due to Load | % Distress Due to Climate/ Durability | % Distress Due to Other | Type of Distress |
|---|---|---|---|---|---|---|---|---|---|
| TA2SD | 01 | PCC | 11,136 | 6/1/1980 | 83 | 62 | 10 | 28 | Corner Break, Corner Spalling, Joint Spalling, Joint Seal Damage, Large Patch, LTD Cracking |

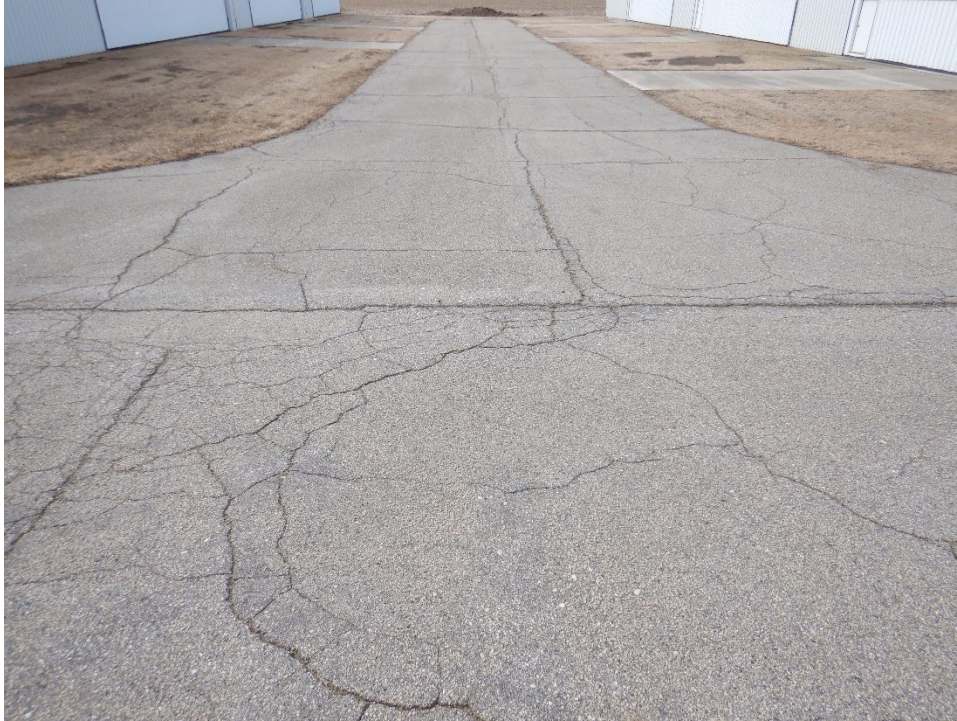
TH01SD-01. Overview.

| Branch | Section | Surface Type | Section Area (sf) | LCD | 2026 PCI | % Distress Due to Load | % Distress Due to Climate/ Durability | % Distress Due to Other | Type of Distress |
|---|---|---|---|---|---|---|---|---|---|
| TH01SD | 01 | APC | 17,540 | 1/1/1998 | 13 | 36 | 59 | 5 | Alligator Cracking, Joint Reflection Cracking, L&T Cracking, Patching, Swelling, Weathering |

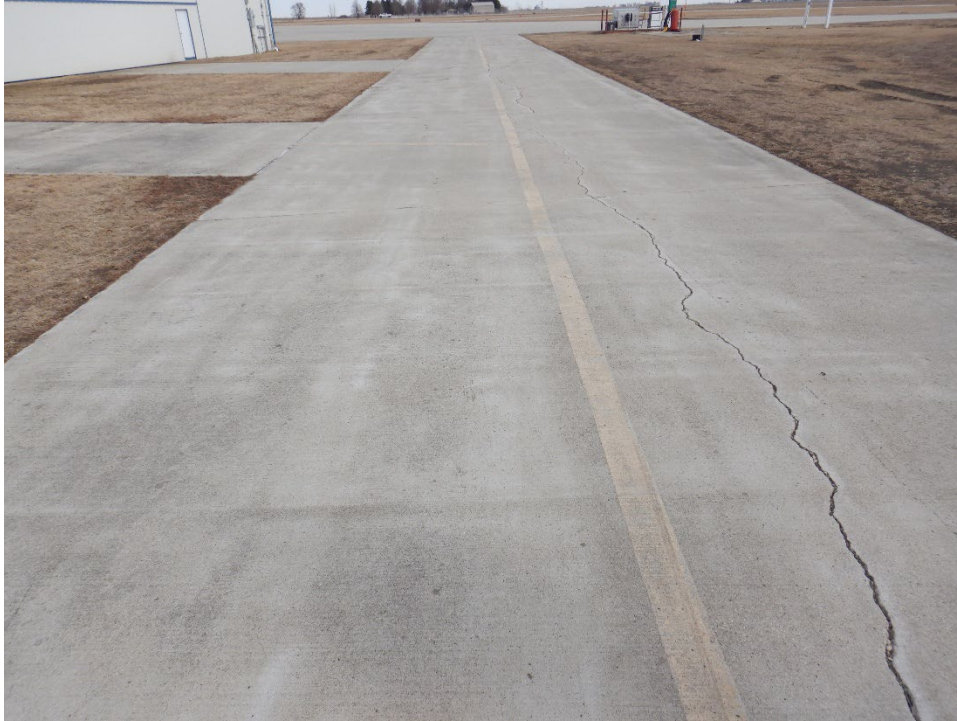
TH01SD-03. Overview.

| Branch | Section | Surface Type | Section Area (sf) | LCD | 2026 PCI | % Distress Due to Load | % Distress Due to Climate/ Durability | % Distress Due to Other | Type of Distress |
|---|---|---|---|---|---|---|---|---|---|
| TH01SD | 03 | PCC | 4,200 | 6/1/1994 | 4 | 74 | 7 | 19 | Faulting, Joint Seal Damage, LTD Cracking, Shattered Slab |
