# Sibley Municipal Airport

## Pavement Management Report

**AUGUST 2025**

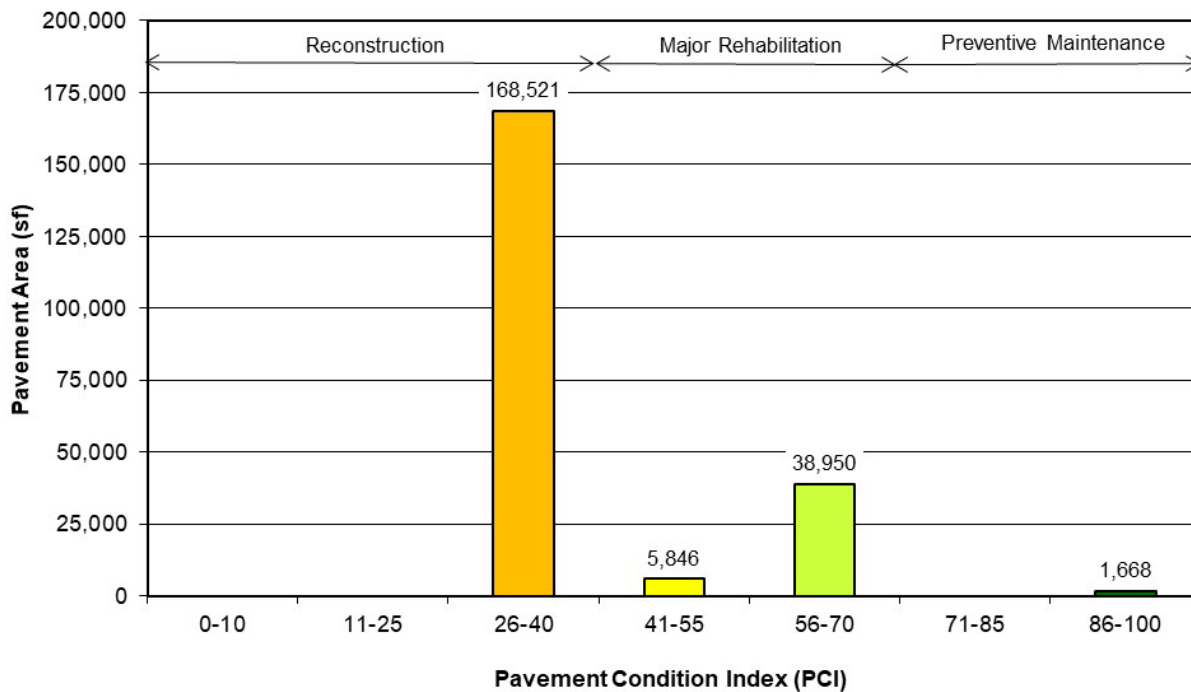
Figure 6. Pavement area by PCI range at Sibley Municipal Airport.

The pavements at Sibley Municipal Airport were inspected in March 2025. The 2025 area-weighted condition of Sibley Municipal Airport is 38, with conditions ranging from 29 to 87 (on a scale of 0 [failed] to 100 [excellent]). During the previous pavement inspection in 2018, the area-weighted PCI of the airport was 62.

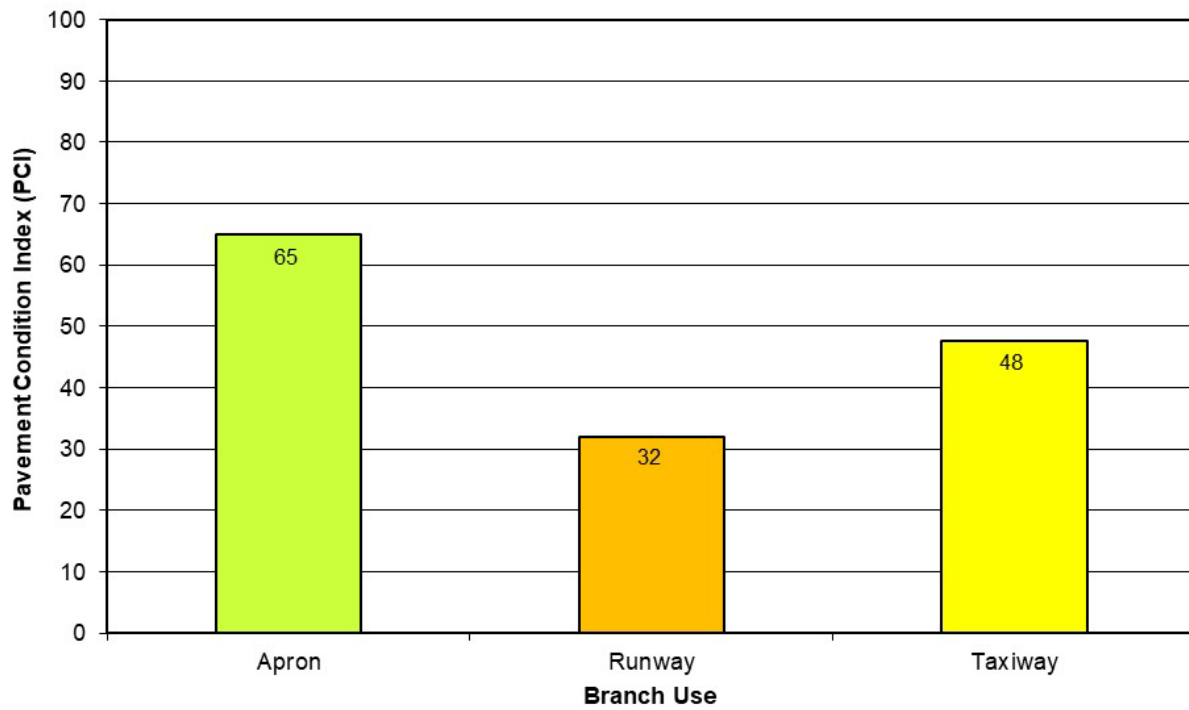
Figure 7. Area-weighted PCI by branch use at Sibley Municipal Airport.

(Values on chart are area weighted.)

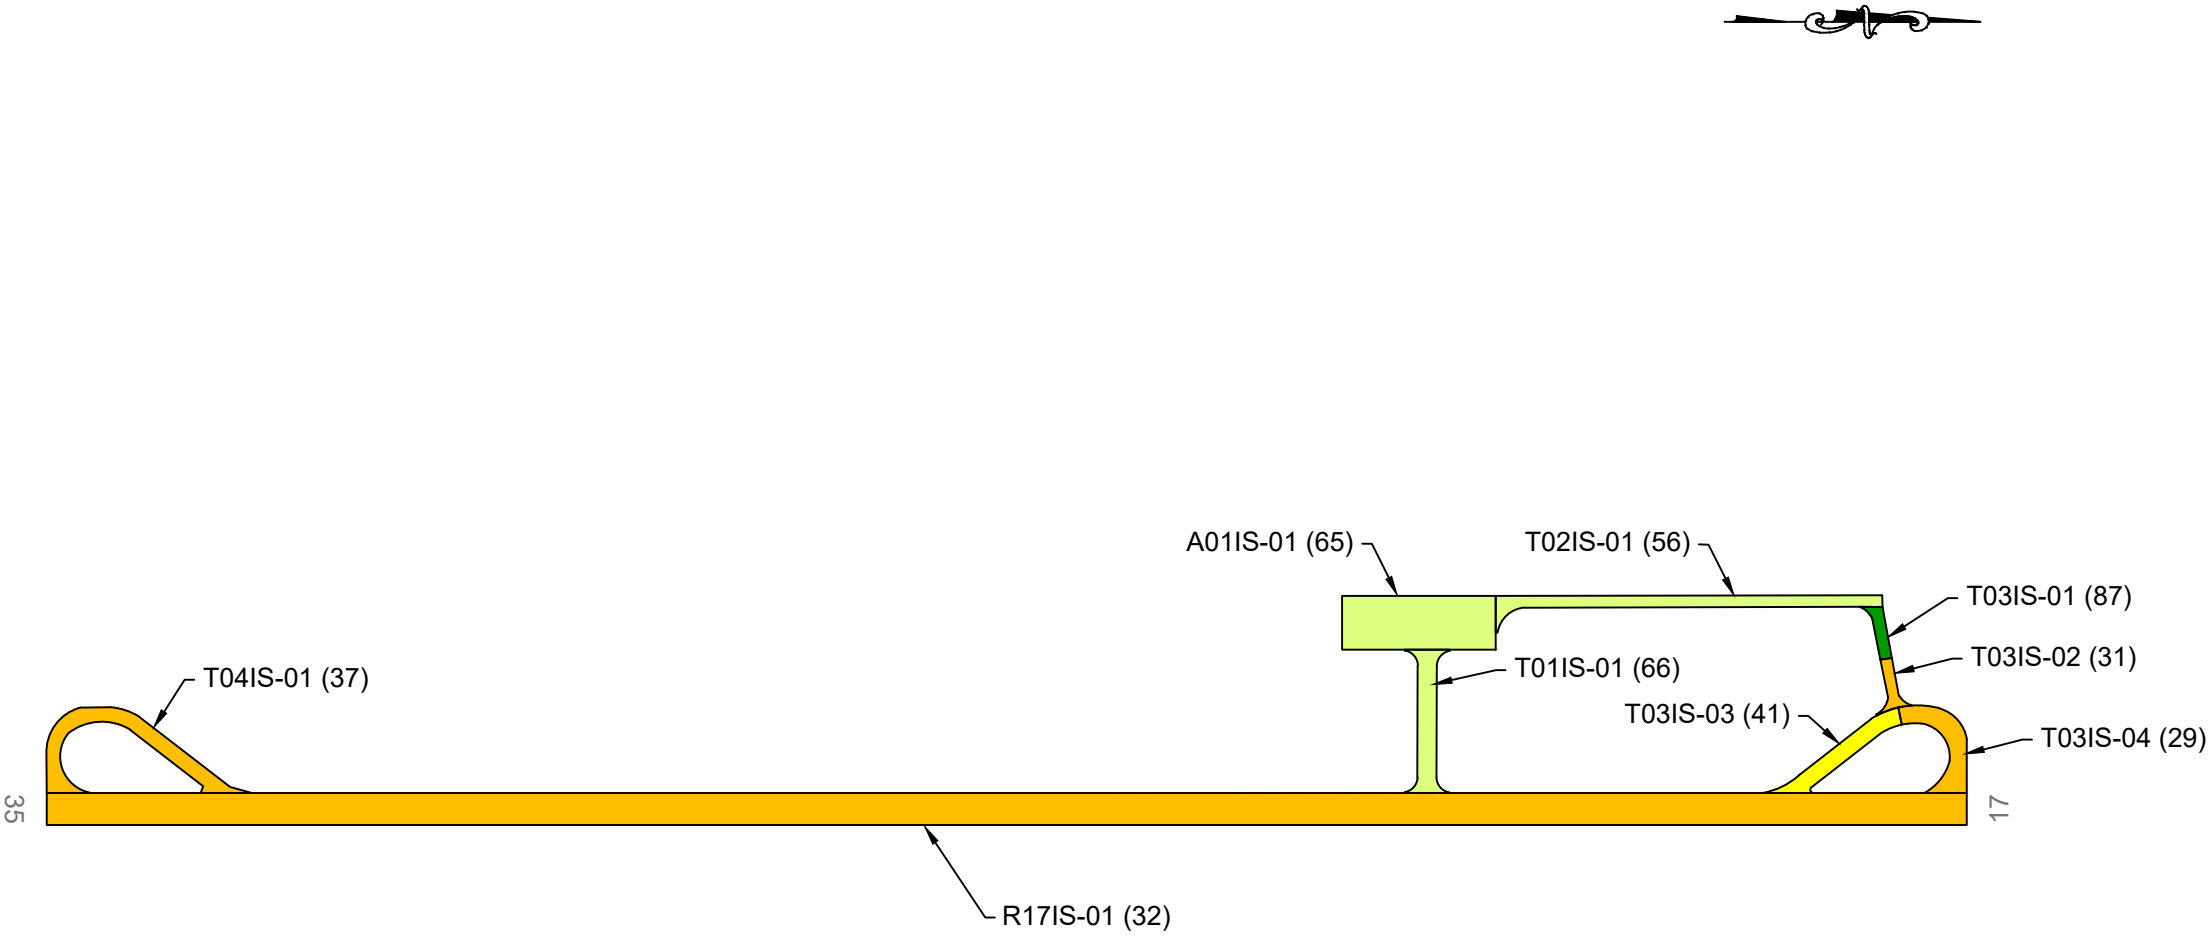
FIGURE 8. PCI MAP.

Figure 6 summarizes the overall condition of the pavements at Sibley Municipal Airport, and Figure 7 presents area-weighted condition (average PCI adjusted to account for the relative size of the pavement sections) by branch use. Figure 8 is a map that displays the condition of the evaluated pavements. Table 1 summarizes the results of the pavement evaluation. Appendix B presents photographs taken during the PCI inspection, and Appendix C contains detailed information on the distress types observed during the visual survey. Appendix D includes detailed work history information that was collected during the record review process.
