# Sioux County Regional Airport

## Pavement Management Report

**AUGUST 2026**

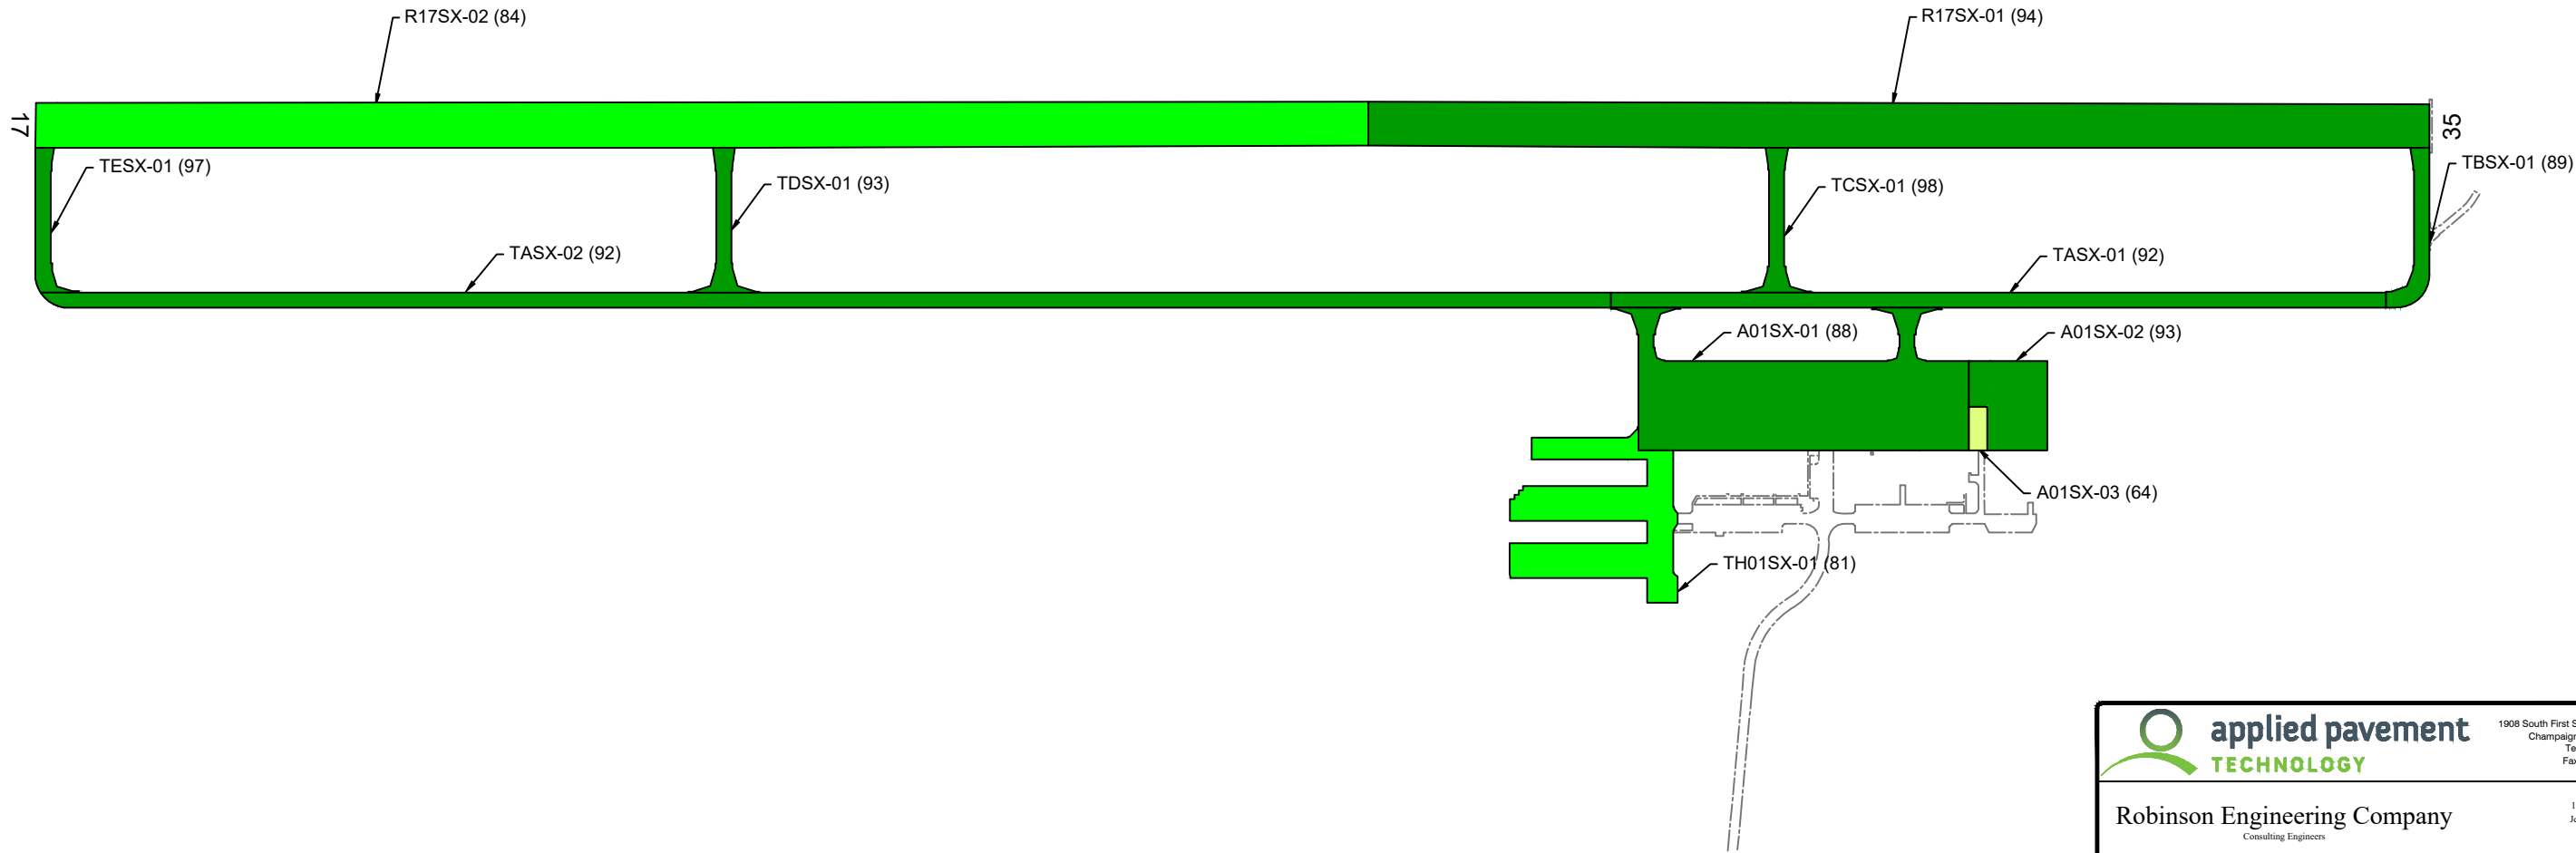
FIGURE 8. PCI MAP.

The pavements at Sioux County Regional Airport were inspected in March 2026. The 2026 area-weighted condition of Sioux County Regional Airport is 89, with conditions ranging from 64 to 98 (on a scale of 0 [Failed] to 100 [Excellent]). During the previous pavement inspection in 2022, the area-weighted PCI of the airport was 93.

Figure 6 summarizes the overall condition of the pavements at Sioux County Regional Airport, and Figure 7 presents area-weighted condition (average PCI adjusted to account for the relative size of the pavement sections) by branch use. Figure 8 is a map that displays the condition of the evaluated pavements. Table 1 summarizes the results of the pavement evaluation. Appendix B presents photographs taken during the PCI inspection, and Appendix C contains detailed information on the distress types observed during the visual survey. Appendix D includes detailed work history information that was collected during the record review process.

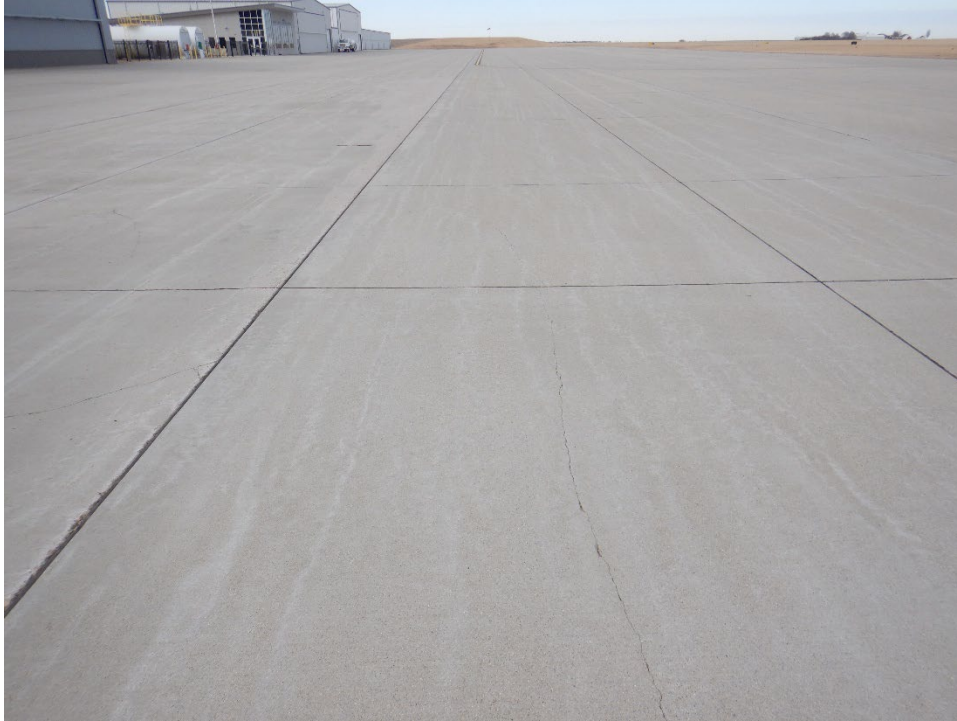
A01SX-01. Overview.

| Branch | Section | Surface Type | Section Area (sf) | LCD | 2026 PCI | % Distress Due to Load | % Distress Due to Climate/Durability | % Distress Due to Other | Type of Distress |
|---|---|---|---|---|---|---|---|---|---|
| A01SX | 01 | PCC | 168,530 | 5/3/2017 | 88 | 25 | 50 | 25 | ASR, Corner Spalling, Joint Spalling, Joint Seal Damage, LTD Cracking, Shattered Slab, Shrinkage Cracking, Small Patch |

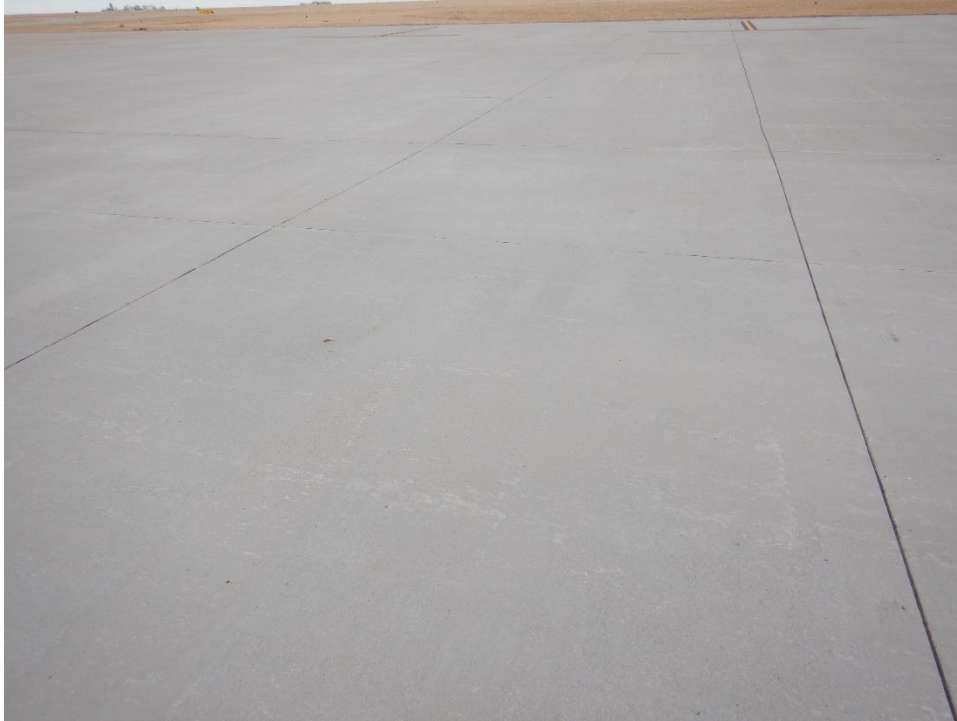
A01SX-02. Overview.

| Branch | Section | Surface Type | Section Area (sf) | LCD | 2026 PCI | % Distress Due to Load | % Distress Due to Climate/Durability | % Distress Due to Other | Type of Distress |
|---|---|---|---|---|---|---|---|---|---|
| A01SX | 02 | PCC | 32,715 | 6/3/2021 | 93 | 0 | 94 | 6 | Corner Spalling, Joint Seal Damage |

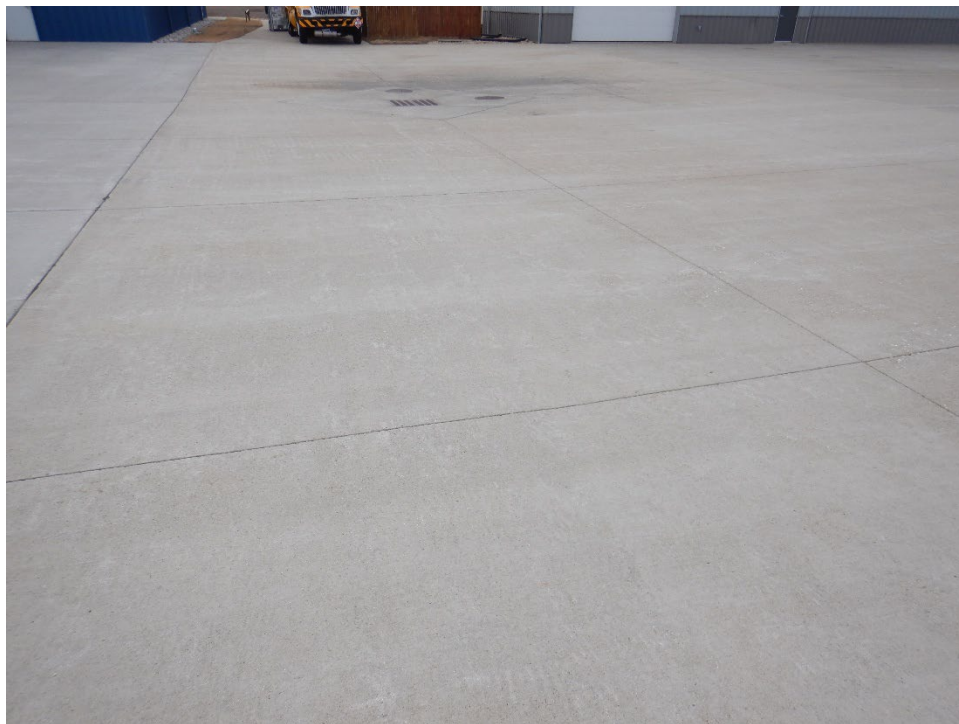
A01SX-03. Overview.

| Branch | Section | Surface Type | Section Area (sf) | LCD | 2026 PCI | % Distress Due to Load | % Distress Due to Climate/Durability | % Distress Due to Other | Type of Distress |
|---|---|---|---|---|---|---|---|---|---|
| A01SX | 03 | PCC | 4,200 | 7/1/2017 | 64 | 77 | 23 | 0 | Joint Seal Damage, LTD Cracking, Shattered Slab |

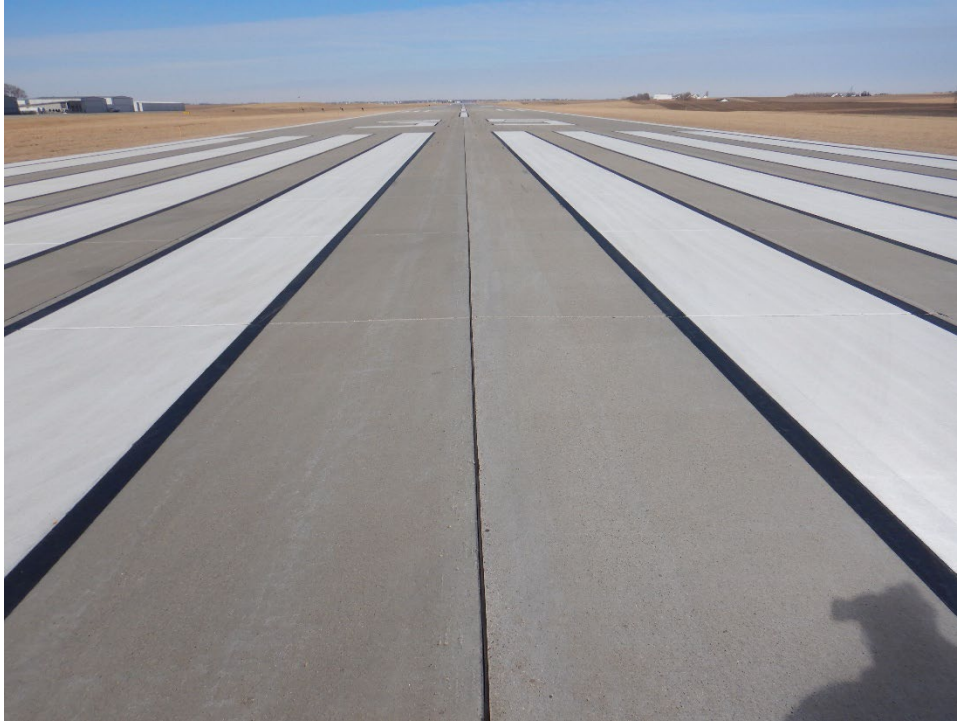
R17SX-01. Overview.

| Branch | Section | Surface Type | Section Area (sf) | LCD | 2026 PCI | % Distress Due to Load | % Distress Due to Climate/Durability | % Distress Due to Other | Type of Distress |
|---|---|---|---|---|---|---|---|---|---|
| R17SX | 01 | PCC | 248,593 | 5/3/2017 | 94 | 0 | 72 | 28 | Corner Spalling, Faulting, Joint Seal Damage |

Runway 17/35 consisted of two sections. Section 01 contained low-severity faulting and low- and medium-severity corner spalling and joint seal damage. Low-severity longitudinal, transverse, and diagonal (LTD) cracking and low- and medium-severity corner spalling, joint seal damage, faulting, and joint spalling were identified in Section 02. An atypical area of high-severity faulting was observed and recorded as an additional sample unit in accordance with ASTM D5340.

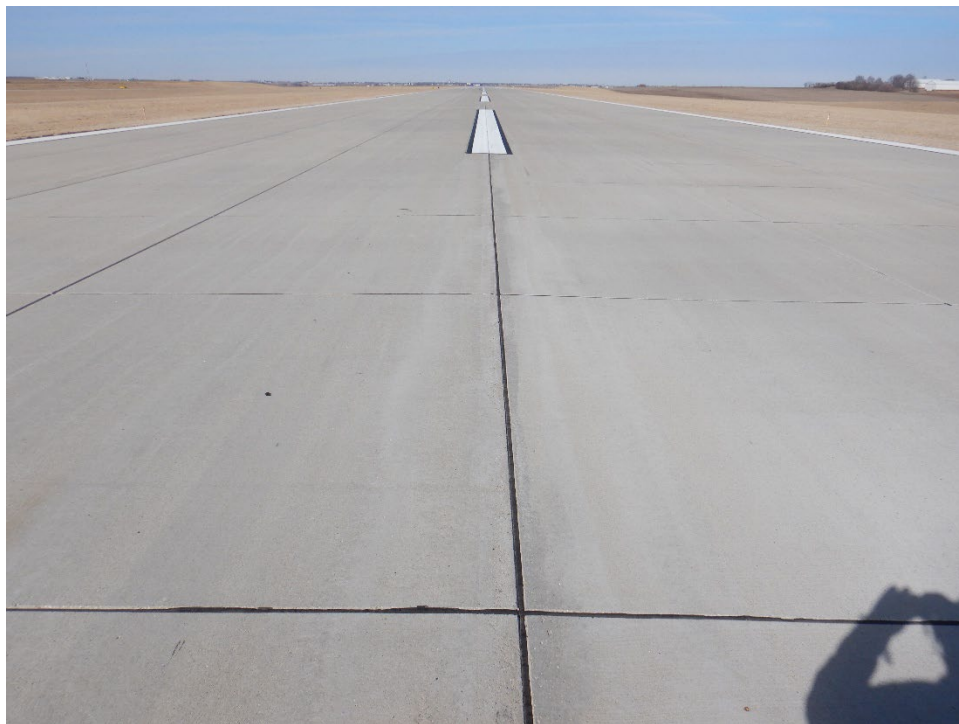
R17SX-02. Overview.

| Branch | Section | Surface Type | Section Area (sf) | LCD | 2026 PCI | % Distress Due to Load | % Distress Due to Climate/Durability | % Distress Due to Other | Type of Distress |
|---|---|---|---|---|---|---|---|---|---|
| R17SX | 02 | PCC | 316,622 | 6/3/2018 | 84 | 4 | 34 | 62 | Corner Spalling, Faulting, Joint Spalling, Joint Seal Damage, LTD Cracking |

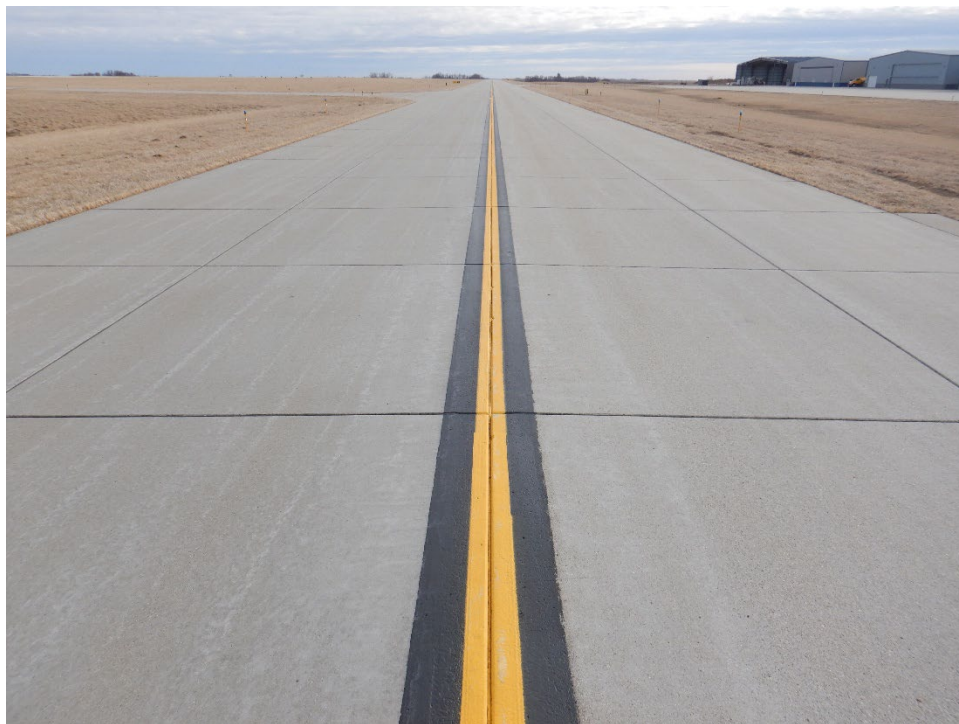
TASX-01. Overview.

| Branch | Section | Surface Type | Section Area (sf) | LCD | 2026 PCI | % Distress Due to Load | % Distress Due to Climate/Durability | % Distress Due to Other | Type of Distress |
|---|---|---|---|---|---|---|---|---|---|
| TASX | 01 | PCC | 62,300 | 5/3/2017 | 92 | 0 | 86 | 14 | Corner Spalling, Joint Seal Damage, Small Patch |

Taxiway A was defined by two sections. Section 01 contained areas of low-severity small patching and medium-severity corner spalling and joint seal damage. Shrinkage cracking and medium-severity corner spalling, joint seal damage, and joint spalling were identified in Section 02.

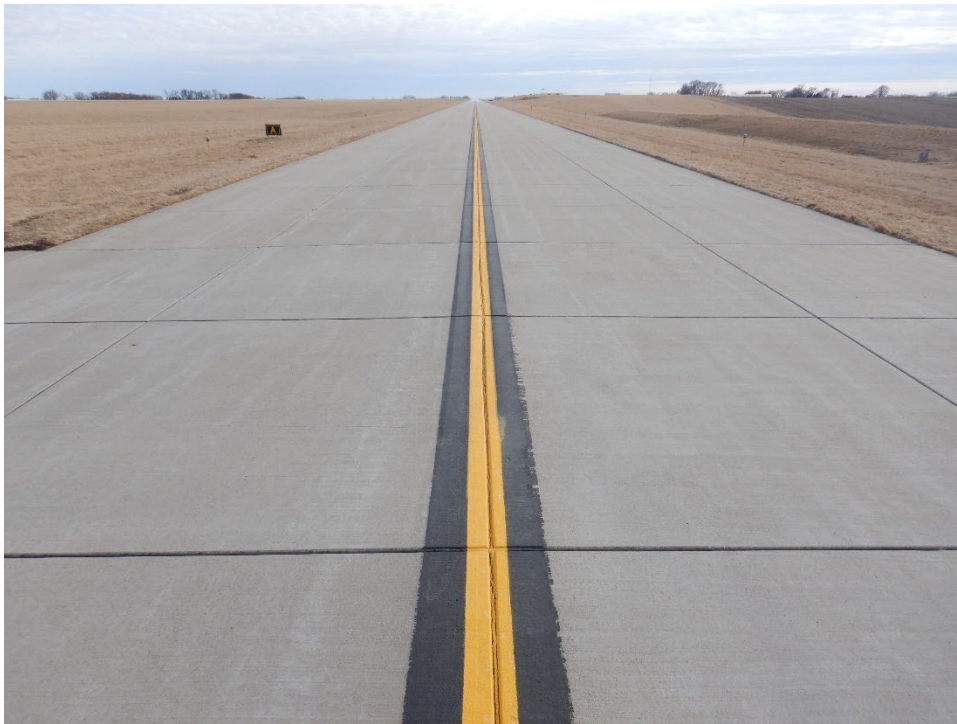
TASX-02. Overview.

| Branch | Section | Surface Type | Section Area (sf) | LCD | 2026 PCI | % Distress Due to Load | % Distress Due to Climate/Durability | % Distress Due to Other | Type of Distress |
|---|---|---|---|---|---|---|---|---|---|
| TASX | 02 | PCC | 125,649 | 6/3/2018 | 92 | 0 | 78 | 22 | Corner Spalling, Joint Spalling, Joint Seal Damage, Shrinkage Cracking |

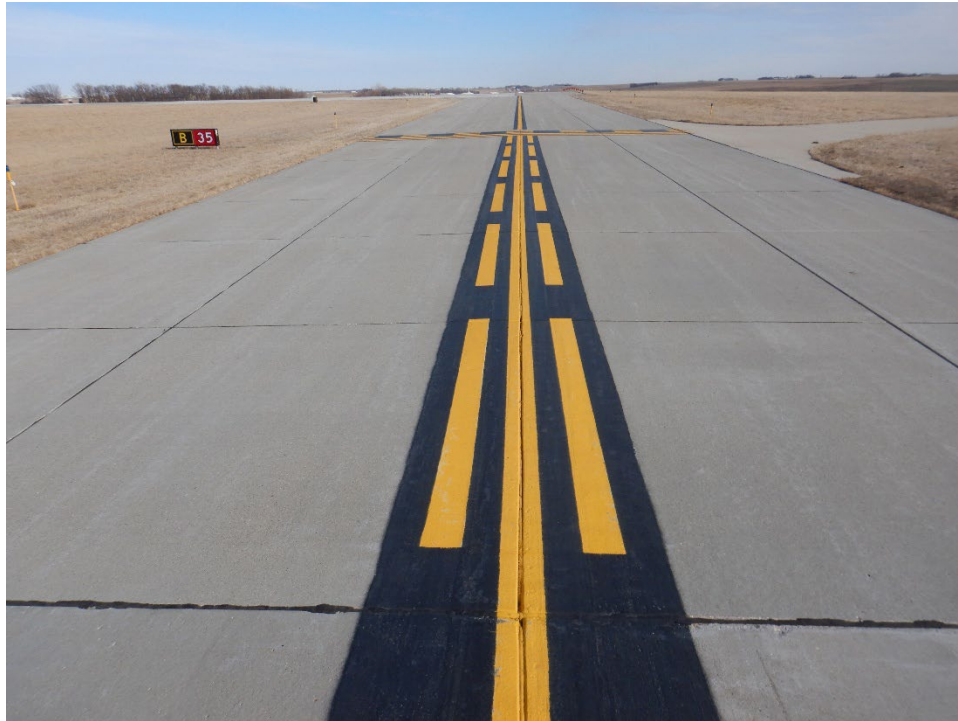
TBSX-01. Overview.

| Branch | Section | Surface Type | Section Area (sf) | LCD | 2026 PCI | % Distress Due to Load | % Distress Due to Climate/Durability | % Distress Due to Other | Type of Distress |
|---|---|---|---|---|---|---|---|---|---|
| TBSX | 01 | PCC | 15,102 | 5/3/2017 | 89 | 16 | 58 | 26 | Corner Break, Faulting, Joint Spalling, Joint Seal Damage, LTD Cracking |

Taxiway B contained one section. Medium-severity joint seal damage and joint spalling and low-severity corner break, faulting, and LTD cracking were observed in Section 01.

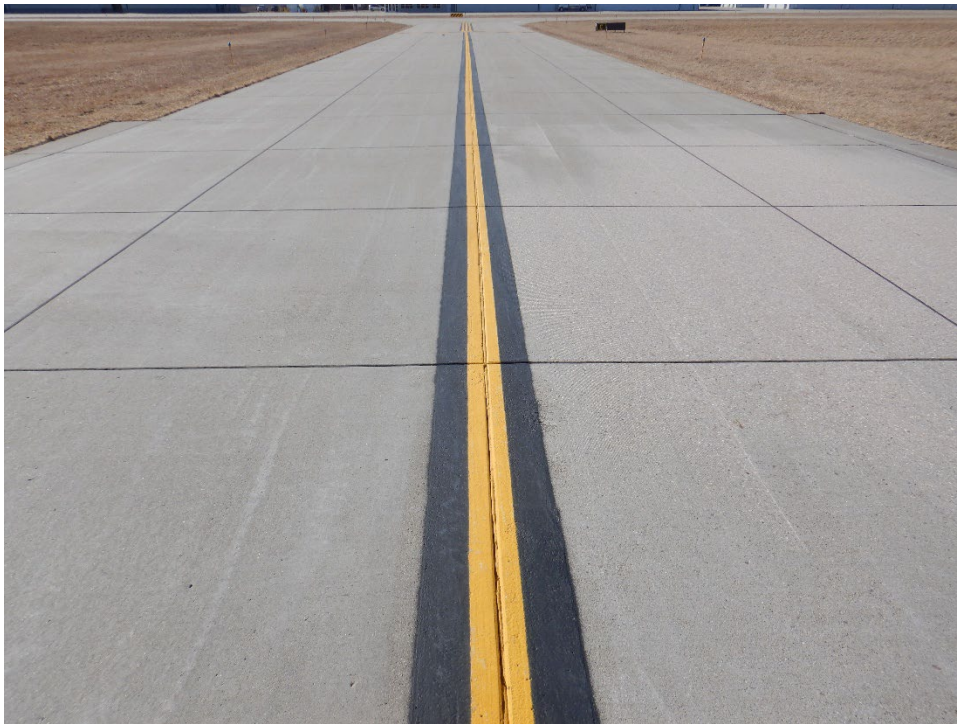
TCSX-01. Overview.

| Branch | Section | Surface Type | Section Area (sf) | LCD | 2026 PCI | % Distress Due to Load | % Distress Due to Climate/Durability | % Distress Due to Other | Type of Distress |
|---|---|---|---|---|---|---|---|---|---|
| TCSX | 01 | PCC | 13,880 | 5/3/2017 | 98 | 0 | 85 | 15 | Joint Spalling, Joint Seal Damage |

Taxiway C consisted of one section in *Excellent* condition that contained only low-severity joint seal damage and joint spalling.

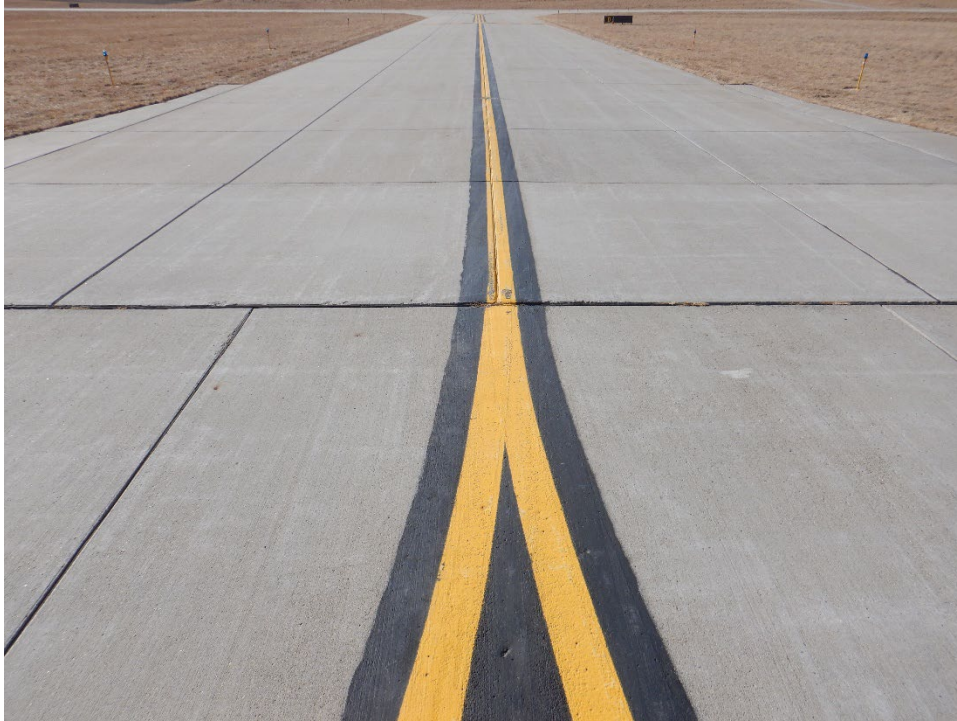
TDSX-01. Overview.

| Branch | Section | Surface Type | Section Area (sf) | LCD | 2026 PCI | % Distress Due to Load | % Distress Due to Climate/Durability | % Distress Due to Other | Type of Distress |
|---|---|---|---|---|---|---|---|---|---|
| TDSX | 01 | PCC | 13,971 | 6/3/2018 | 93 | 0 | 25 | 75 | Corner Spalling, Faulting, Joint Seal Damage |

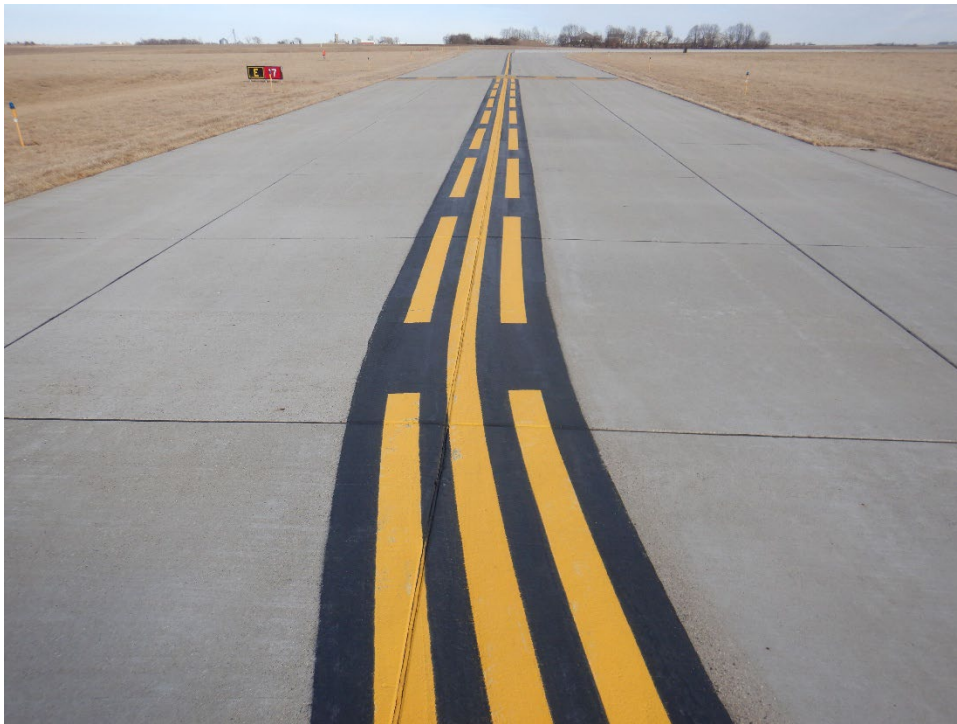
TESX-01. Overview.

| Branch | Section | Surface Type | Section Area (sf) | LCD | 2026 PCI | % Distress Due to Load | % Distress Due to Climate/Durability | % Distress Due to Other | Type of Distress |
|---|---|---|---|---|---|---|---|---|---|
| TESX | 01 | PCC | 12,656 | 6/3/2018 | 97 | 0 | 59 | 41 | Joint Spalling, Joint Seal Damage |

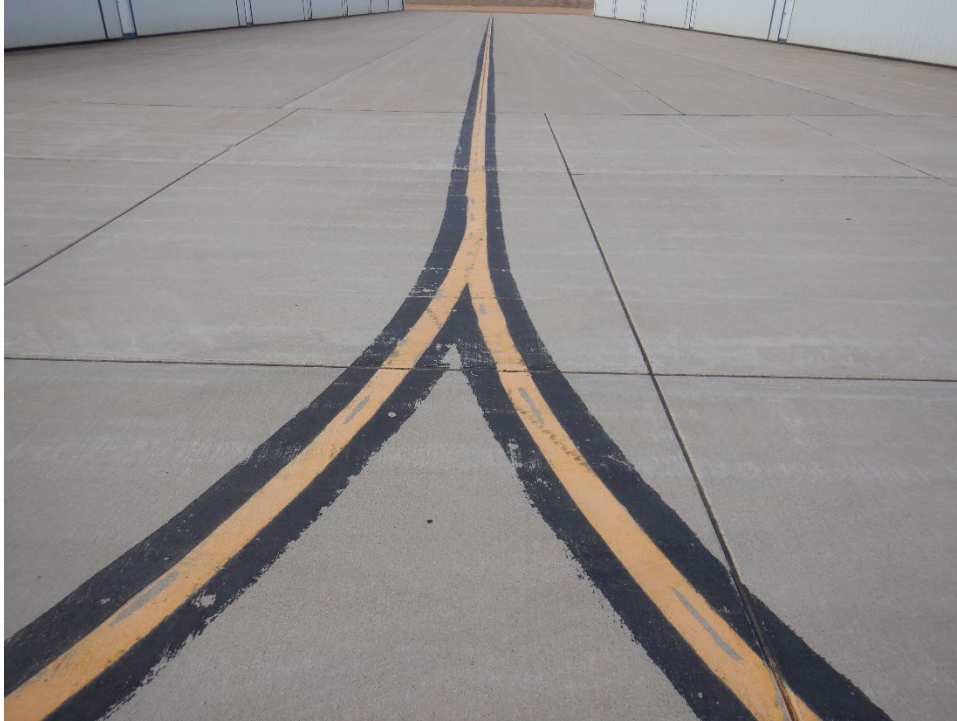
TH01SX-01. Overview.

| Branch | Section | Surface Type | Section Area (sf) | LCD | 2026 PCI | % Distress Due to Load | % Distress Due to Climate/Durability | % Distress Due to Other | Type of Distress |
|---|---|---|---|---|---|---|---|---|---|
| TH01SX | 01 | PCC | 84,848 | 6/3/2018 | 81 | 0 | 52 | 48 | Faulting, Joint Spalling, Joint Seal Damage, Large Patch |
