# Spirit Lake Municipal Airport

## Pavement Management Report

**AUGUST 2025**

# SPIRIT LAKE MUNICIPAL AIRPORT PAVEMENT MANAGEMENT REPORT

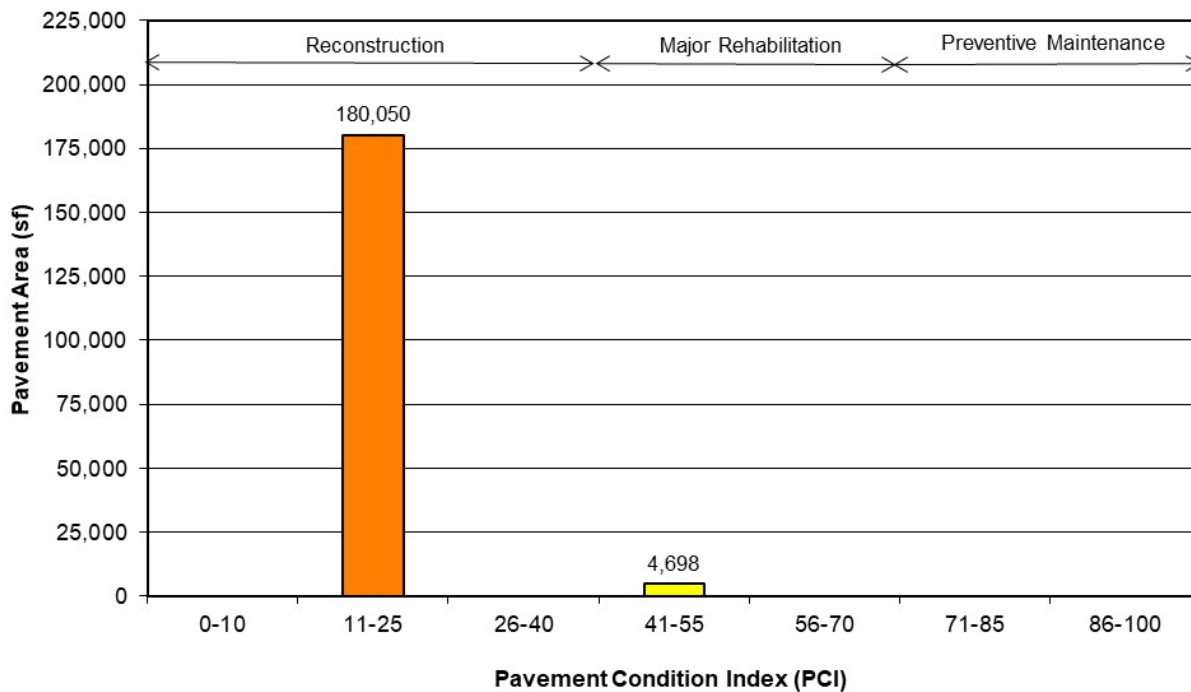
Figure 6. Pavement area by PCI range at Spirit Lake Municipal Airport.

The pavements at Spirit Lake Municipal Airport were inspected in March 2025. The 2025 area-weighted condition of Spirit Lake Municipal Airport is 24, with conditions ranging from 13 to 53 (on a scale of 0 [failed] to 100 [excellent]). During the previous pavement inspection in 2018, the area-weighted PCI of the airport was 34.

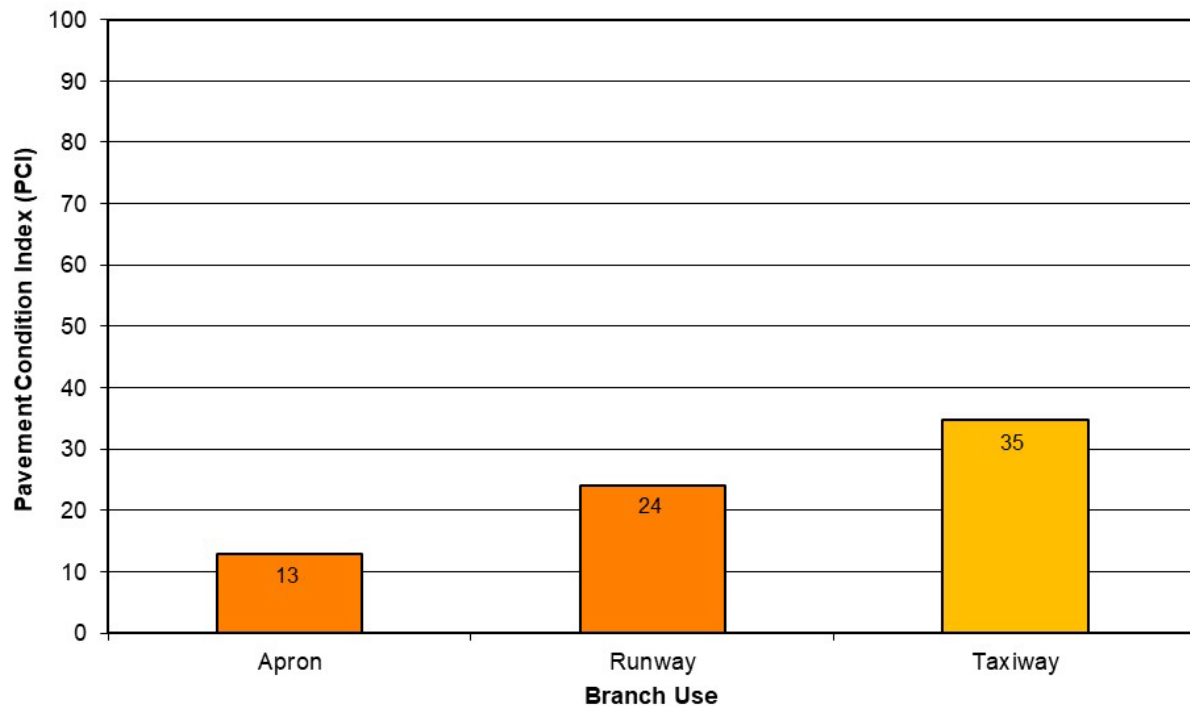
Figure 7. Area-weighted PCI by branch use at Spirit Lake Municipal Airport.

Figure 6 summarizes the overall condition of the pavements at Spirit Lake Municipal Airport, and Figure 7 presents area-weighted condition (average PCI adjusted to account for the relative size of the pavement sections) by branch use. Figure 8 is a map that displays the condition of the evaluated pavements. Table 1 summarizes the results of the pavement evaluation. Appendix B presents photographs taken during the PCI inspection, and Appendix C contains detailed information on the distress types observed during the visual survey. Appendix D includes detailed work history information that was collected during the record review process.
