# Storm Lake Municipal Airport

## Pavement Management Report

# STORM LAKE MUNICIPAL AIRPORT PAVEMENT MANAGEMENT REPORT

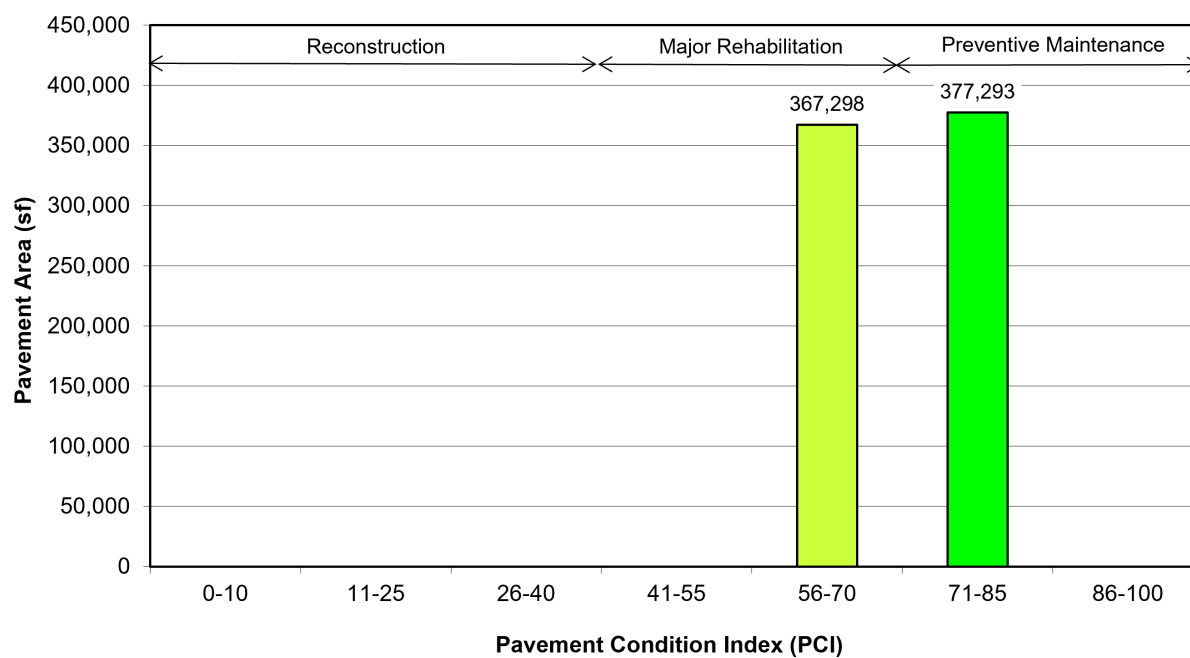
Figure 6. Pavement area by PCI range at Storm Lake Municipal Airport.

Figure 6 summarizes the overall condition of the pavements at Storm Lake Municipal Airport, and Figure 7 presents area-weighted condition (average PCI adjusted to account for the relative size of the pavement sections) by branch use. Figure 8 is a map that displays the condition of the evaluated pavements. Table 1 summarizes the results of the pavement evaluation. Appendix B presents photographs taken during the PCI inspection, and Appendix C contains detailed information on the distress types observed during the visual survey. Appendix D includes detailed work history information that was collected during the record review process.

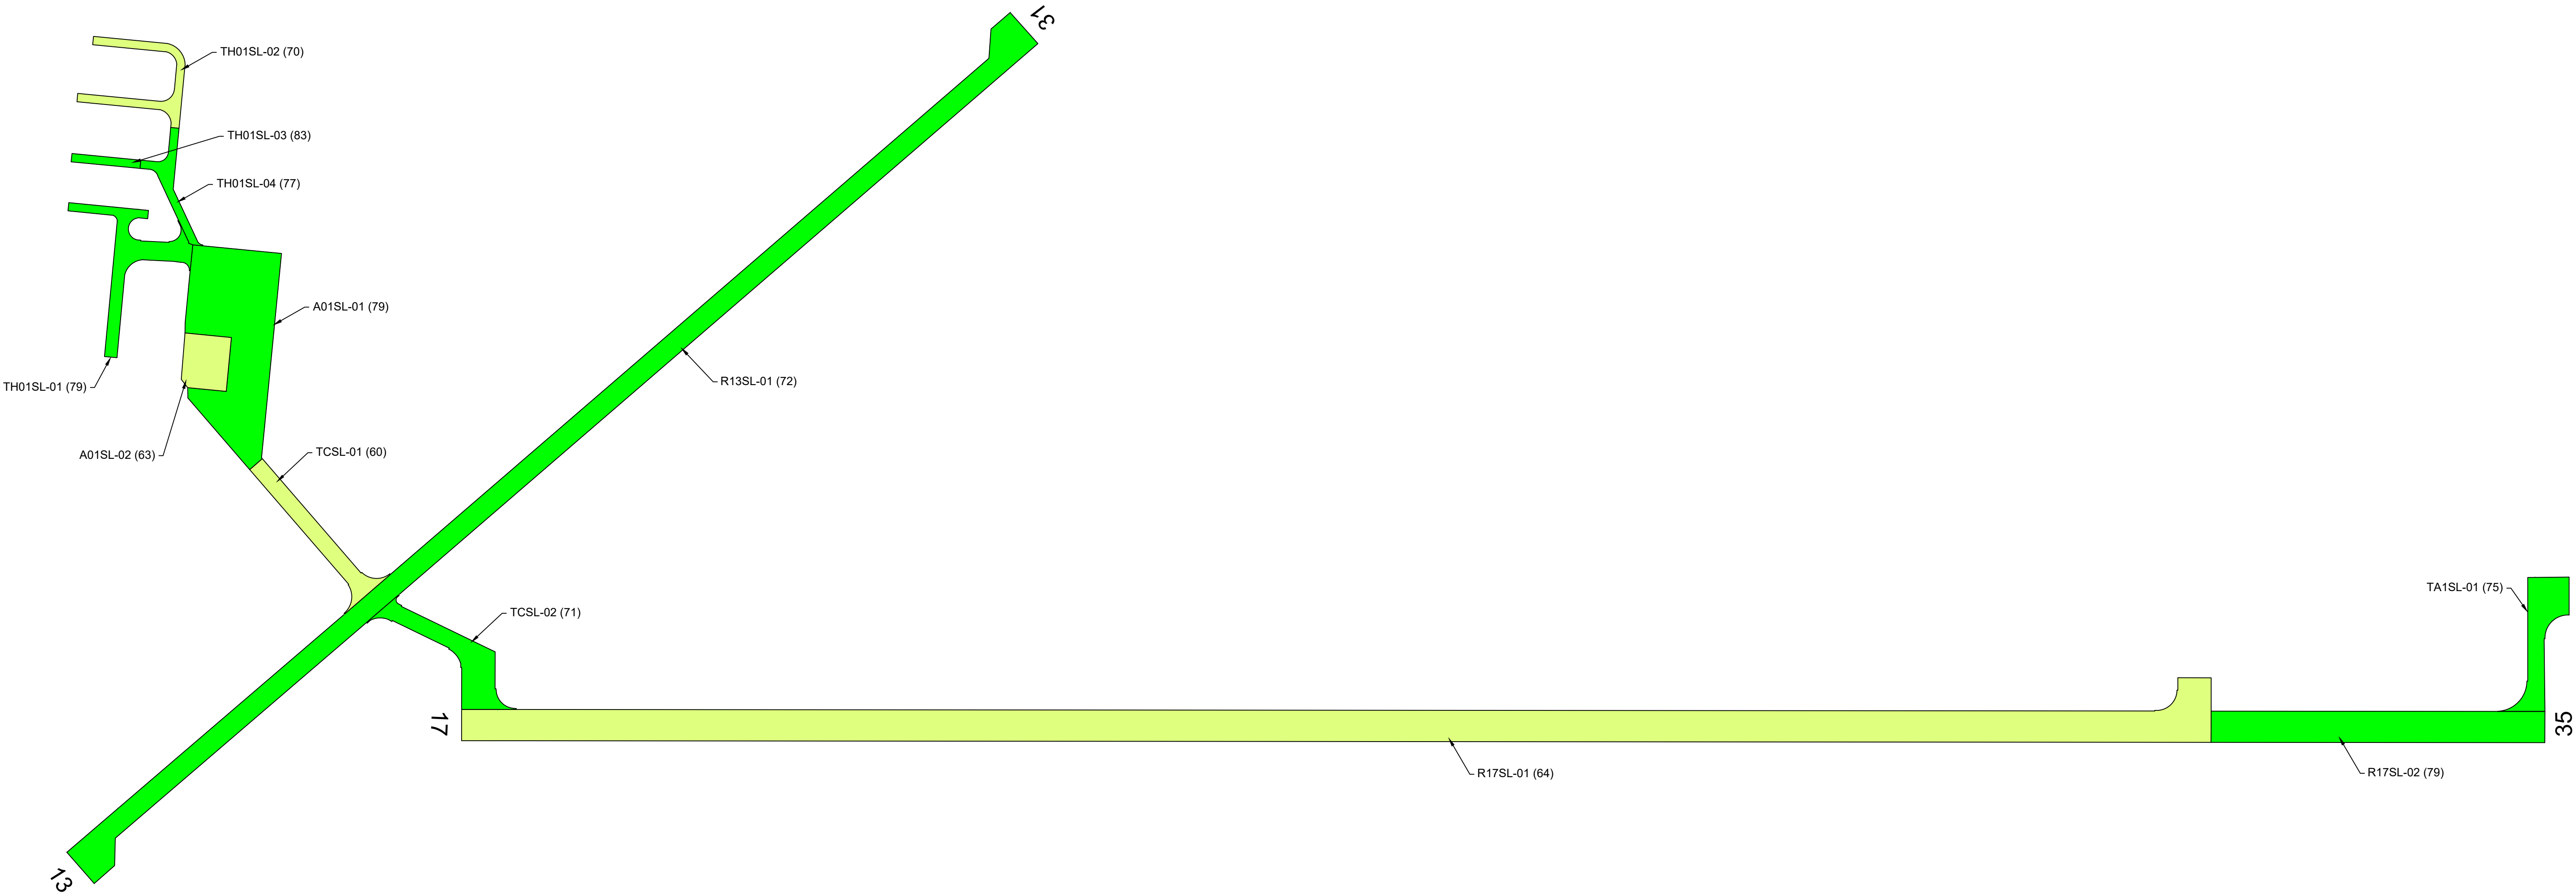
FIGURE 8. PCI MAP.

The pavements at Storm Lake Municipal Airport were inspected in March 2026. The 2026 area-weighted condition of Storm Lake Municipal Airport is 70, with conditions ranging from 60 to 83 (on a scale of 0 [*Failed*] to 100 [*Excellent*]). During the previous pavement inspection in 2022, the area-weighted PCI of the airport was 73.
