# Washington Municipal Airport

## Pavement Management Report

**JULY 2023**

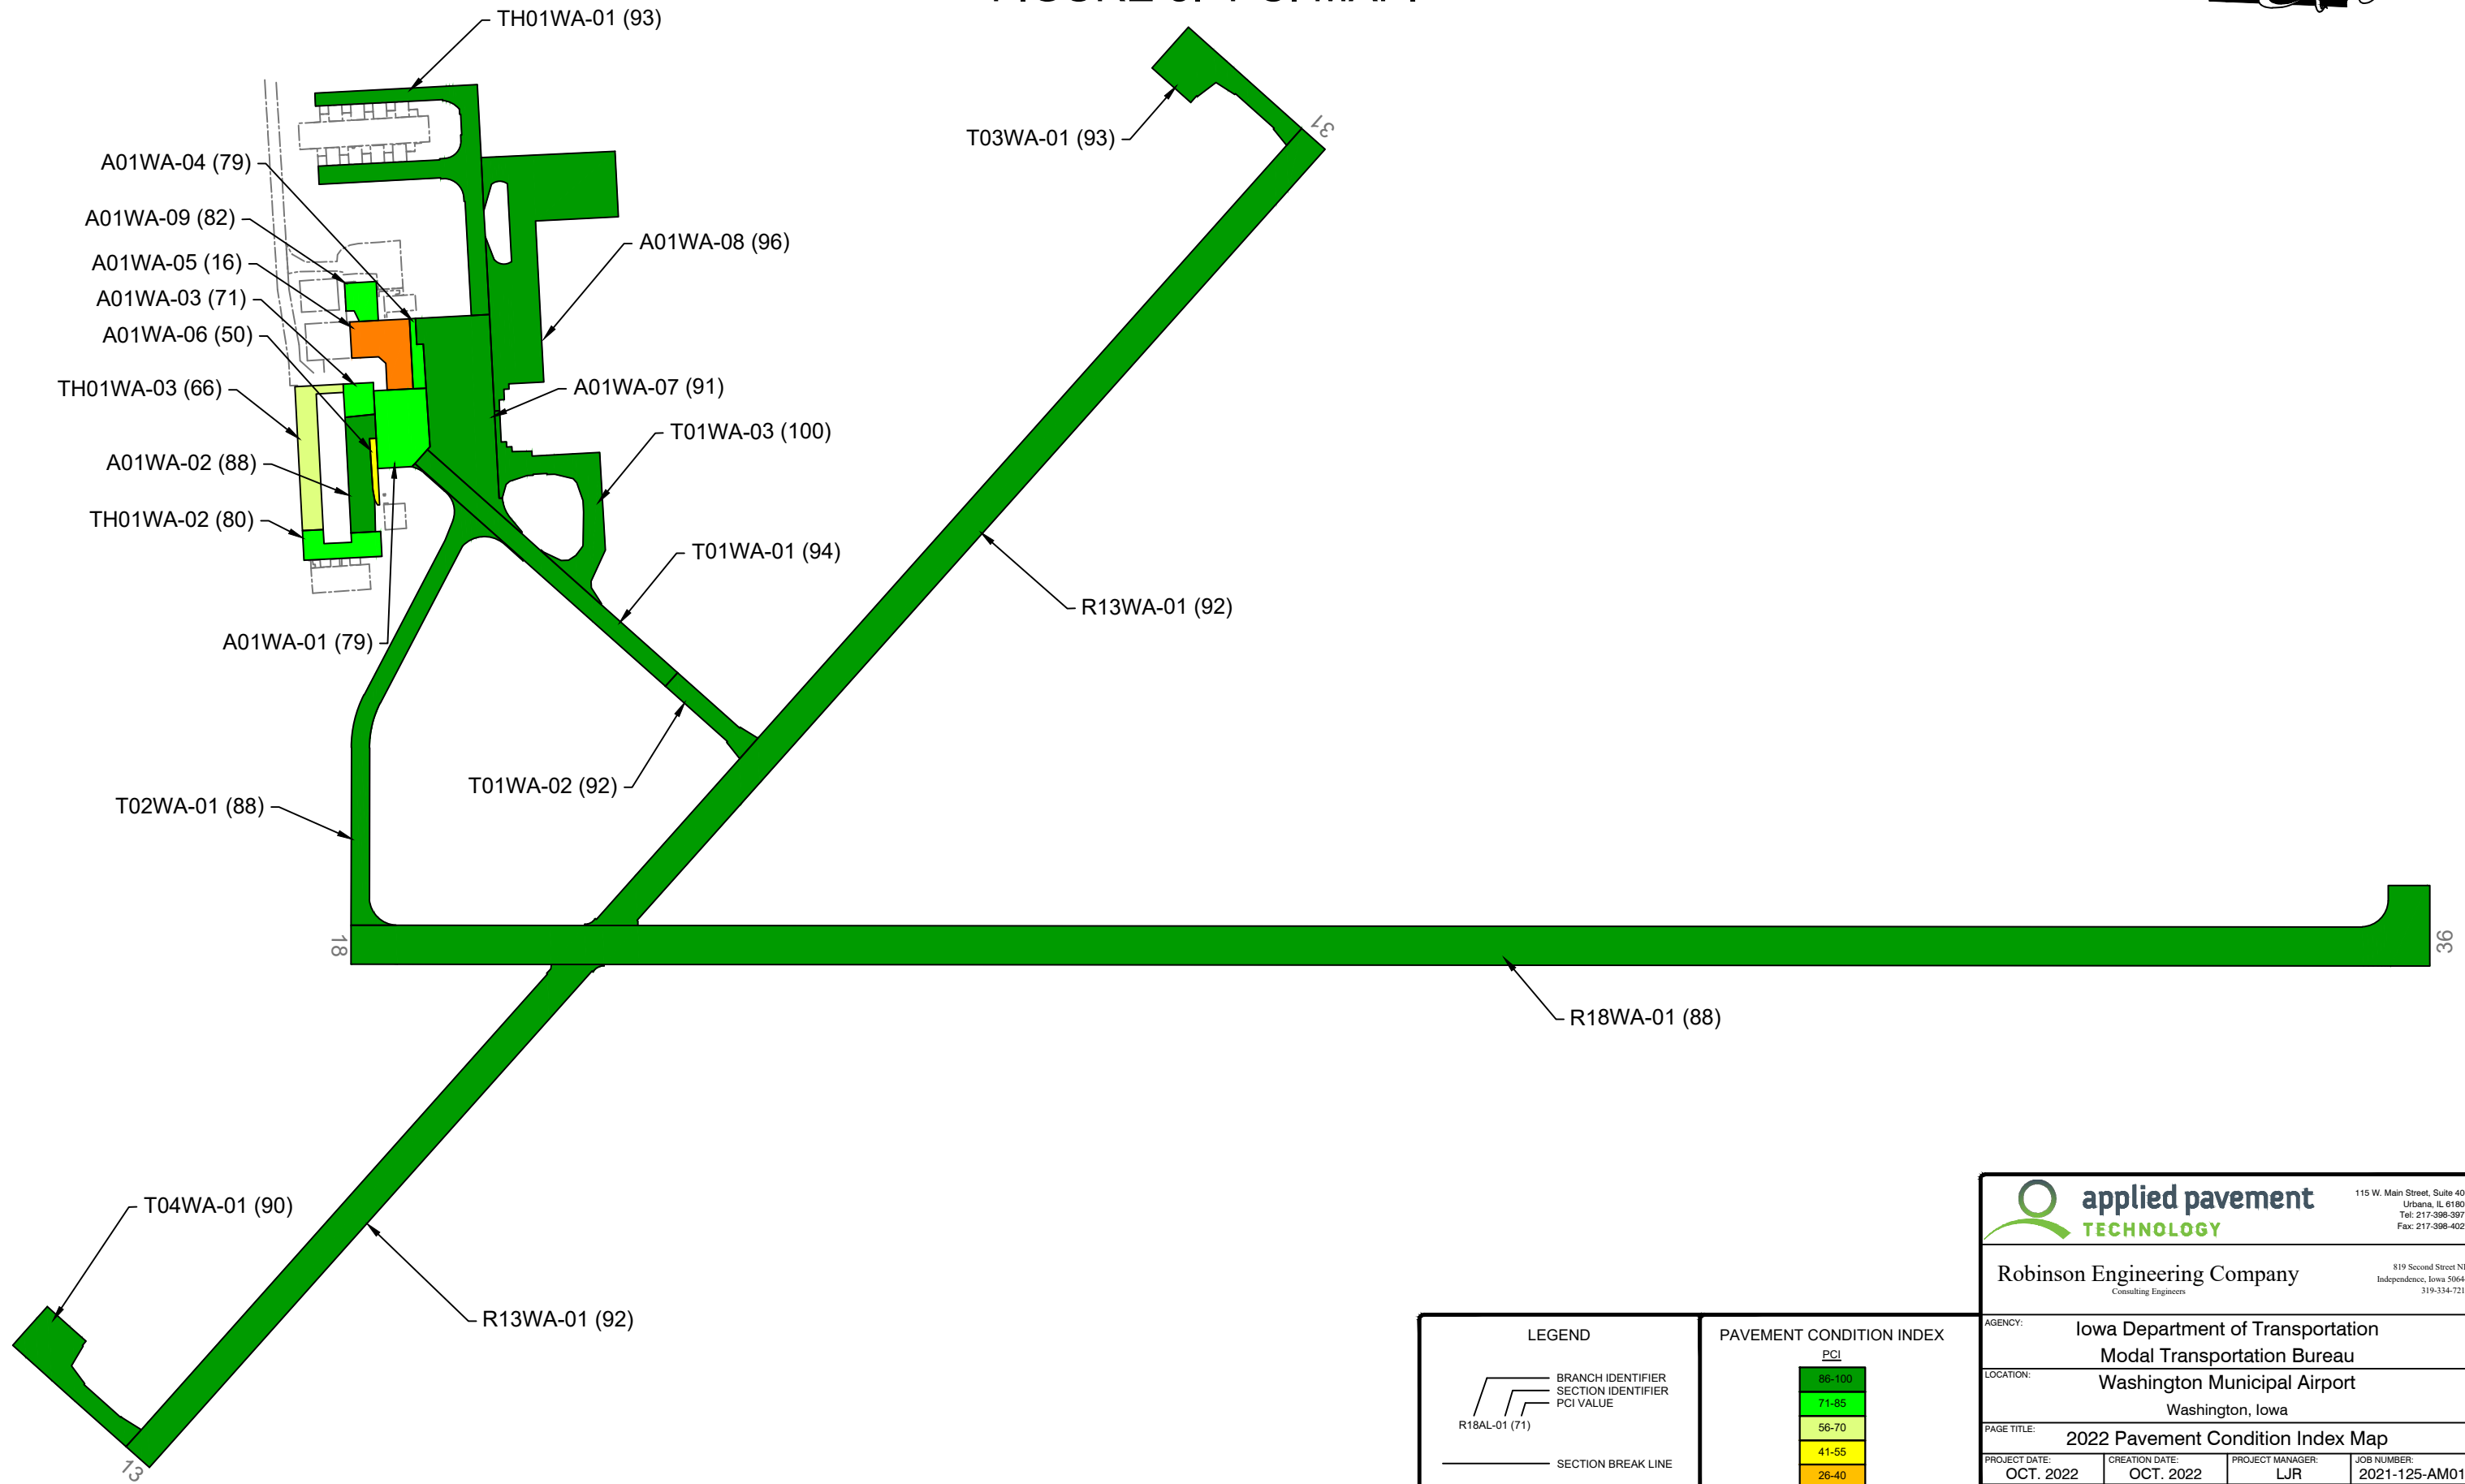
FIGURE 8. PCI MAP.

The pavements at Washington Municipal Airport were inspected in November 2022. The 2022 area-weighted condition of Washington Municipal Airport is 89, with conditions ranging from 16 to 100 (on a scale of 0 [failed] to 100 [excellent]). During the previous pavement inspection in 2019, the area-weighted PCI of the airport was 60.

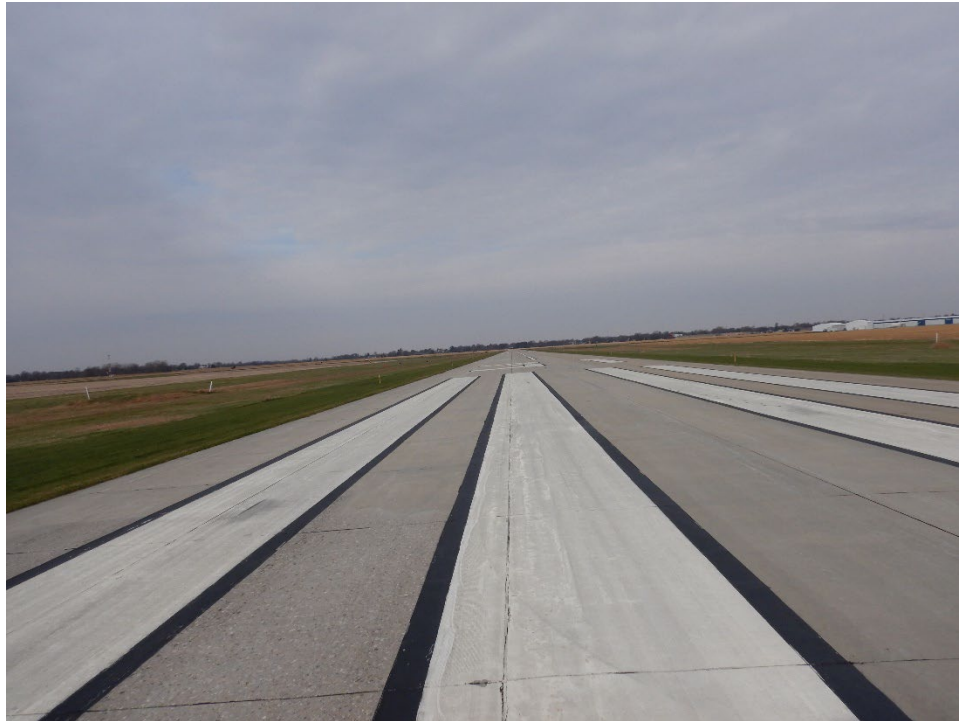
R13WA-01. Overview.

Runway 13/31 was defined by one section. Areas of medium-severity joint seal damage and low-severity joint spalling and corner spalling were recorded in Section 01 during the inspection.

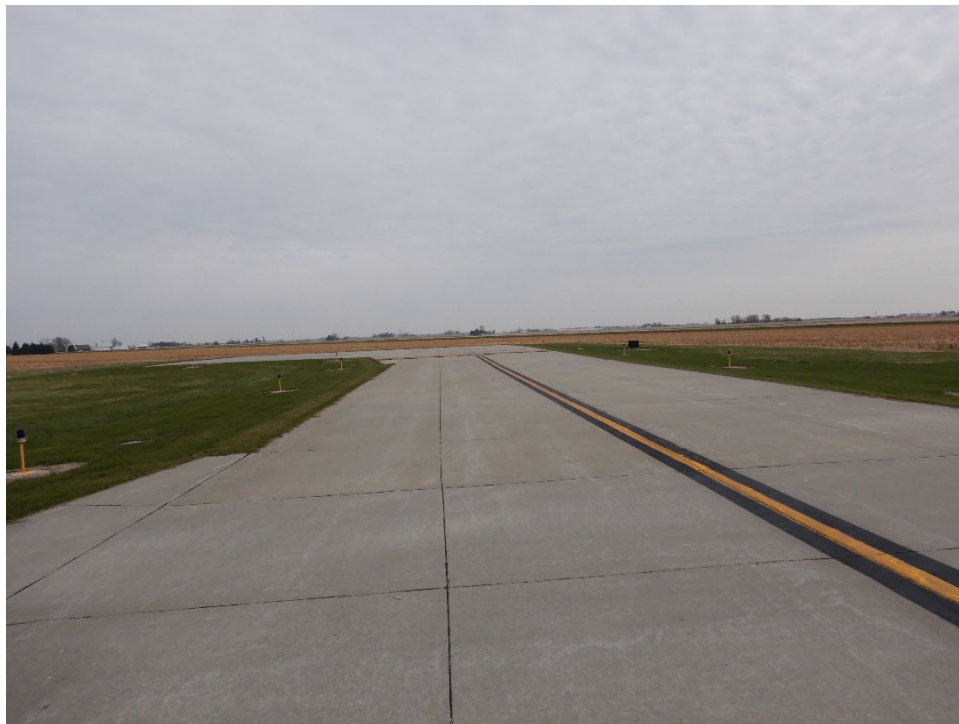
T03WA-01. Overview.

Taxiway 03 contained one section. Medium-severity joint seal damage was recorded throughout Section 01.
