# Washington Municipal Airport

## Pavement Management Report

**AUGUST 2026**

# WASHINGTON MUNICIPAL AIRPORT PAVEMENT MANAGEMENT REPORT

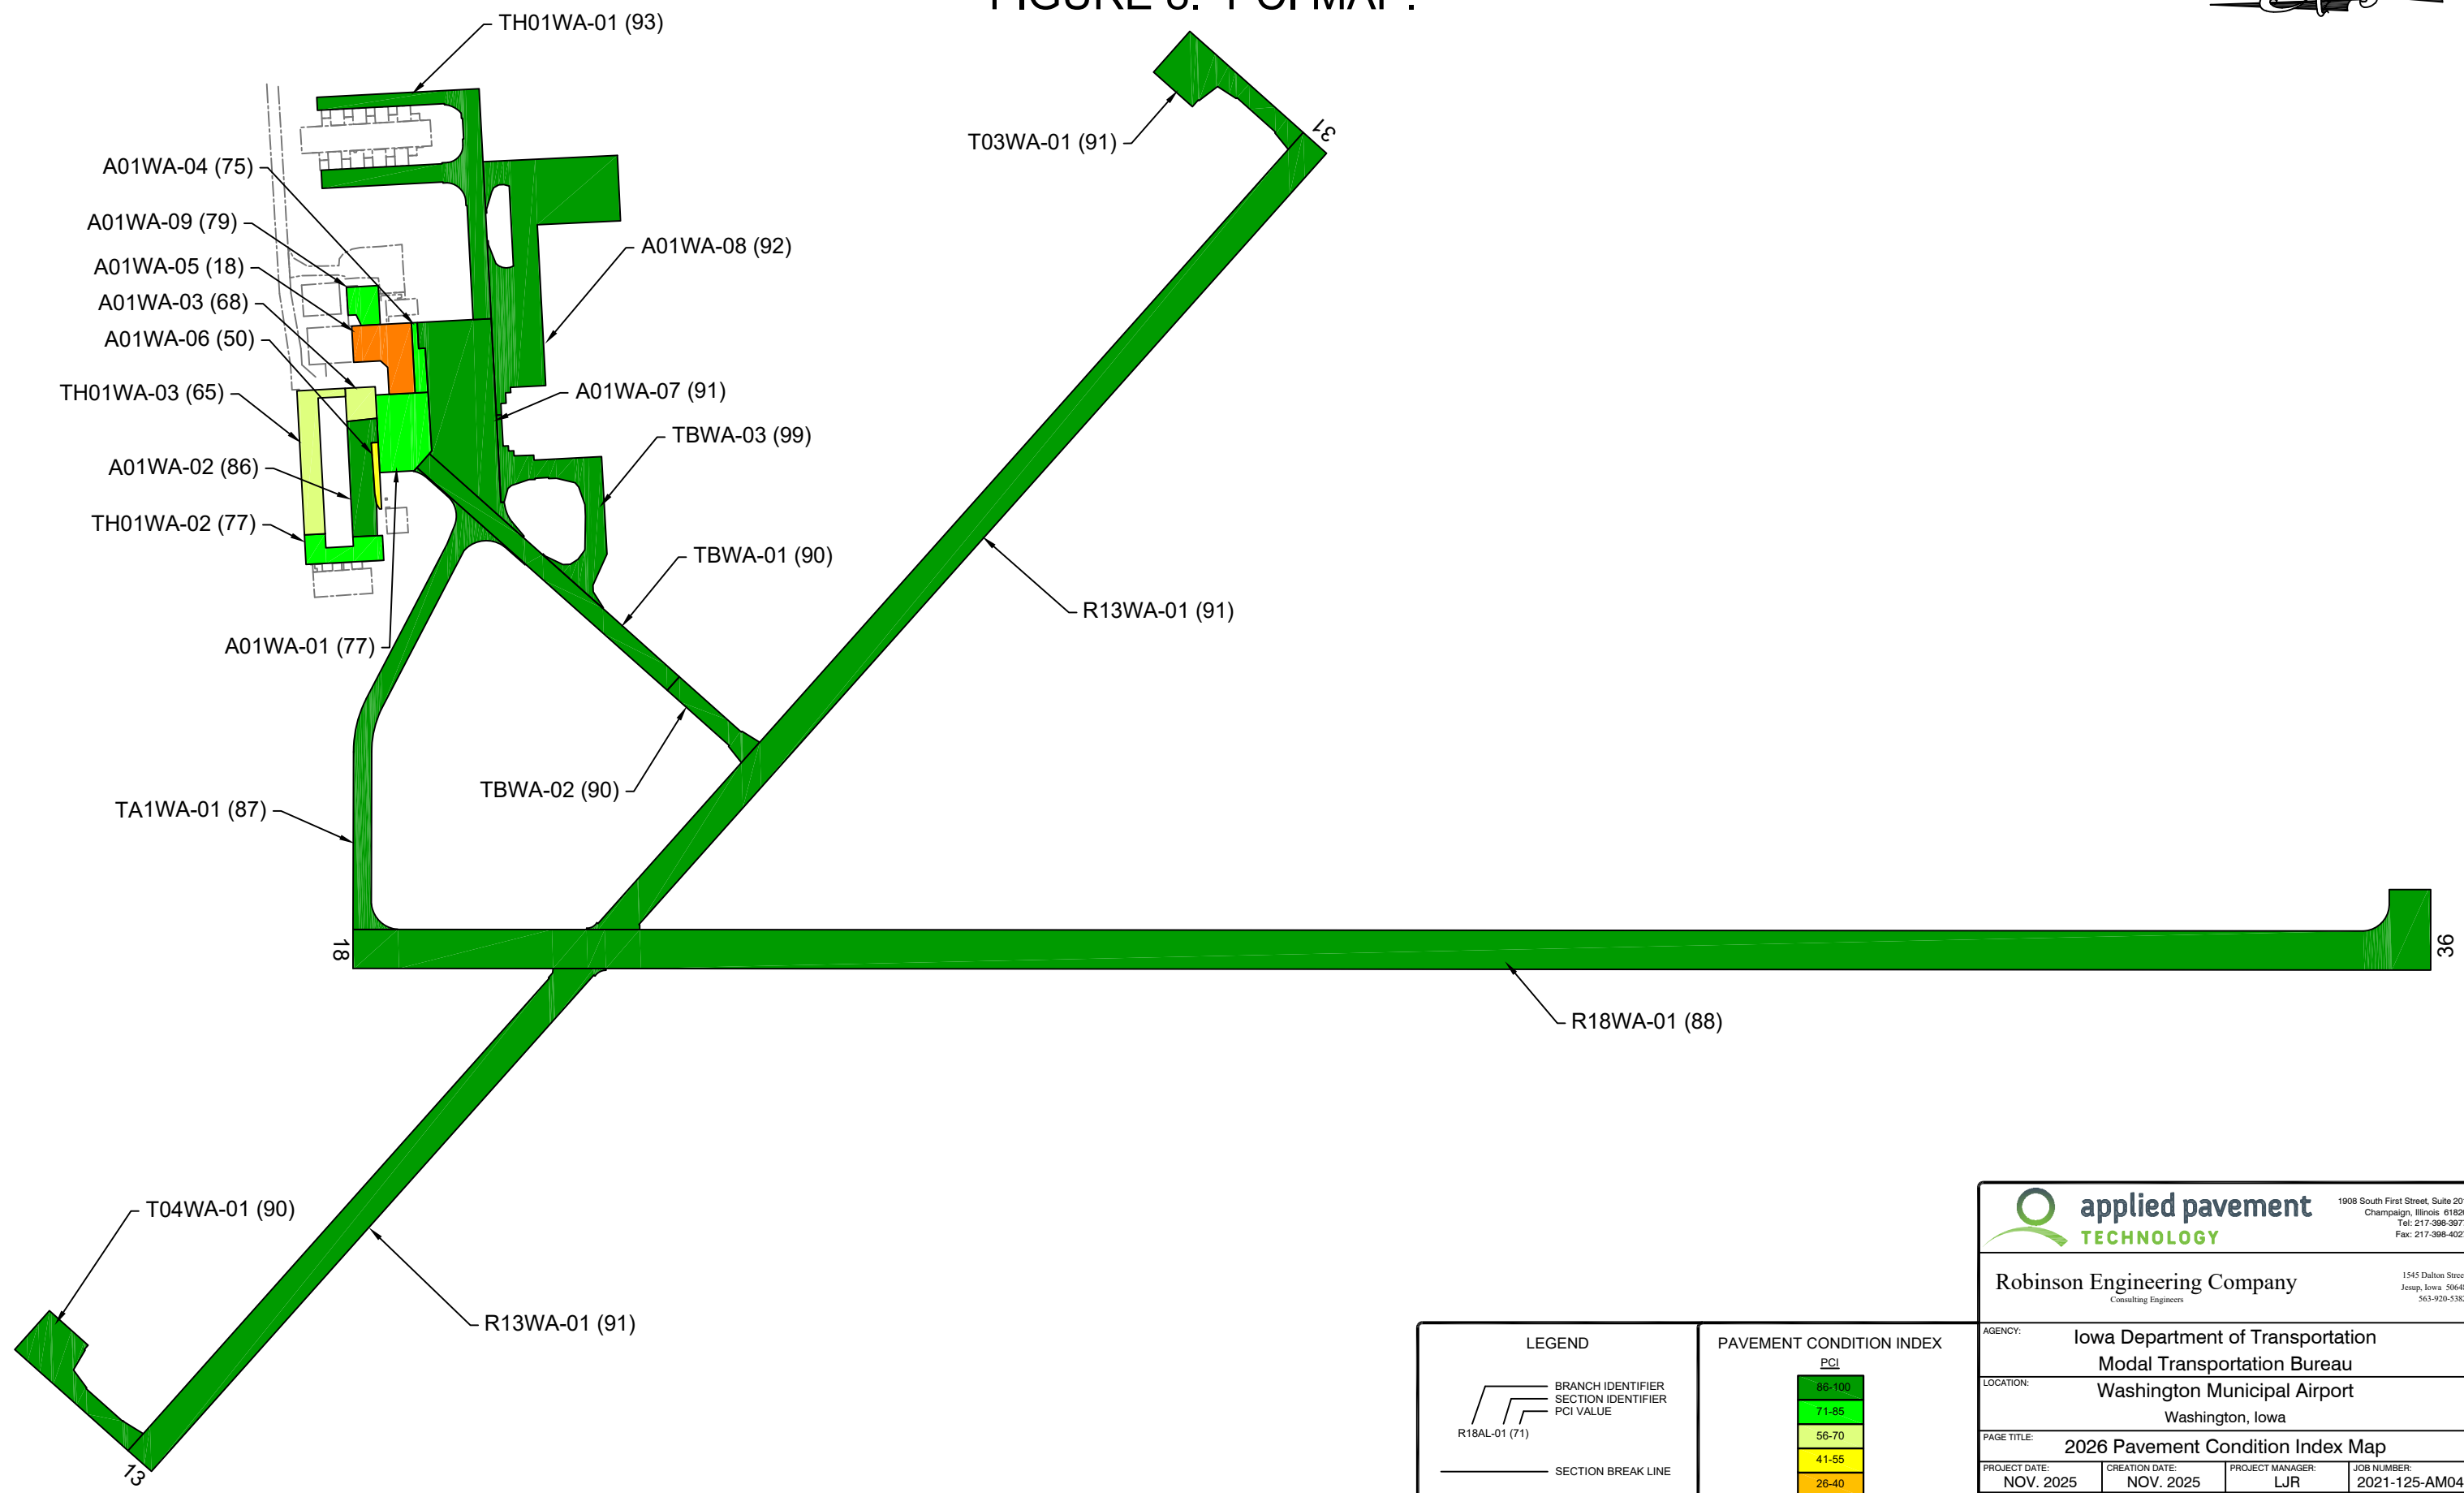
FIGURE 8. PCI MAP.

The pavements at Washington Municipal Airport were inspected in March 2026. The 2026 area-weighted condition of Washington Municipal Airport is 88, with conditions ranging from 18 to 99 (on a scale of 0 [*Failed*] to 100 [*Excellent*]). During the previous pavement inspection in 2022, the area-weighted PCI of the airport was 89.

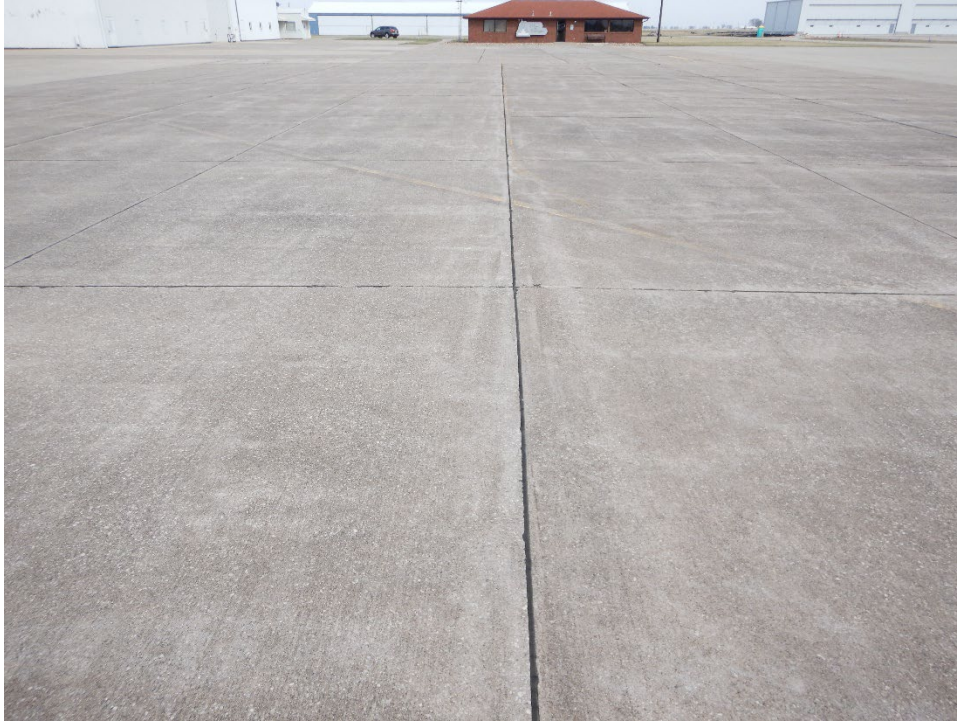
A01WA-01. Overview.

| Branch | Section | Surface Type | Section Area (sf) | LCD | 2026 PCI | % Distress Due to Load | % Distress Due to Climate/Durability | % Distress Due to Other | Type of Distress |
|---|---|---|---|---|---|---|---|---|---|
| A01WA | 01 | PCC | 14,582 | 6/2/1964 | 77 | 0 | 25 | 75 | Corner Spalling, Faulting, Joint Spalling, Joint Seal Damage, Shrinkage Cracking |

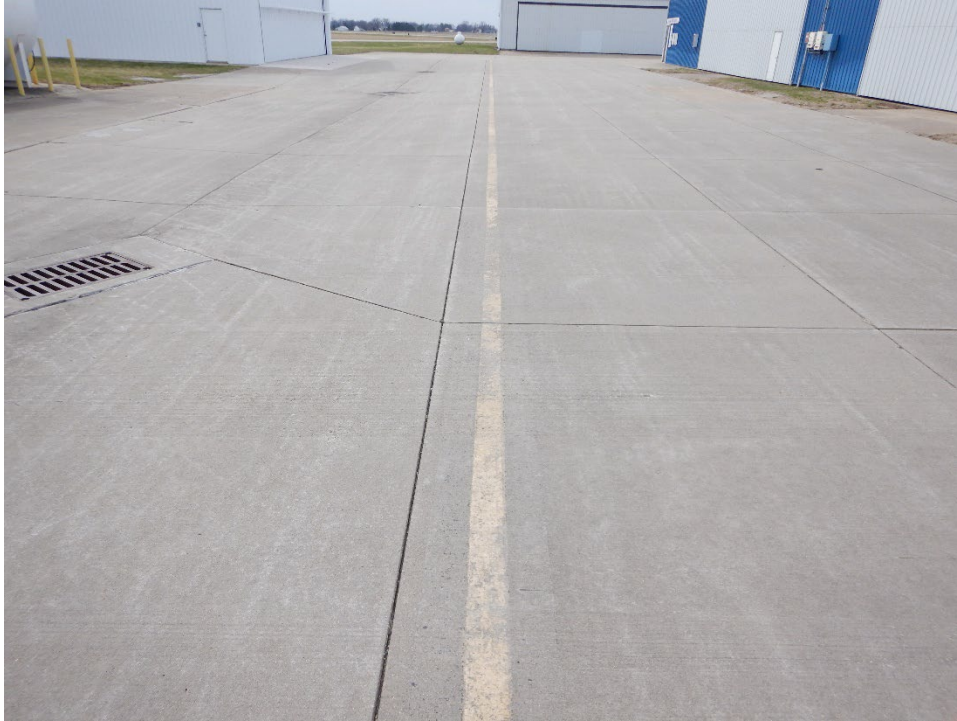
A01WA-02. Overview.

| Branch | Section | Surface Type | Section Area (sf) | LCD | 2026 PCI | % Distress Due to Load | % Distress Due to Climate/Durability | % Distress Due to Other | Type of Distress |
|---|---|---|---|---|---|---|---|---|---|
| A01WA | 02 | PCC | 10,978 | 10/1/2004 | 86 | 0 | 43 | 57 | Faulting, Joint Spalling, Joint Seal Damage, Large Patch, Shrinkage Cracking |

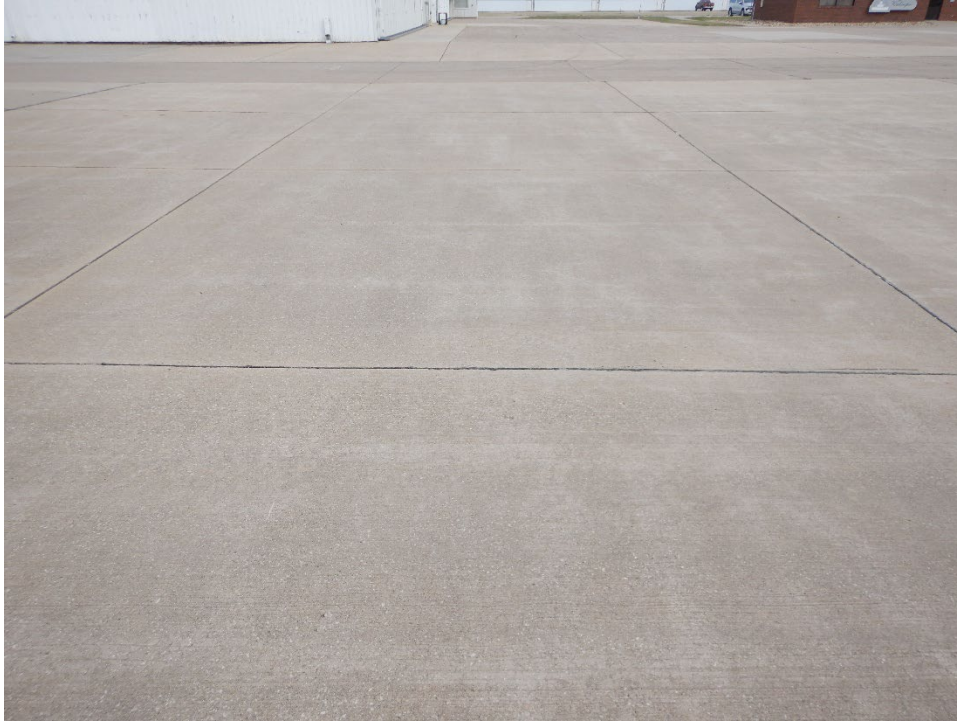
A01WA-03. Overview.

| Branch | Section | Surface Type | Section Area (sf) | LCD | 2026 PCI | % Distress Due to Load | % Distress Due to Climate/Durability | % Distress Due to Other | Type of Distress |
|---|---|---|---|---|---|---|---|---|---|
| A01WA | 03 | PCC | 3,625 | 6/1/1984 | 68 | 42 | 27 | 31 | Corner Break, Joint Spalling, Joint Seal Damage, LTD Cracking, Shrinkage Cracking, Small Patch |

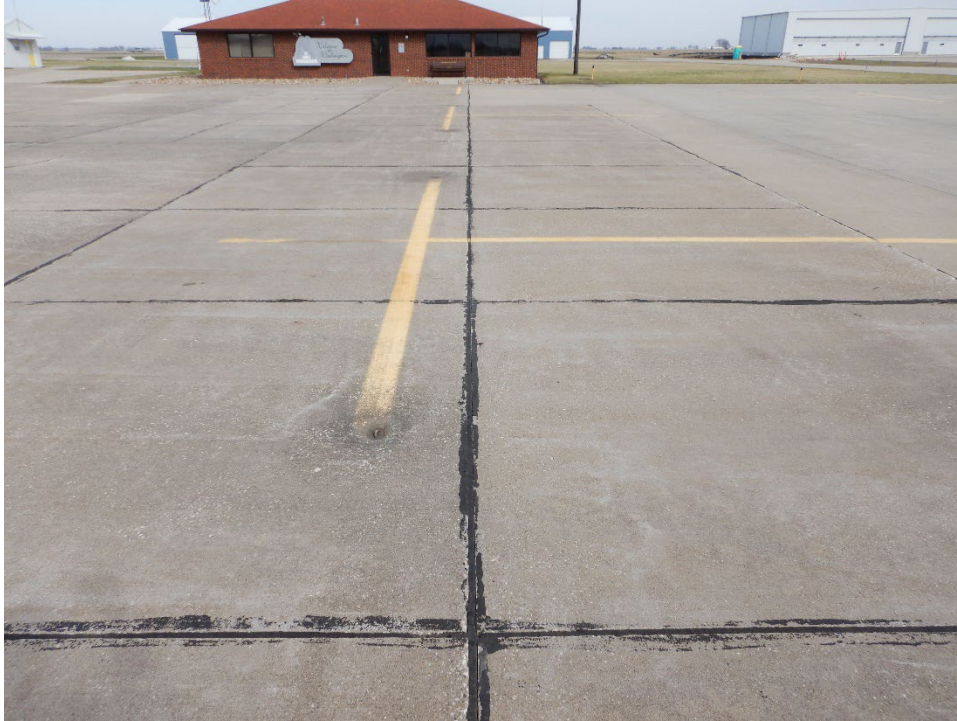
A01WA-04. Overview.

| Branch | Section | Surface Type | Section Area (sf) | LCD | 2026 PCI | % Distress Due to Load | % Distress Due to Climate/Durability | % Distress Due to Other | Type of Distress |
|---|---|---|---|---|---|---|---|---|---|
| A01WA | 04 | PCC | 2,659 | 6/1/1986 | 75 | 19 | 48 | 33 | Corner Spalling, Faulting, Joint Seal Damage, LTD Cracking |

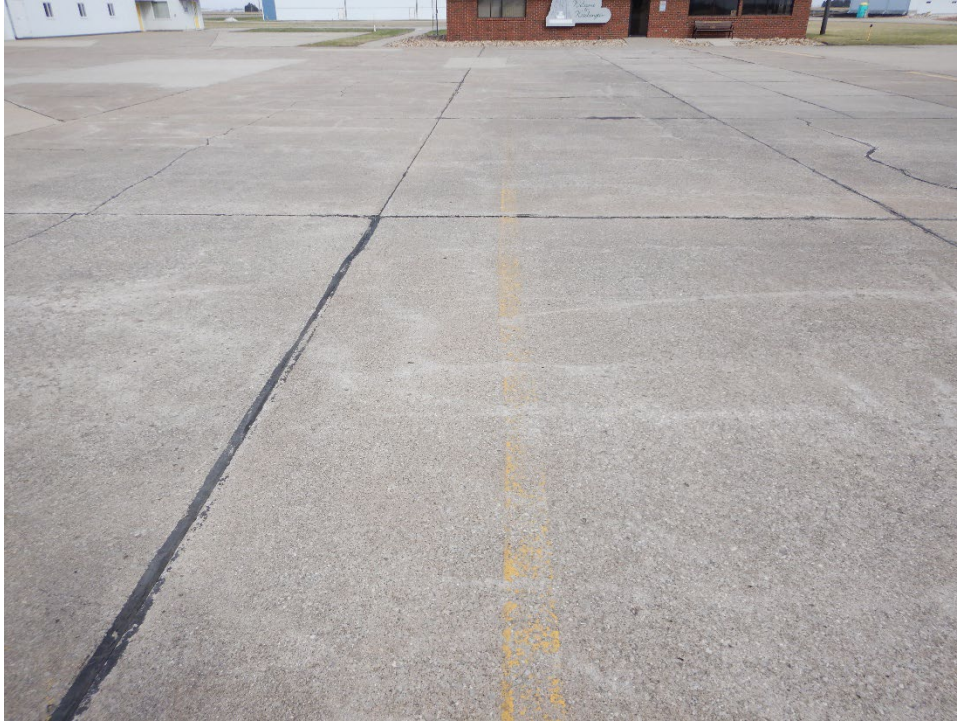
A01WA-05. Overview.

| Branch | Section | Surface Type | Section Area (sf) | LCD | 2026 PCI | % Distress Due to Load | % Distress Due to Climate/Durability | % Distress Due to Other | Type of Distress |
|---|---|---|---|---|---|---|---|---|---|
| A01WA | 05 | PCC | 11,384 | 8/1/1964 | 18 | 79 | 8 | 13 | Corner Break, Joint Spalling, Joint Seal Damage, Large Patch, LTD Cracking, Shattered Slab, Small Patch |

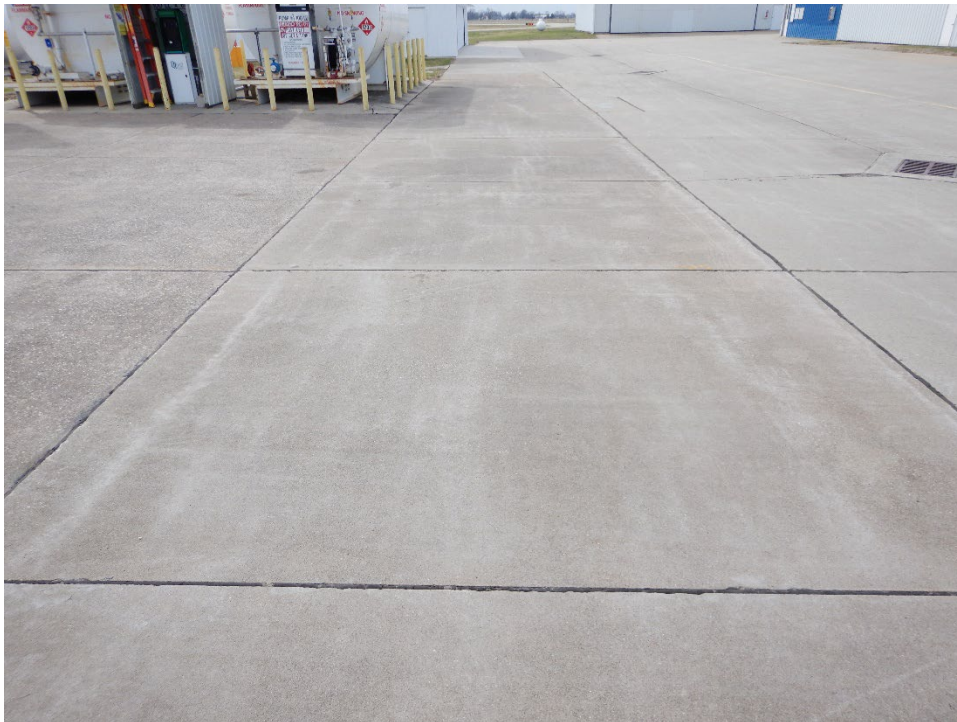
A01WA-06. Overview.

| Branch | Section | Surface Type | Section Area (sf) | LCD | 2026 PCI | % Distress Due to Load | % Distress Due to Climate/Durability | % Distress Due to Other | Type of Distress |
|---|---|---|---|---|---|---|---|---|---|
| A01WA | 06 | PCC | 1,471 | 6/30/1994 | 50 | 69 | 11 | 20 | Corner Break, Faulting, Joint Spalling, Joint Seal Damage, Shattered Slab |

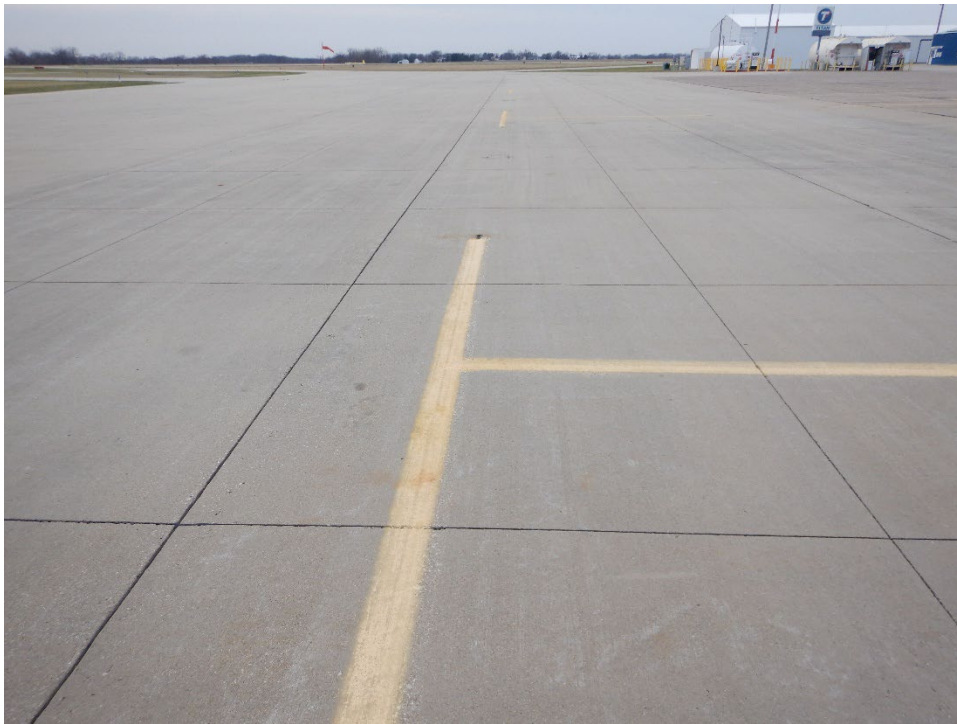
A01WA-07. Overview.

| Branch | Section | Surface Type | Section Area (sf) | LCD | 2026 PCI | % Distress Due to Load | % Distress Due to Climate/Durability | % Distress Due to Other | Type of Distress |
|---|---|---|---|---|---|---|---|---|---|
| A01WA | 07 | PCC | 43,029 | 3/10/2003 | 91 | 0 | 72 | 28 | Faulting, Joint Seal Damage |

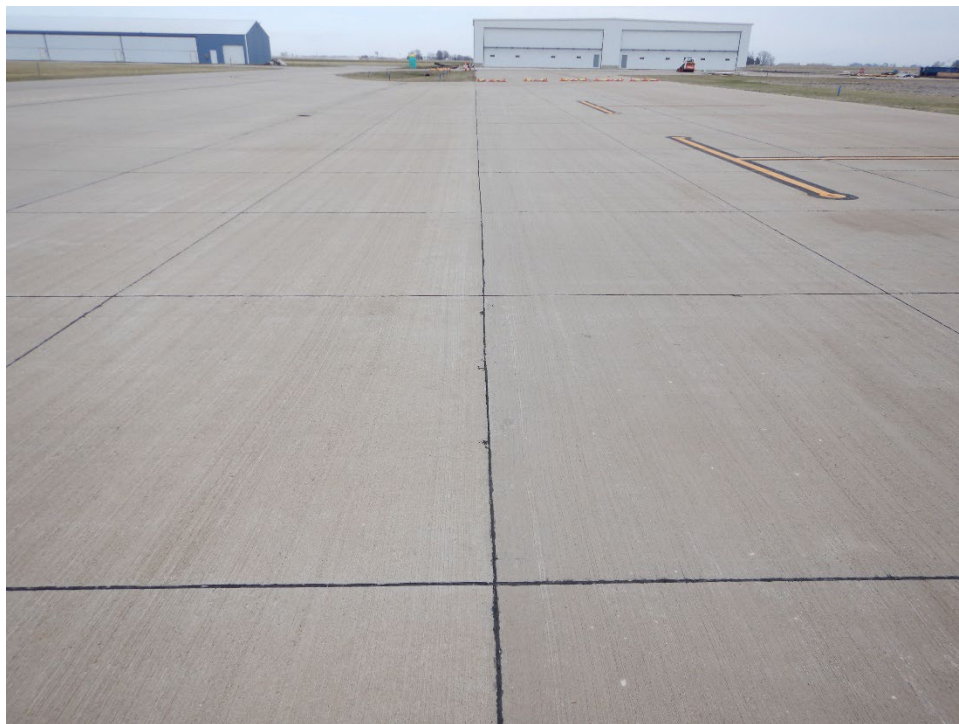
A01WA-08. Overview.

| Branch | Section | Surface Type | Section Area (sf) | LCD | 2026 PCI | % Distress Due to Load | % Distress Due to Climate/Durability | % Distress Due to Other | Type of Distress |
|---|---|---|---|---|---|---|---|---|---|
| A01WA | 08 | PCC | 57,327 | 6/1/2016 | 92 | 8 | 71 | 21 | Corner Spalling, Joint Spalling, Joint Seal Damage, LTD Cracking |

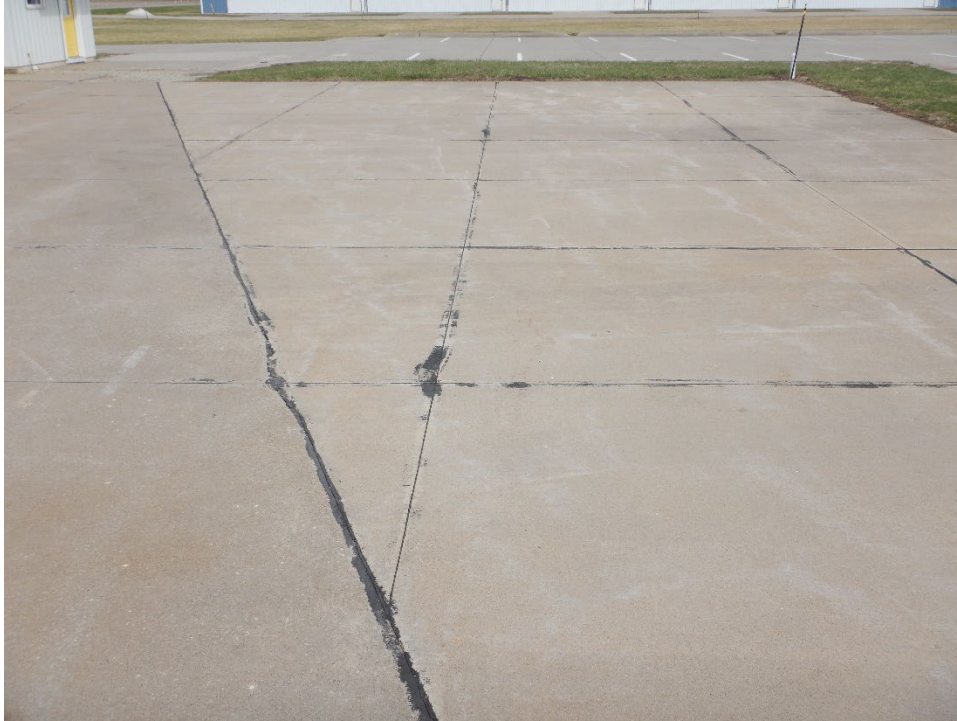
A01WA-09. Overview.

| Branch | Section | Surface Type | Section Area (sf) | LCD | 2026 PCI | % Distress Due to Load | % Distress Due to Climate/Durability | % Distress Due to Other | Type of Distress |
|---|---|---|---|---|---|---|---|---|---|
| A01WA | 09 | PCC | 4,154 | 1/1/2003 | 79 | 75 | 23 | 2 | Corner Break, Joint Spalling, Joint Seal Damage, LTD Cracking, Shattered Slab |

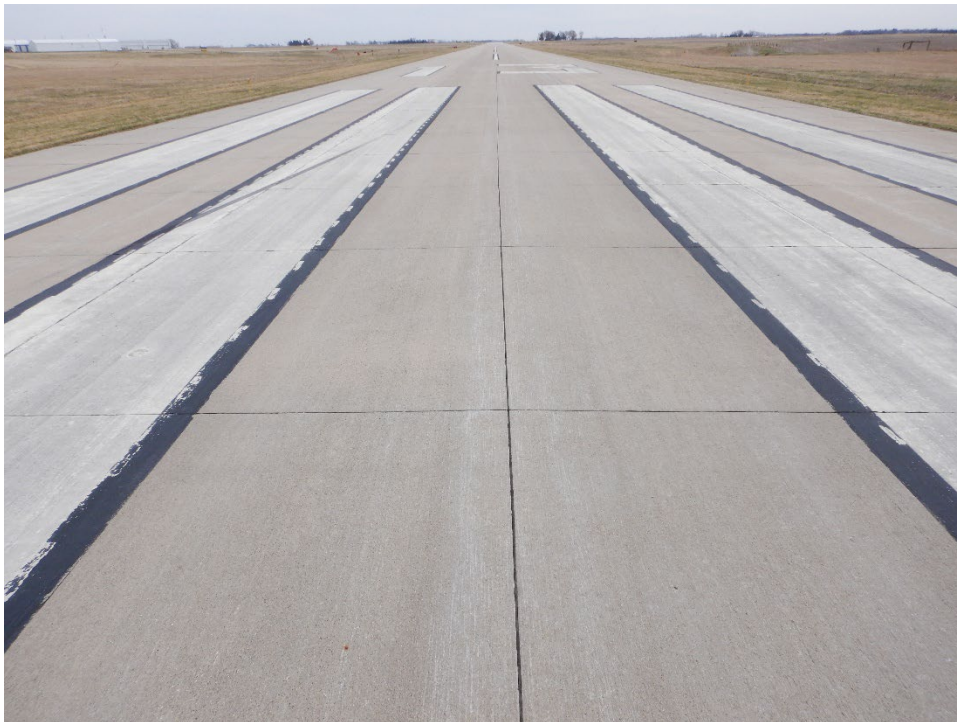
R13WA-01. Overview.

| Branch | Section | Surface Type | Section Area (sf) | LCD | 2026 PCI | % Distress Due to Load | % Distress Due to Climate/Durability | % Distress Due to Other | Type of Distress |
|---|---|---|---|---|---|---|---|---|---|
| R13WA | 01 | PCC | 198,270 | 6/3/2015 | 91 | 0 | 90 | 10 | Corner Spalling, Joint Spalling, Joint Seal Damage |

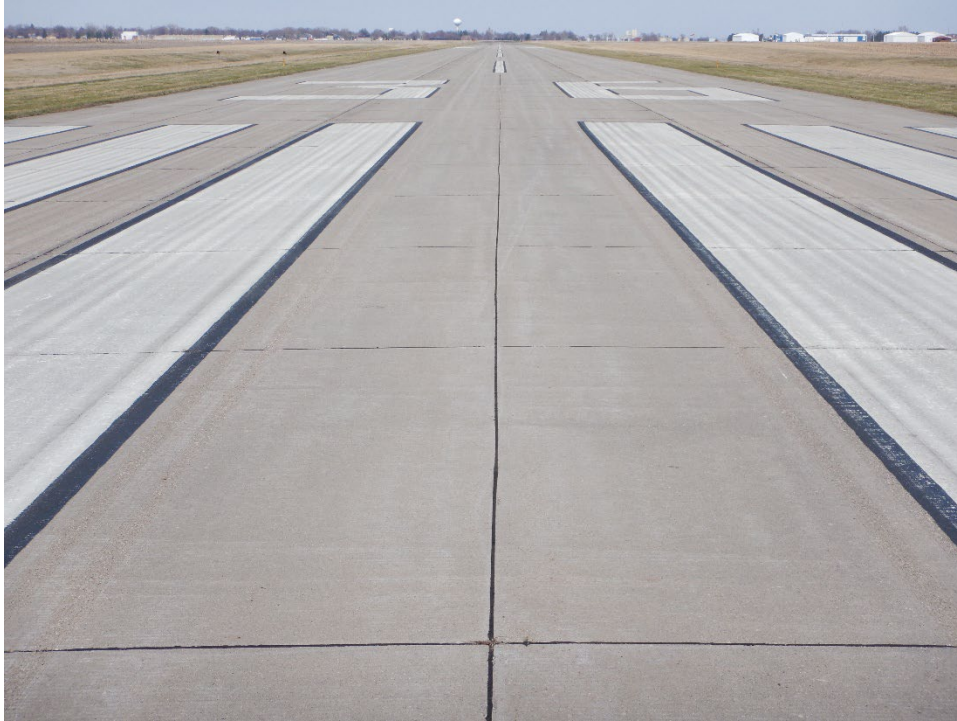
R18WA-01. Overview.

| Branch | Section | Surface Type | Section Area (sf) | LCD | 2026 PCI | % Distress Due to Load | % Distress Due to Climate/Durability | % Distress Due to Other | Type of Distress |
|---|---|---|---|---|---|---|---|---|---|
| R18WA | 01 | PCC | 307,422 | 6/1/1991 | 88 | 0 | 61 | 39 | ASR, Corner Spalling, Faulting, Joint Spalling, Joint Seal Damage |

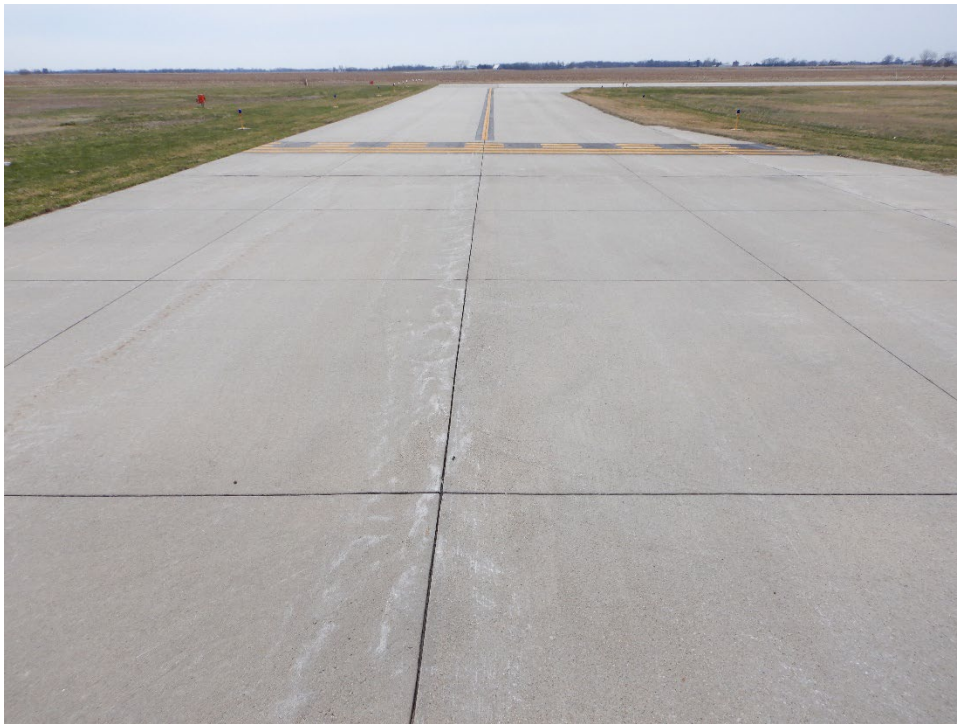
T03WA-01. Overview.

| Branch | Section | Surface Type | Section Area (sf) | LCD | 2026 PCI | % Distress Due to Load | % Distress Due to Climate/Durability | % Distress Due to Other | Type of Distress |
|---|---|---|---|---|---|---|---|---|---|
| T03WA | 01 | PCC | 18,055 | 6/3/2015 | 91 | 0 | 100 | 0 | Joint Seal Damage |

Taxiway 03 consisted of one section. Medium- and high-severity joint seal damage were observed throughout Section 01.

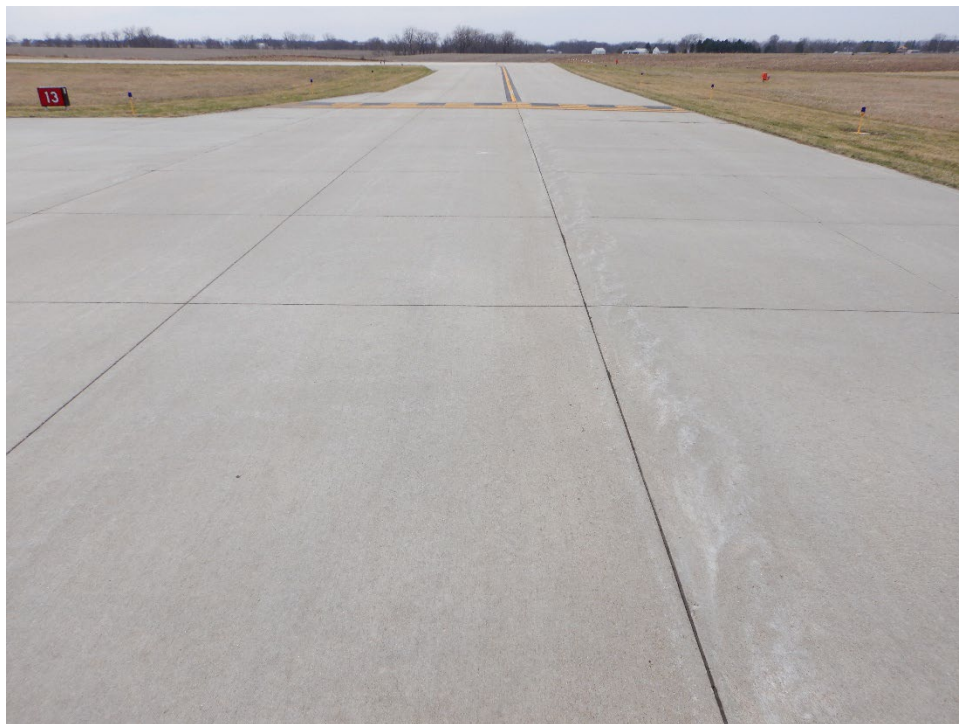
T04WA-01. Overview.

| Branch | Section | Surface Type | Section Area (sf) | LCD | 2026 PCI | % Distress Due to Load | % Distress Due to Climate/Durability | % Distress Due to Other | Type of Distress |
|---|---|---|---|---|---|---|---|---|---|
| T04WA | 01 | PCC | 17,620 | 6/3/2015 | 90 | 0 | 84 | 16 | Faulting, Joint Seal Damage |

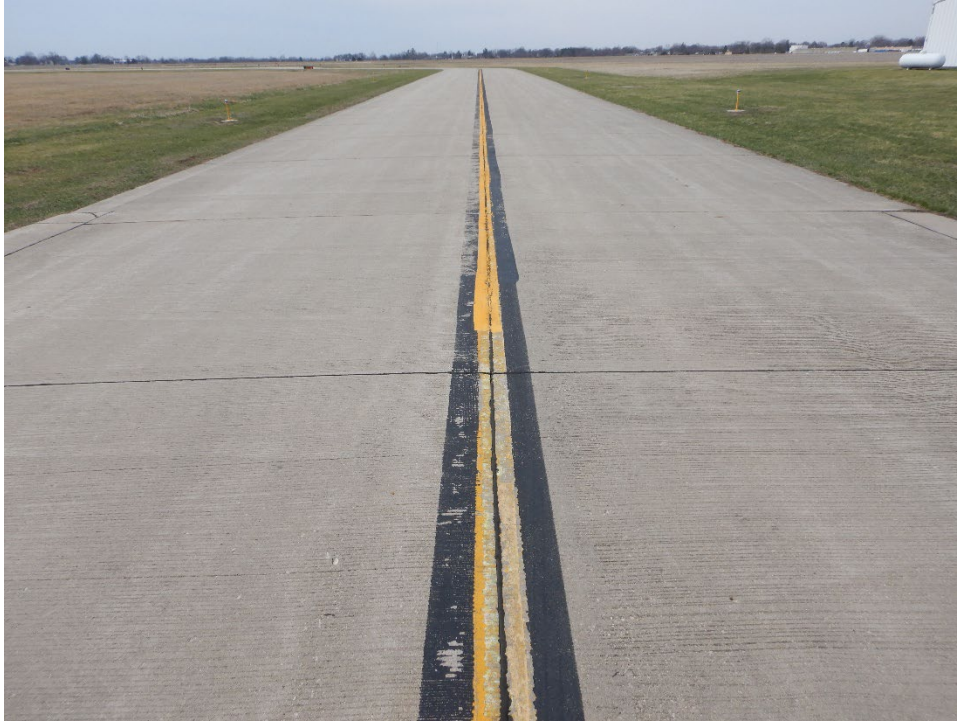
TA1WA-01. Overview.

| Branch | Section | Surface Type | Section Area (sf) | LCD | 2026 PCI | % Distress Due to Load | % Distress Due to Climate/Durability | % Distress Due to Other | Type of Distress |
|---|---|---|---|---|---|---|---|---|---|
| TA1WA | 01 | PCC | 32,237 | 7/1/1991 | 87 | 33 | 48 | 19 | Corner Break, Corner Spalling, Joint Seal Damage, Large Patch, LTD Cracking, Small Patch |

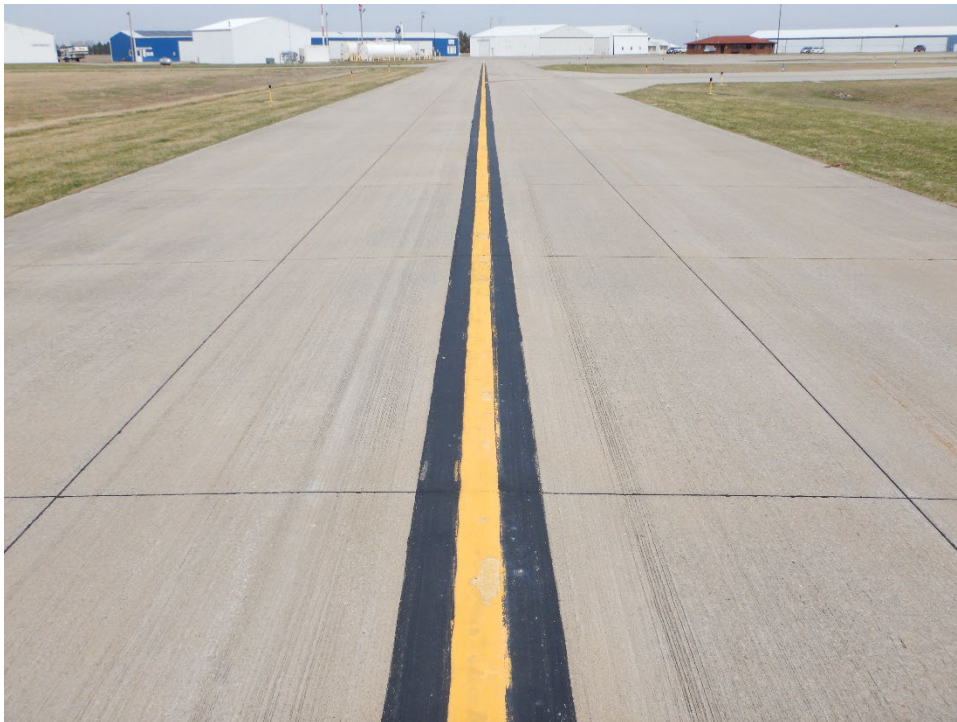
TBWA-01. Overview.

| Branch | Section | Surface Type | Section Area (sf) | LCD | 2026 PCI | % Distress Due to Load | % Distress Due to Climate/Durability | % Distress Due to Other | Type of Distress |
|---|---|---|---|---|---|---|---|---|---|
| TBWA | 01 | PCC | 22,995 | 6/1/2003 | 90 | 0 | 54 | 46 | Corner Spalling, Joint Spalling, Joint Seal Damage |

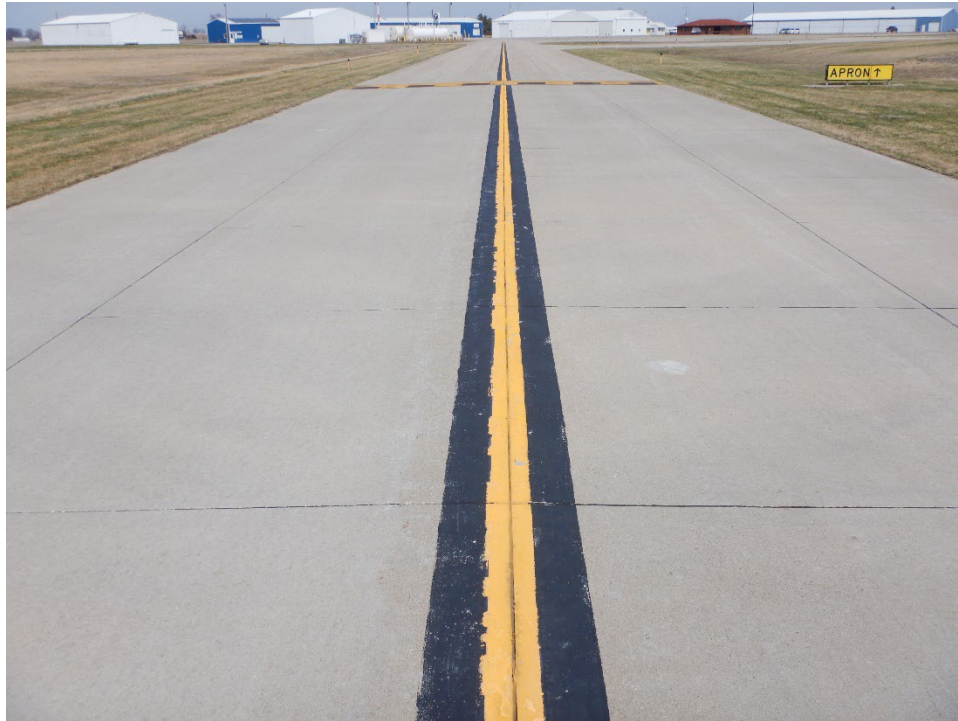
TBWA-02. Overview.

| Branch | Section | Surface Type | Section Area (sf) | LCD | 2026 PCI | % Distress Due to Load | % Distress Due to Climate/Durability | % Distress Due to Other | Type of Distress |
|---|---|---|---|---|---|---|---|---|---|
| TBWA | 02 | PCC | 7,410 | 6/3/2015 | 90 | 29 | 60 | 11 | Joint Spalling, Joint Seal Damage, LTD Cracking |

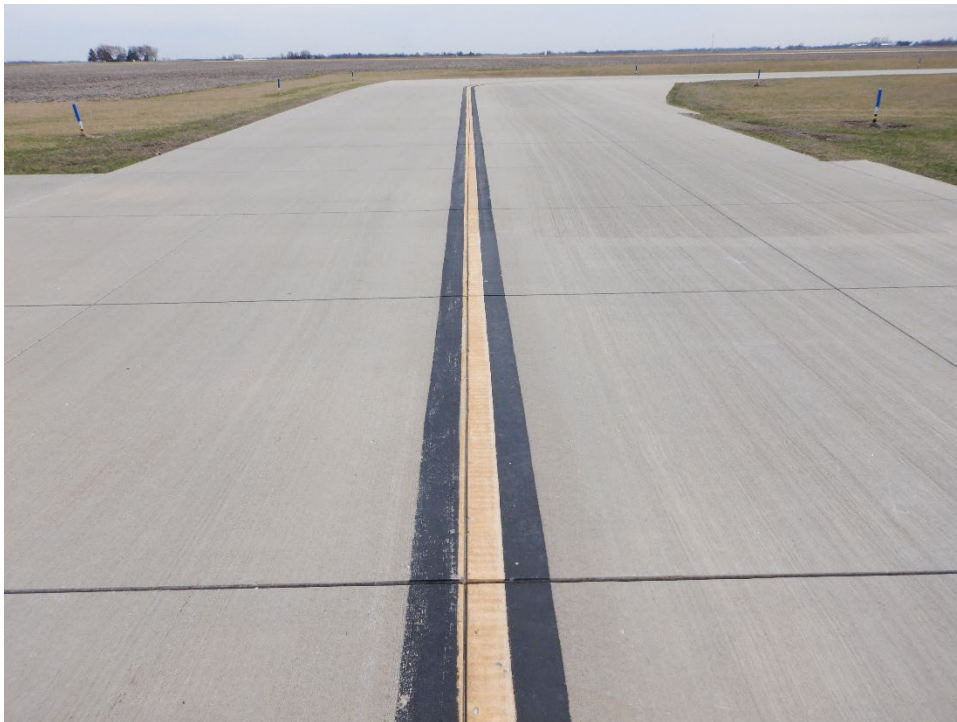
TBWA-03. Overview.

| Branch | Section | Surface Type | Section Area (sf) | LCD | 2026 PCI | % Distress Due to Load | % Distress Due to Climate/Durability | % Distress Due to Other | Type of Distress |
|---|---|---|---|---|---|---|---|---|---|
| TBWA | 03 | PCC | 20,474 | 3/3/2020 | 99 | 33 | 0 | 67 | ASR, Corner Break, Joint Spalling |

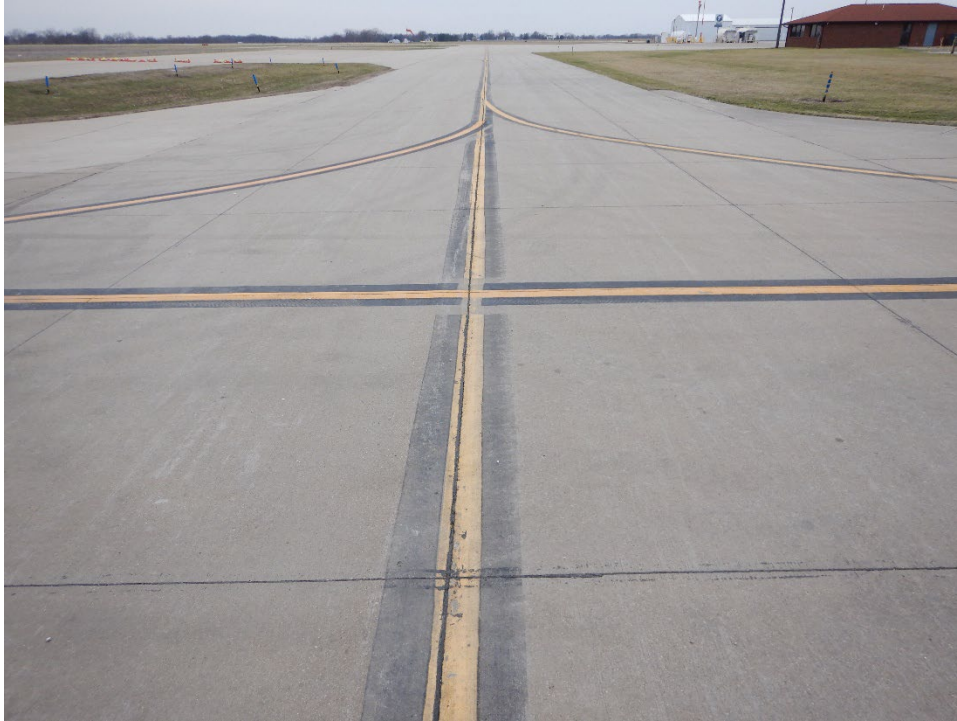
TH01WA-01. Overview.

| Branch | Section | Surface Type | Section Area (sf) | LCD | 2026 PCI | % Distress Due to Load | % Distress Due to Climate/Durability | % Distress Due to Other | Type of Distress |
|---|---|---|---|---|---|---|---|---|---|
| TH01WA | 01 | PCC | 33,422 | 3/10/2003 | 93 | 0 | 100 | 0 | Joint Seal Damage |

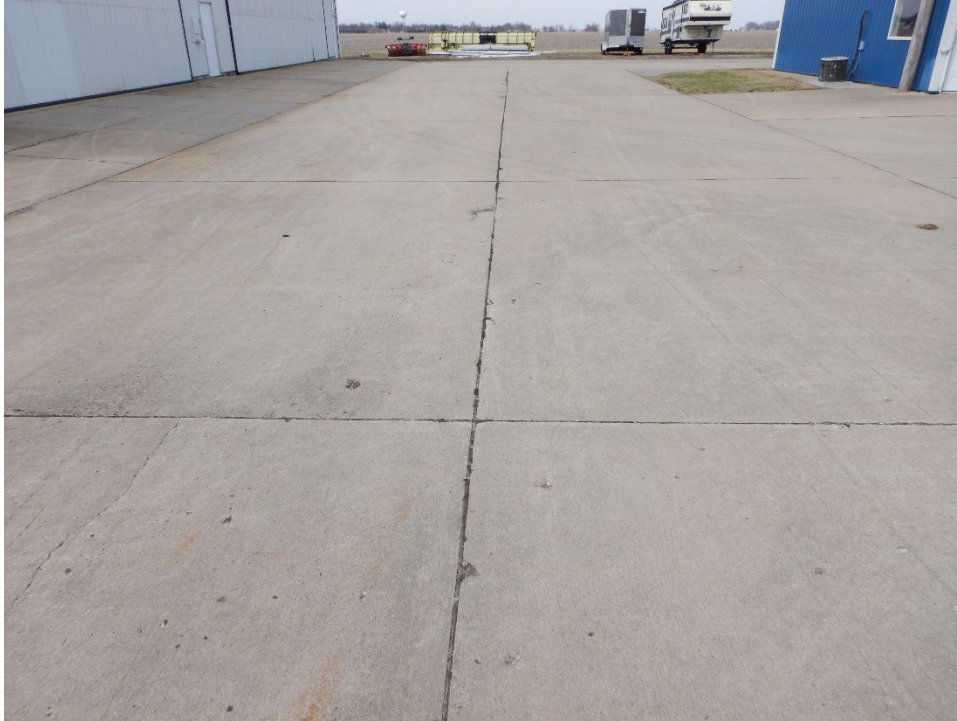
TH01WA-02. Overview.

| Branch | Section | Surface Type | Section Area (sf) | LCD | 2026 PCI | % Distress Due to Load | % Distress Due to Climate/Durability | % Distress Due to Other | Type of Distress |
|---|---|---|---|---|---|---|---|---|---|
| TH01WA | 02 | PCC | 6,606 | 1/1/1994 | 77 | 13 | 41 | 46 | Joint Spalling, Joint Seal Damage, LTD Cracking, Small Patch |

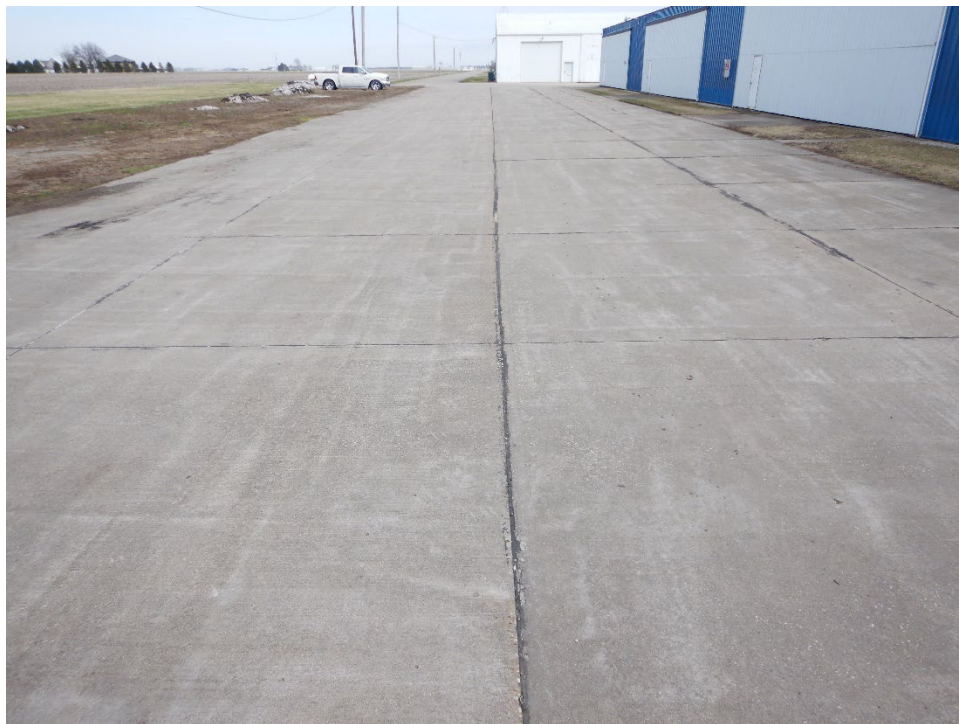
TH01WA-03. Overview.

| Branch | Section | Surface Type | Section Area (sf) | LCD | 2026 PCI | % Distress Due to Load | % Distress Due to Climate/Durability | % Distress Due to Other | Type of Distress |
|---|---|---|---|---|---|---|---|---|---|
| TH01WA | 03 | PCC | 11,948 | 1/1/1994 | 65 | 69 | 26 | 5 | Faulting, Joint Seal Damage, LTD Cracking |
