# Waukon Municipal Airport

**PAVEMENT MANAGEMENT REPORT**

**AUGUST 2019**

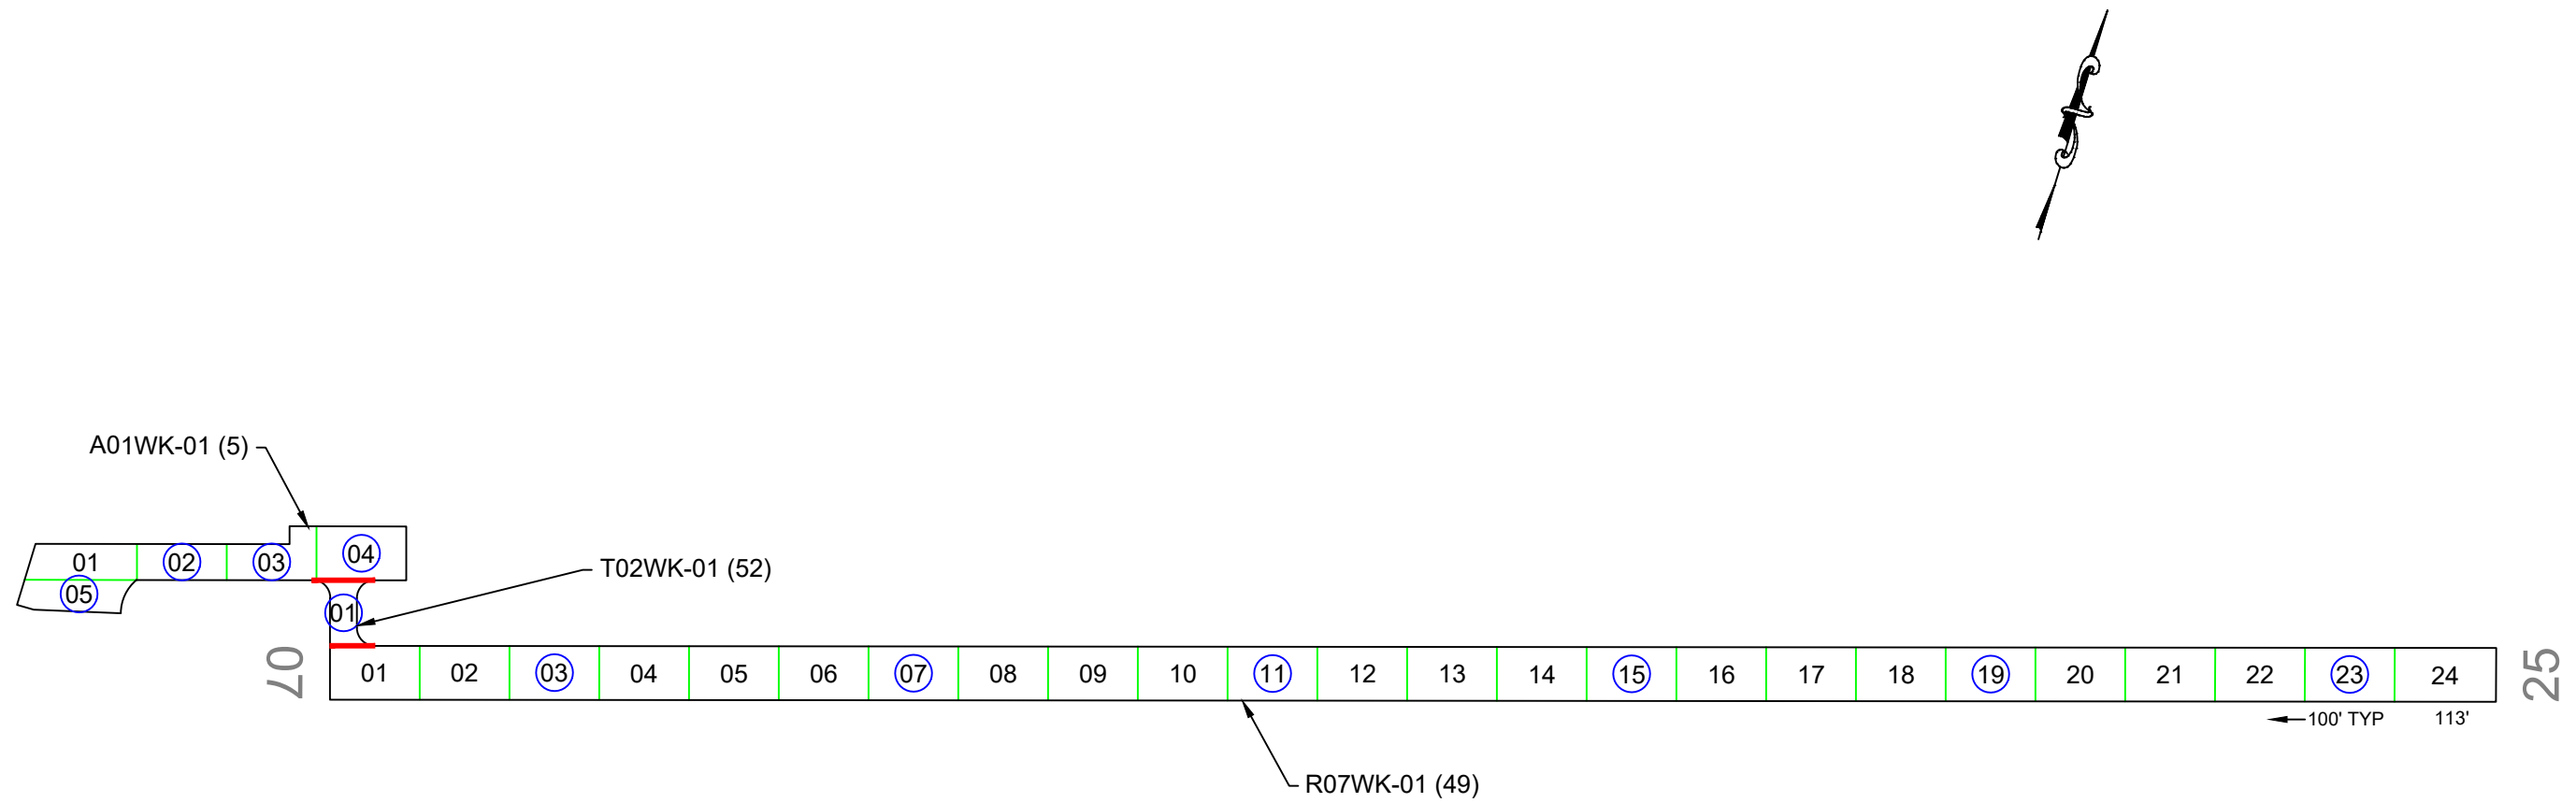
FIGURE 3. NETWORK DEFINITION MAP.

Approximately 170,638 square feet of pavement were evaluated at Waukon Municipal Airport, as illustrated in Figure 2. This figure also shows the area-weighted age in years of the pavements at the time of the inspection. Figure 3 provides a map that details how the pavement network was divided into management units and identifies the sample units that were evaluated during the pavement inspection at Waukon Municipal Airport.

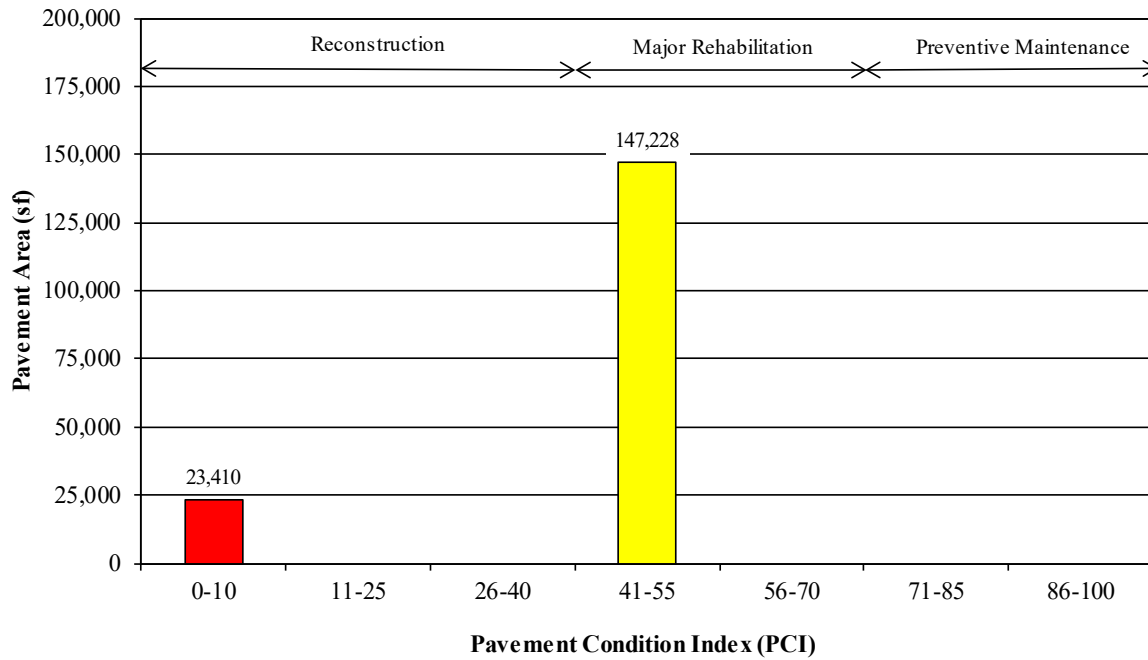
Figure 6. Pavement area by PCI range at Waukon Municipal Airport.

Figure 6 summarizes the overall condition of the pavements at Waukon Municipal Airport, and Figure 7 presents area-weighted condition (average PCI adjusted to account for the relative size of the pavement sections) by branch use. Figure 8 is a map that displays the condition of the evaluated pavements. Table 1 summarizes the results of the pavement evaluation. Appendix B presents photographs taken during the PCI inspection, and Appendix C contains detailed information on the distresses observed during the visual survey. Appendix D includes detailed work history information that was collected during the record review process.

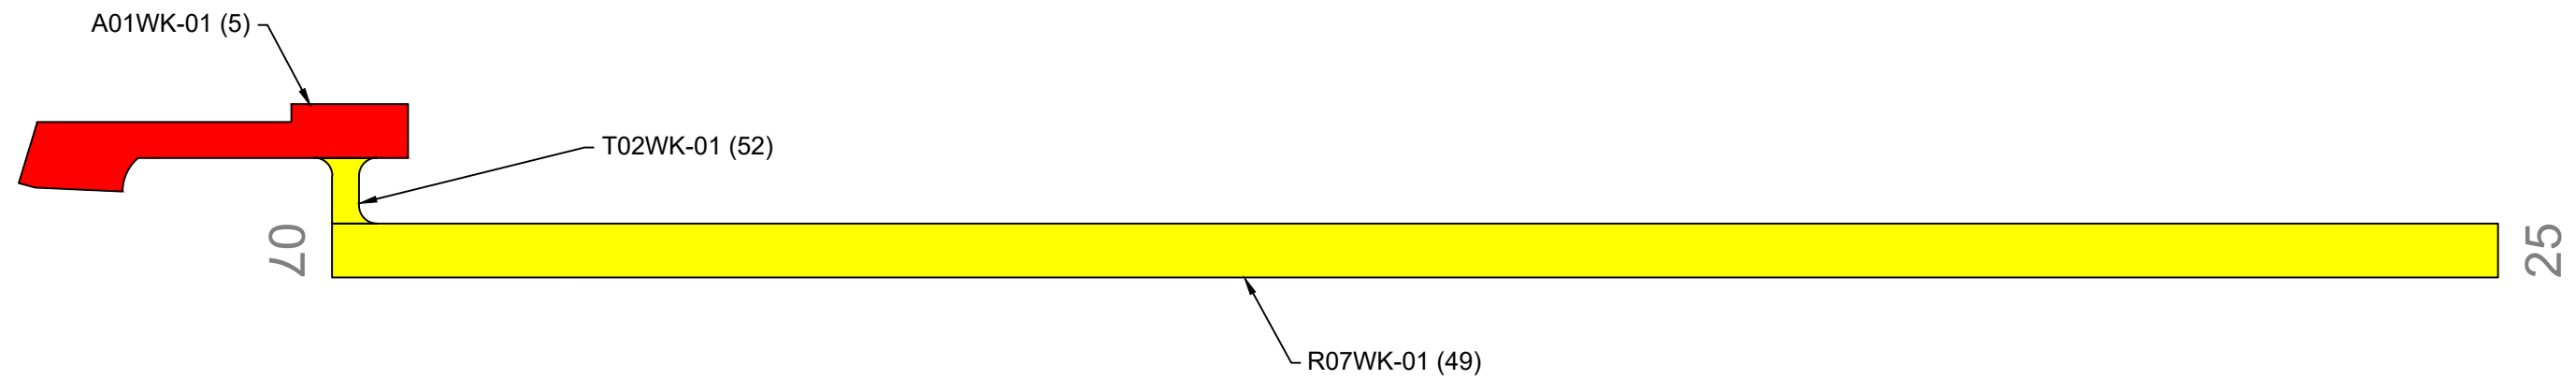
FIGURE 8. PCI MAP.

The pavements at Waukon Municipal Airport were inspected on November 13, 2018. The 2018 area-weighted condition of Waukon Municipal Airport is 43, with conditions ranging from 5 to 52 (on a scale of 0 [failed] to 100 [excellent]). During the previous pavement inspection in 2014, the area-weighted PCI of the airport was 66.
